Inspection Photos

Operator: ST CROIX OPERATING INC - 81490

Location ID: 455607

Inspection Doc. Number: 682504213

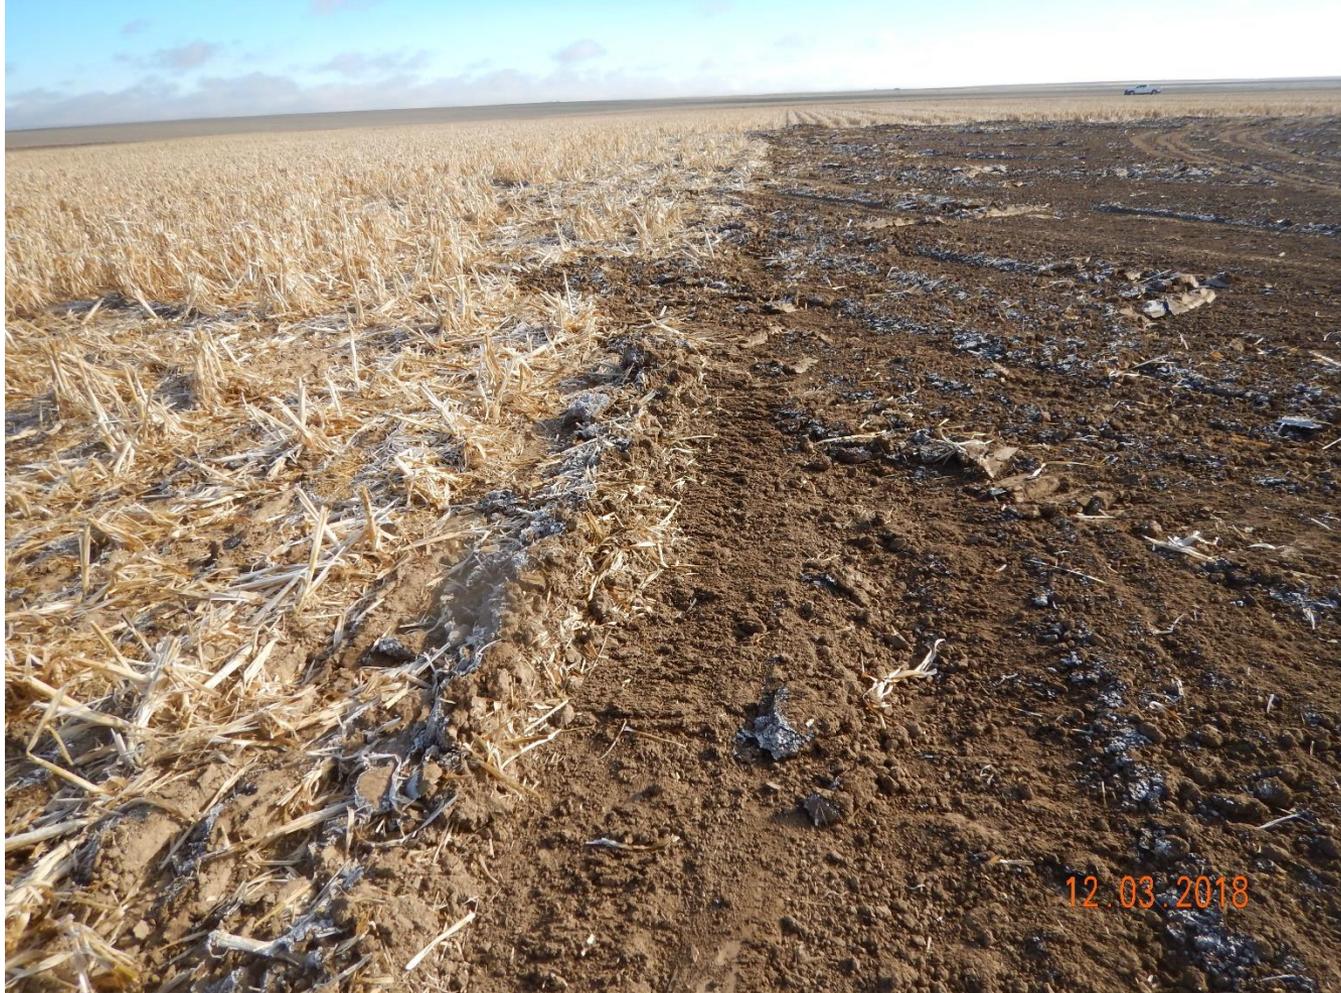
Photo 10: Photo taken from the northwest corner of the location. Photo shows operator appears to have conducted soil salvage operations, however, sufficient soil salvage does not appear to have been conducted on the entire location in accordance with 1002.b. Photo shows areas on the north end compared to the reference; it is unlikely that the entire topsoil horizon has been salvaged in these area.

Photo 16: Photo taken from the center of the pad, facing North. Photo shows areas of the south and west end of the pad where ~1 inch of soil appears to have been salvaged when compared to the adjacent reference.

Photo 17: Photo taken from the north end of the pad, facing east. See comments under photo 16 and photo 10.

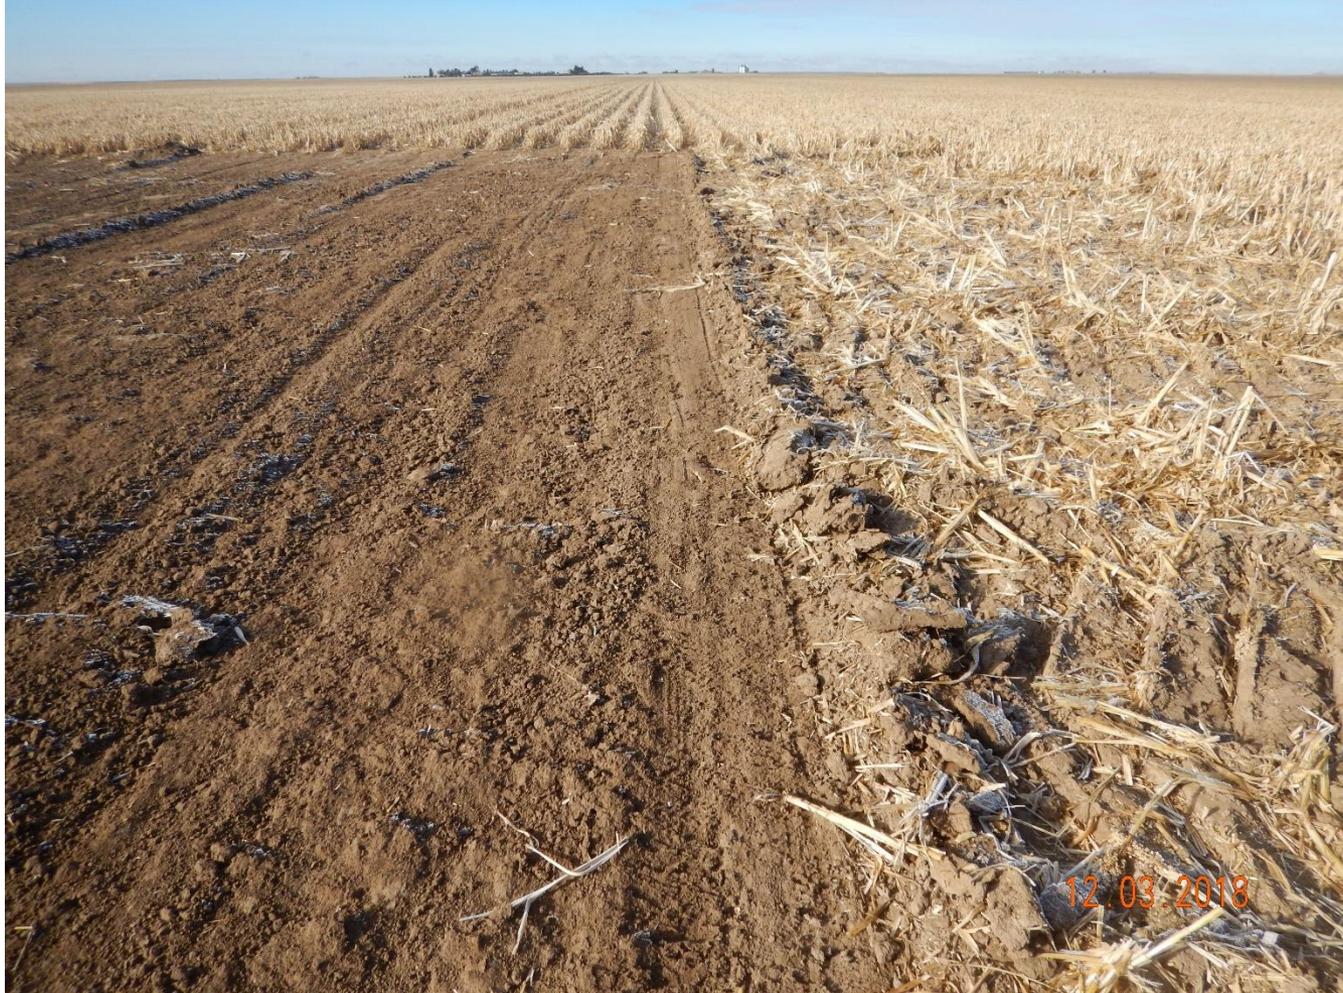
Photo 18: Photo taken from the north end of the pad, facing west. See comments under photo 16 and photo 10.

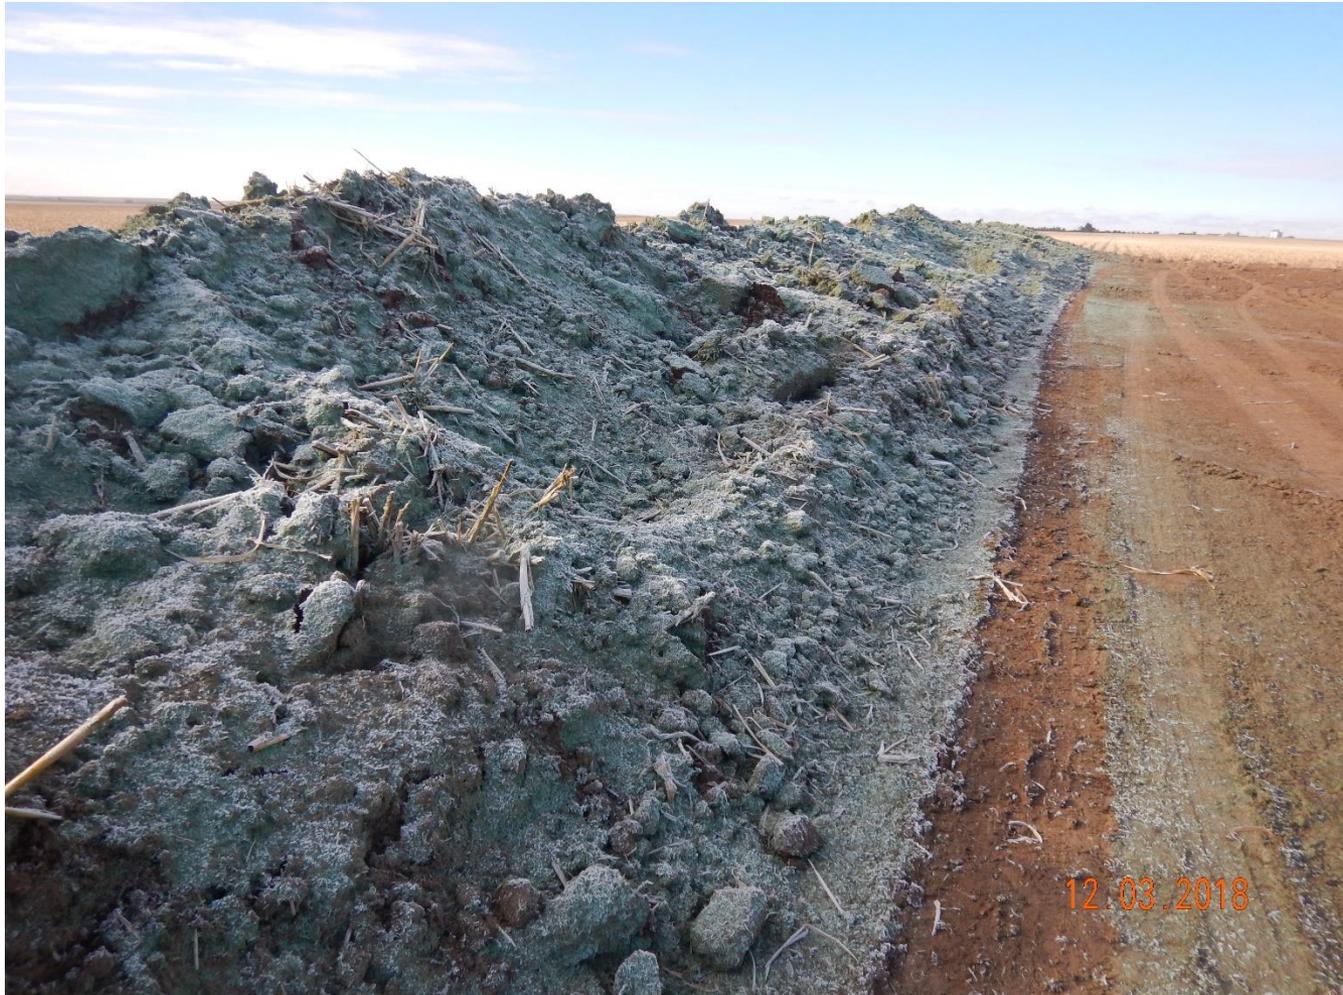
Photo 19: Photo taken from the southeast end of the location, facing west. Photo shows soil stockpile.
