Inspection Photos
Location Name: Kelsall 33-7 #4-1
API: 05-067-09866

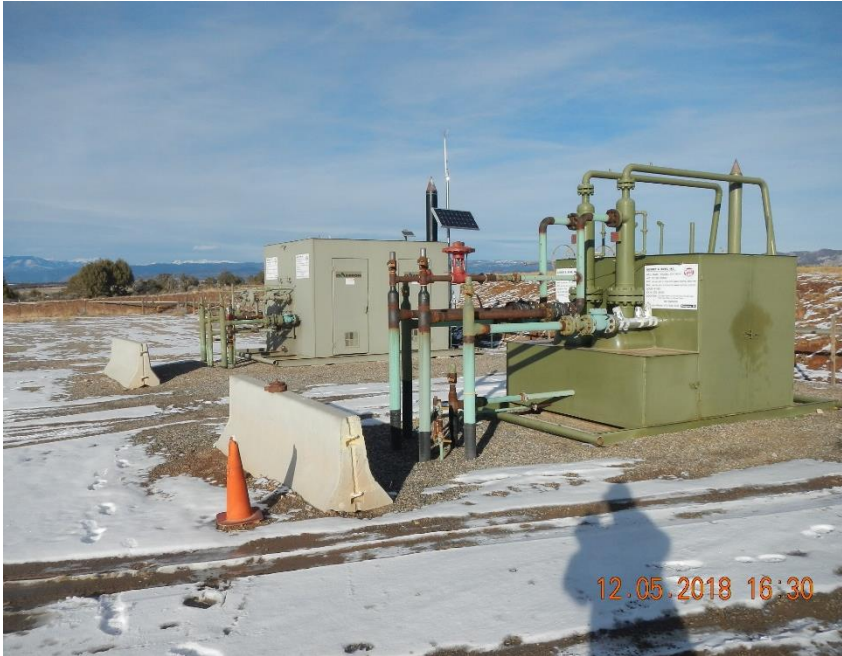
Horizontal heated separators for wells #4-1 through #4-4.

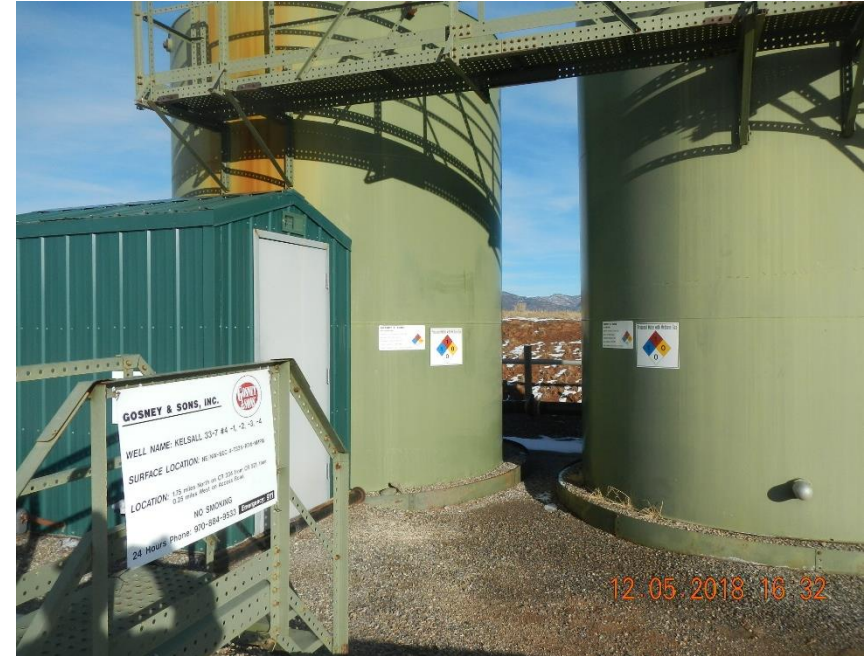
2 - 300 bbl. produced water ASTs.

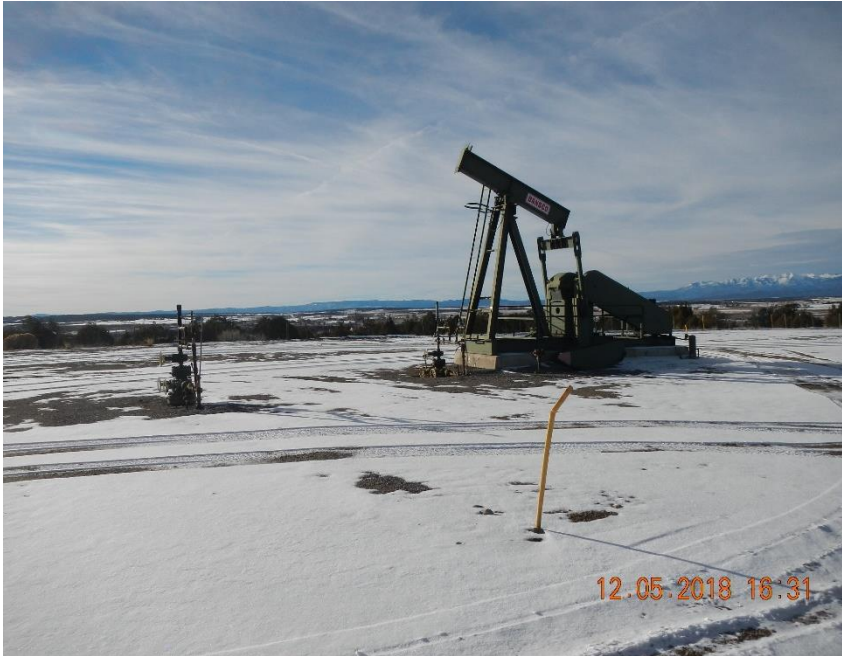
#4-3 and #4-4 well heads. Pump jack on #4-3 was dismantled at the time of this inspection.

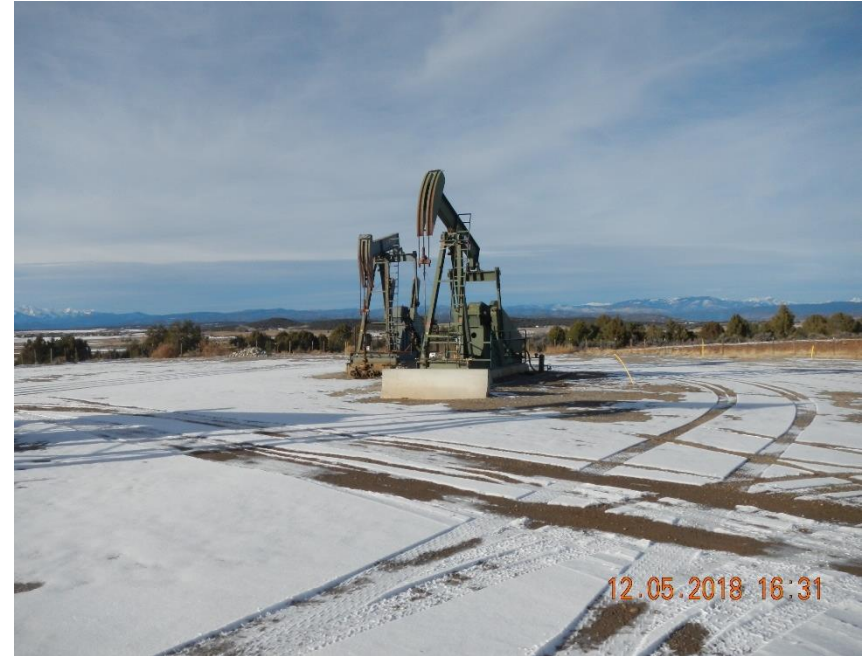
#4-1 and #4-2 well heads and pump jacks.

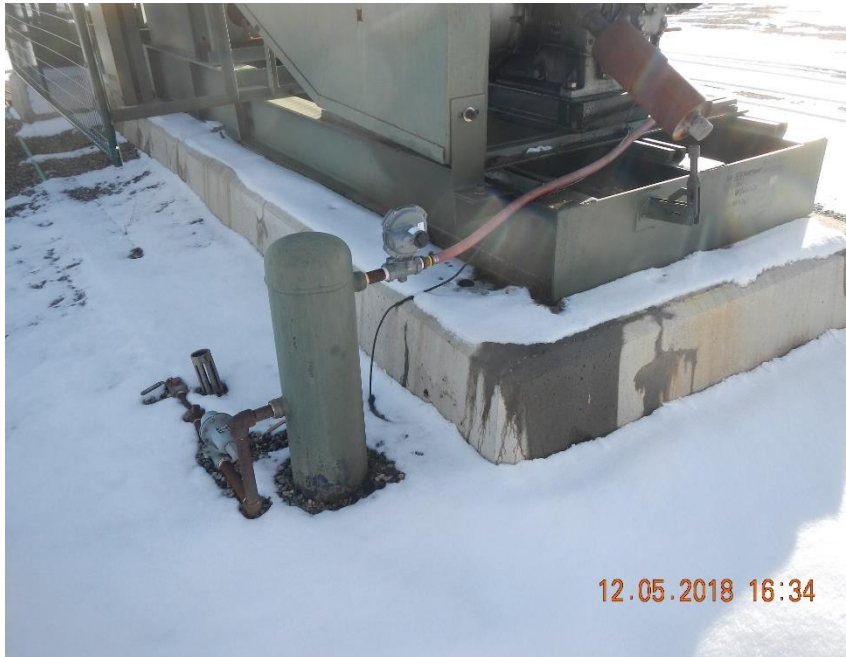
Lube oil leak underneath prime mover on #4-3.

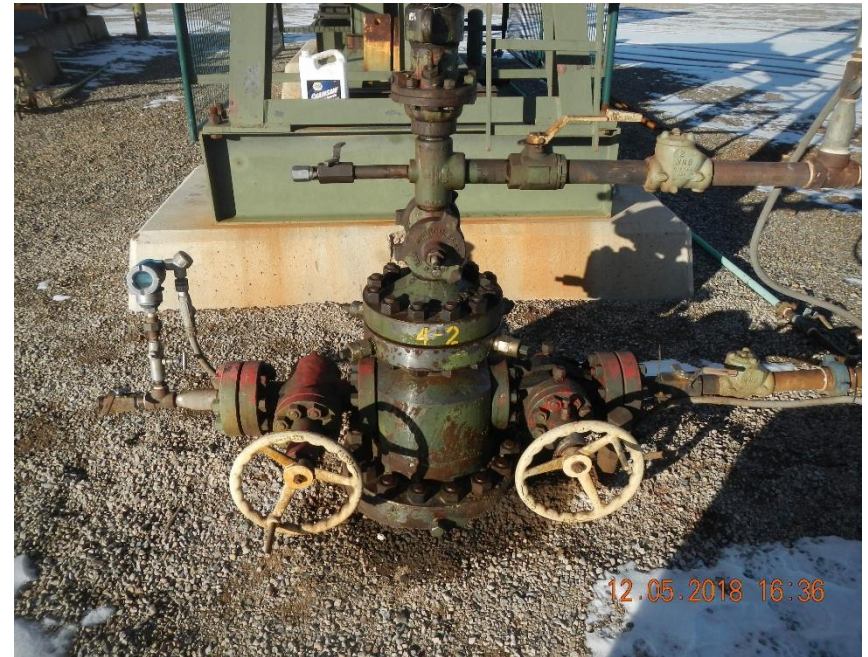
Stained soil at #4-2 well head.

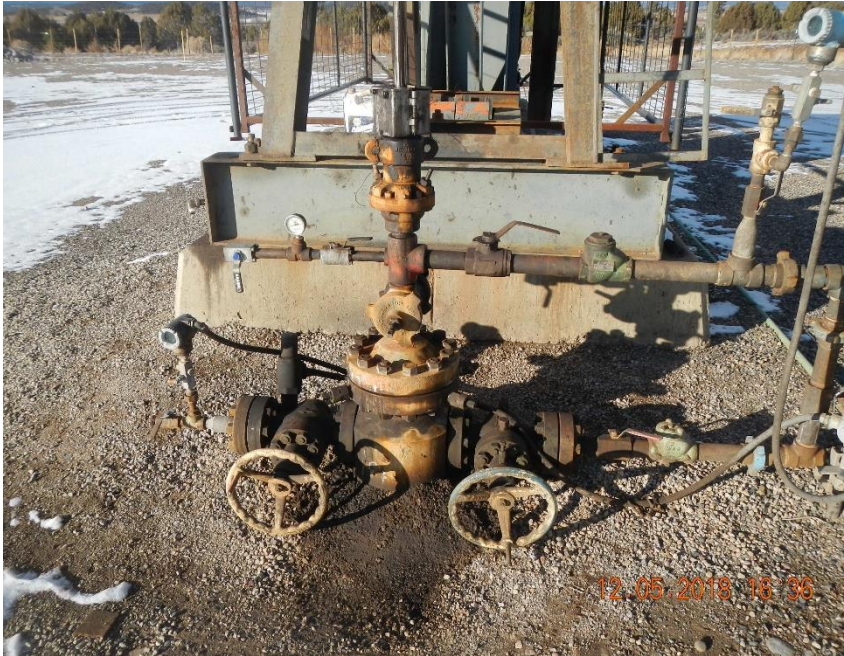
Stained soil at #4-1 well head.

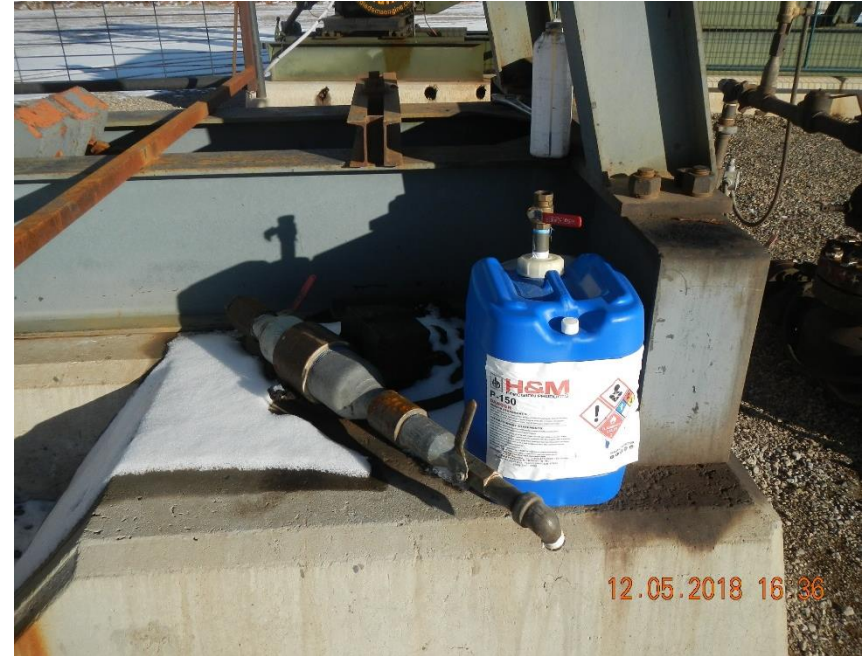
Unused equipment and containers stored at base of pump jack.

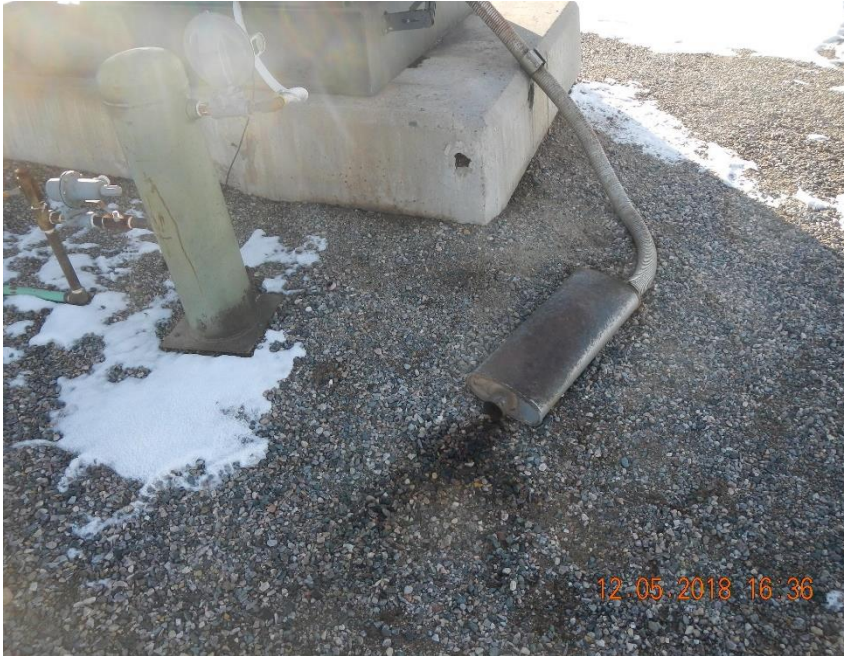
Stained soil at exhaust for prime mover.

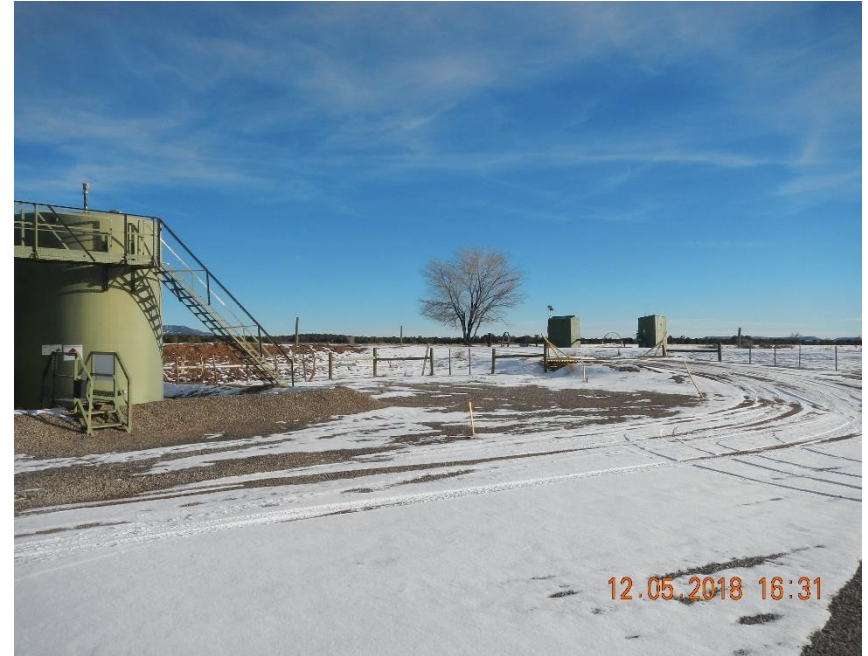
Meter shacks adjacent to location.
