Inspection Photos

Location Name: Pond 10 Centralized E&P Waste Management Facility

Facility ID: #159504 Pit Facility ID: #291946

Inspection Date: November 28, 2018

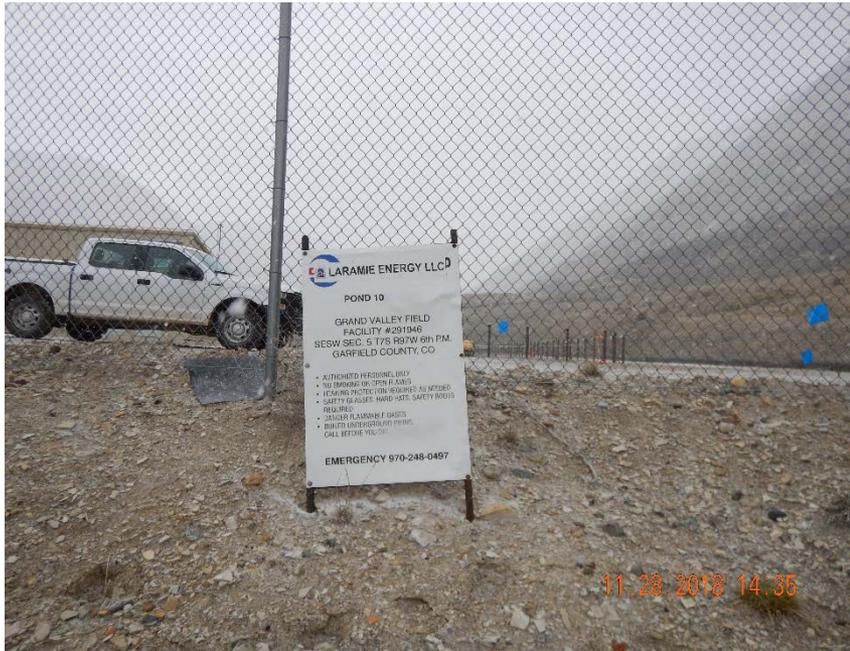
Photo #1 – Sign located at SE corner of pit.

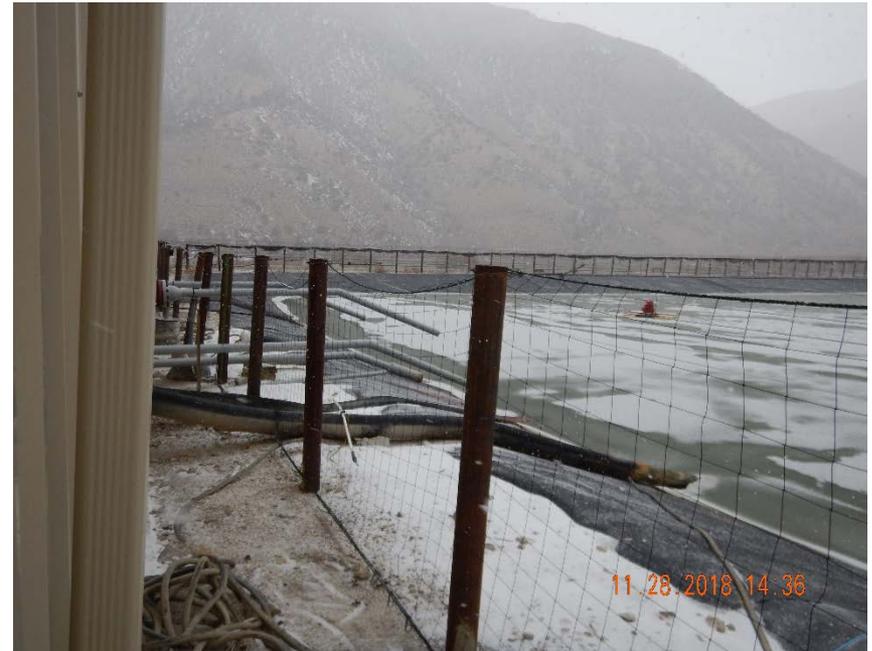
Photo #2 – Inlets to Pond 10 pit located on south side.

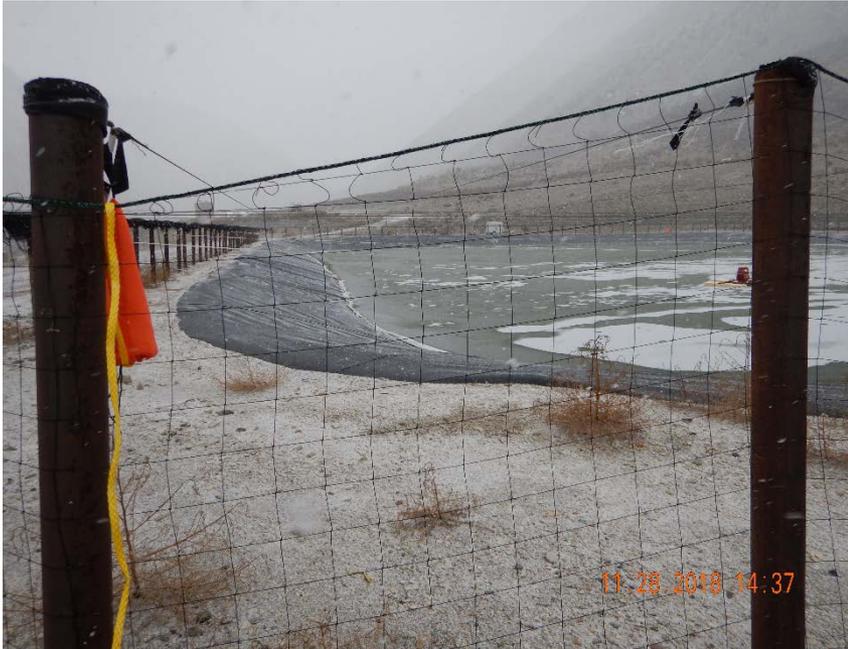
Photo #3 – Wildlife netting over top of Pond 10 pit has been removed for the winter months, per agreement between operator and CPW.

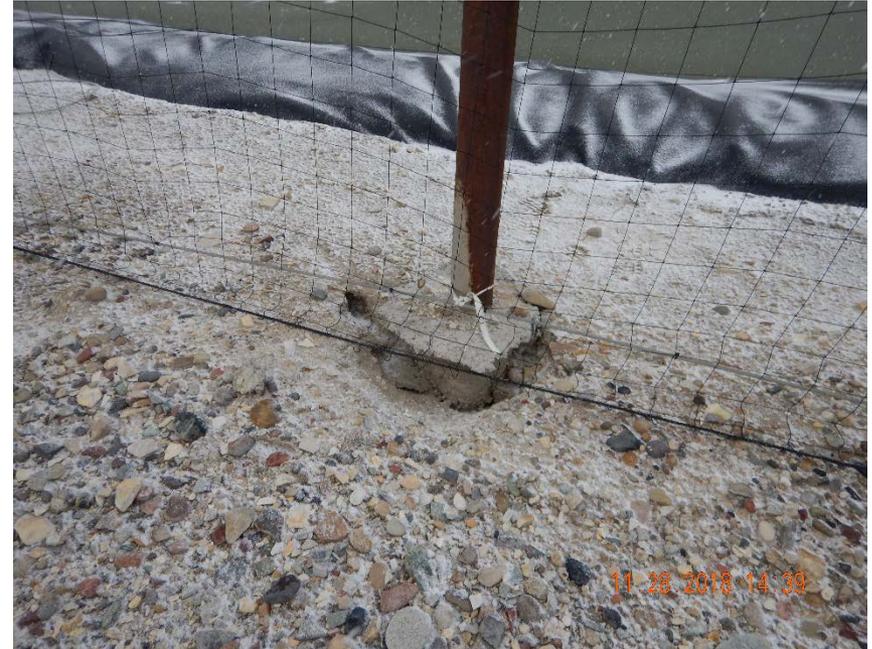
Photo #4 – Maintenance required at several netting posts along west side of pit (1).

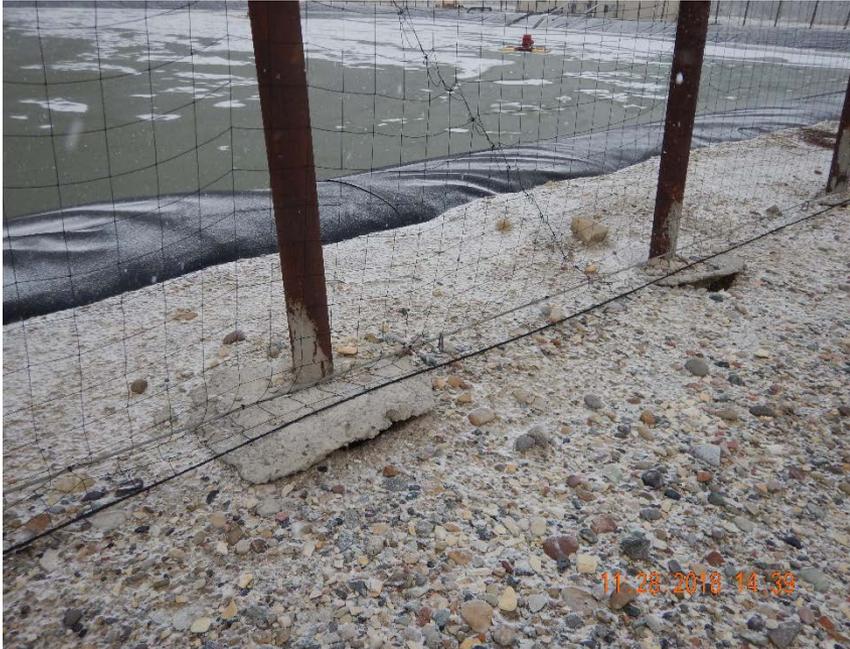
Photo #5 - Maintenance required at several netting posts along west side of pit (2).

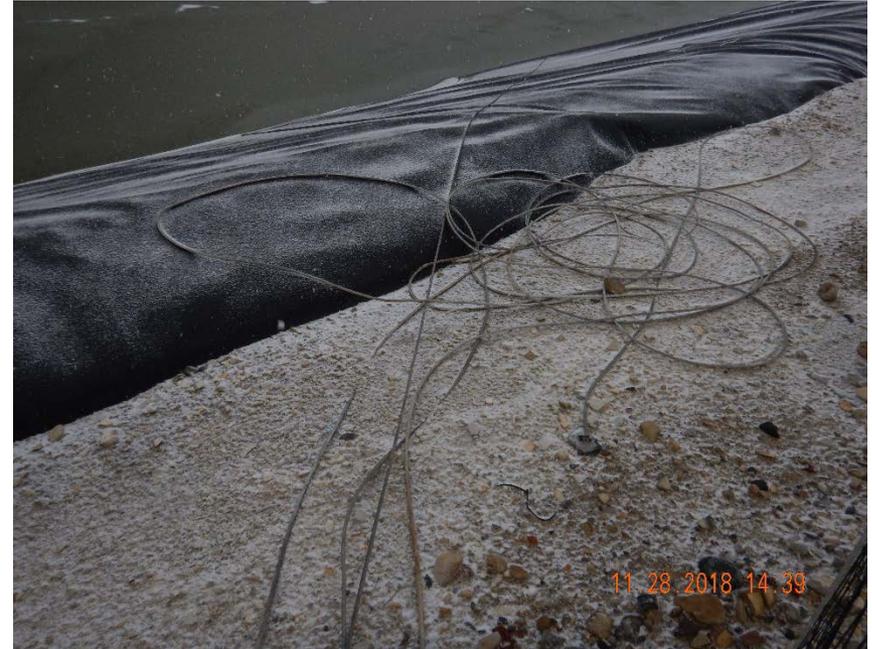
Photo #6 – Unused equipment (steel cable) stored on west side of pit, in contact with pit liner.

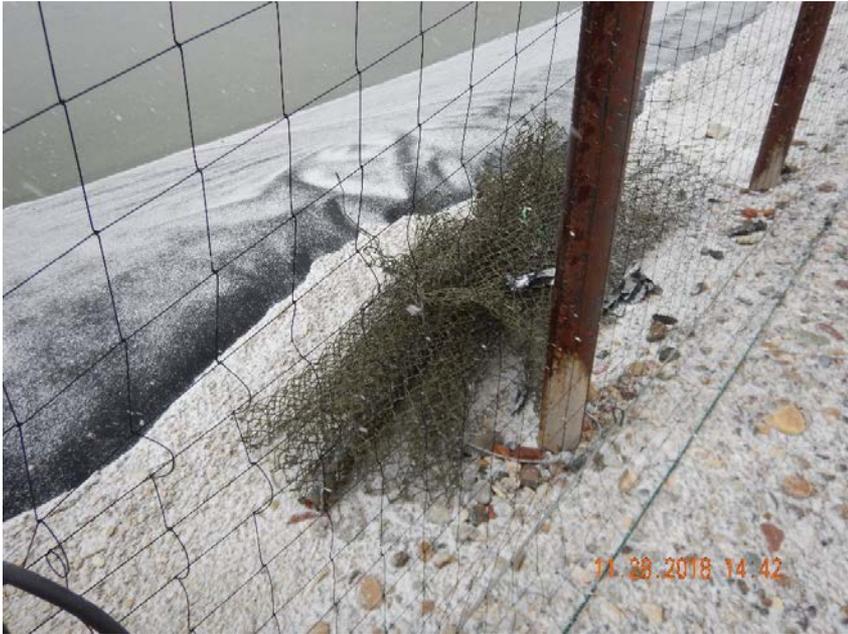
Photo #7 - Unused equipment (chain link) stored on north side of pit.

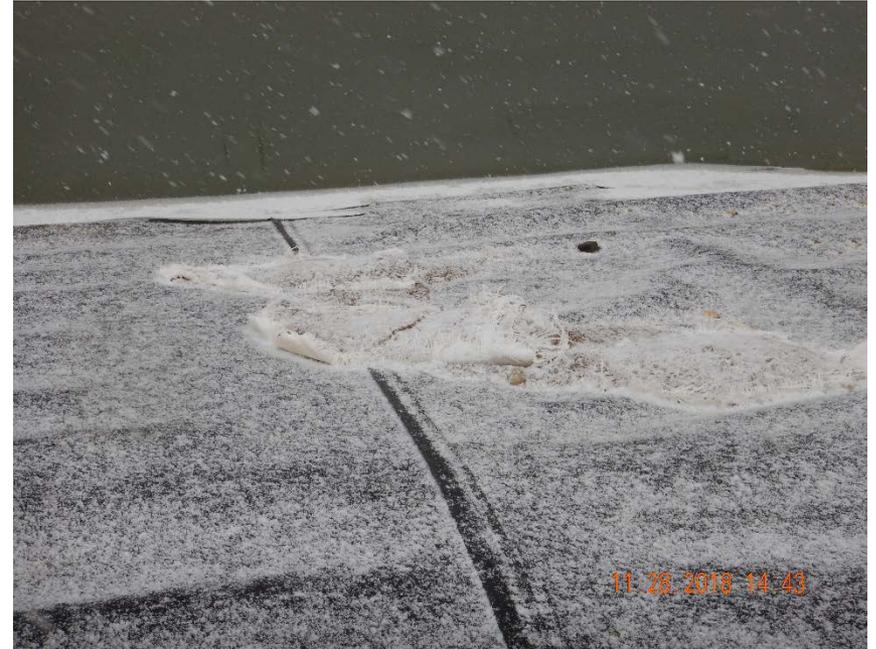
Photo #8 – Foreign material (sand bag remnants) on top of liner on east side of pit.

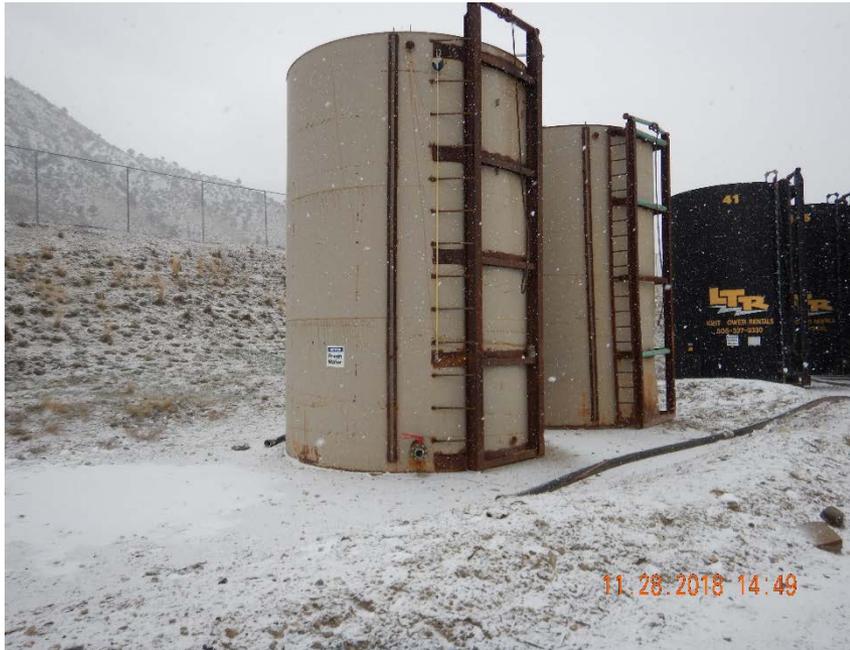
Photo #9 – View of 400 bbl fresh water ASTs from north. Tan ASTs in foreground are visible in COGCC GIS Online 2017 Aerial photographs. Black ASTs in background are not.

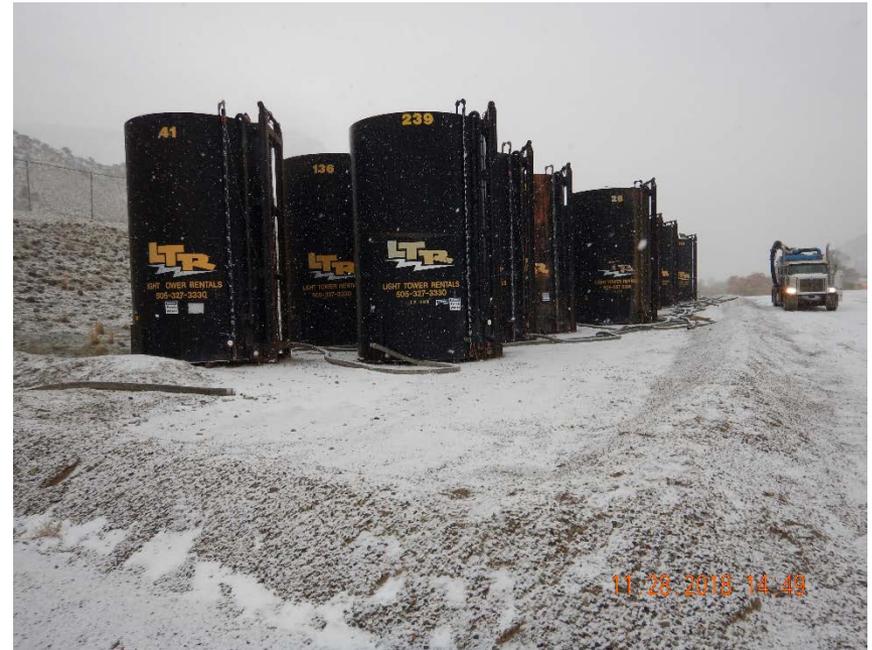
Photo #10 – View of south tank battery from NW corner. Most of these LTR tanks were labelled “Fresh Water” on inspection date.

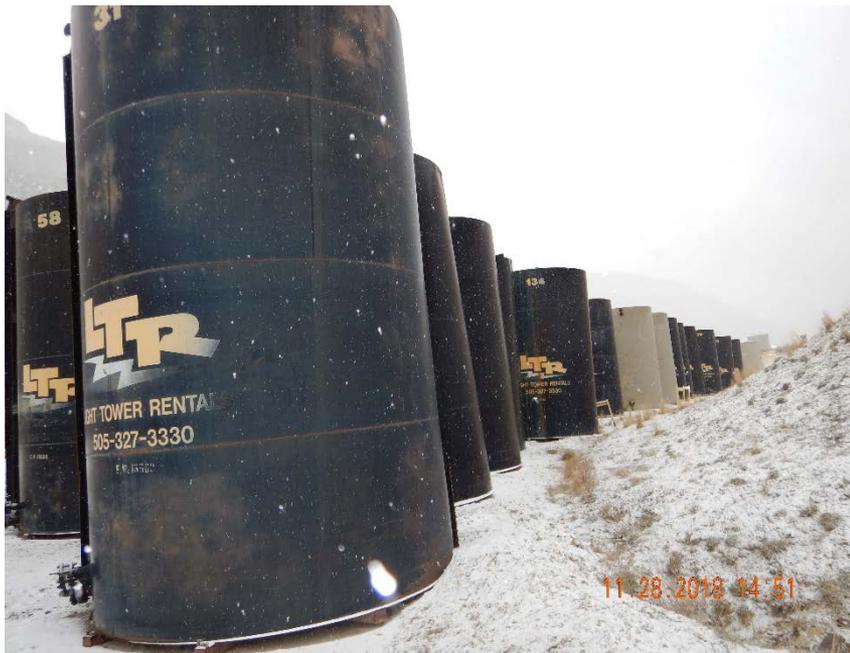
Photo #11 – View of south tank battery from SE corner. Note absence of earthen berm along east side of tank battery.

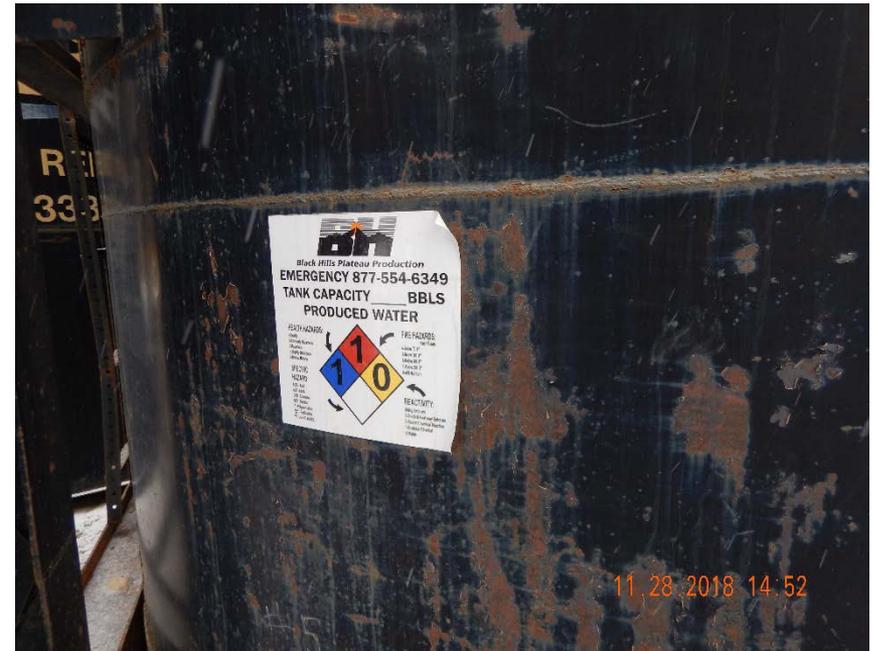
Photo #12 – One of several tanks in south tank battery that was labelled “Produced Water.” These tanks did not appear to be in use on inspection date, many were labelled “Do not use”.
