# Inspection Photos

Operator: ABILENE PERFECT ENERGY JV LLC -  
10581

Location ID: 433129

Inspection Doc. Number: 682504269  
Lincoln County, CO

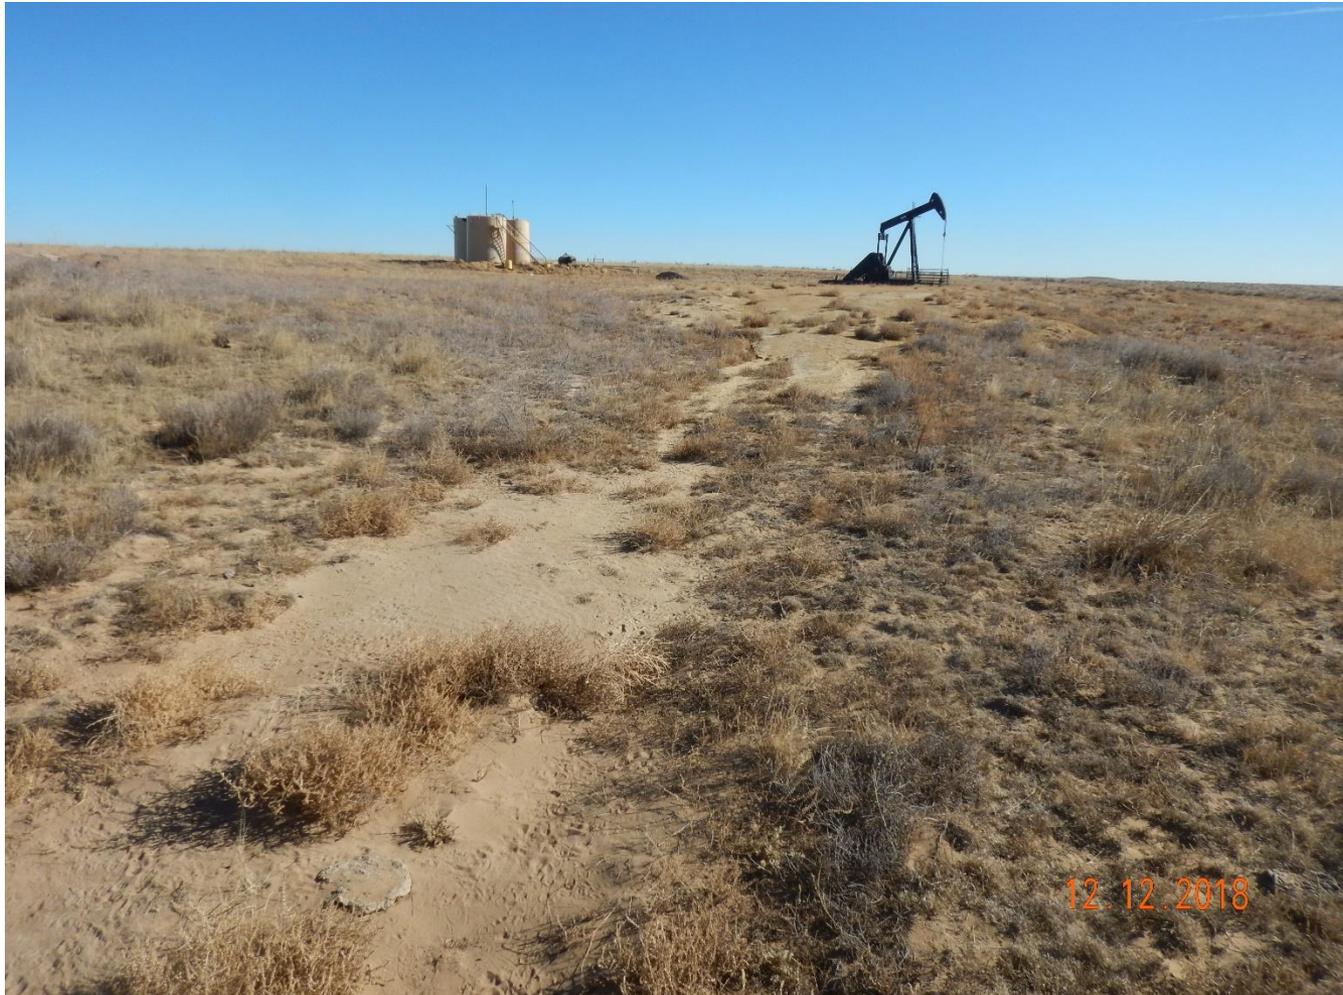
**Photo 1:** Photo taken from the North end of the location, facing south. Photo shows location

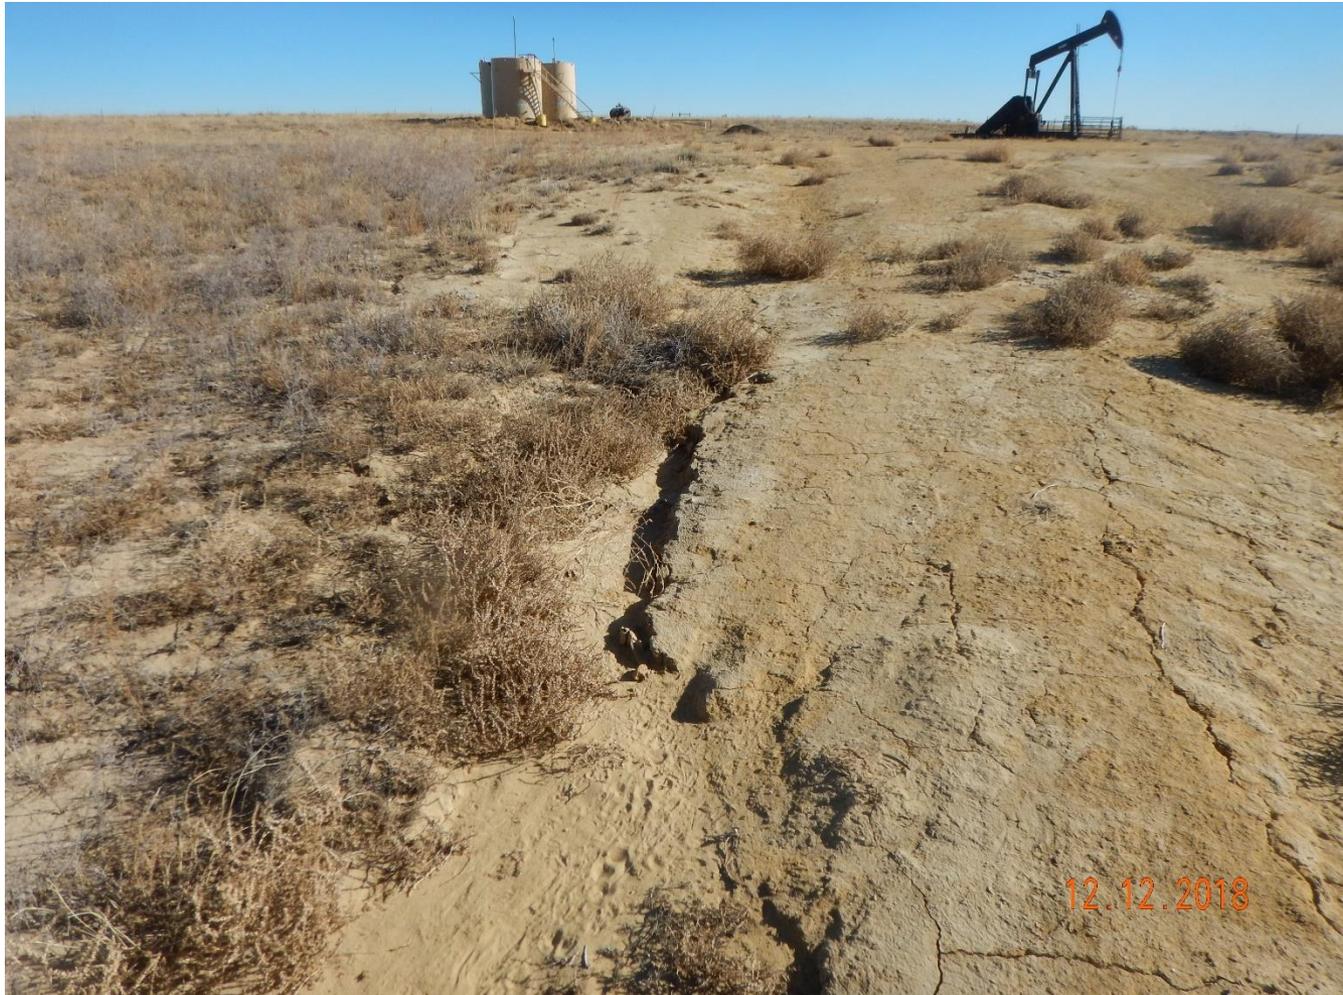
**Photo 2:** Photo taken from the North end of the location, facing south. Photo shows erosion has continued to degrade access road and location. Unable to find evidence of maintenance, or evidence that the required BMPs have been installed per 1002.f and corrective actions.

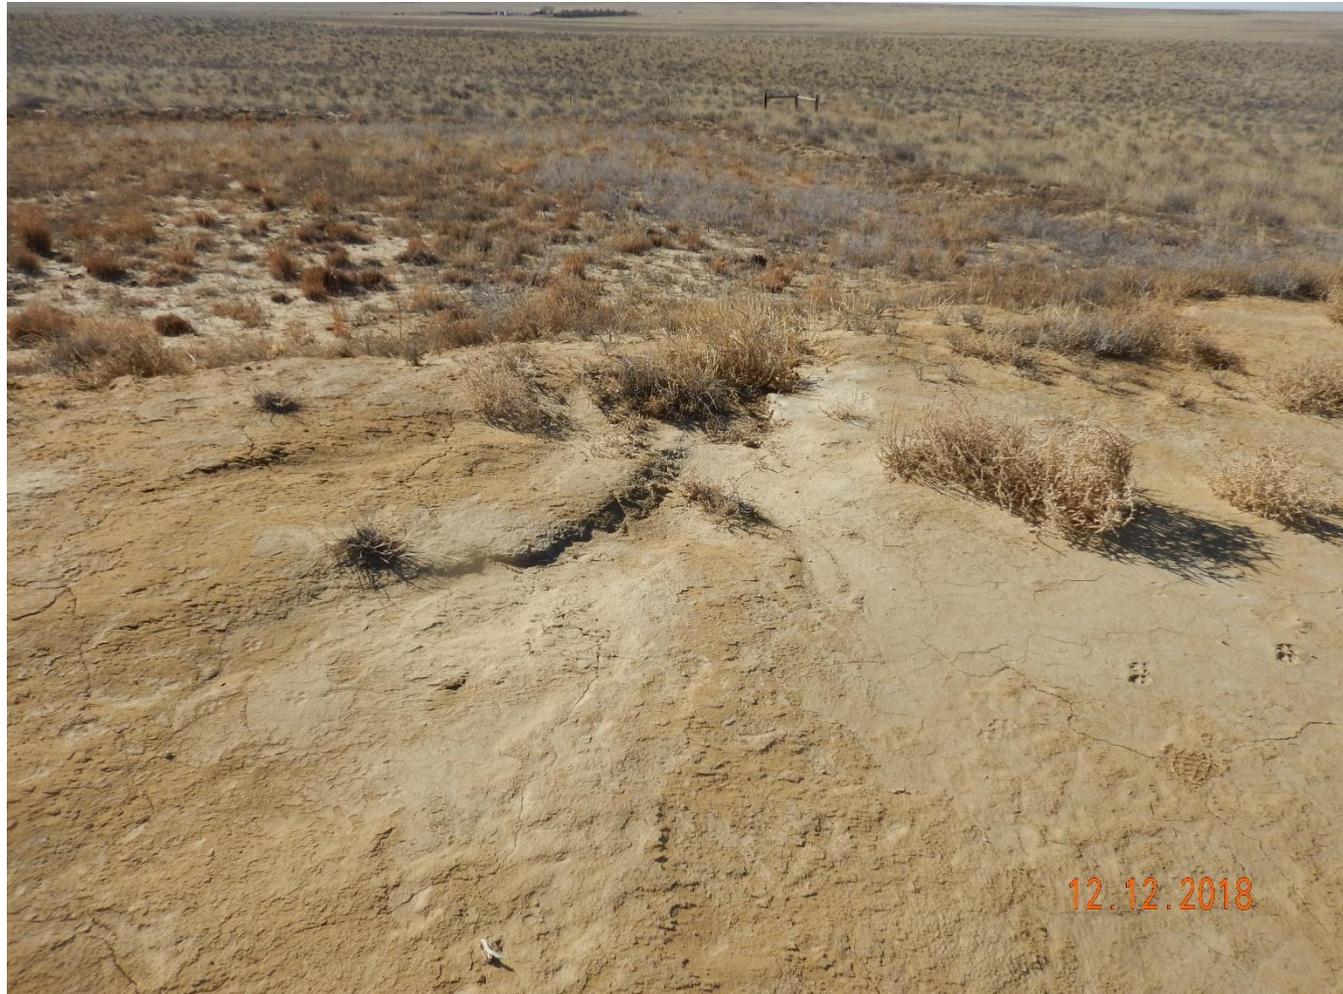
**Photo 3:** Photo taken from the North end of the location, facing west. Photo shows erosion has continued to degrade access road and location. Unable to find evidence of maintenance, or evidence that the required BMPs have been installed per 1002.f and corrective actions.

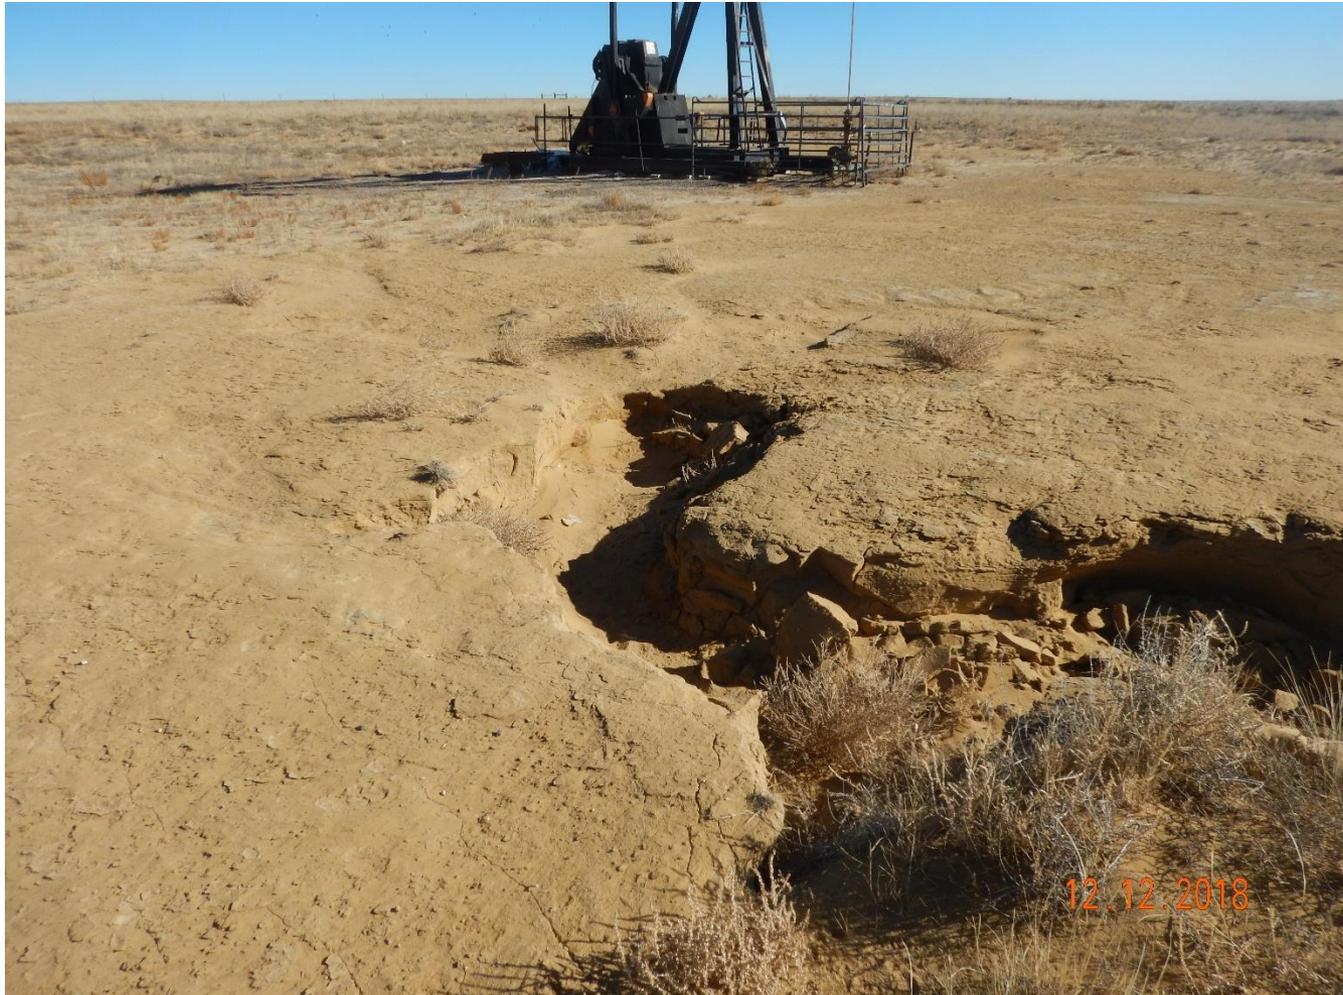
**Photo 4:** Photo taken from the northwest end of the production area, facing southeast. Stormwater erosion has created a large gully on the northwest end of the location. Photo shows the “head” of the erosion. Photo shows stormwater erosion has been allowed to continue causing degradation to the location and interim areas. Unable to find evidence of maintenance and stabilization, or evidence that the required BMPs have been installed per 1002.f and per corrective actions.

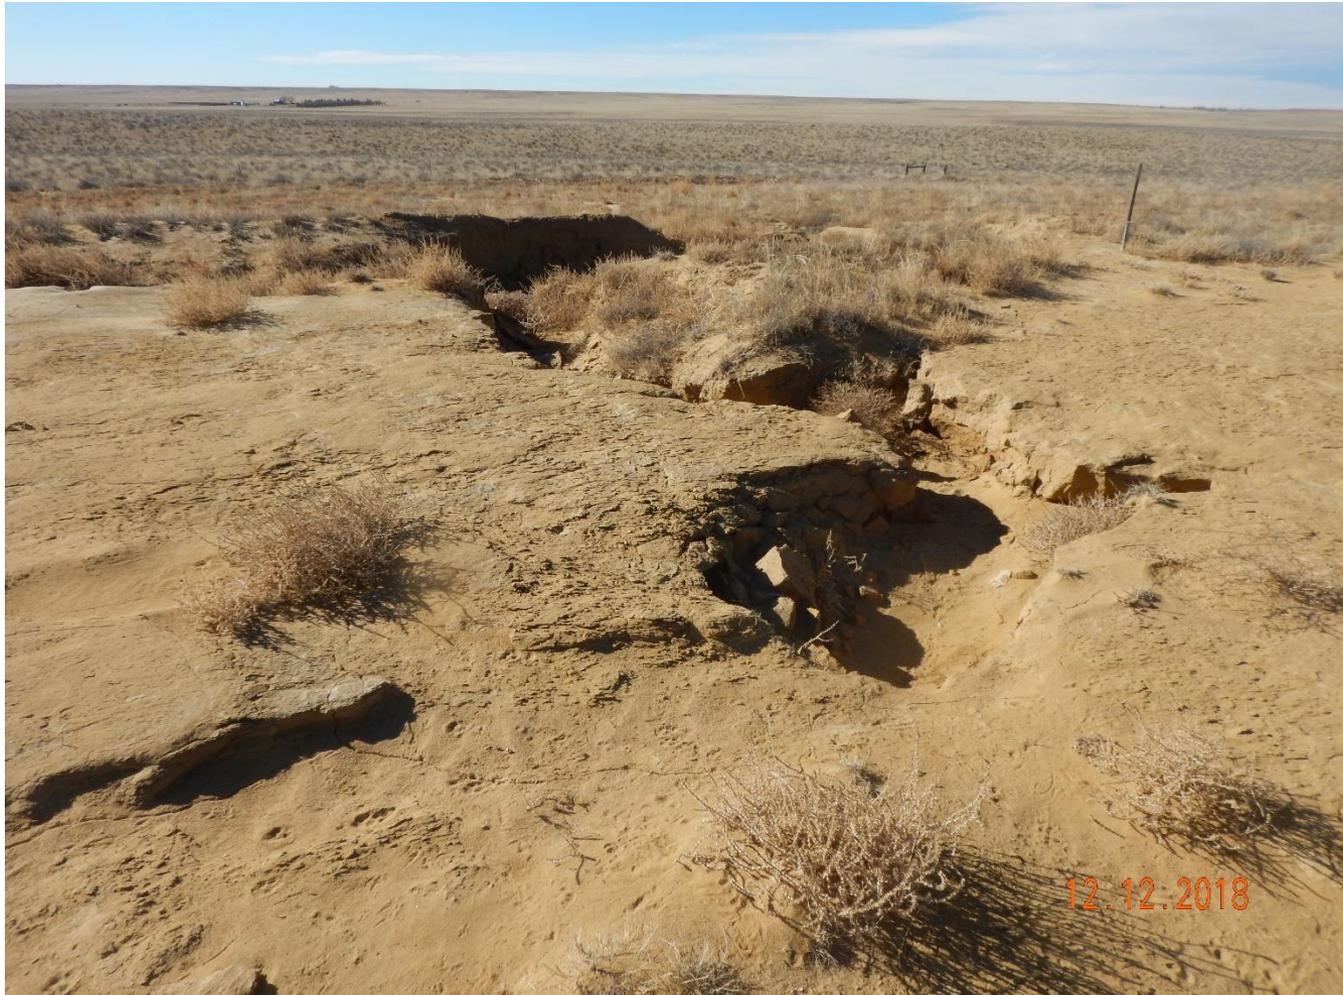
**Photo 5:** Continued from photo 4, facing west. See comments under photo 4.

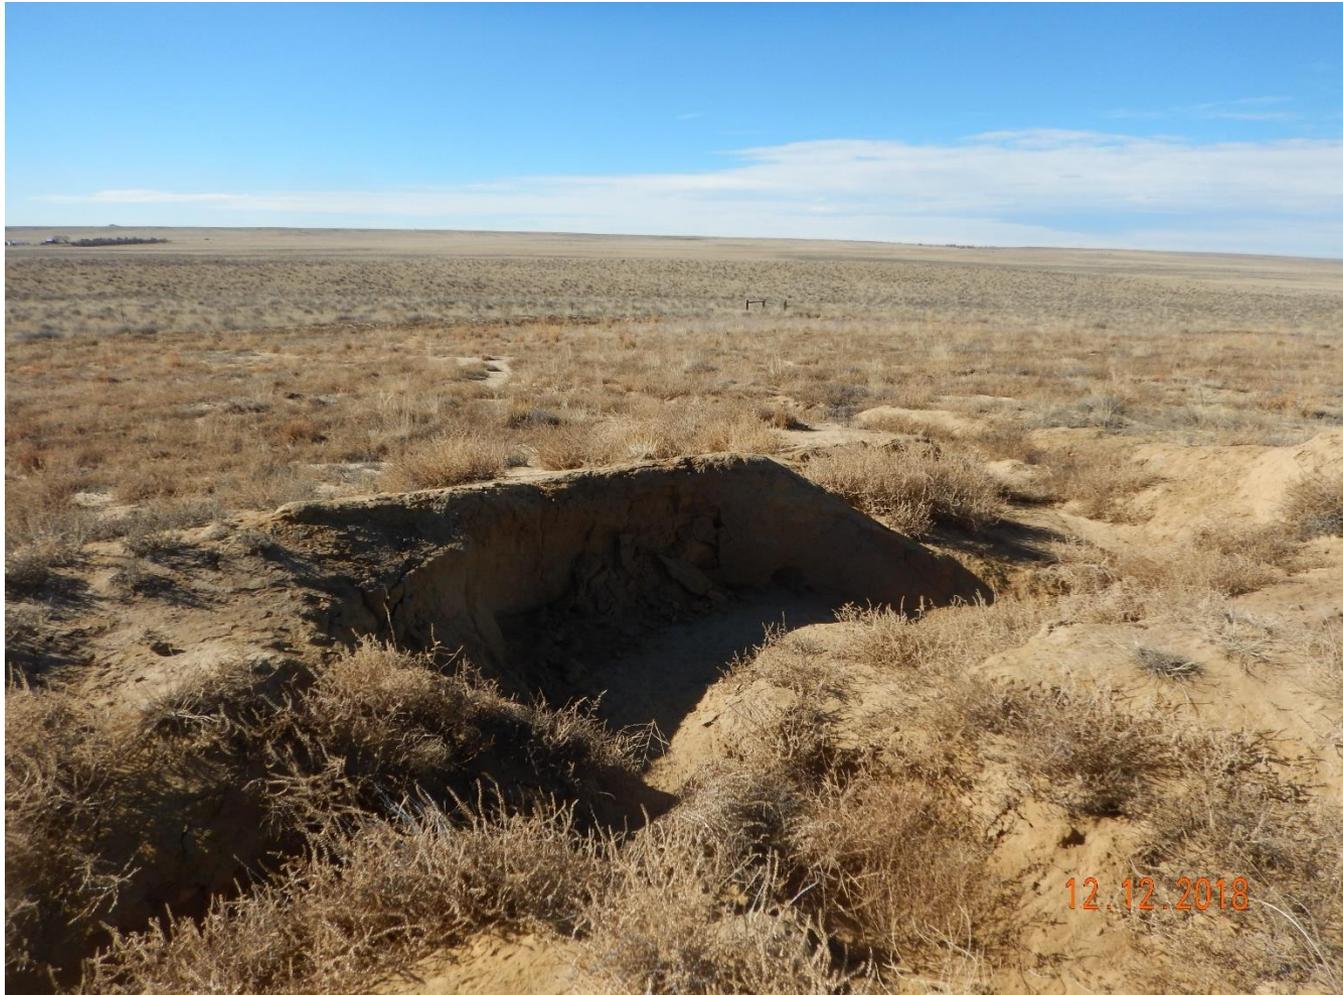
**Photo 6:** Continued from photo 4, facing northwest. See comments under photo 4.

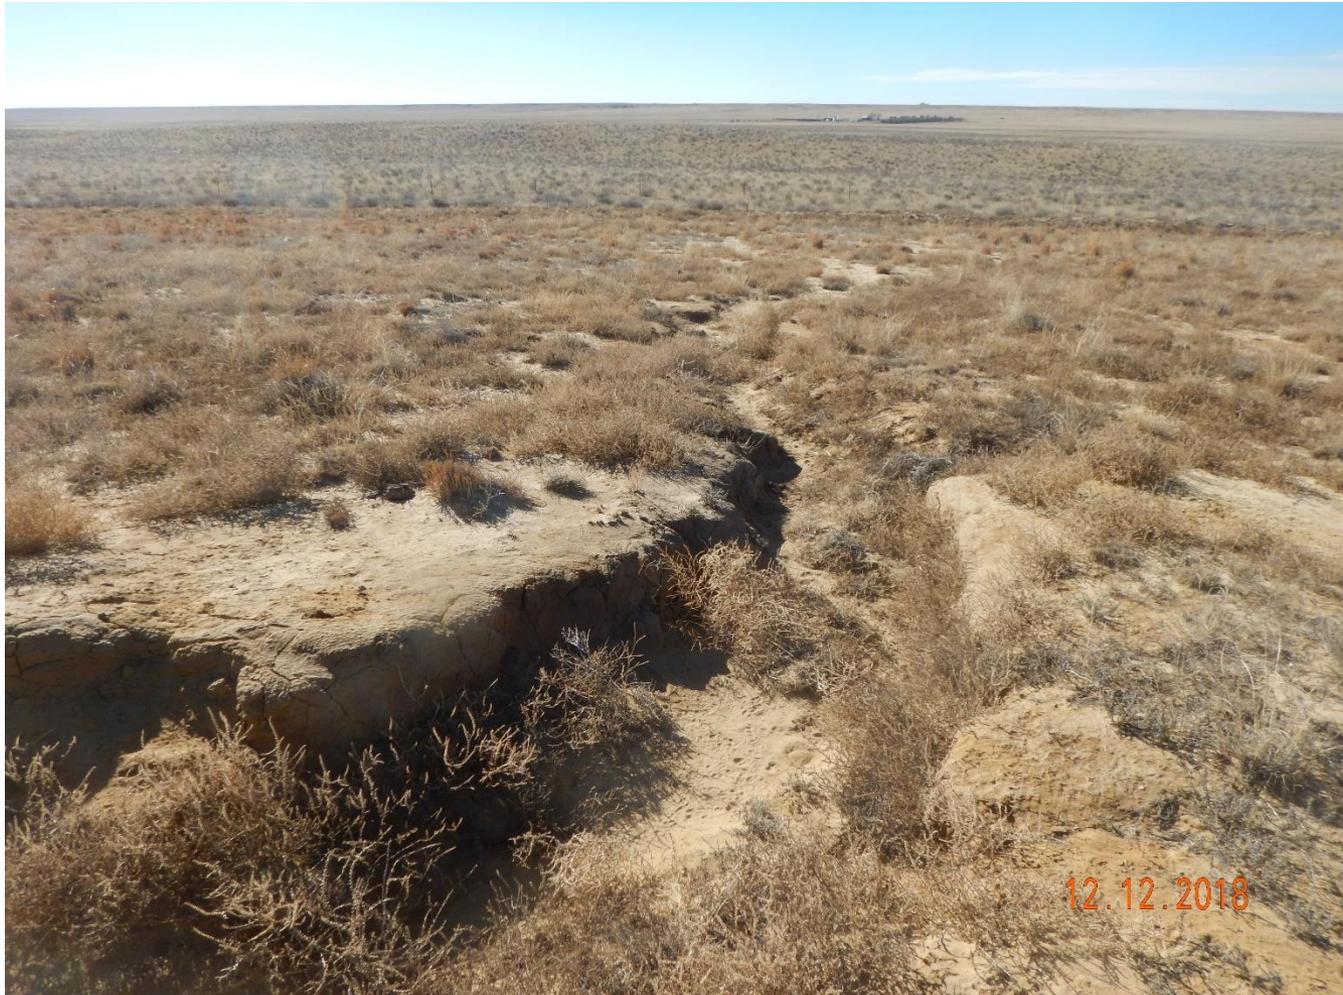
**Photo 7:** Continued from photo 4, facing west. See comments under photo 4.

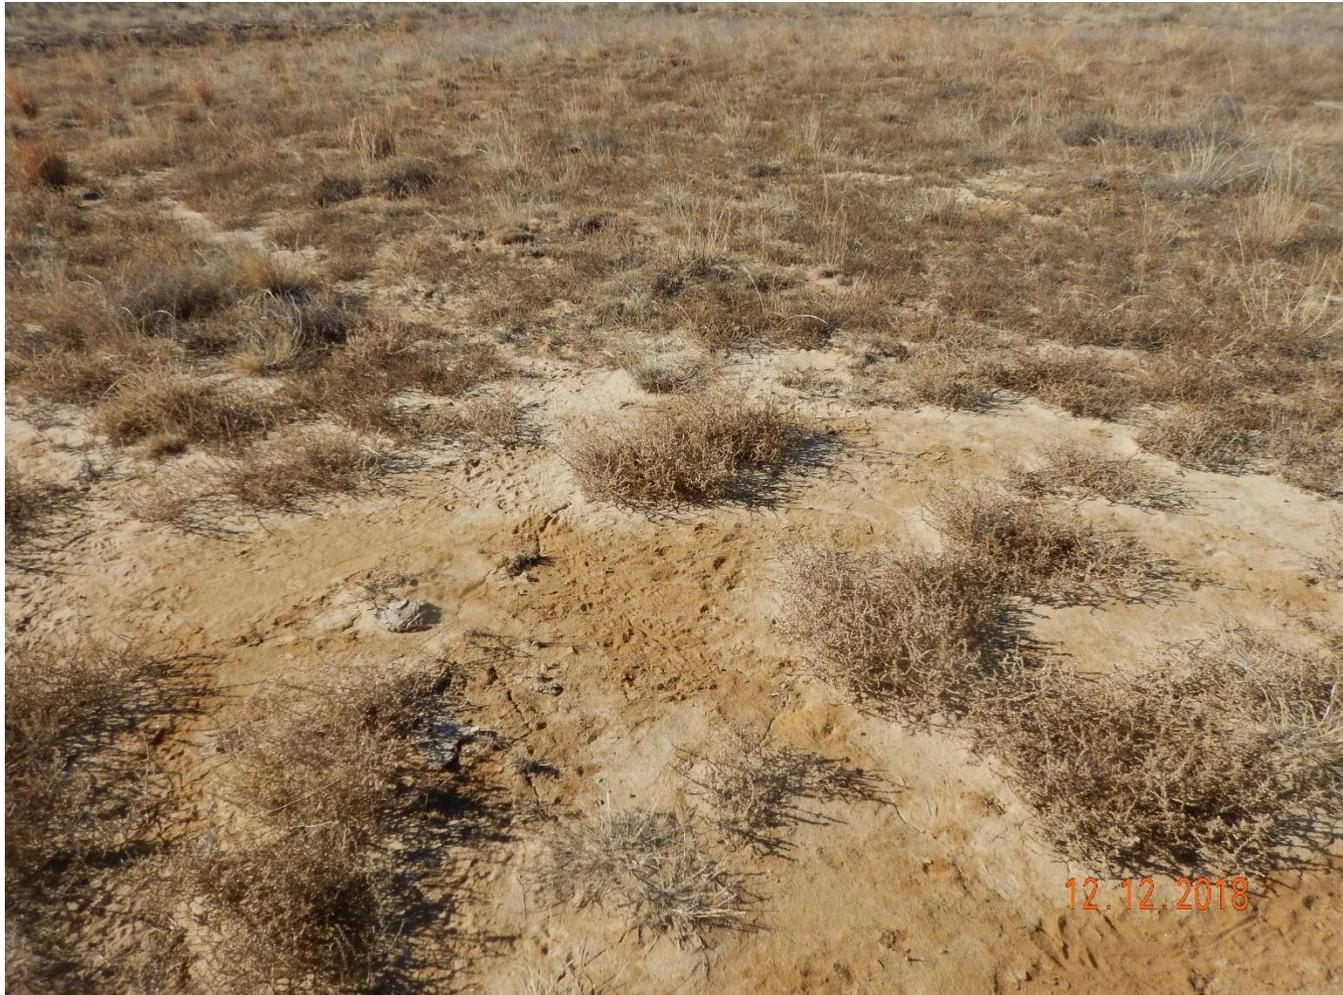
**Photo 8:** Photo taken from the interim areas west of the location. Photo shows sediment deposition due to stormwater runoff from the pad.

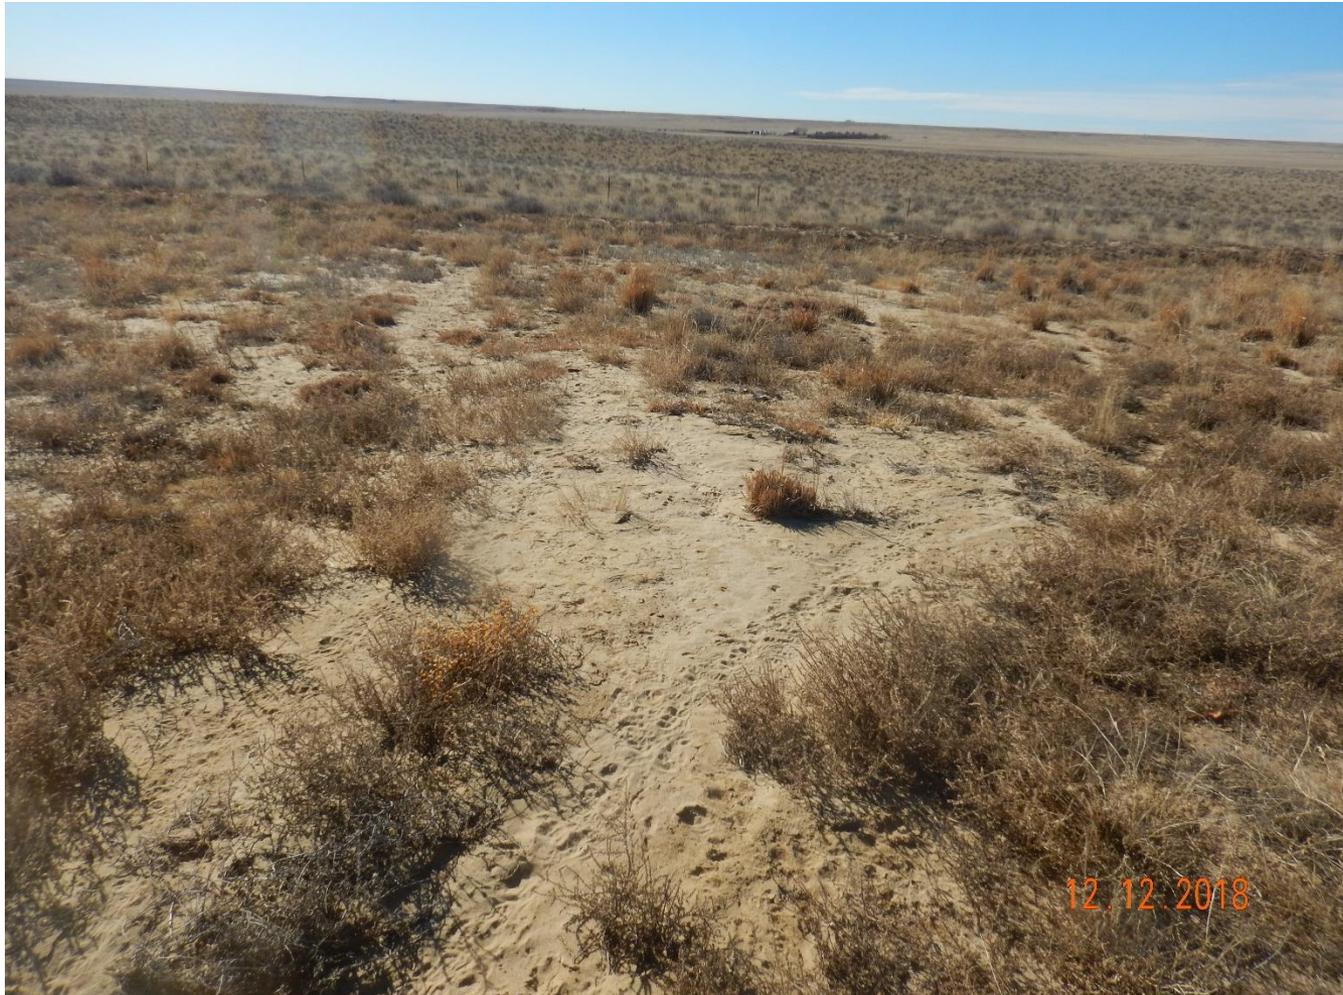
**Photo 9:** See comments under photo 8.

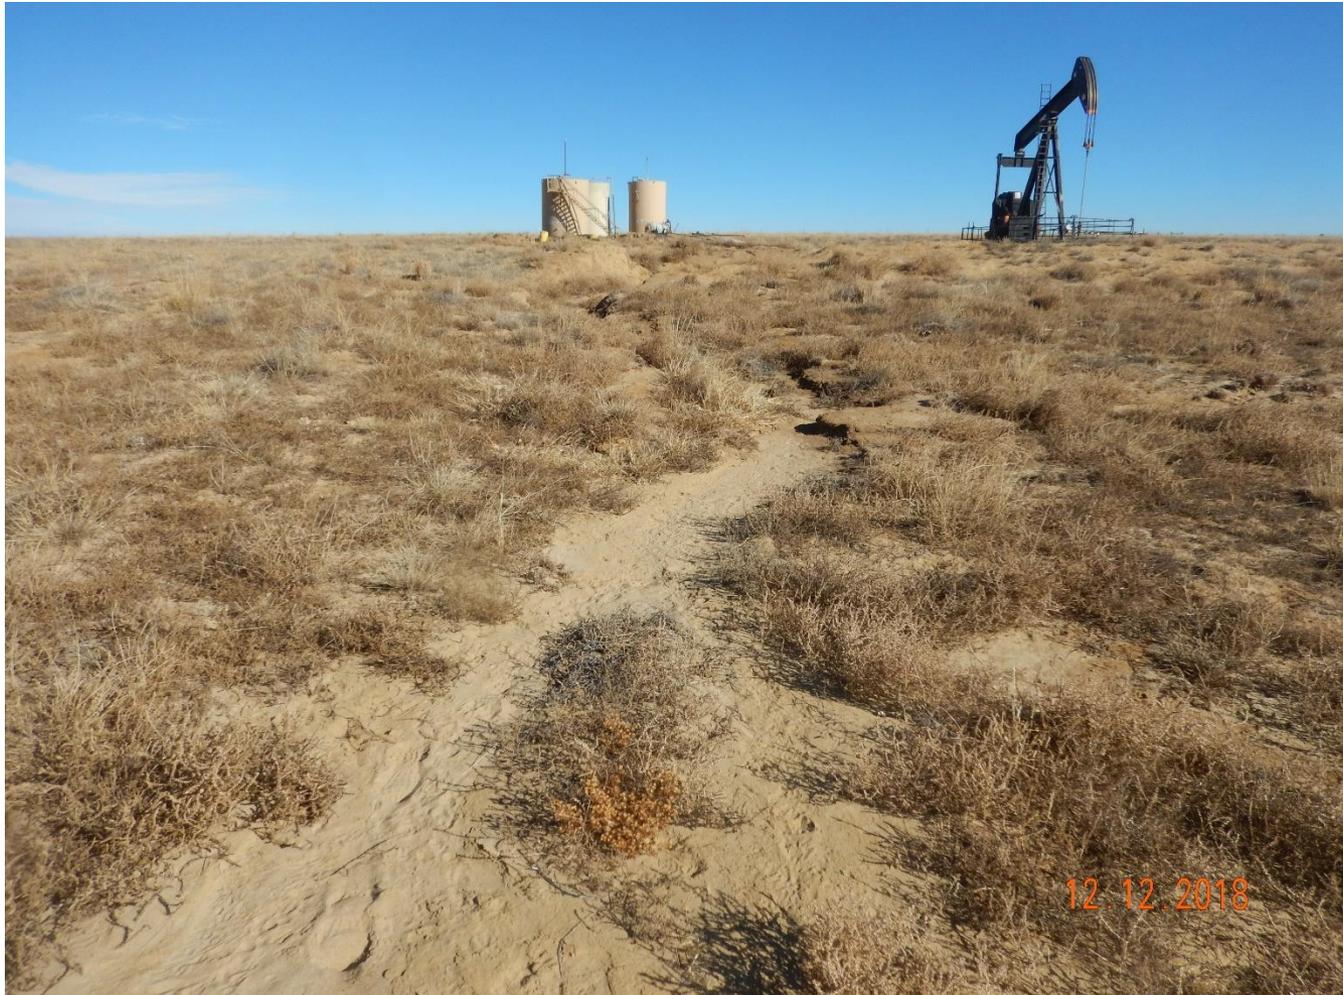
**Photo 10:** Photo taken from the interim areas west of the location, facing east. Photo shows stormwater erosion has been allowed to continue causing degradation to the location and interim areas. Unable to find evidence of maintenance and stabilization, or evidence that the required BMPs have been installed per 1002.f and per corrective actions.

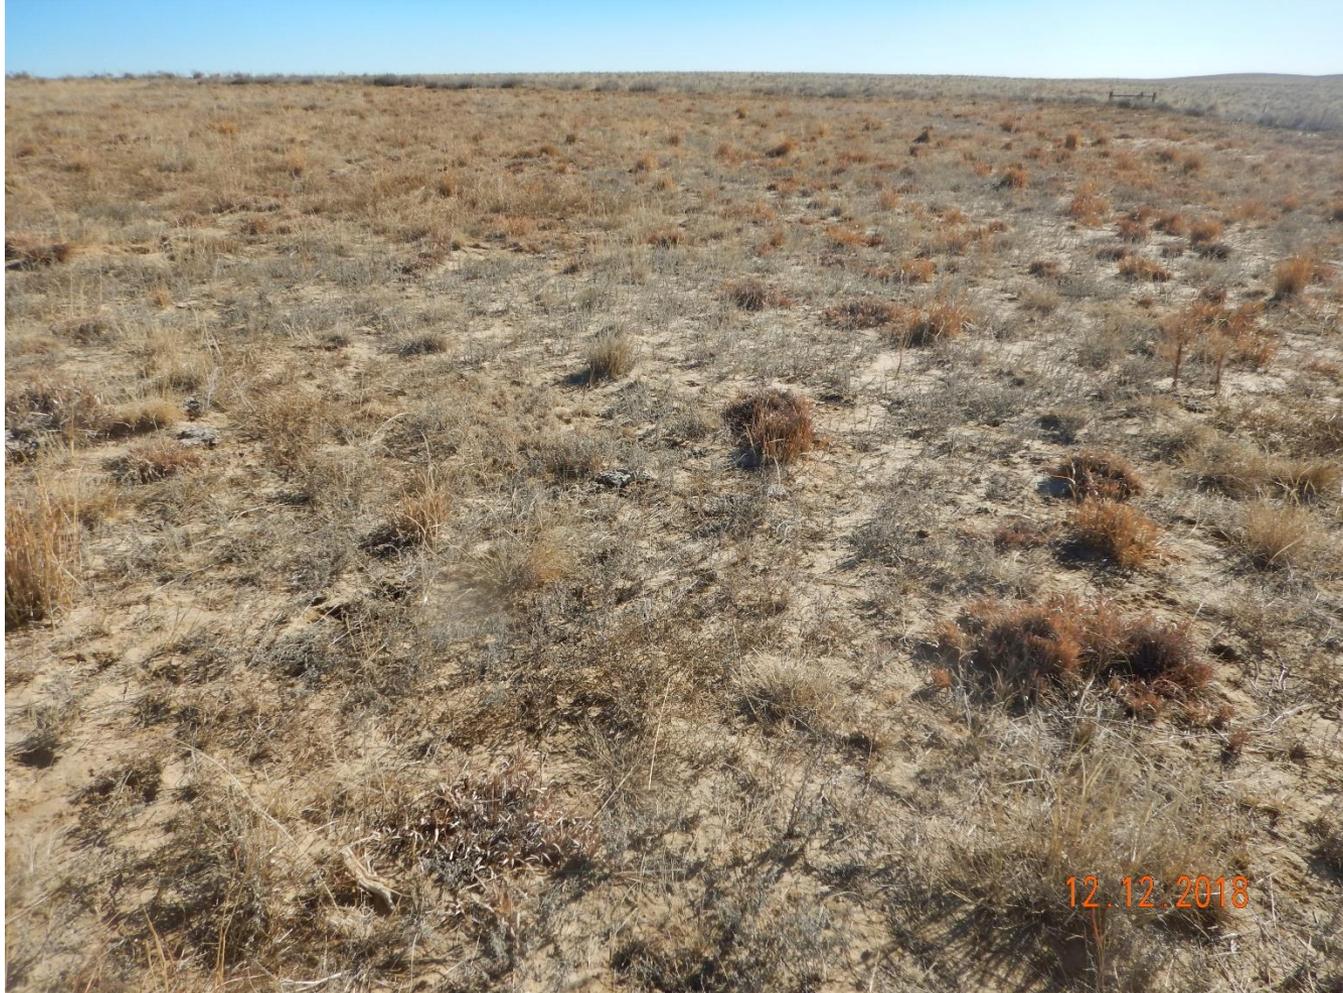
**Photo 11:** Photo taken from the western interim areas. Photo shows vegetation is predominantly undesirable weedy plant species or annual grass. Photo also shows interim areas also remain predominantly bare and exposed soil.

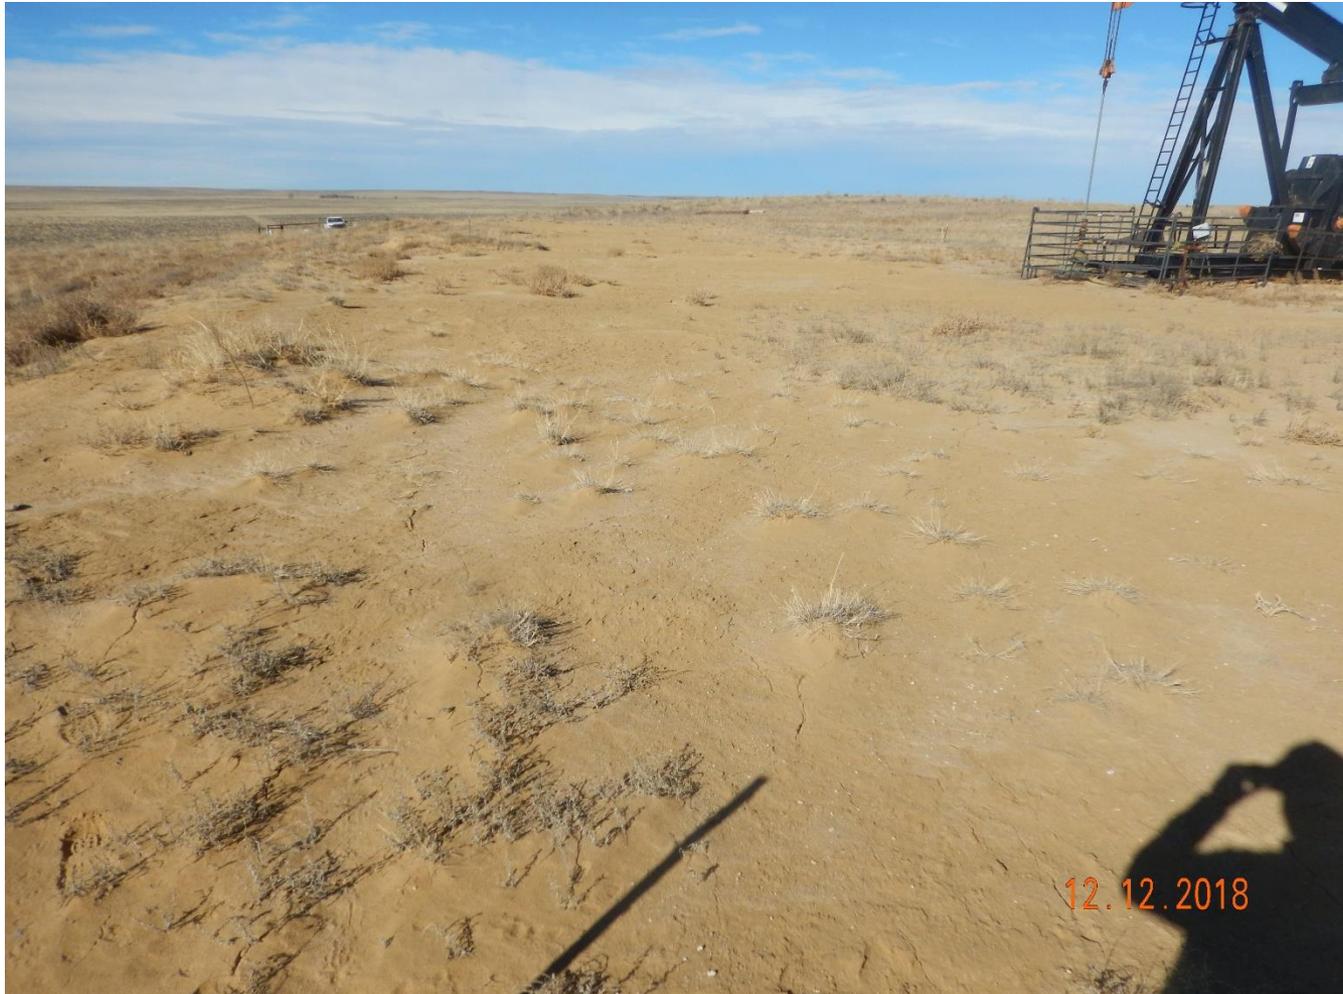
**Photo 12:** Photo taken from the southwest corner of the pad, facing north. Photo shows location.

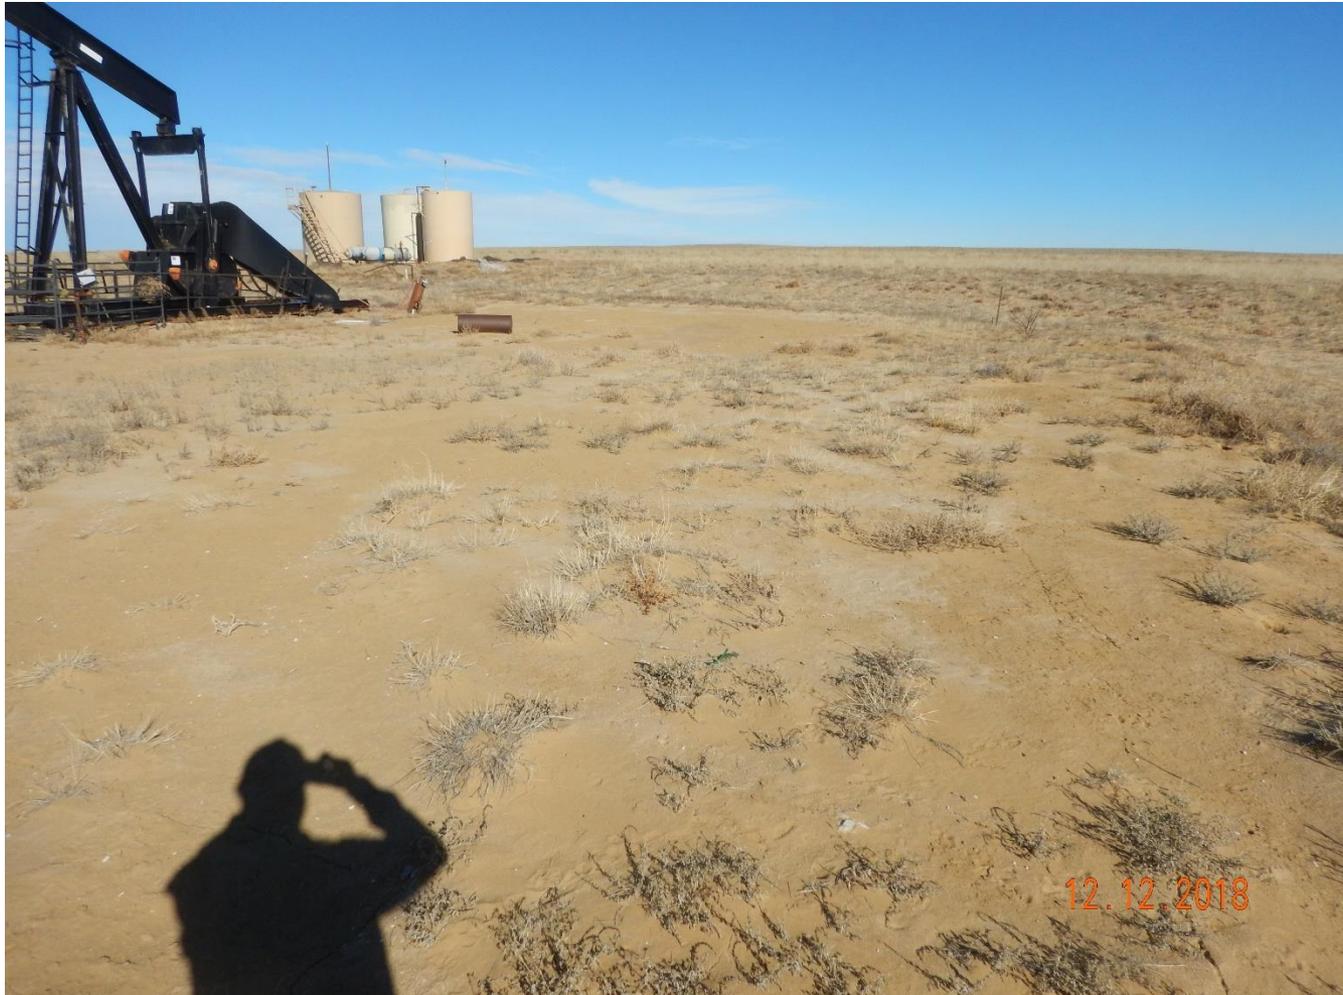
**Photo 13:** Photo taken from the southwest corner of the pad, facing east. Photo shows location.

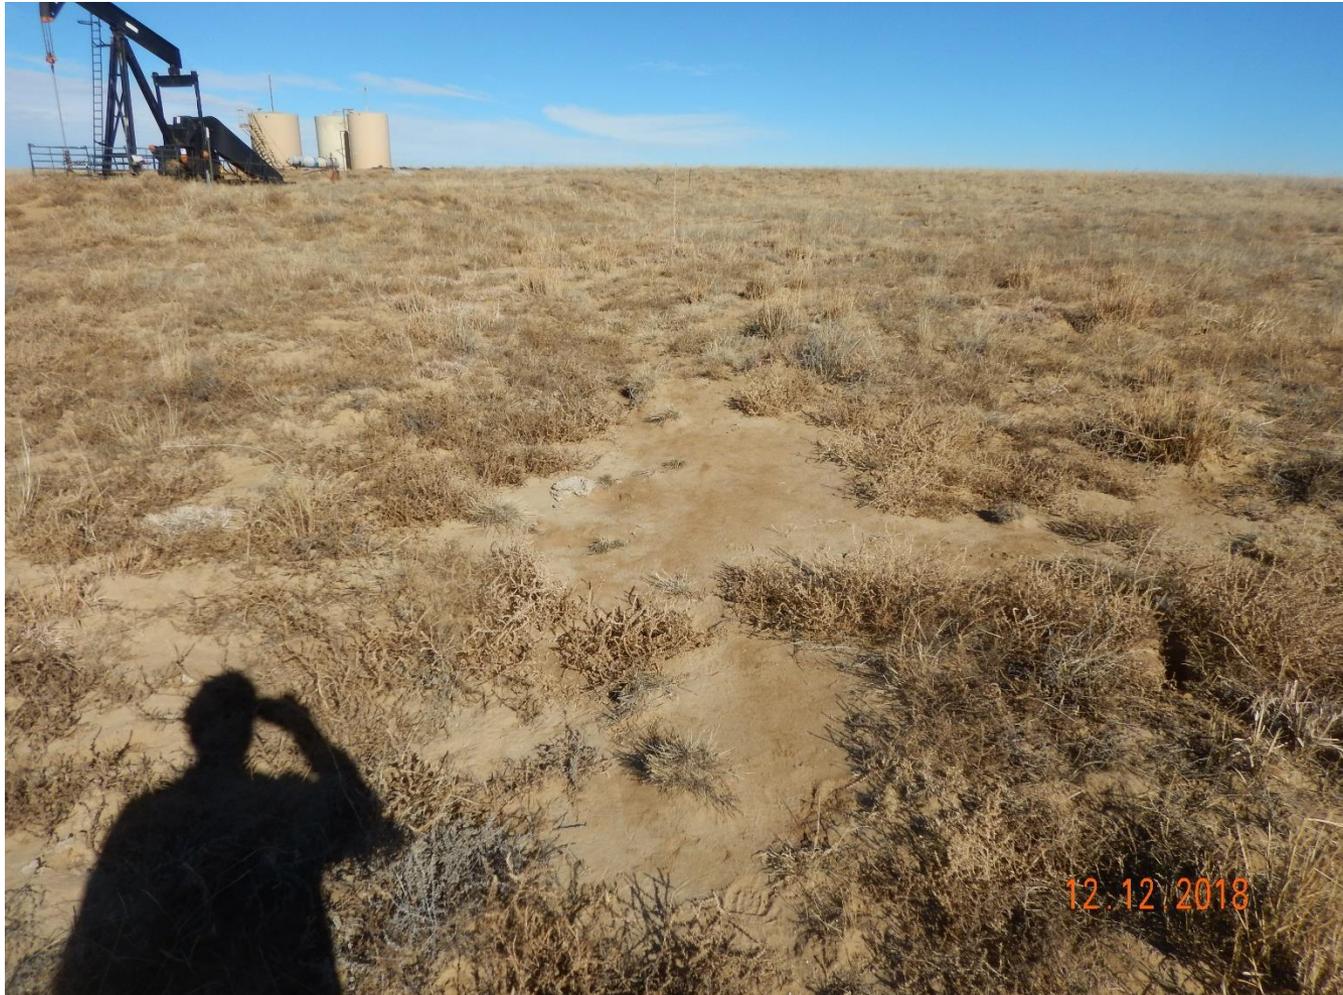
**Photo 14:** Photo taken from the north end of the interim areas. Photo shows additional areas where stormwater runoff from the pad has deposited sediment on the interim areas.

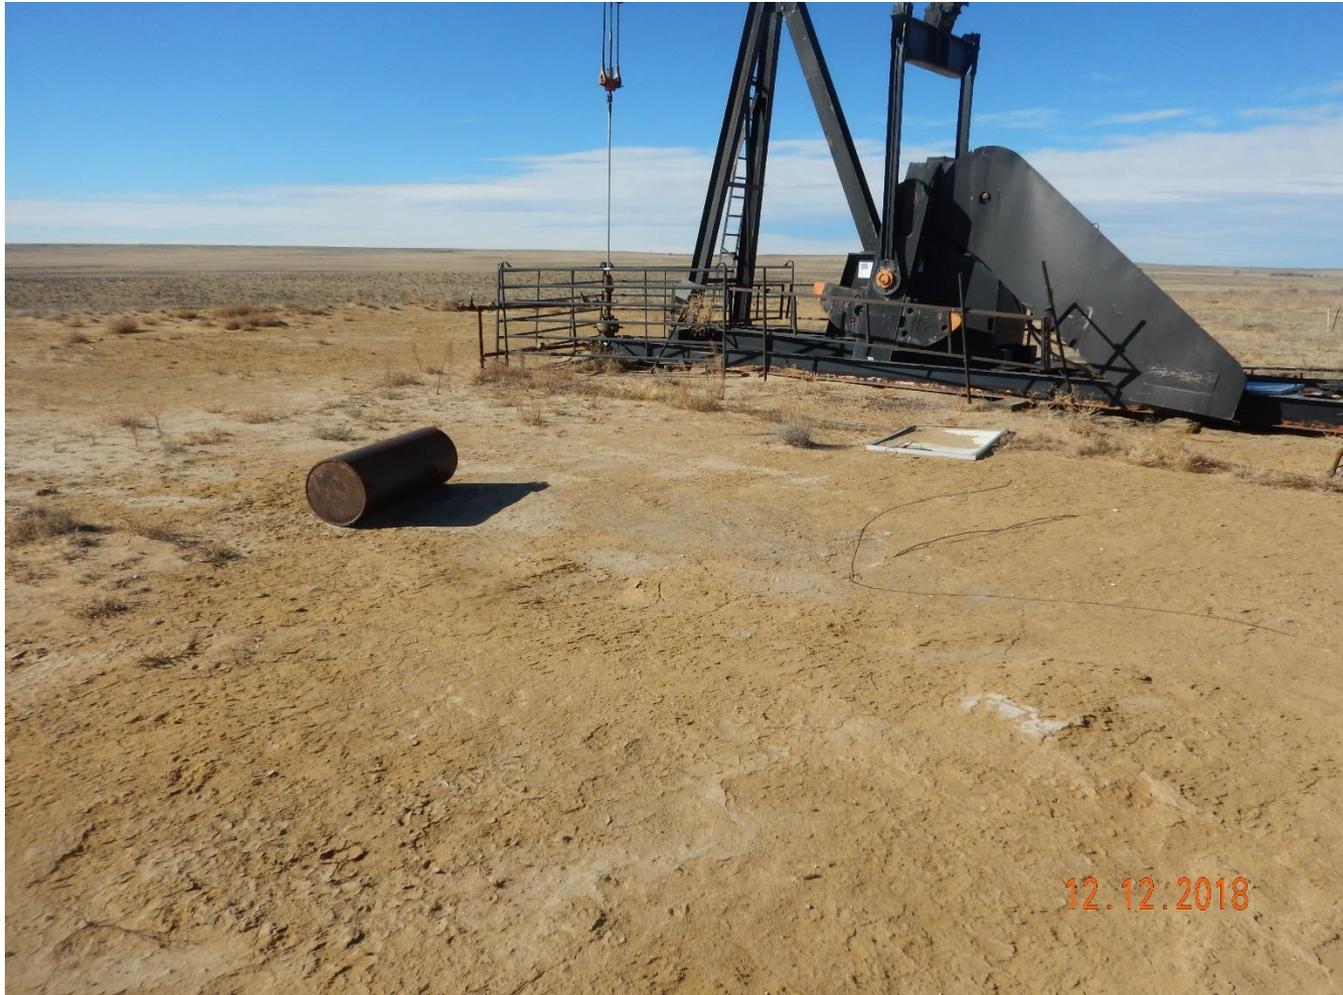
**Photo 15:** Photo taken from the south end of the well, facing northwest. Previous inspection documented various trash debris and unused equipment strewn about the well. Photo shows trash debris and unused equipment has not been properly removed and stored, or disposed, per corrective actions.

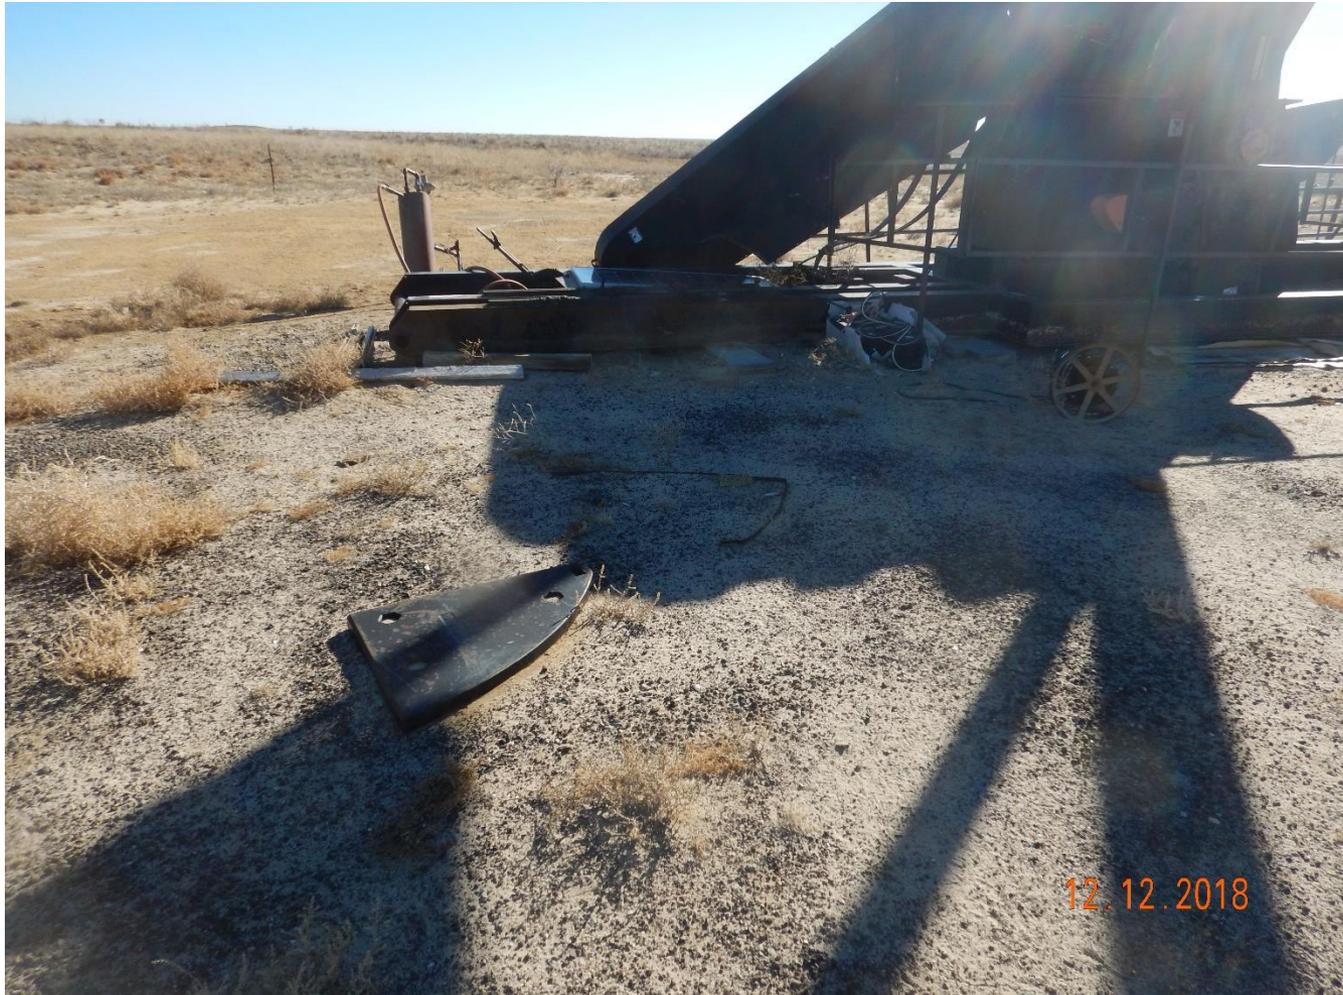
**Photo 16:** Photo taken from the north end of the well, facing south. Previous inspection documented various trash debris and unused equipment strewn about the well. Photo shows trash debris and unused equipment has not been properly removed and stored, or disposed, per corrective actions.
