# Inspection Photos

Operator: ABILENE PERFECT ENERGY JV LLC -  
10581

Location ID: 433129

Inspection Doc. Number: 682504269  
Lincoln County, CO

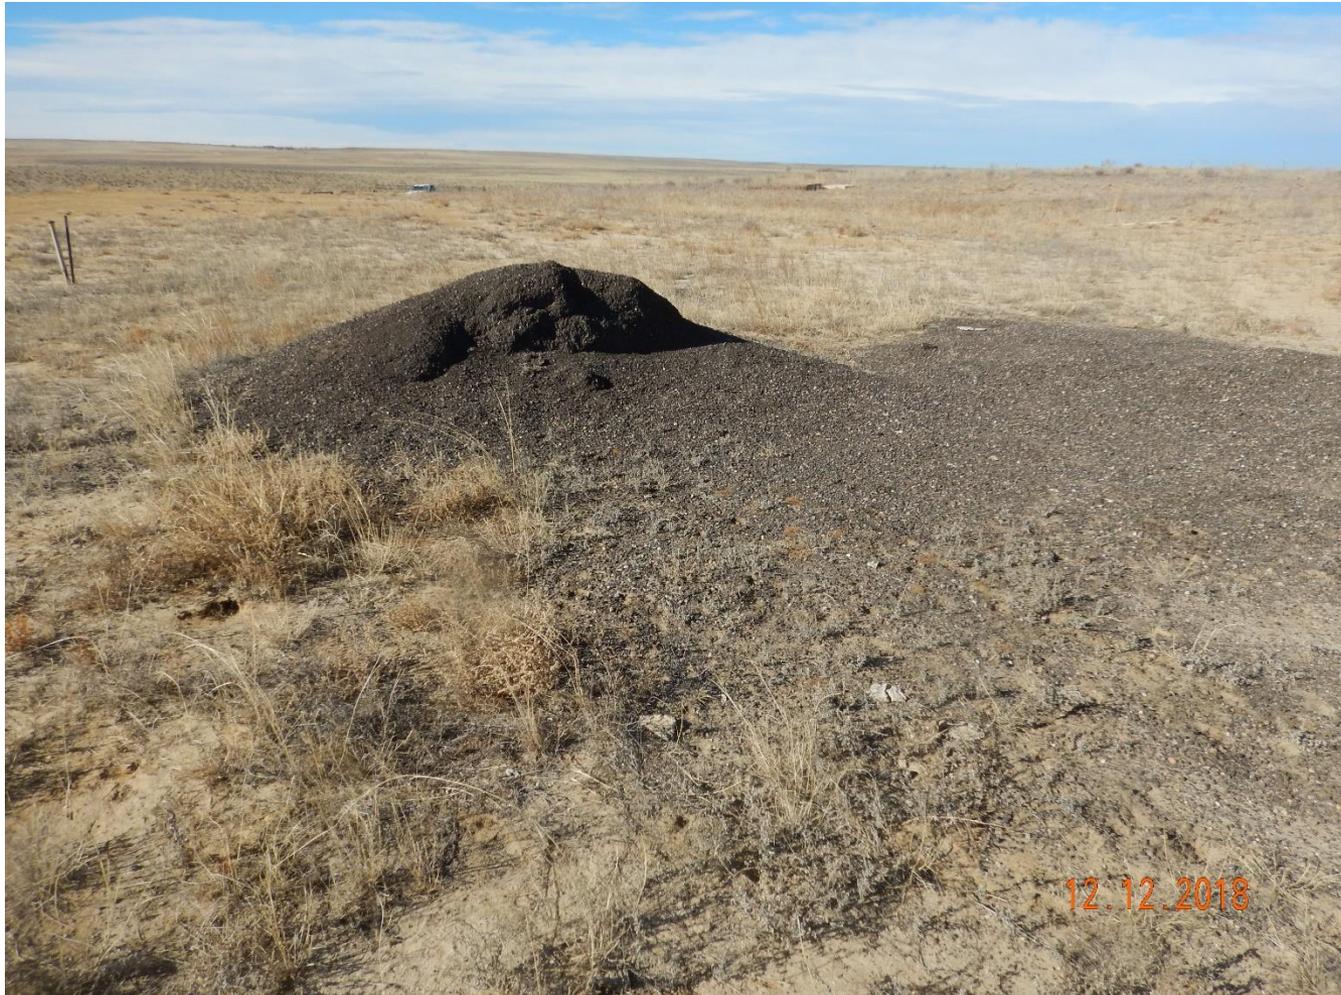
**Photo 17:** Photo taken from the central area of the pad, facing northwest. Previous inspections required operator to remove gravel pile from location. Photo shows pile remaining.

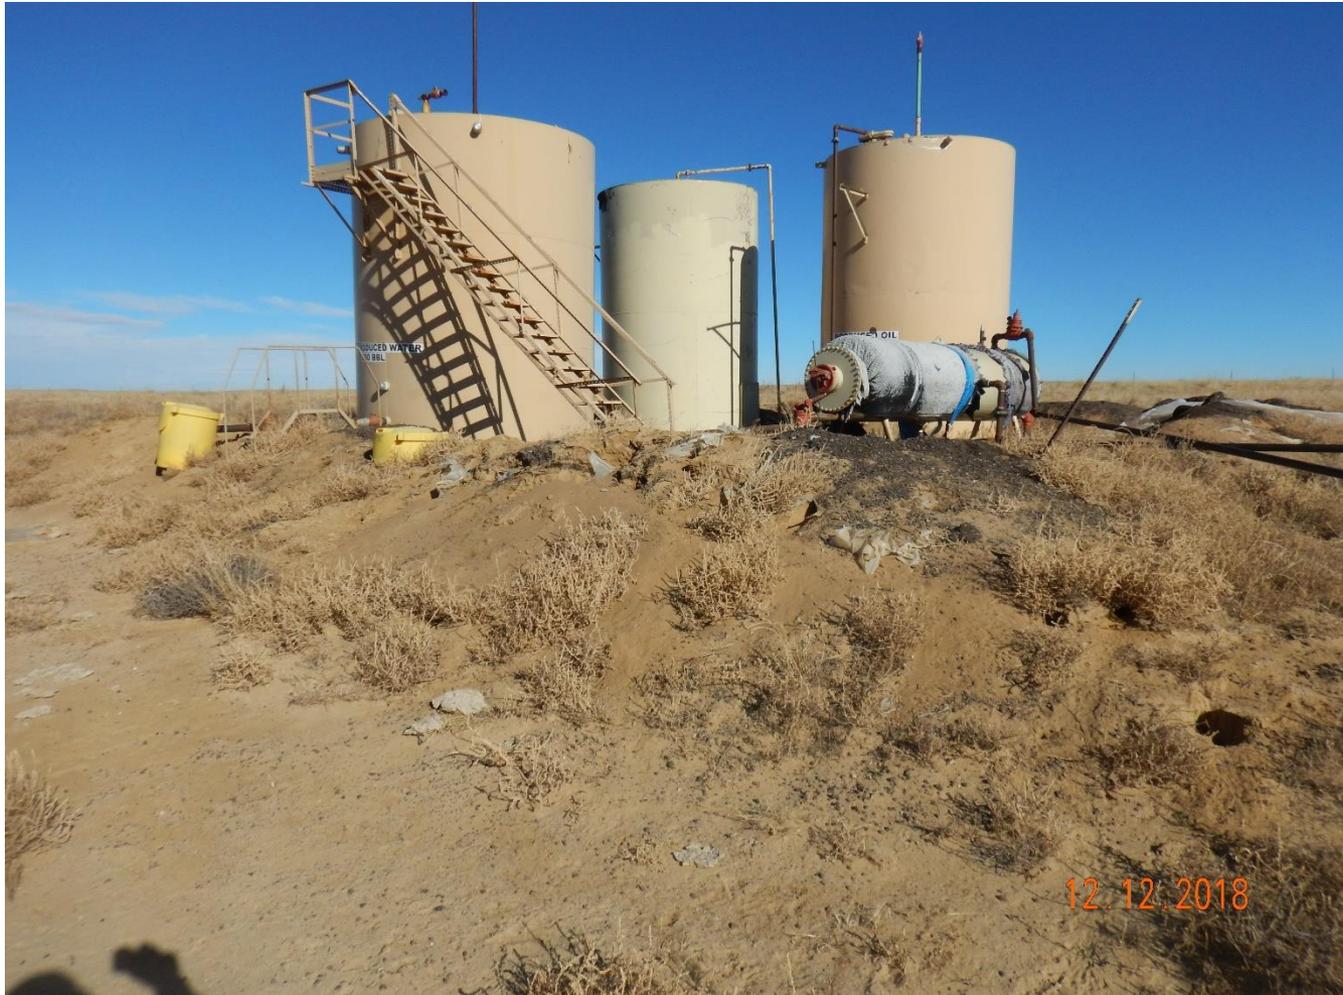
**Photo 18:** Photo taken from the southwest end of the tanks on location, facing northeast. Previous inspection documented incomplete signage on tanks, including NFPA diamond labeling, and required operator to implement proper signage. Photo shows additional signage has not been implemented.

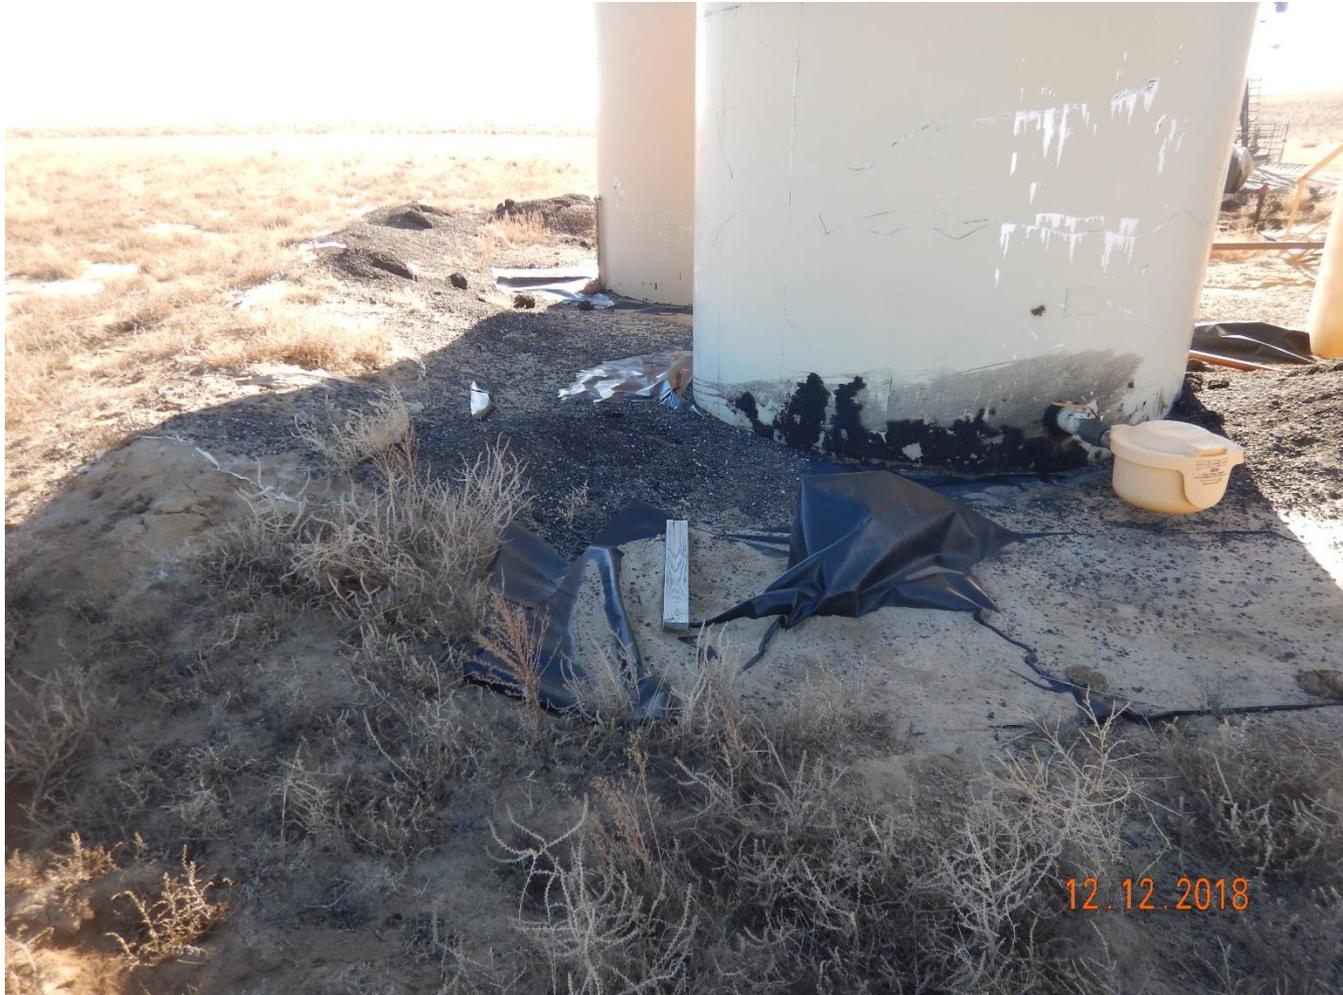
**Photo 19:** Photo taken from the northeast end of the tanks on location, facing south. Previous inspections documented that the berms around the tanks were inadequate and required operator to repair or install berms, or secondary containment devices. Photo shows berms, or other secondary containment devices have not been repaired or installed; berm missing from the northern end of the tanks.

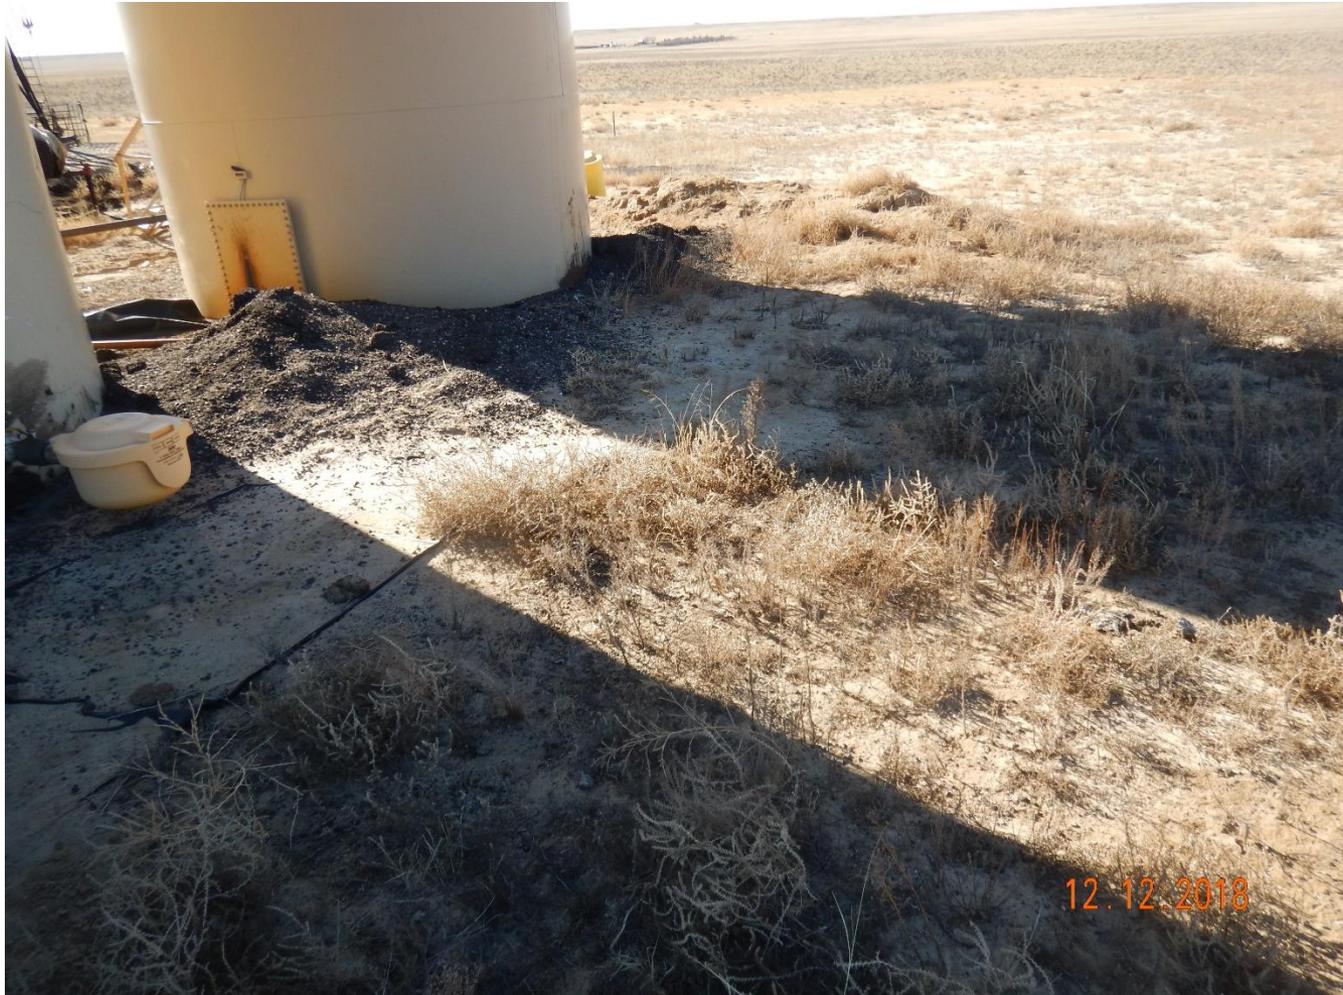
**Photo 20:** Photo taken from the northeast end of the tanks on location, facing east. See comments under photo 19.

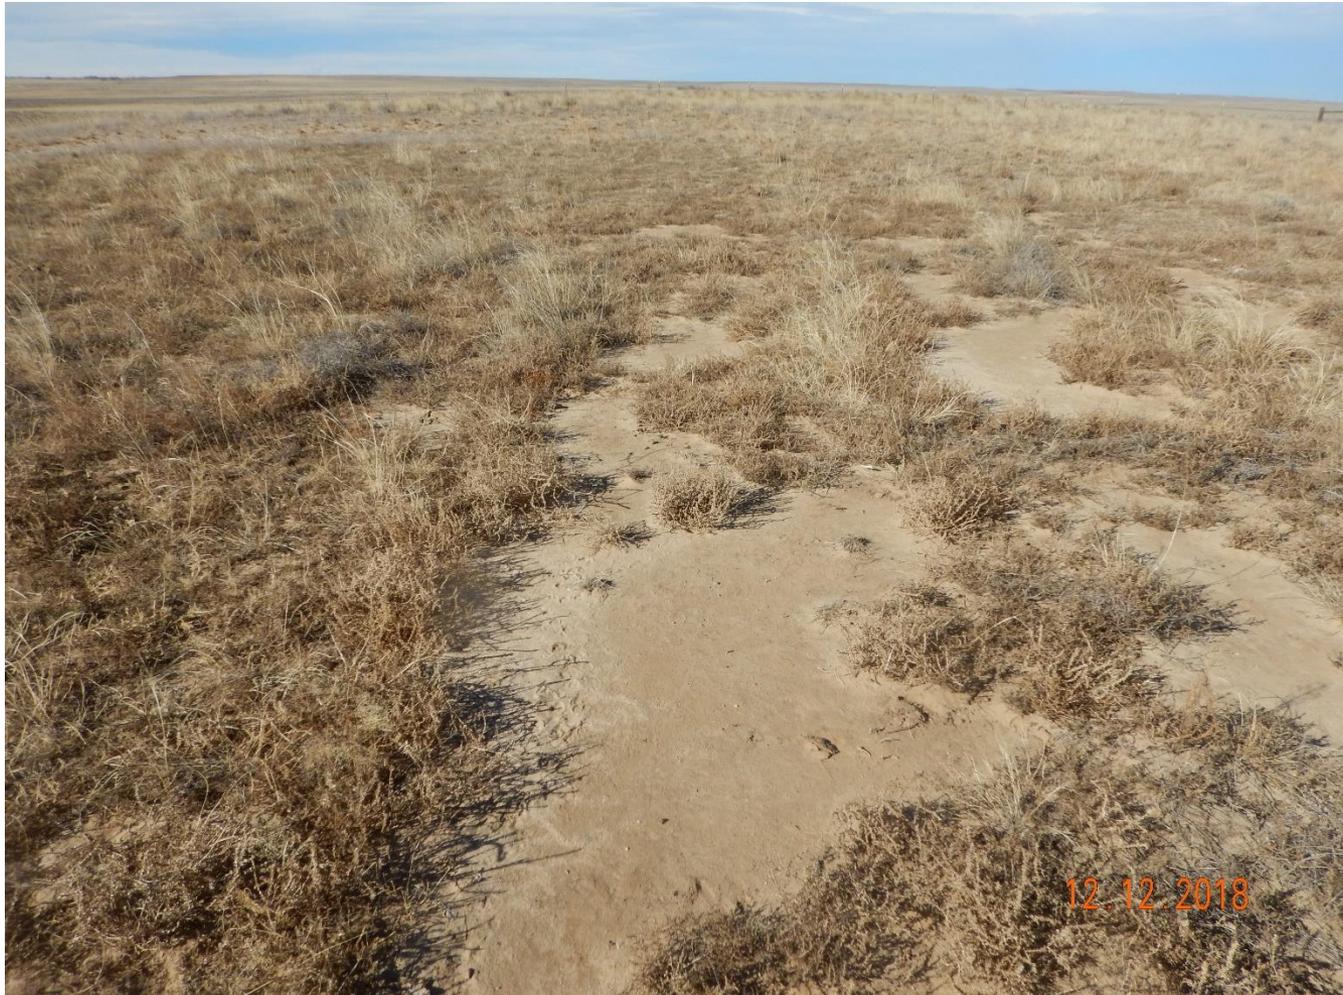
**Photo 21:** Photo taken from the northeast end of the location. Photo shows area of the former pit remains predominantly bare and exposed soil. Unable to find evidence that additional reclamation activities have been conducted.

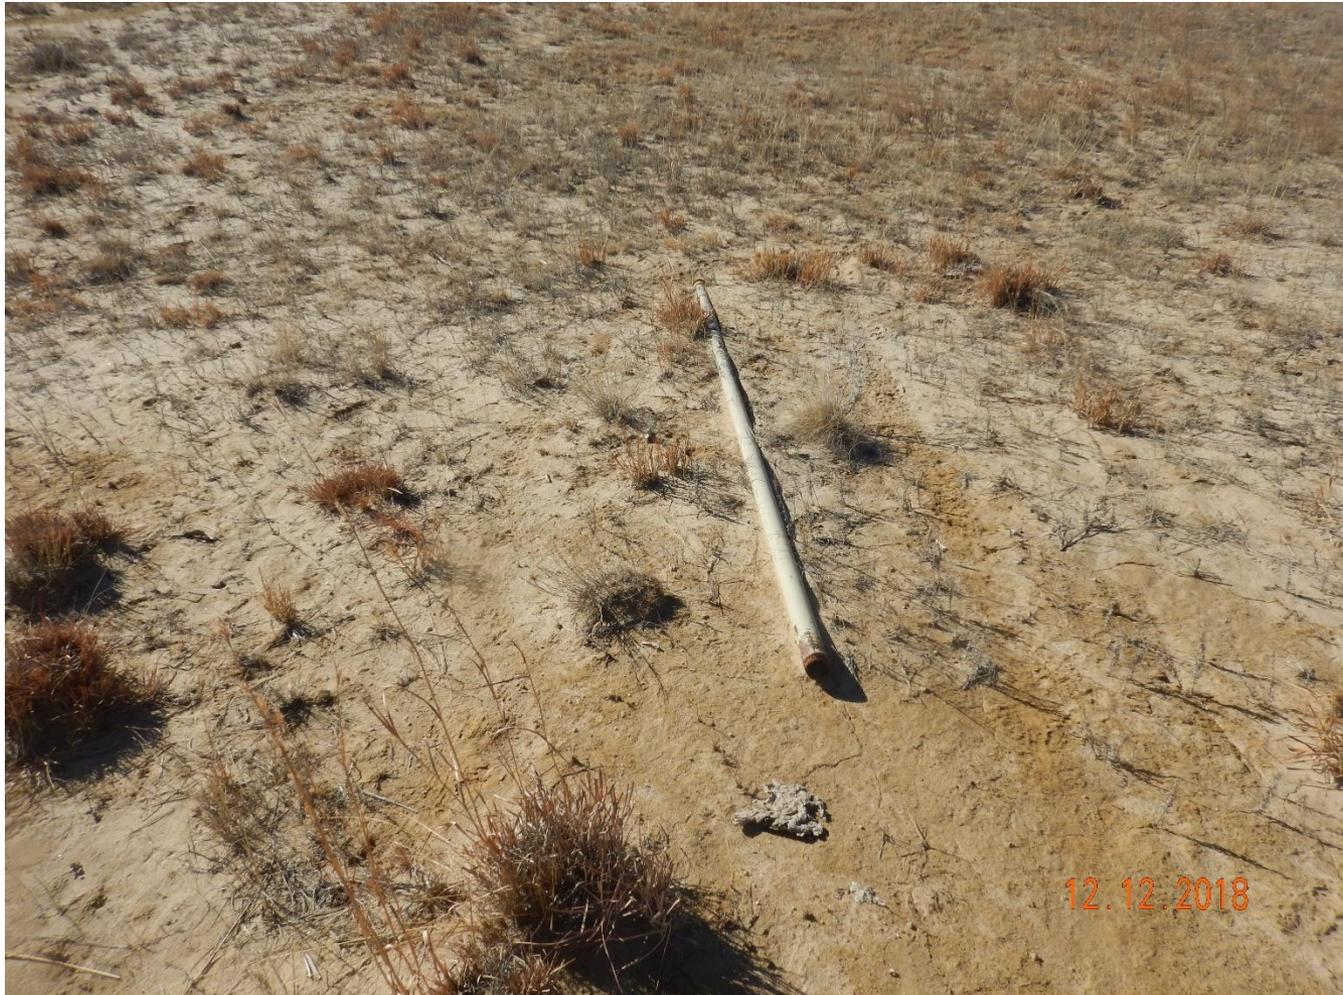
**Photo 22:** Photo taken from the north end of the location. Previous inspections documented various debris and unused equipment remaining on the location and required removal. Photo shows equipment/debris has not been removed.

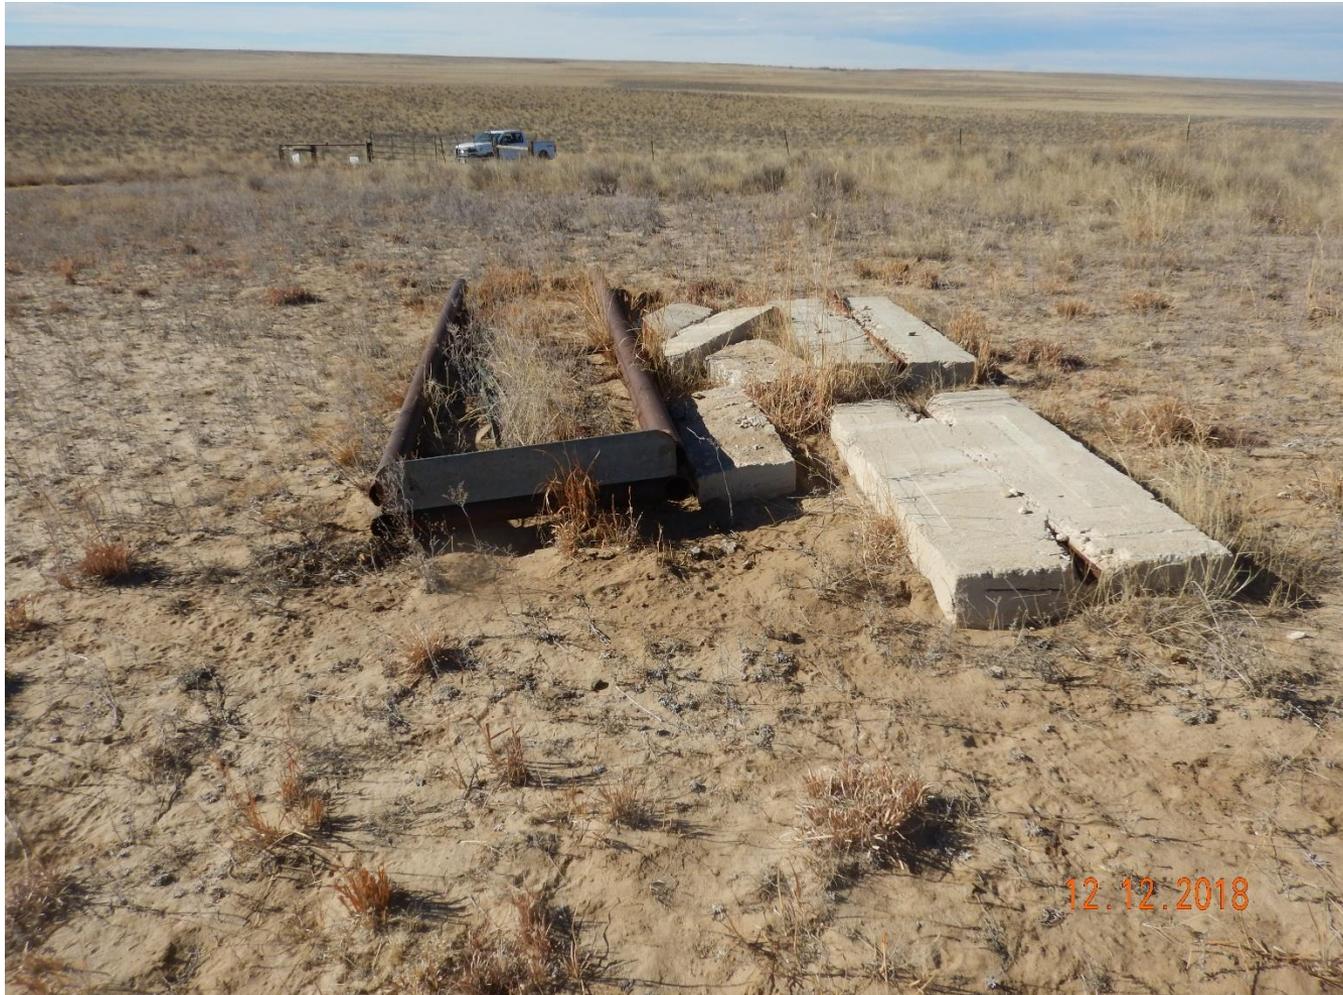
**Photo 23:** Photo taken from the north end of the location, facing northwest. Previous inspections documented various debris and unused equipment remaining on the location and required removal. Photo shows equipment/debris has not been removed.

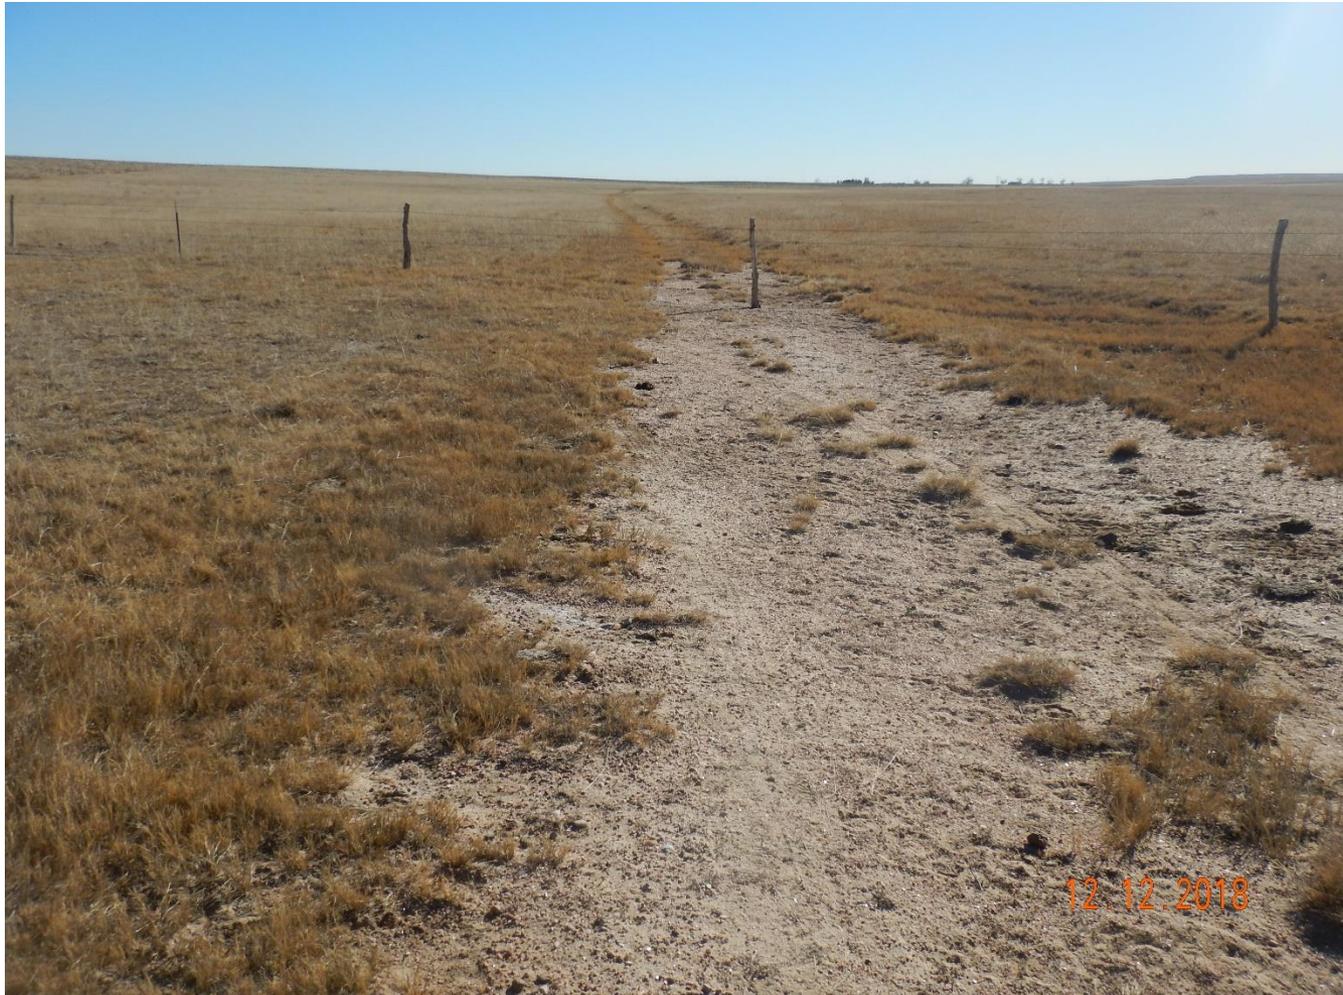
**Photo 24:** Photo taken from the access road, southwest of the location at coordinate 38.94974/-103.39839. Previous inspections documented that the fence blocks off the access road, forcing vehicles to travel off road at a corner of the fence to the east. Previous inspections required operator to install gate to minimize and mitigate surface disturbance in accordance with 1002.e(4). Photo shows gate has not been installed to mitigate surface disturbance.

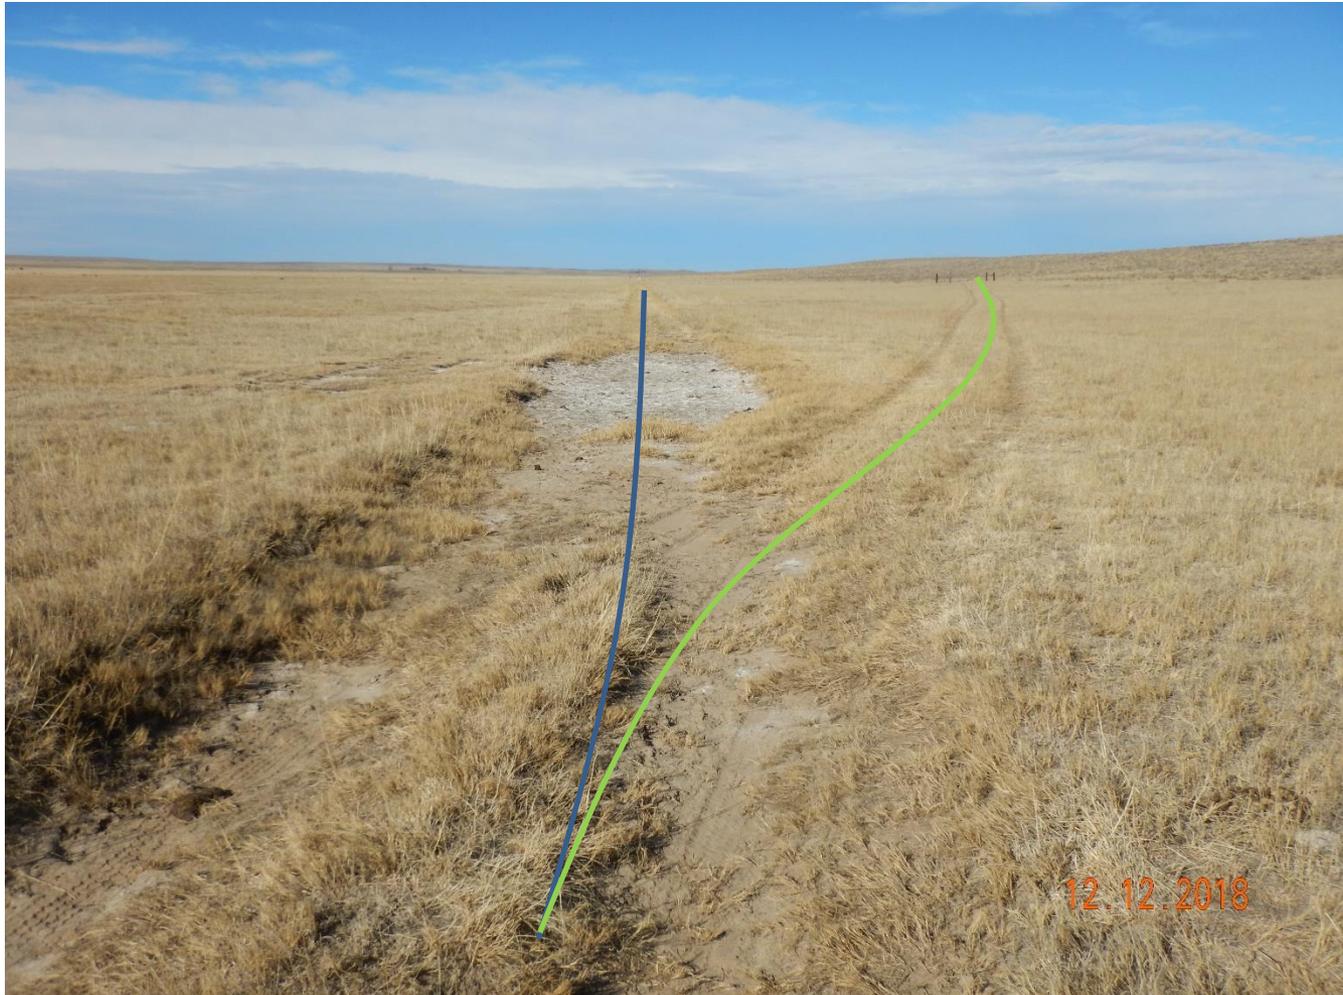
**Photo 25:** Photo taken from the access road, facing north. Continued from photo 24. Road on the left (blue) is the original access road. Photo shows point where vehicle traffic appears to be traveling off the road (green line) due to a fence without a gate constructed across the access road. Any additional disturbance(s) will require reclamation.

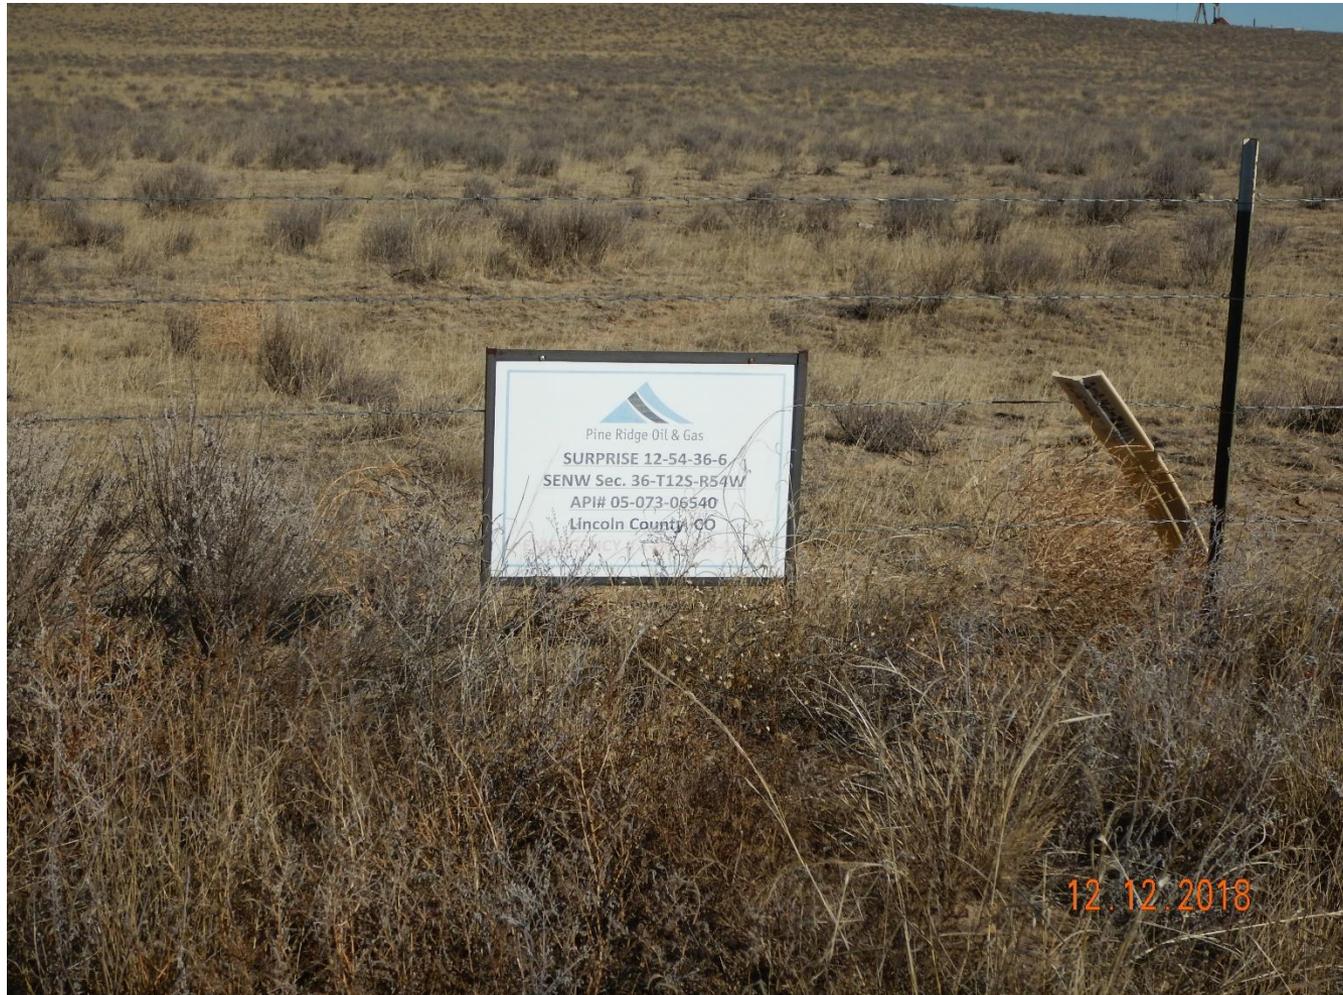
**Photo 26:** Photo taken from the access road entrance at CR-26. Previous inspections required operator to update signage with correct operator information. Photo shows signage has not been updated.
