Inspection Photos

Operator: PHOENIX RESOURCES LLC - 10691

Location ID: 414589

Inspection Doc. Number: 682504271

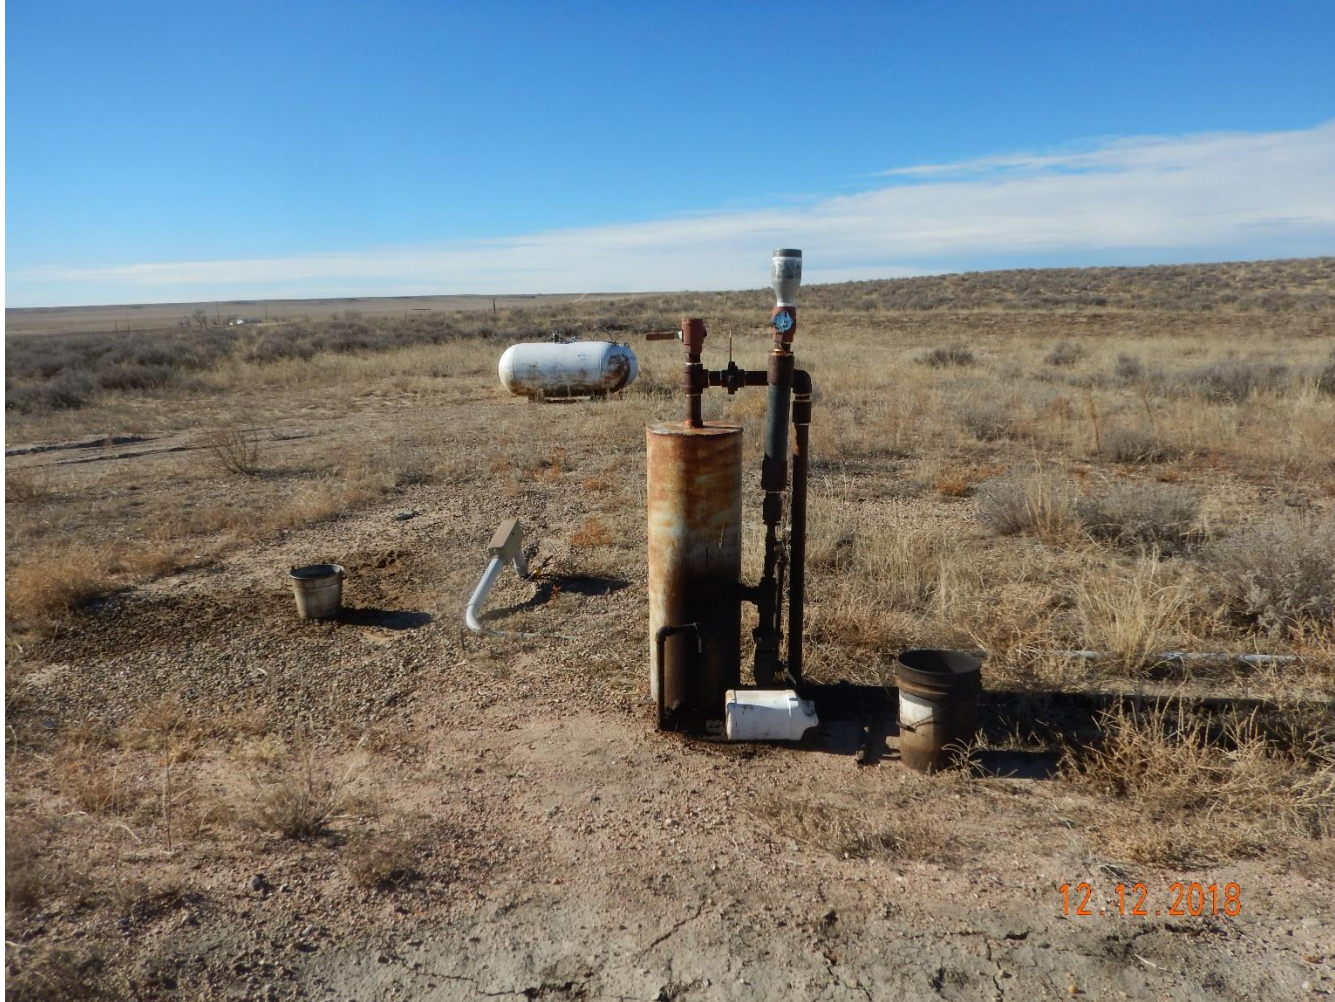
Photo 1: Photo taken from the west end of the location. Previous inspections documented this 5 gallon bucket being used to collect chemicals from equipment and stained soils at the base. Inspections required that equipment needs to be repaired to fix leaks, and bucket needs to be removed and properly disposed or placed in containment. Photo shows bucket and stained soils remain.

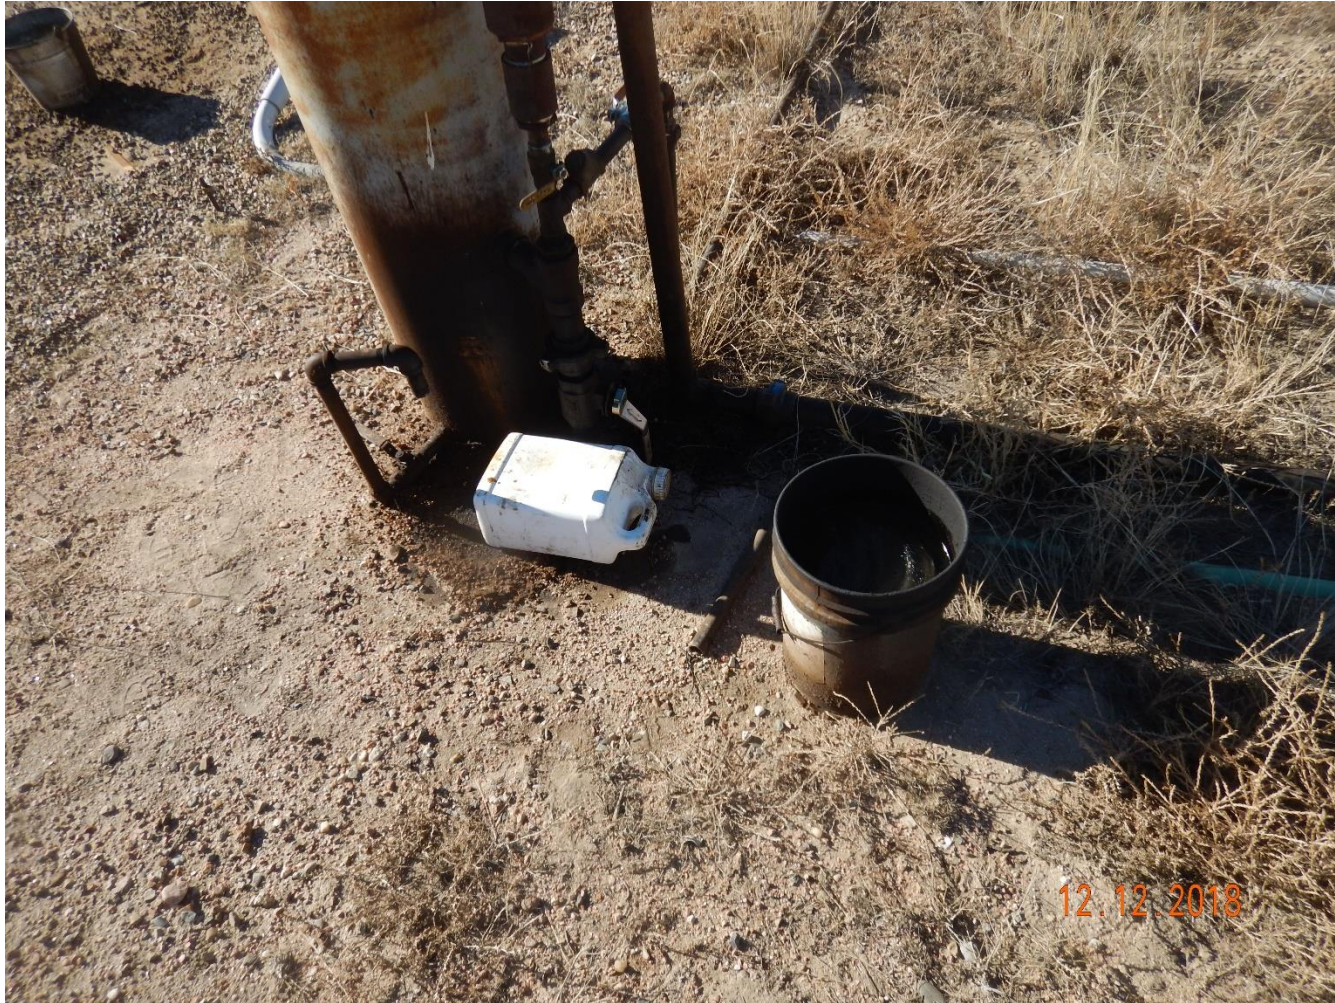
Photo 2: See comment under photo 1.

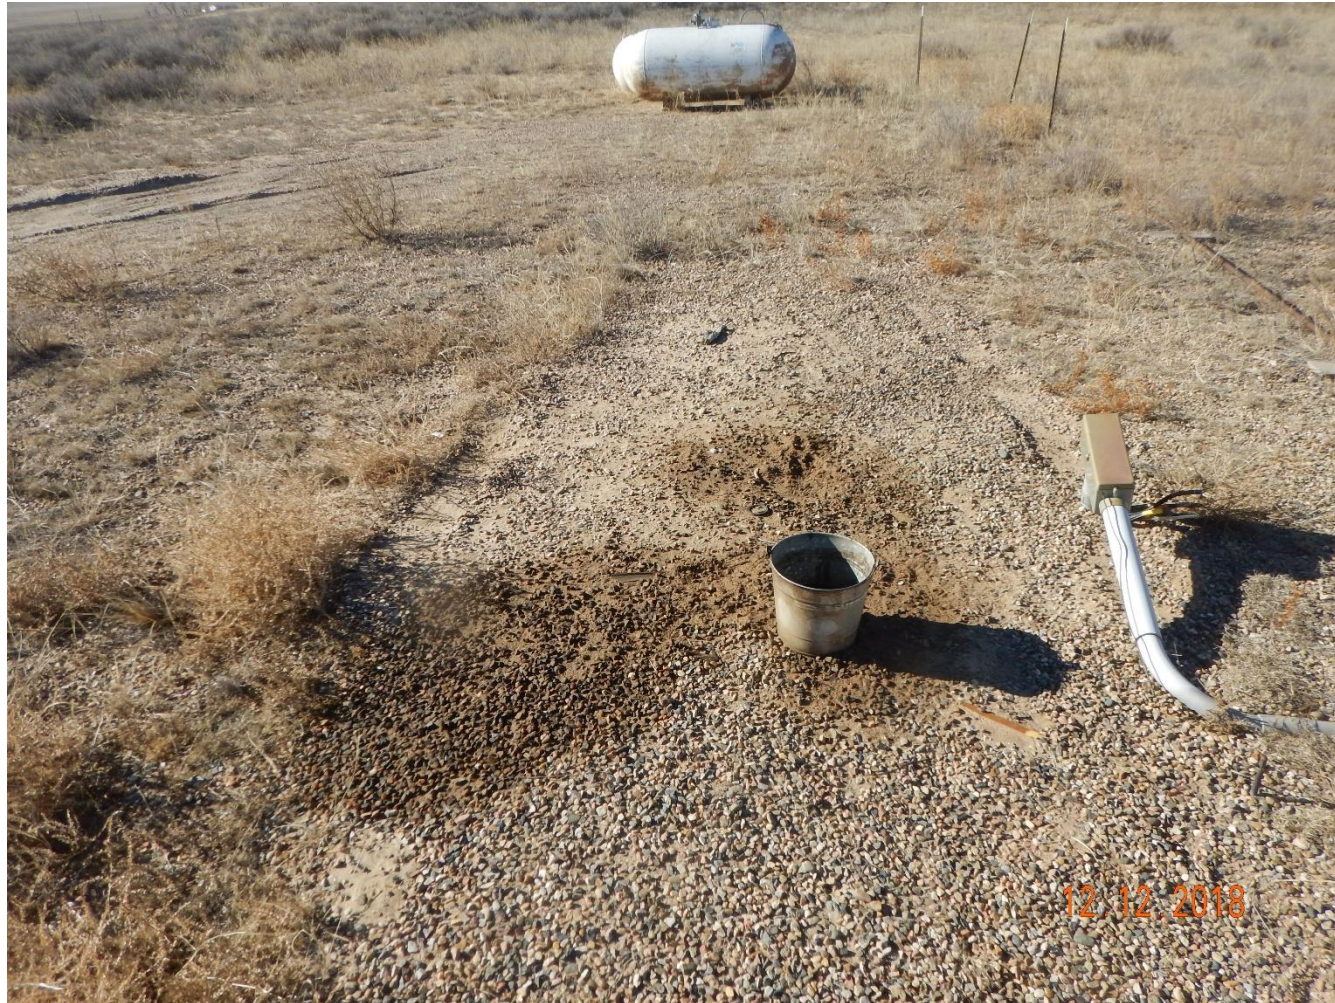
Photo 3: Photo taken from the west end of the location facing west. Photo shows stained soil and a bucket with various contaminated soils without secondary containment.

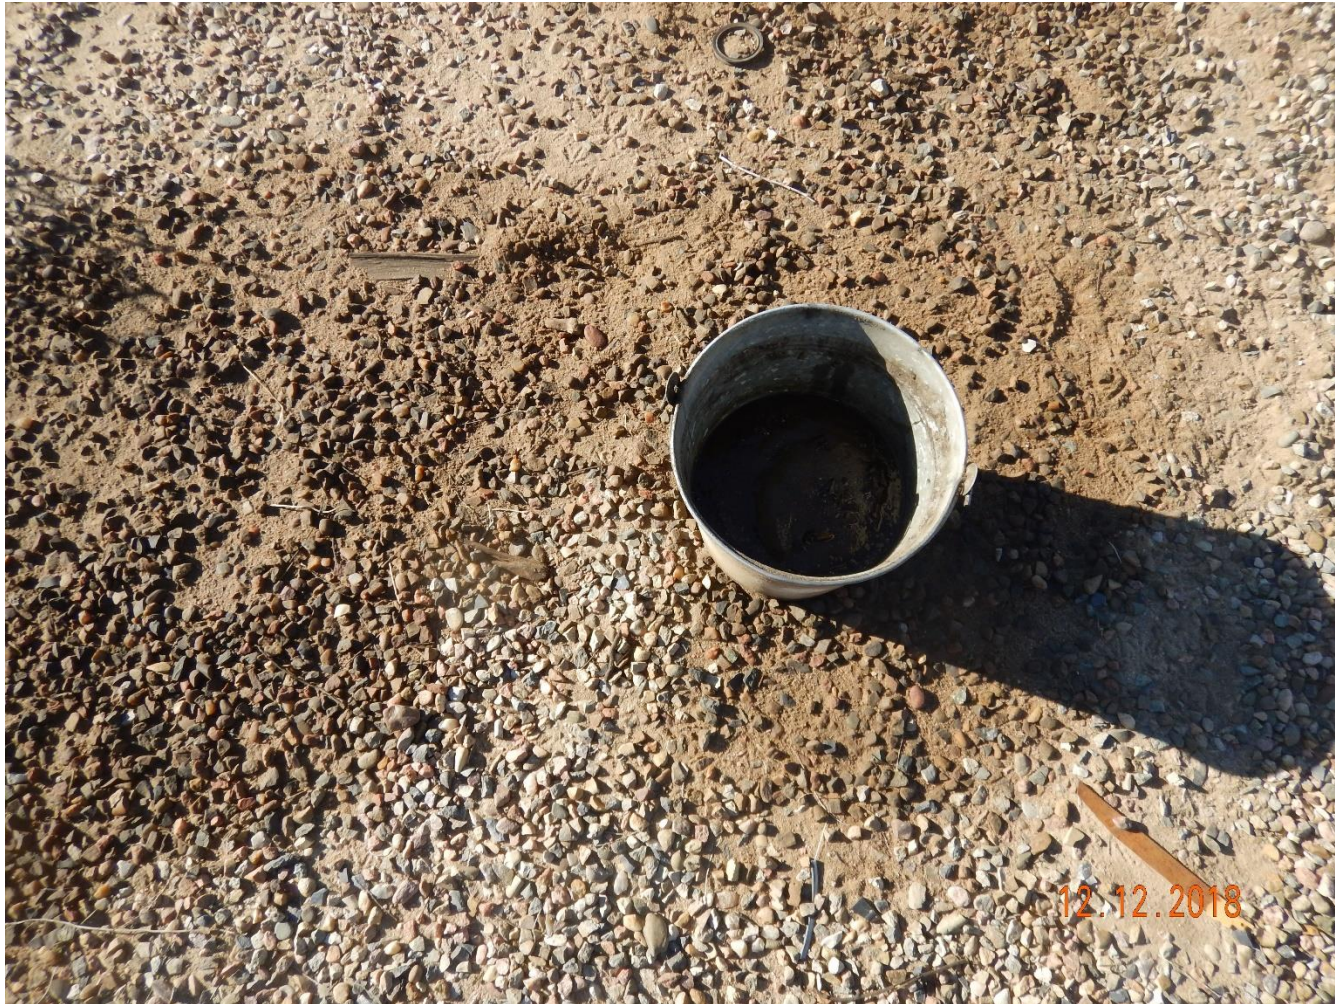
Photo 4: Photo taken from the west end of the location facing west. Photo shows stained soil and a bucket with various contaminated soils without secondary containment.

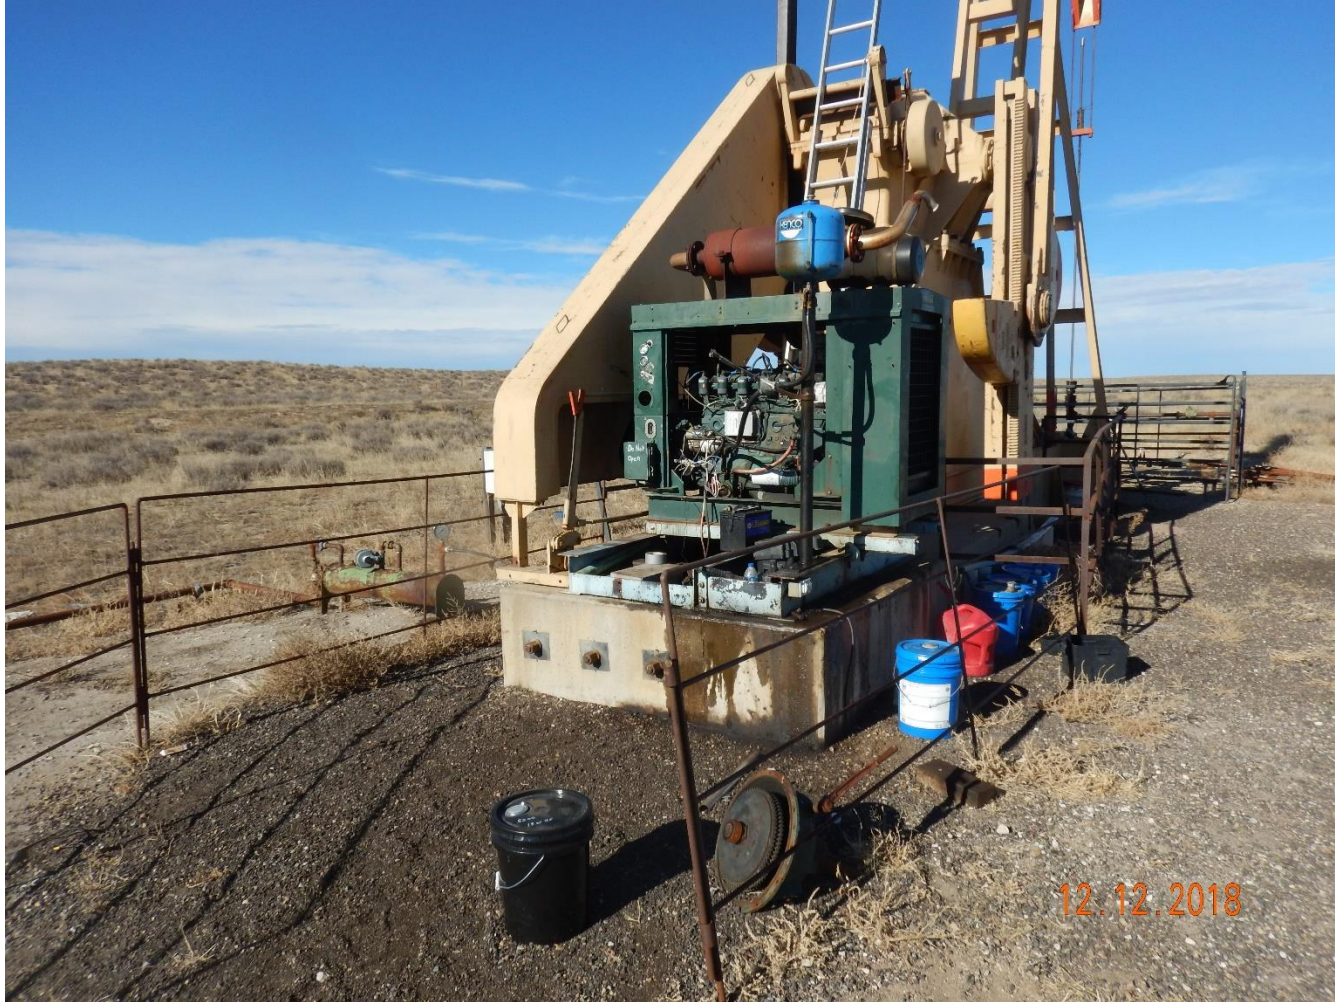
Photo 6: Photo taken from the southeast end of the pump jack, facing northwest. Previous inspections documented numerous 5 gallon buckets w/ chemical and oil jugs found around pump jack, and required containers to be properly removed and disposed, or placed into containment. Photo shows containers have not been removed or placed into containment.

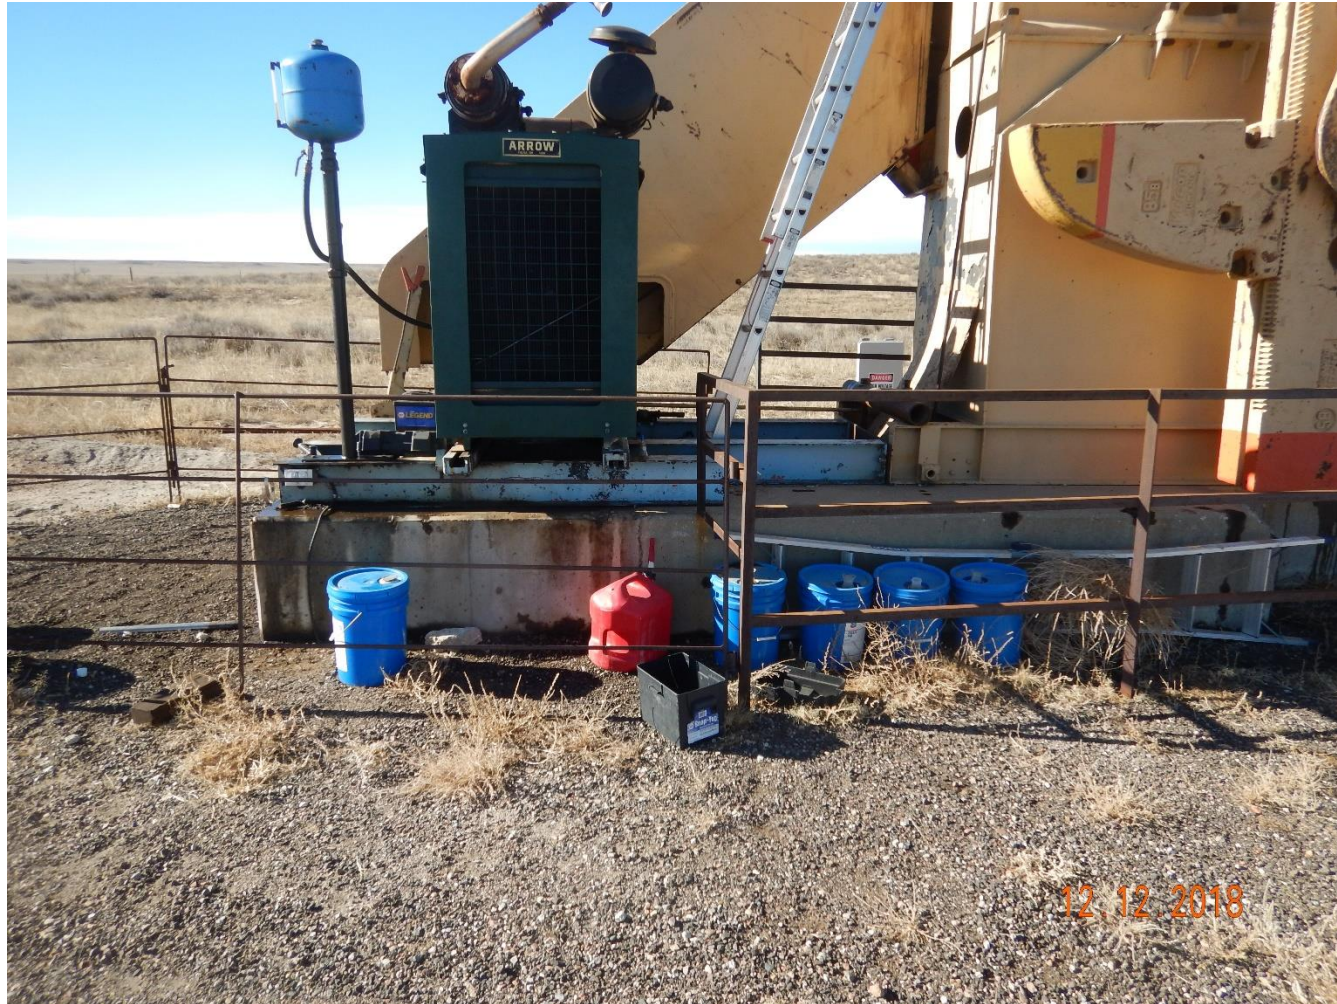
Photo 7: Photo taken from the east end of the pump jack, facing west. Previous inspections documented numerous 5 gallon buckets w/ chemical and oil jugs found around pump jack, and required containers to be properly removed and disposed, or placed into containment. Photo shows containers have not been removed or placed into containment.

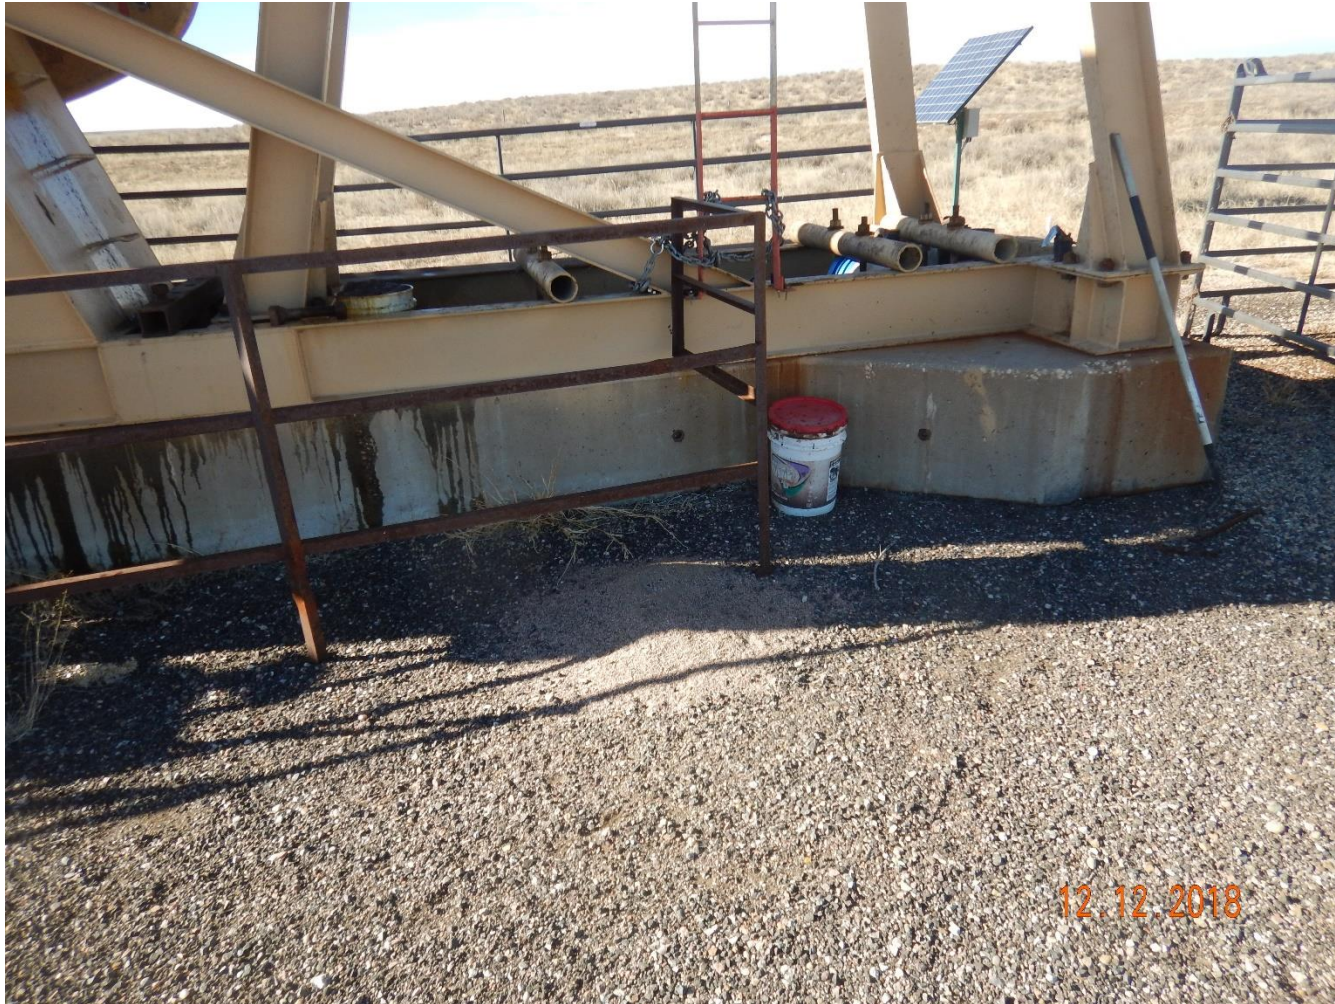
Photo 8: See comments under photo 7

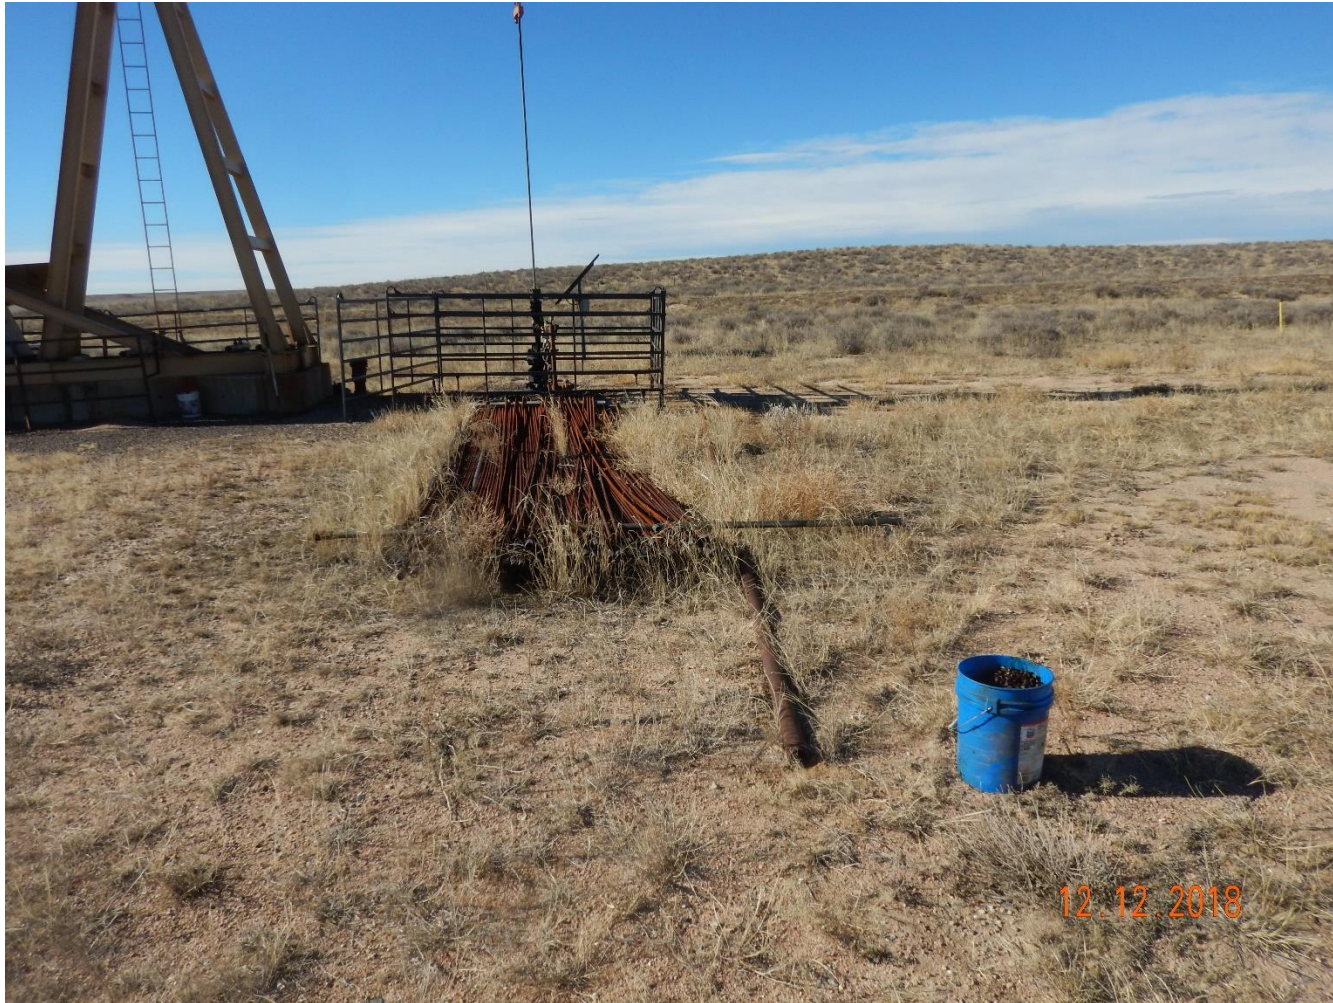
Photo 9: Photo taken from the east end of the pump, facing northwest. Photo shows unused equipment stored on location and a 5 gallon buckets w/ contaminated material. Previous inspections documented required equipment not needed for production needs to be removed, and containers placed within secondary containment.

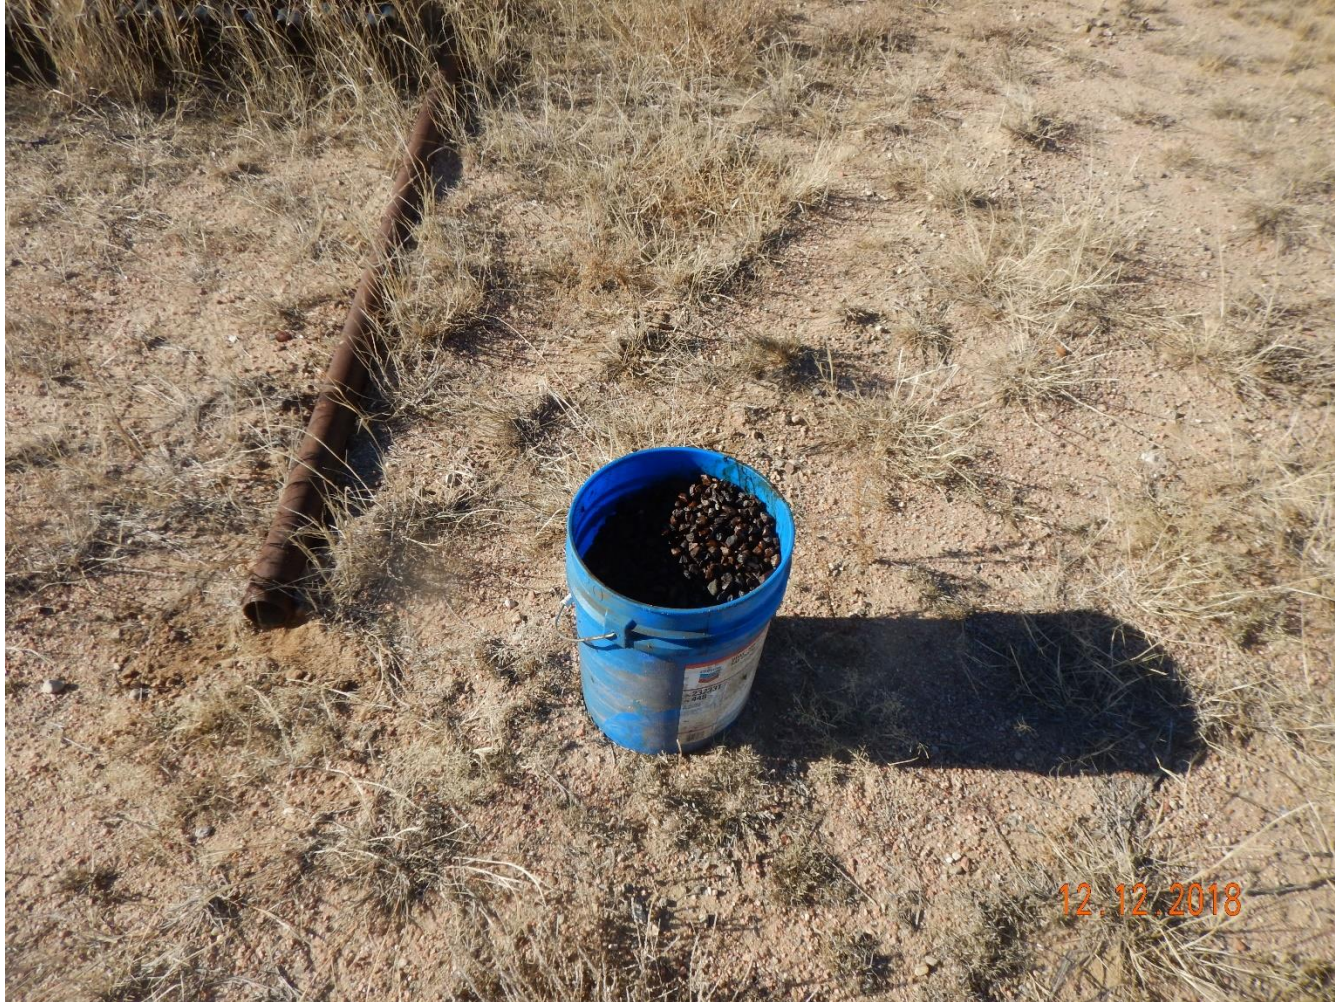
Photo 10: Continued from photo 9. Photo shows bucket with contaminated materials.

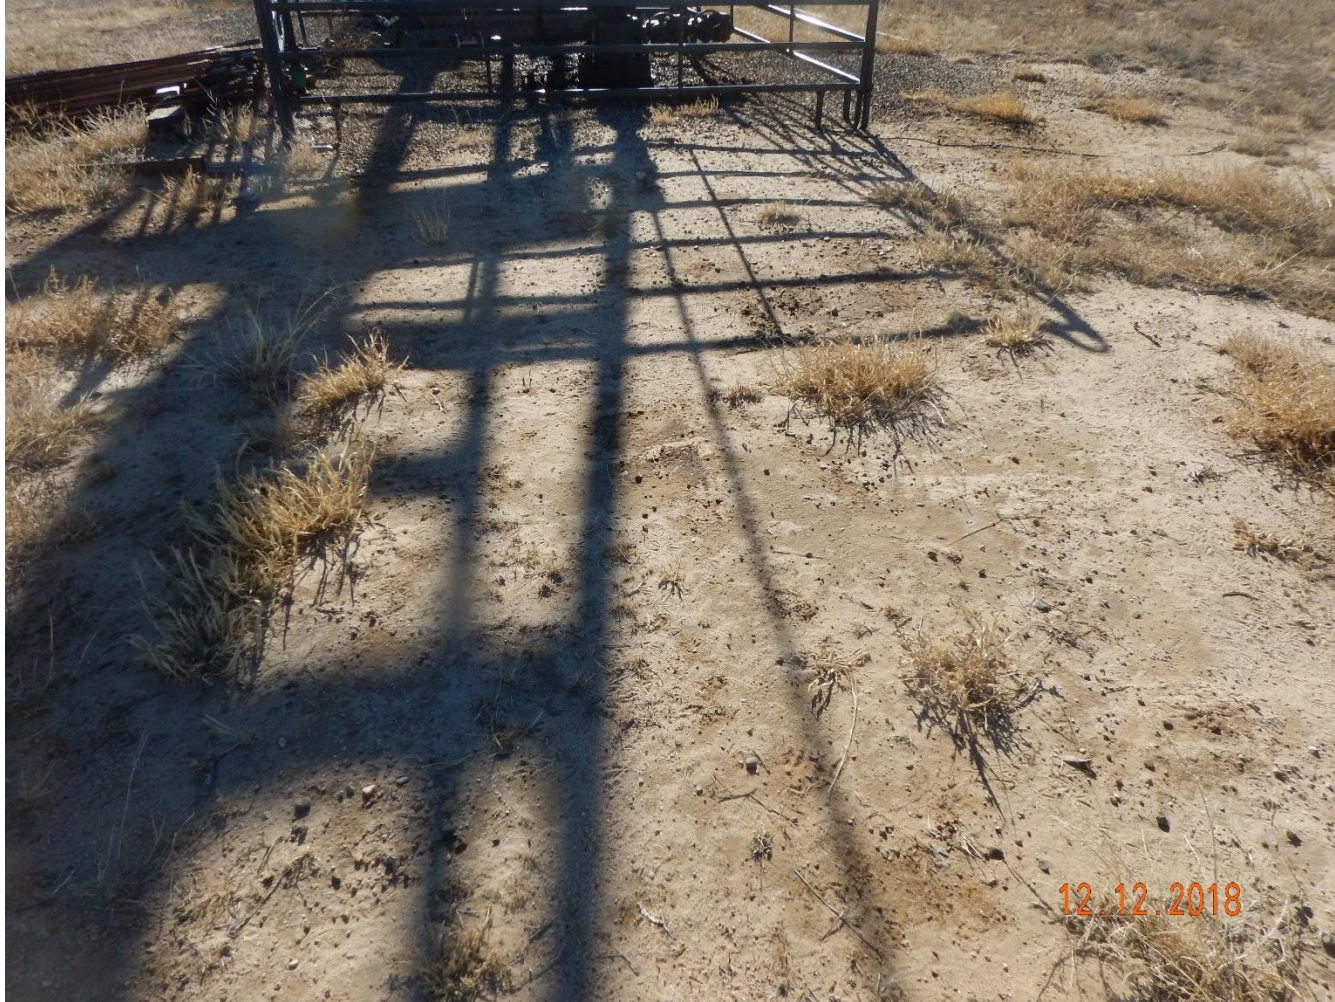
Photo 11: Photo taken from the north end of the well, facing south. Previous inspections documented contaminated soils around well and required stained soils to be cleaned. Photo shows contaminated soils remain.

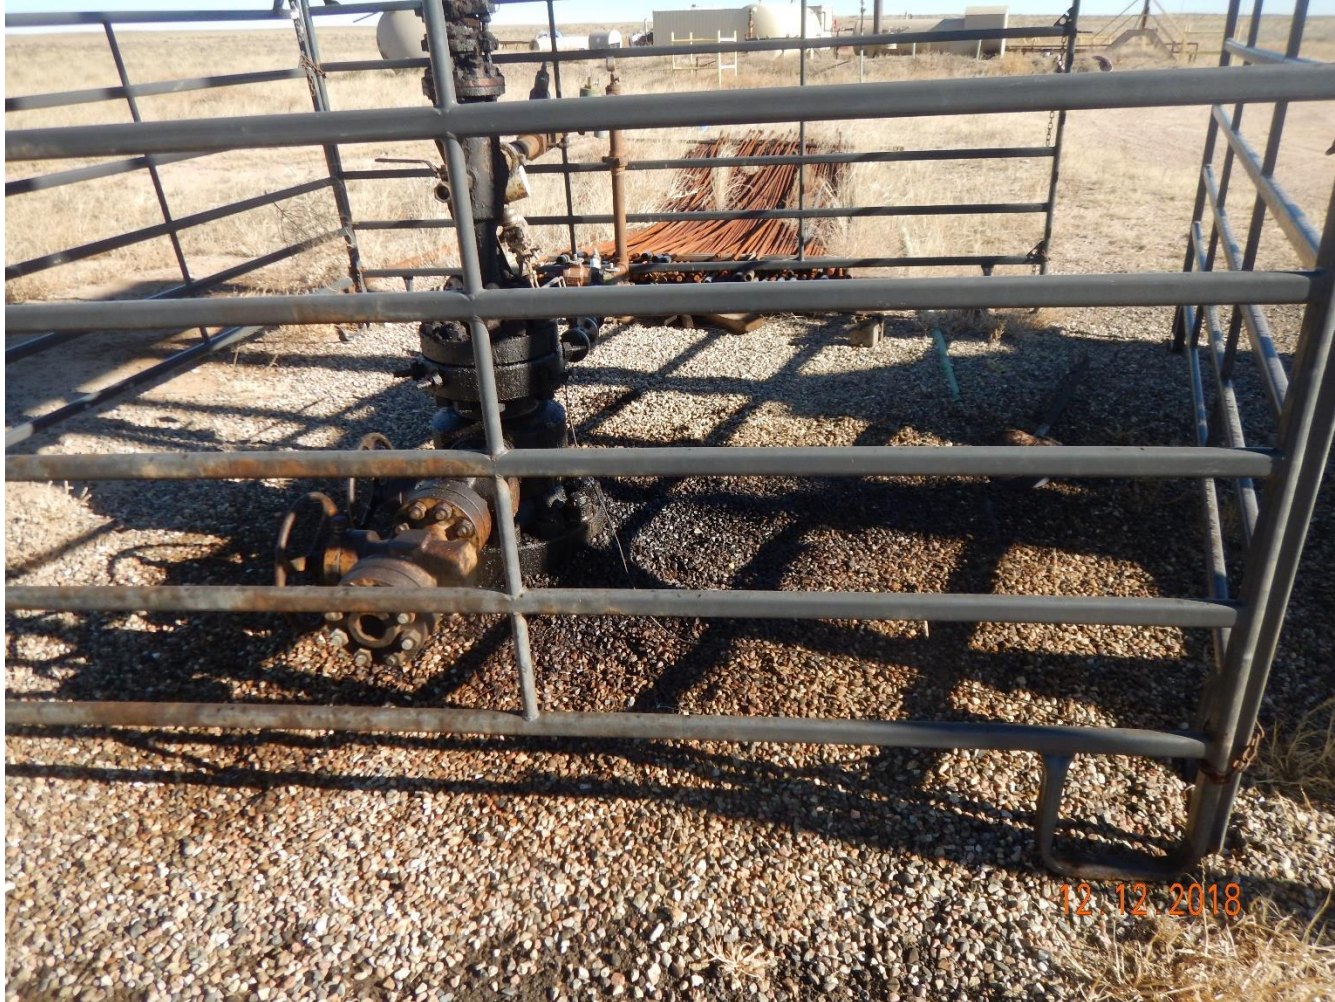
Photo 12: Photo taken from the north end of the well, facing west. Previous inspections documented contaminated soils around well and required stained soils to be cleaned. Photo shows contaminated soils remain.

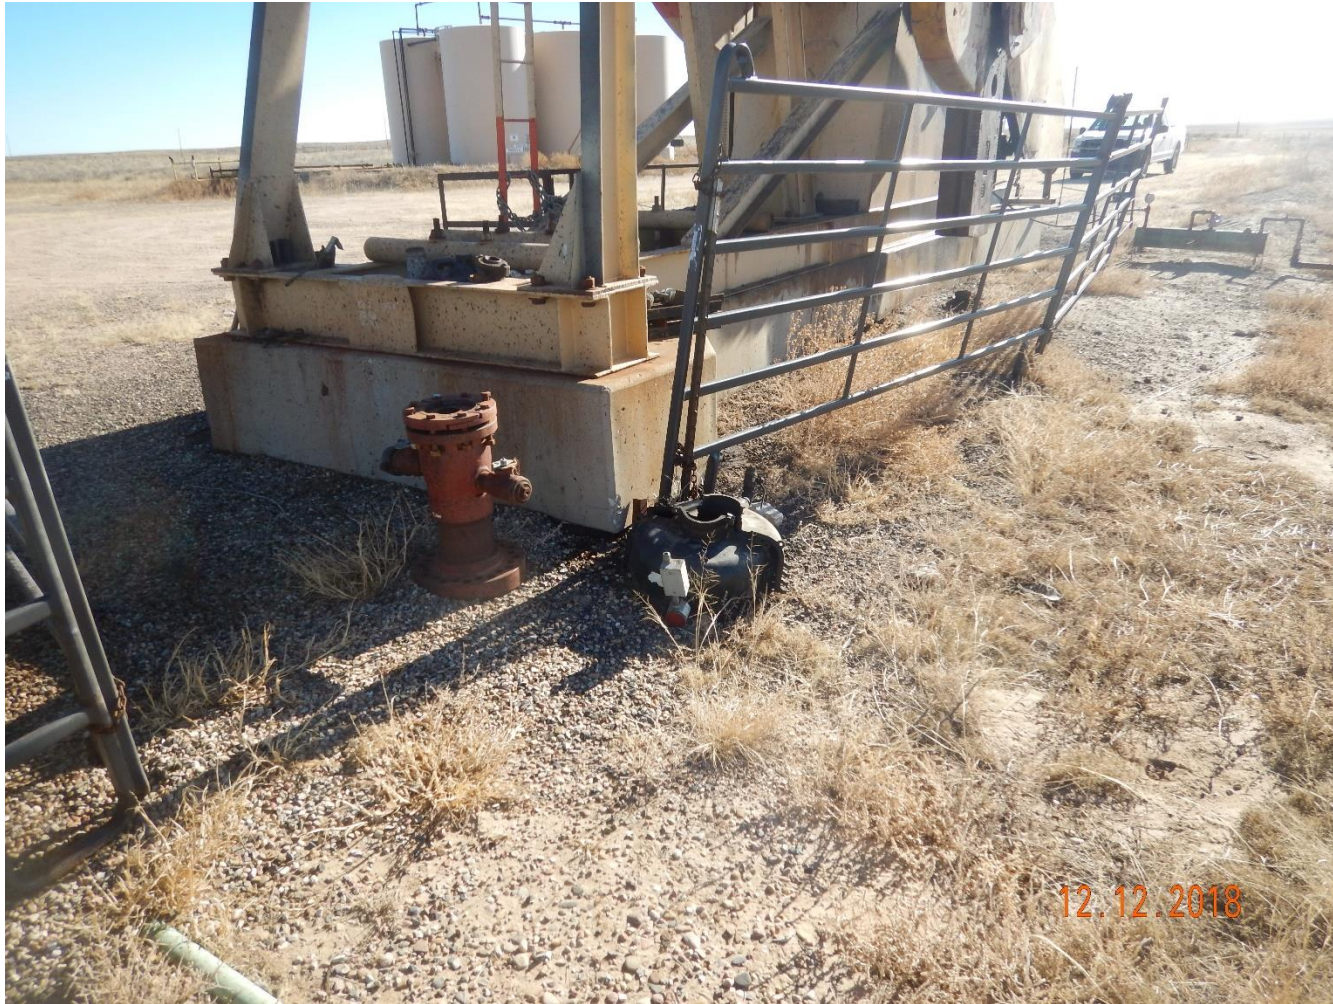
Photo 13: Photo taken from the north end of the well, facing south. Photo shows unused equipment not needed for production remains on location.

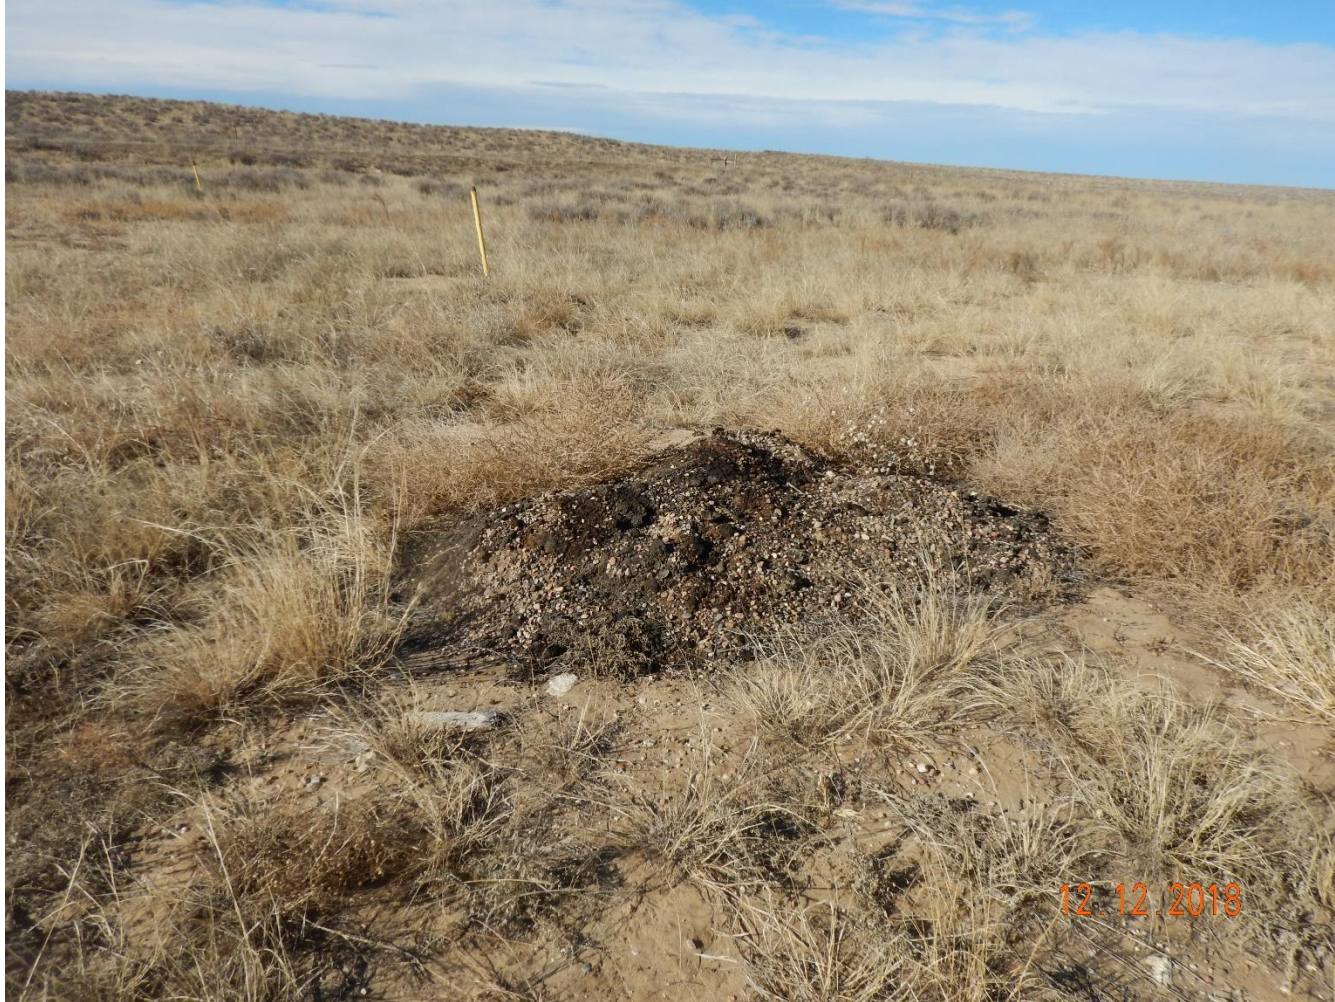
Photo 14: Photo taken from the north end of the location, facing northwest. Previous inspections required contaminated soils to be removed. Photo shows soils remain.

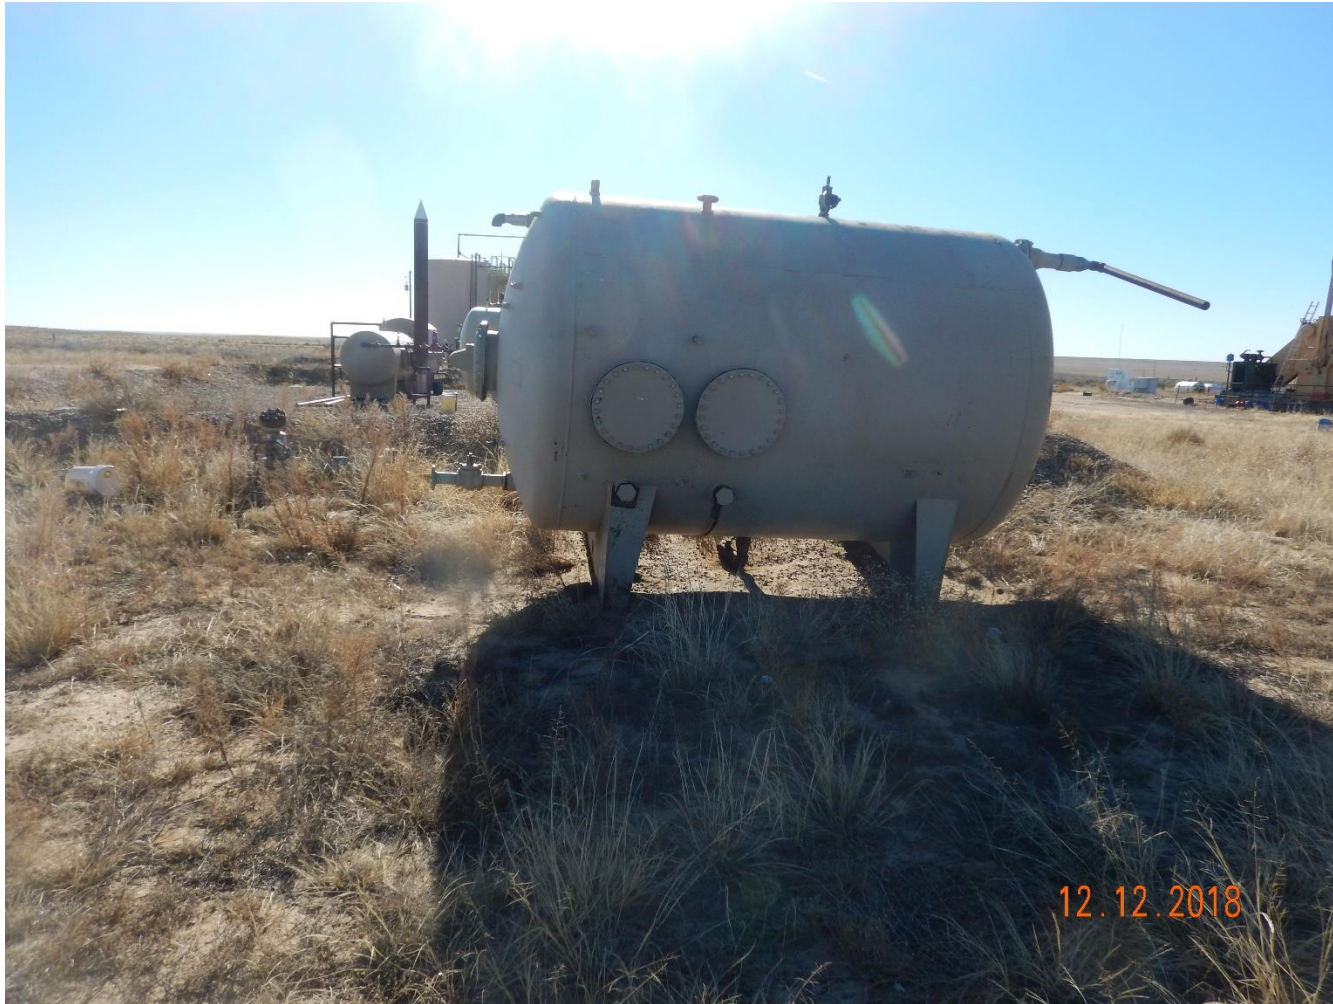
Photo 15: Photo taken from the north end of the location, facing southwest. Photo shows unused equipment not needed for production remains on location.

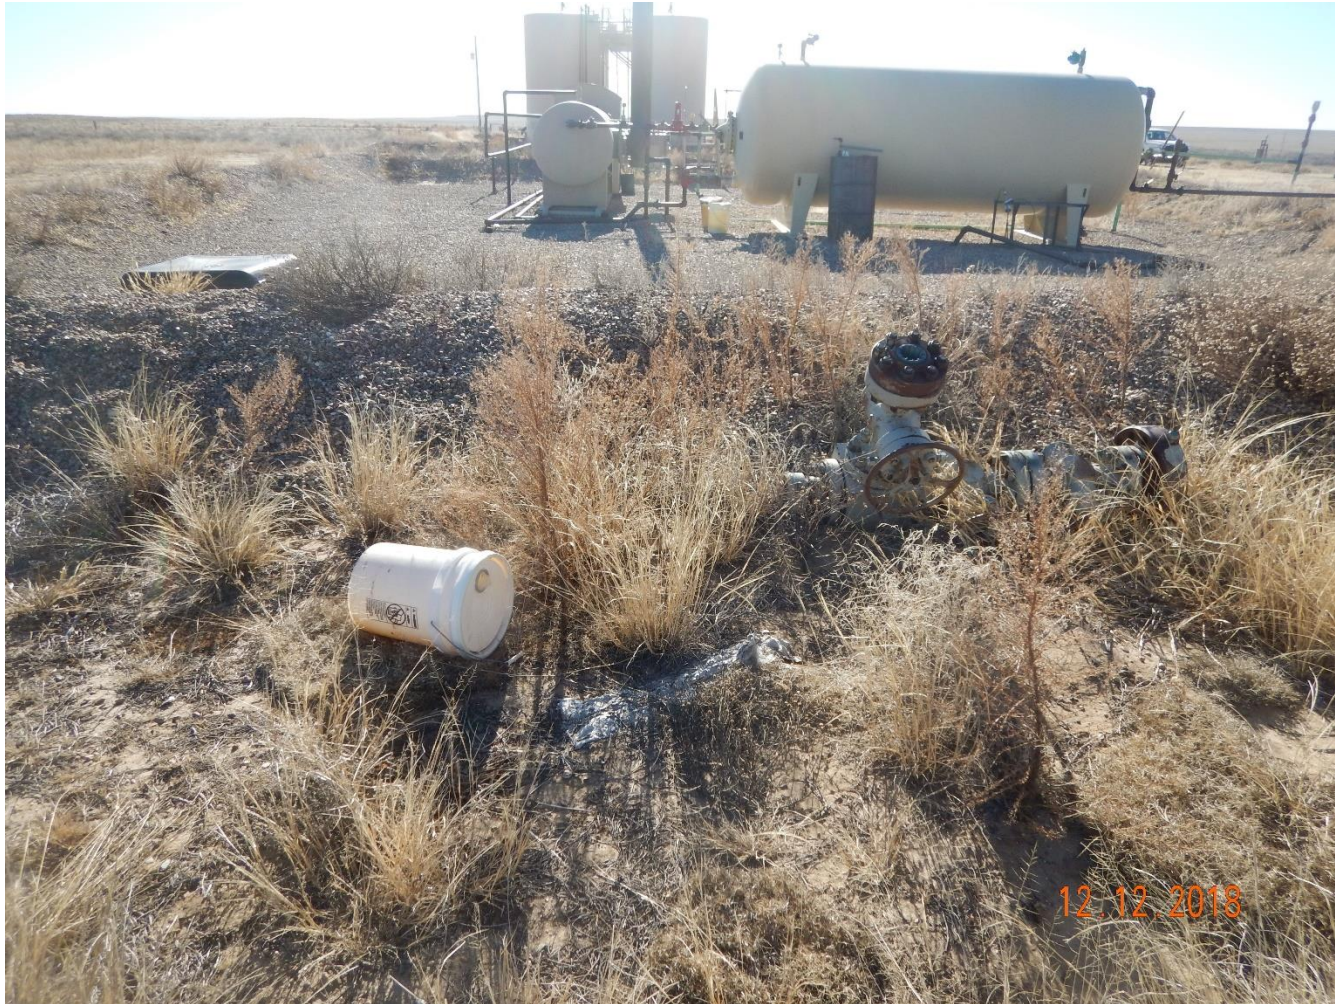
Photo 16: Photo taken from the north end of the location, facing southwest. Photo shows unused equipment not needed for production, and various trash debris remains on location.

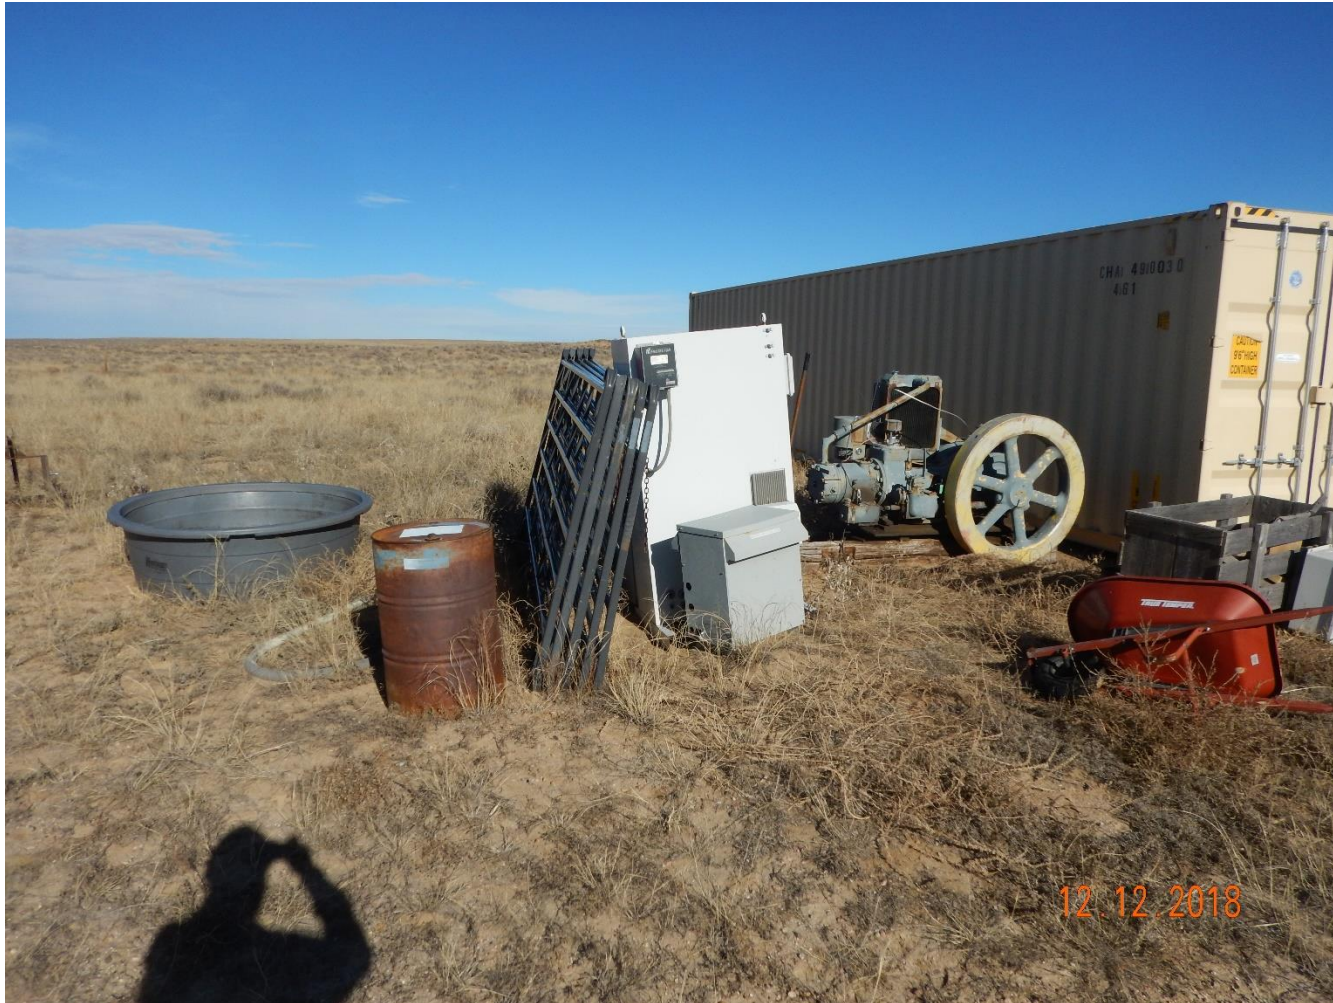
Photo 17: Photo taken from the north end of the location, facing north. Photo shows unused equipment not needed for production remains on location.
