Inspection Photos

Operator: PHOENIX RESOURCES LLC - 10691

Location ID: 414589

Inspection Doc. Number: 682504271

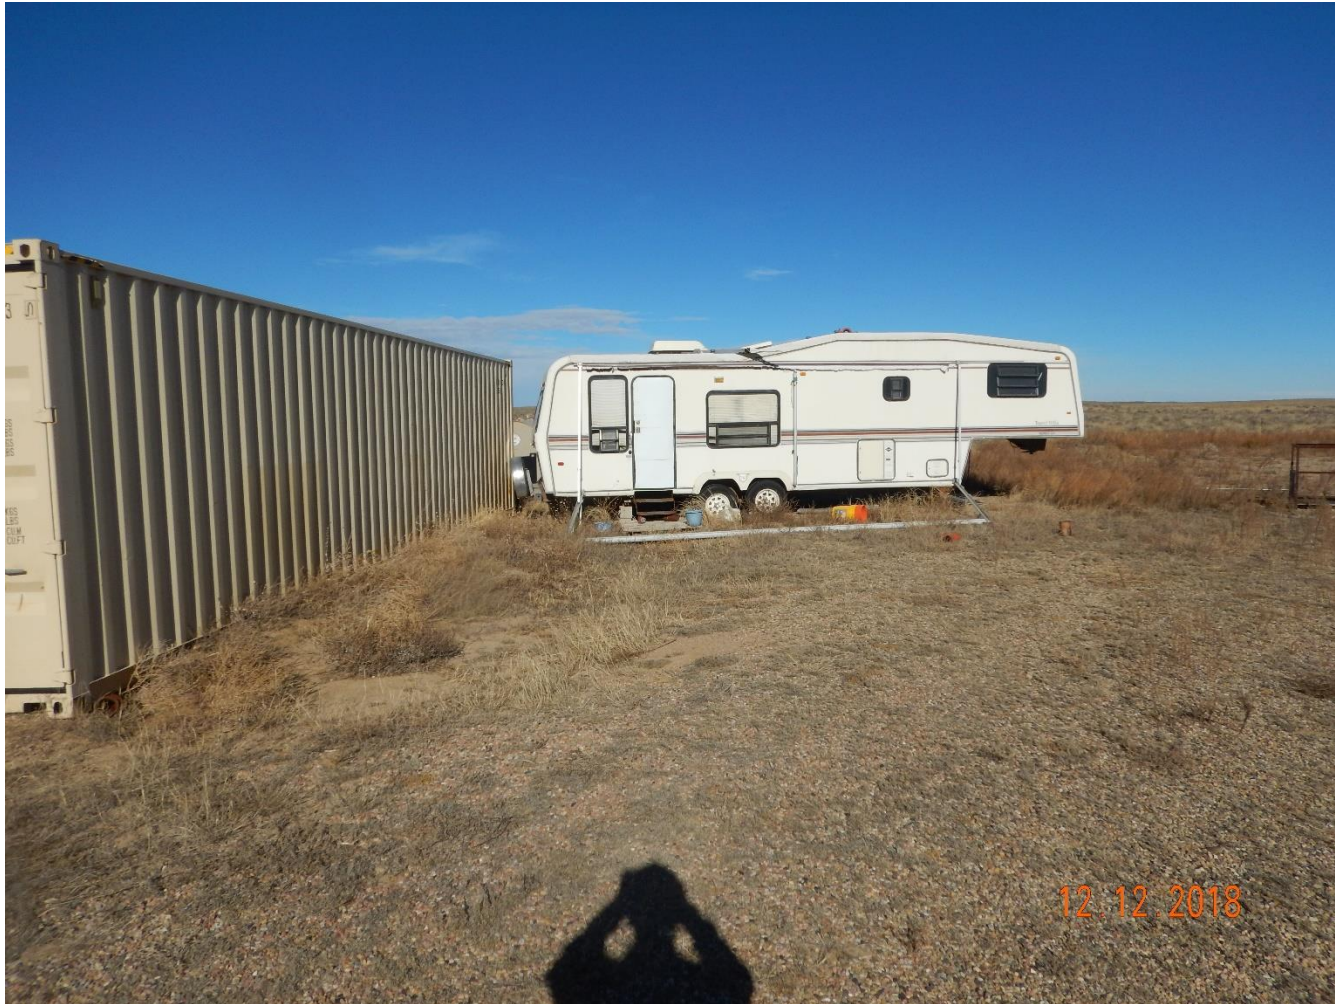
Photo 18: Photo taken from the north end of the location, facing north. Previous inspection documented camper trailer being stored on location. Trailer is not needed for production and was required to be removed. Camper trailer remains. Photo also shows various trash debris around camper trailer.

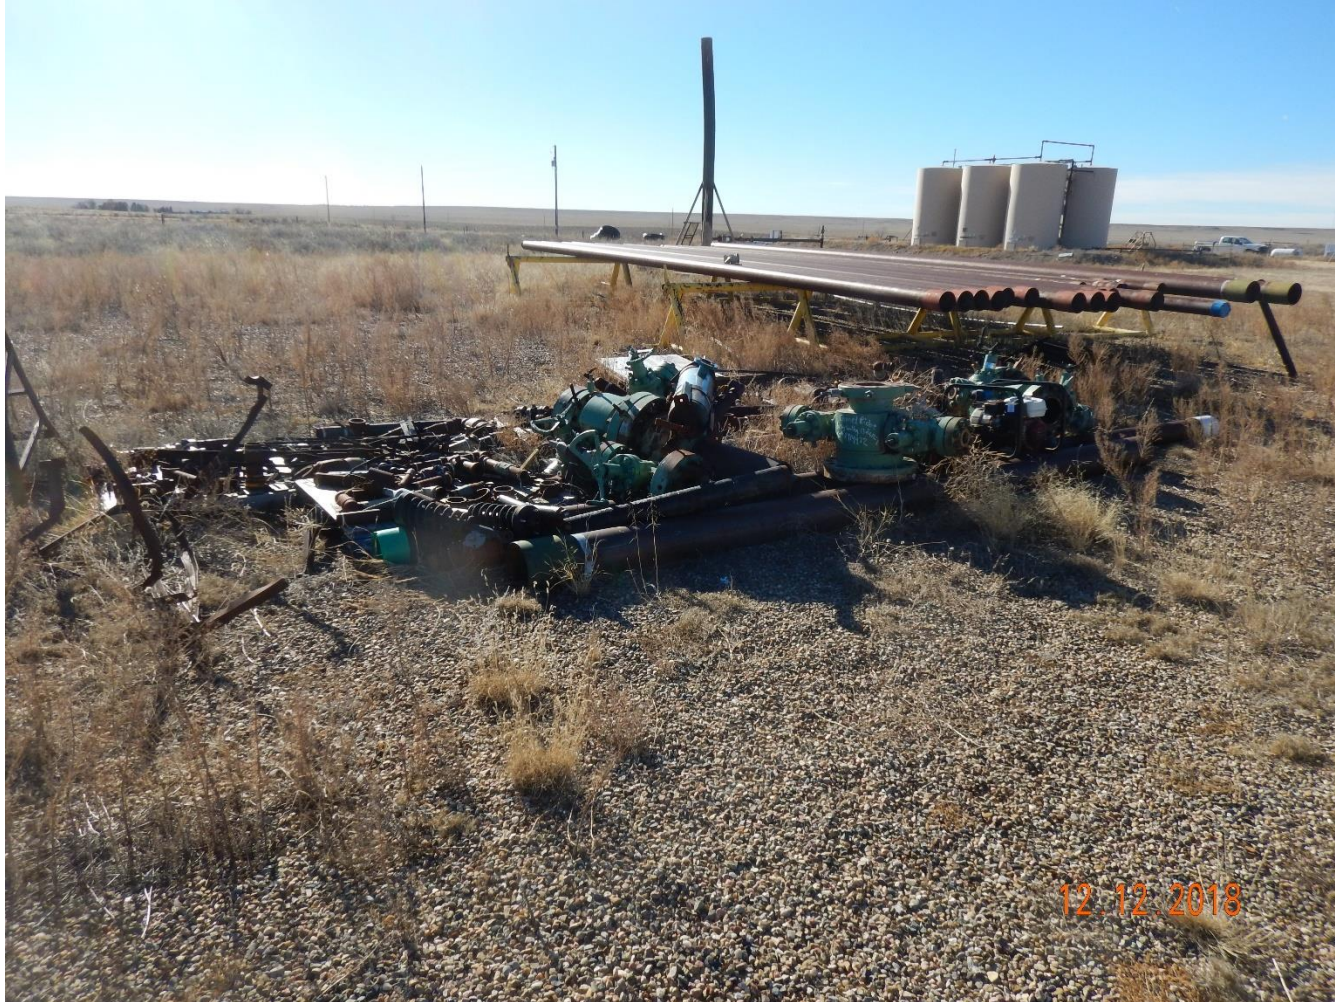
Photo 19: Photo taken from the north end of the location, facing southwest. Photo shows various unused equipment not needed for production remains stored on location.

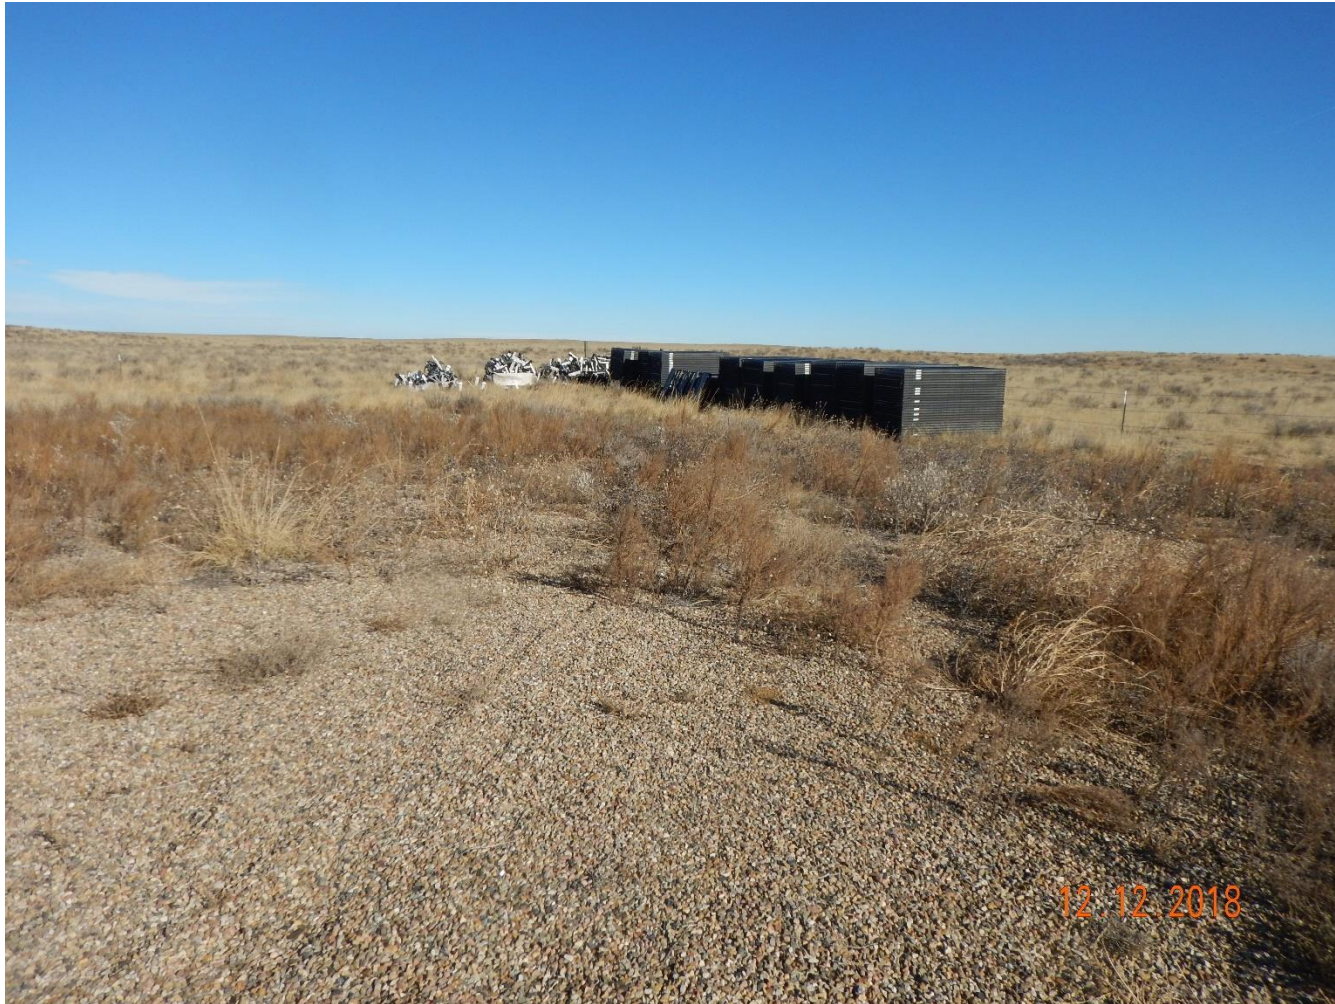
Photo 20: Photo taken from the north end of the location, facing southwest. Photo shows various unused equipment not needed for production remains stored on location.

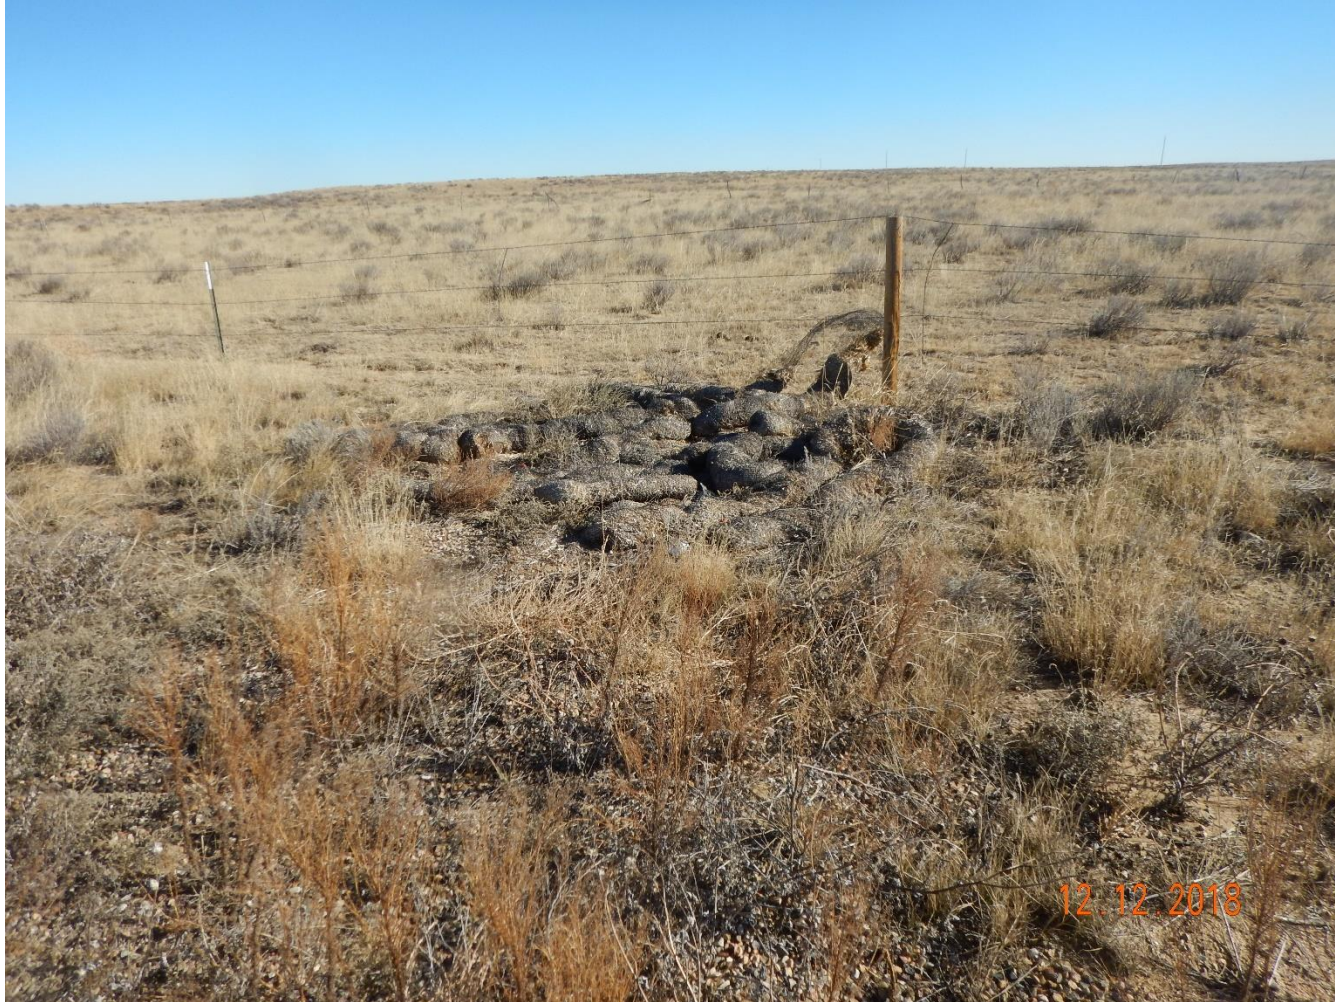
Photo 21: Photo taken from the north end of the location, facing southwest. Photo shows trash debris remains on location.

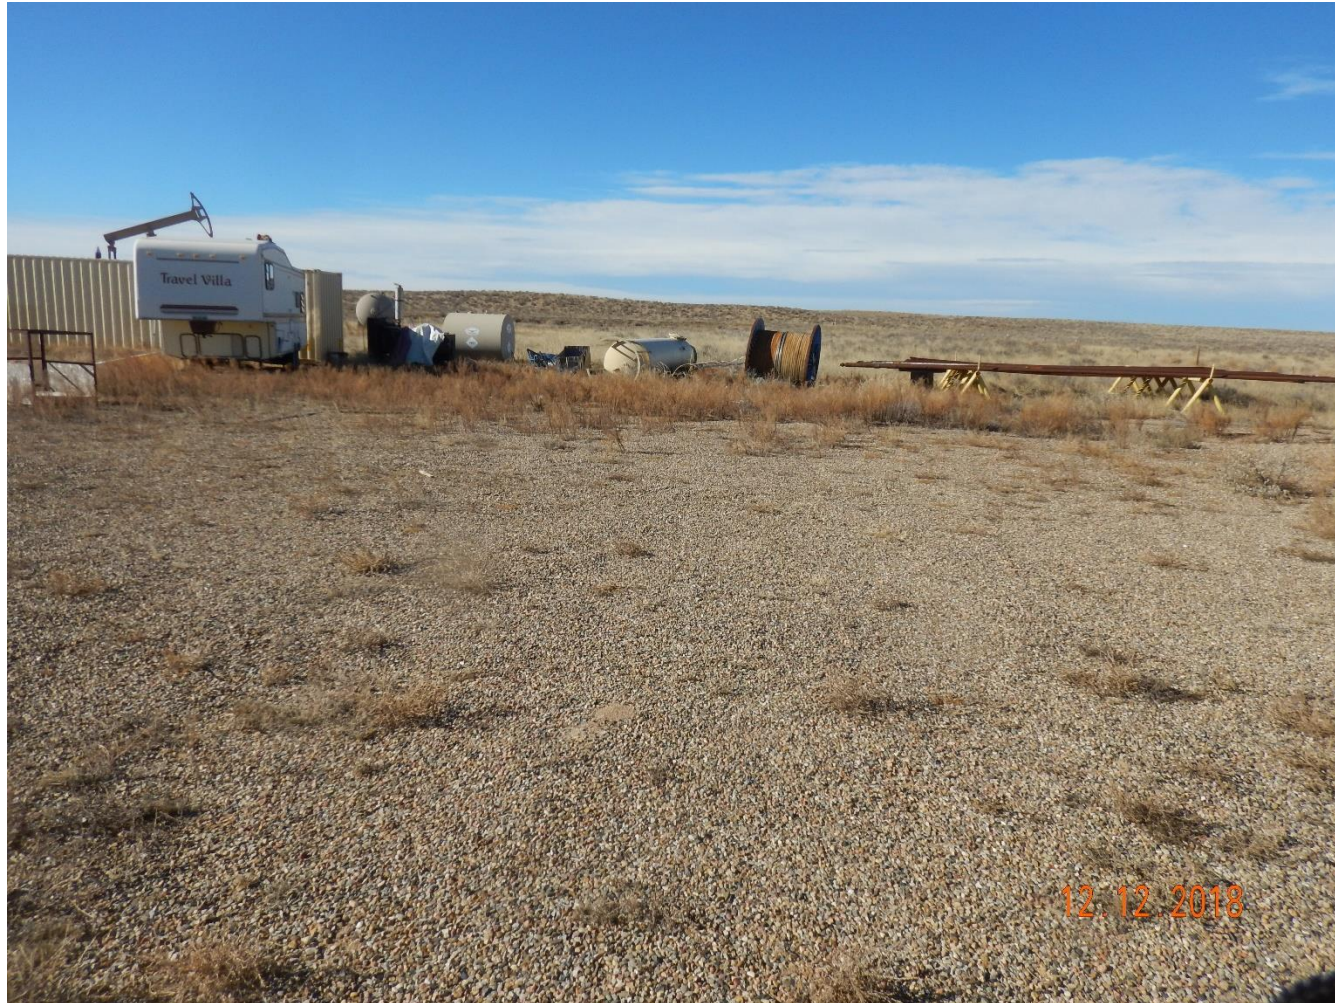
Photo 22: Photo taken from the north end of the location, facing west. Photo shows various unused equipment not needed for production remains stored on location

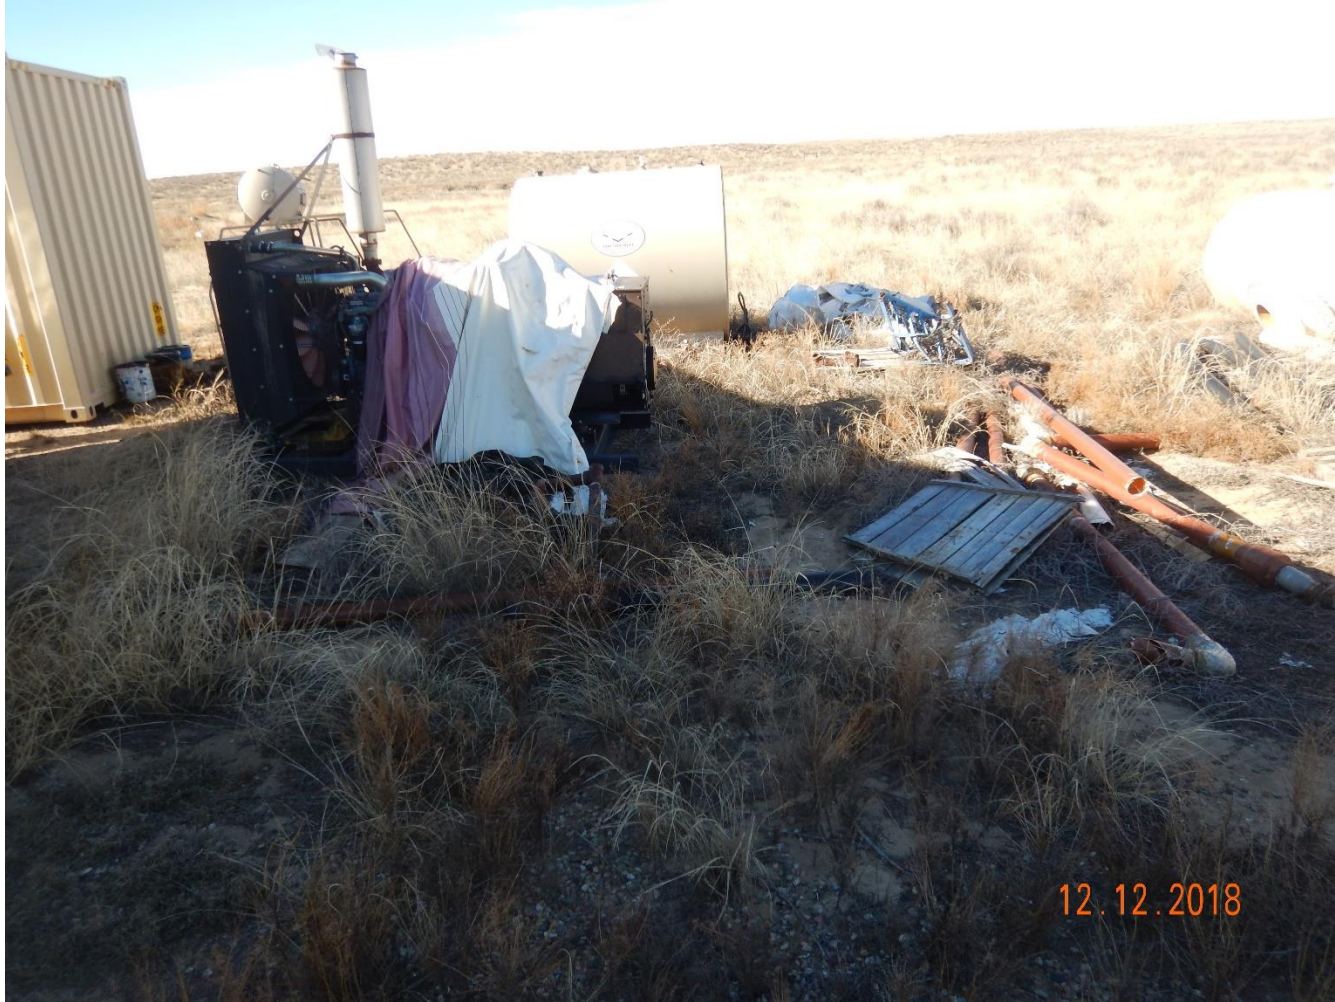
Photo 23: Photo taken from the north end of the location, facing west. Photo shows various unused equipment not needed for production, and trash debris remains stored on location.

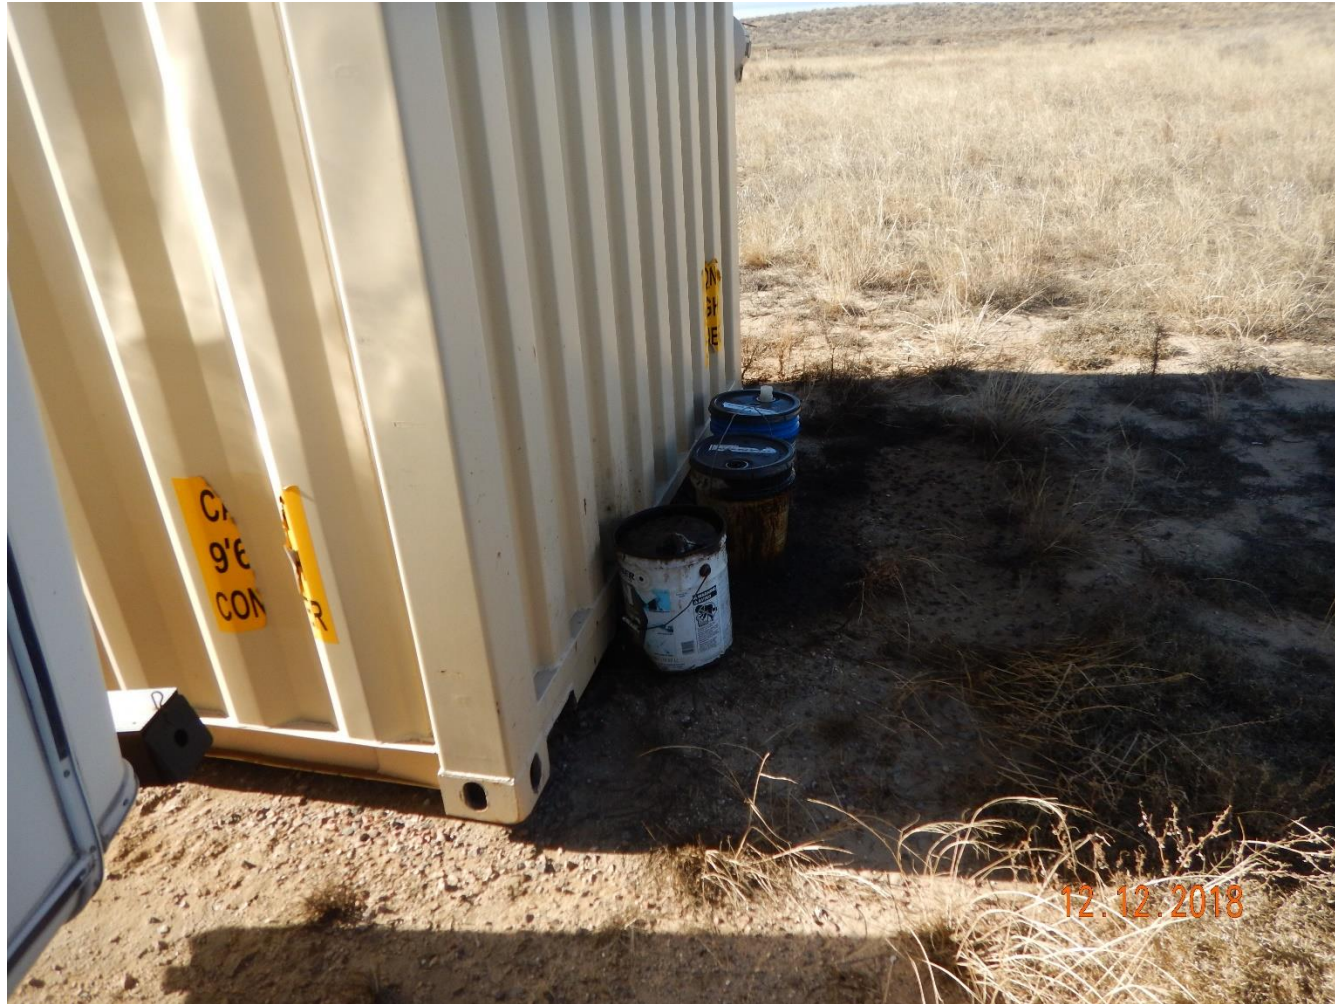
Photo 24: Photo taken from the north end of the location. Previous inspections documented 5 gallon buckets w/ chemical and stained soils and required buckets to be properly removed and disposed, or placed into containment and soil cleaned. Photo shows buckets and contaminated soils remain.

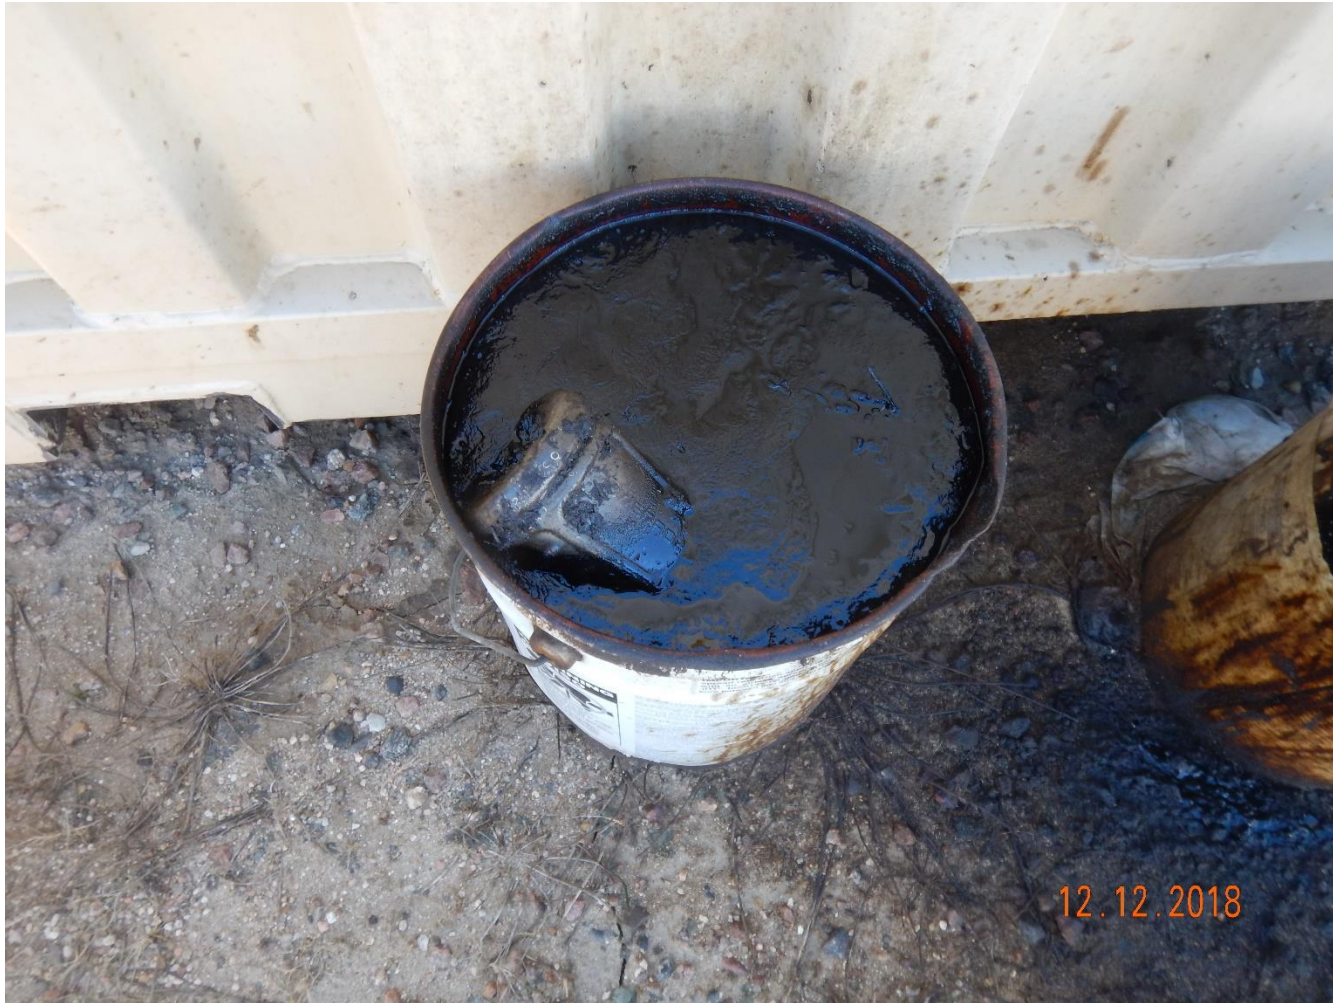
Photo 25: Photo taken from the north end of the location. Previous inspections documented 5 gallon buckets w/ chemical and stained soils and required buckets to be properly removed and disposed, or placed into containment and soil cleaned. Photo shows buckets and contaminated soils remain.

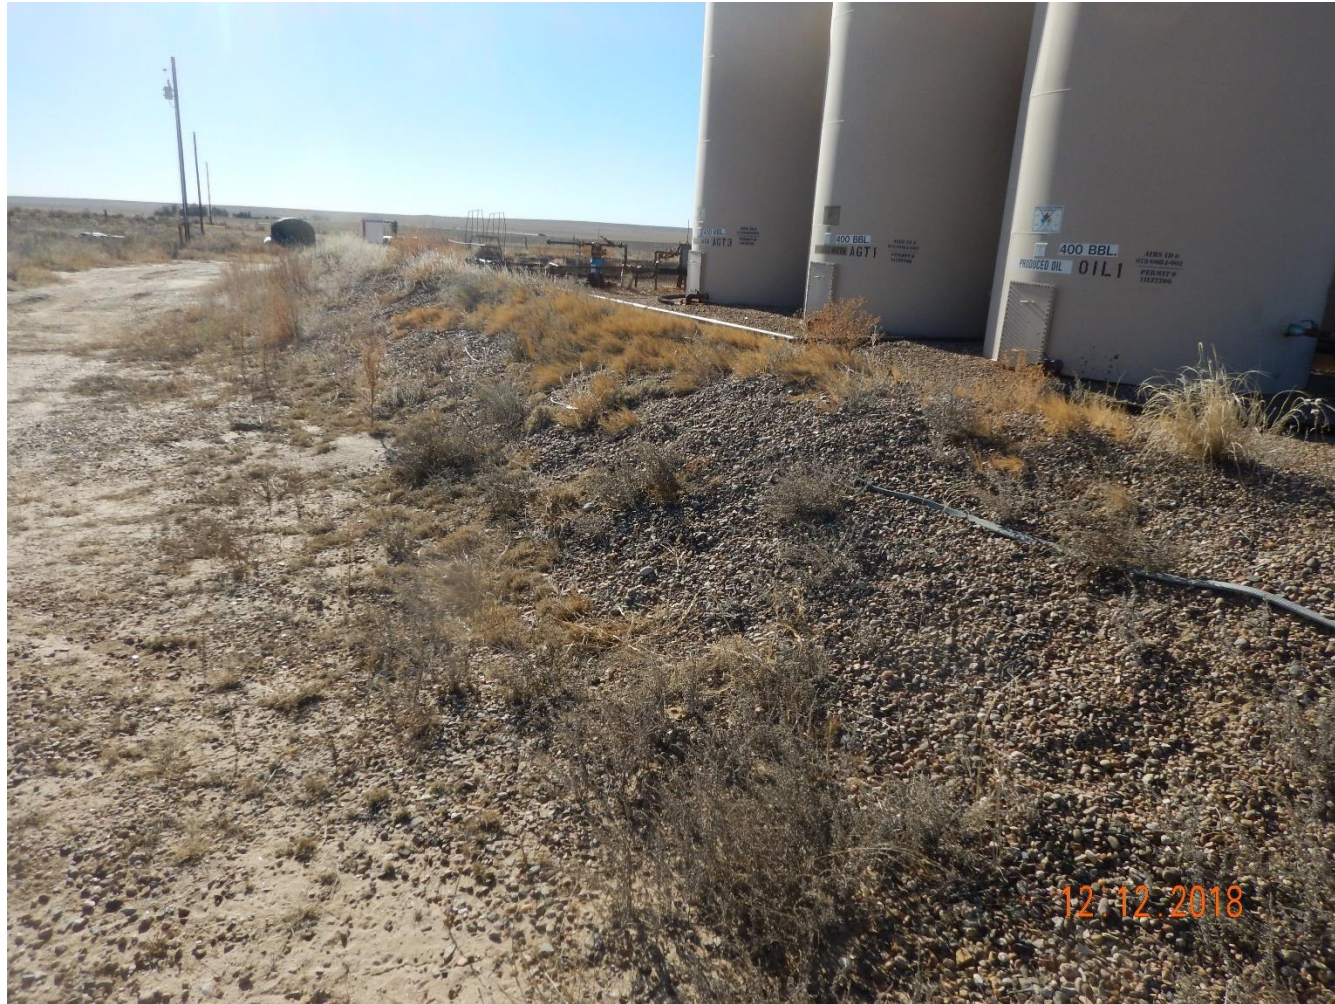
Photo 26: Photo taken from the northeast corner of the tank battery, facing south. Previous inspections required operator to remove vegetation from the berms of the battery and production equipment; vegetation compromises the integrity of the containment berms. Photo shows vegetation has not been removed.

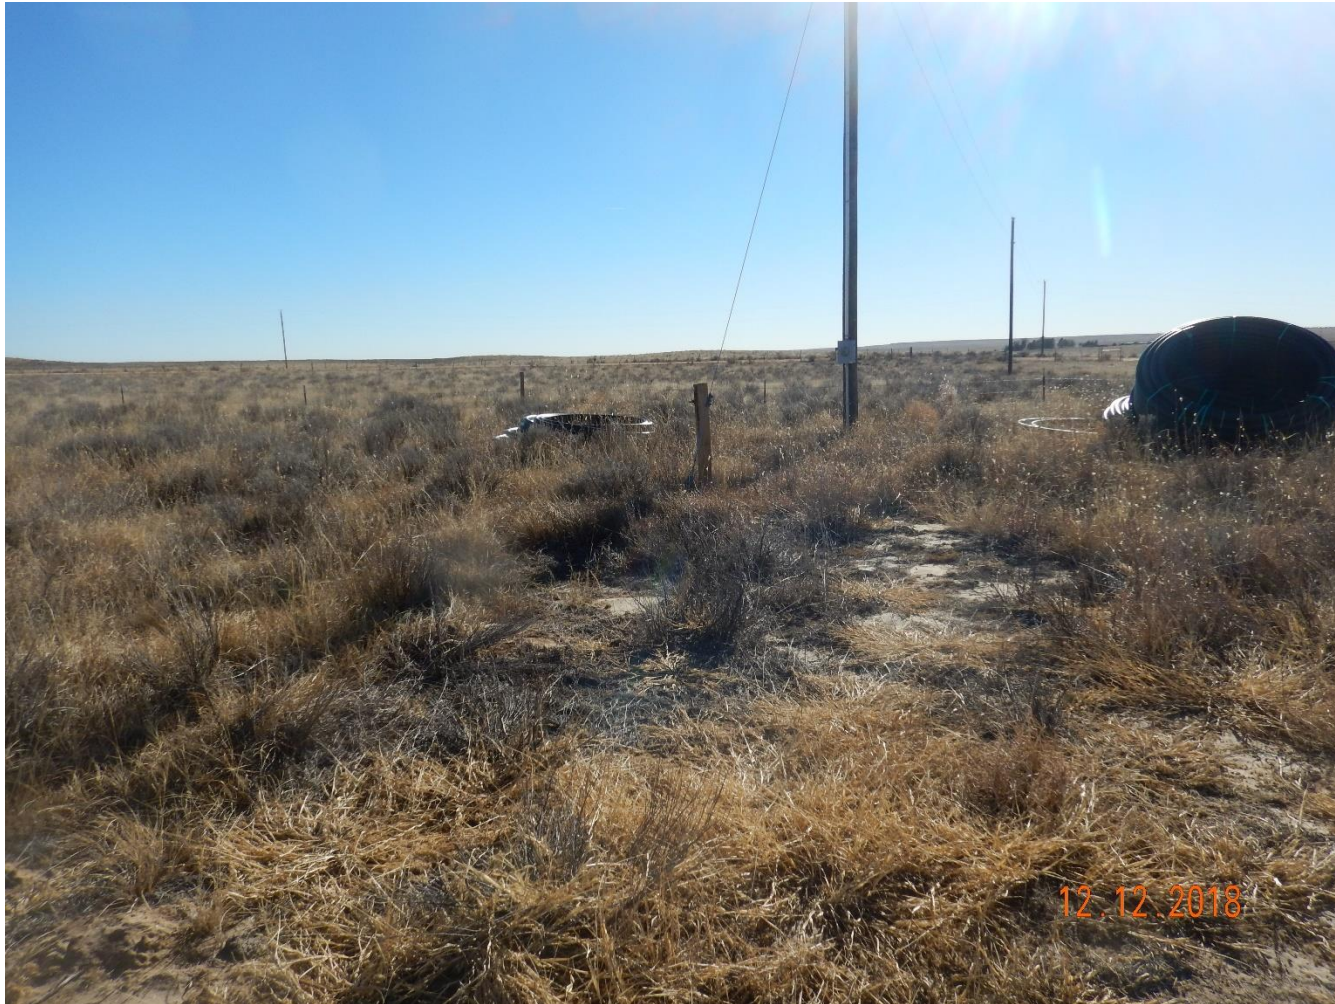
Photo 27: Photo taken from the south end of the location, facing south. Photo shows what appears to be four (4) bundles of pipe stored on the southern interim area. Previous inspections documented that this is unused equipment not needed for production and that needs to be removed from location. Photo shows equipment has not been removed.

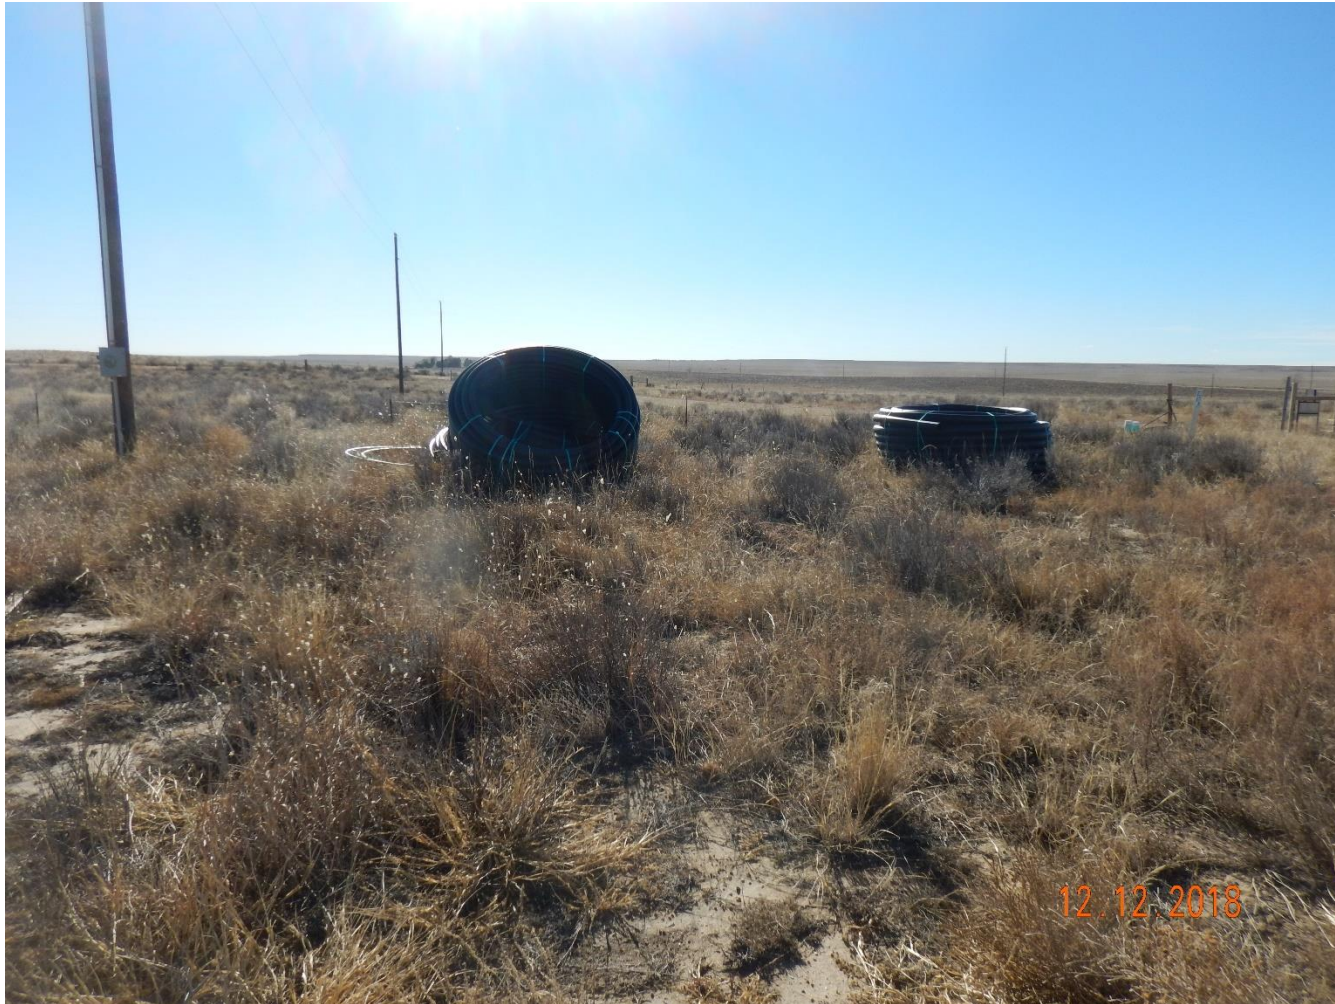
Photo 28: Photo taken from the south end of the location, facing south. Photo shows what appears to be four (4) bundles of pipe stored on the southern interim area. Previous inspections documented that this is unused equipment not needed for production and that needs to be removed from location. Photo shows equipment has not been removed.

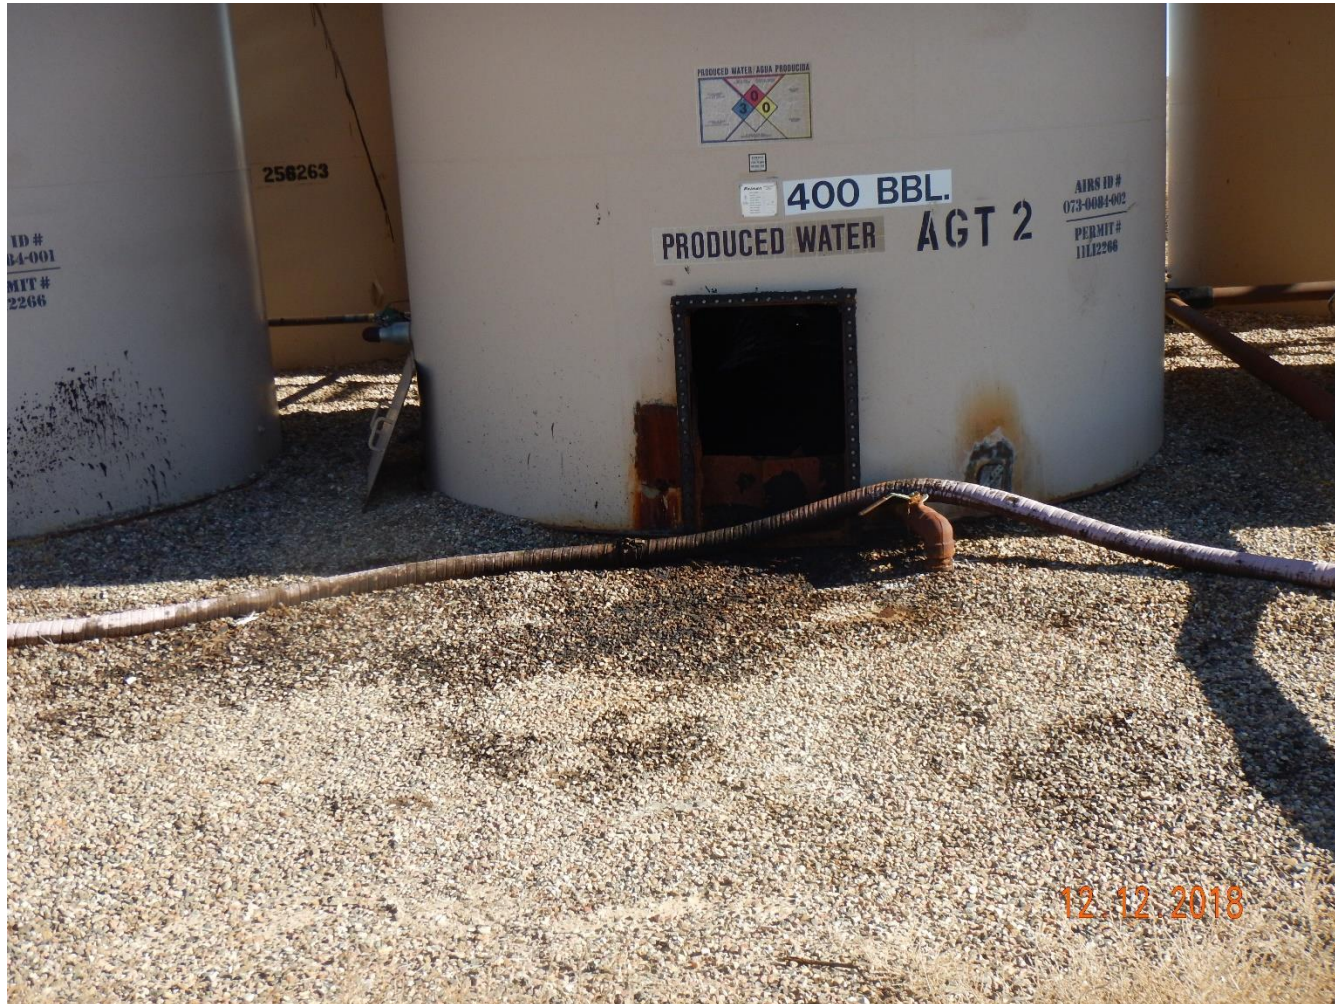
Photo 29: Photo taken from the west end of the tank battery. Previous inspections documented stained soils within the berm, and that the manway cover has been removed from the tank. Photo shows cover has not been replaced and stained soils remain
