# Interim Reclamation and Stormwater Inspection

December 14, 2018

Operator: ENERPLUS RESOURCES (USA) CORPORATION - #10177

Location ID: 450827

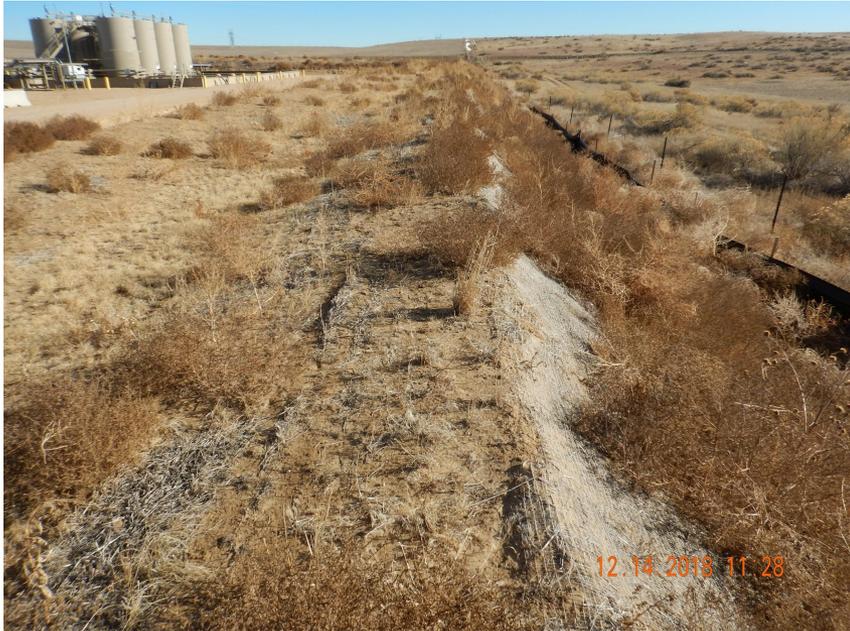
**Photo 1.** Photo taken from the southern southern topsoil stockpile, facing East. Operator has failed to prevent weed establishment on the topsoil stockpile. Note: Appears the Operator attempted to seed the topsoil with desirable vegetation (e.g., blue grama) but weedy, annual vegetation (Kochia) was observed throughout most of the stockpile fill slope areas. Note: Kochia was observed throughout cut and fill slopes of the well pad.

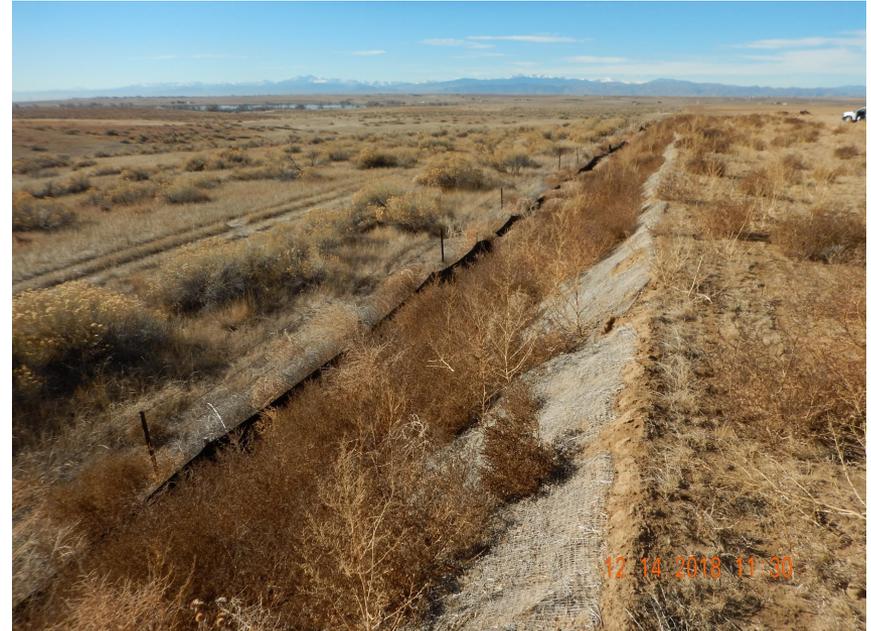
**Photo 2.** Photo taken from the southern southern topsoil stockpile, facing West. See comments under Photo 1.

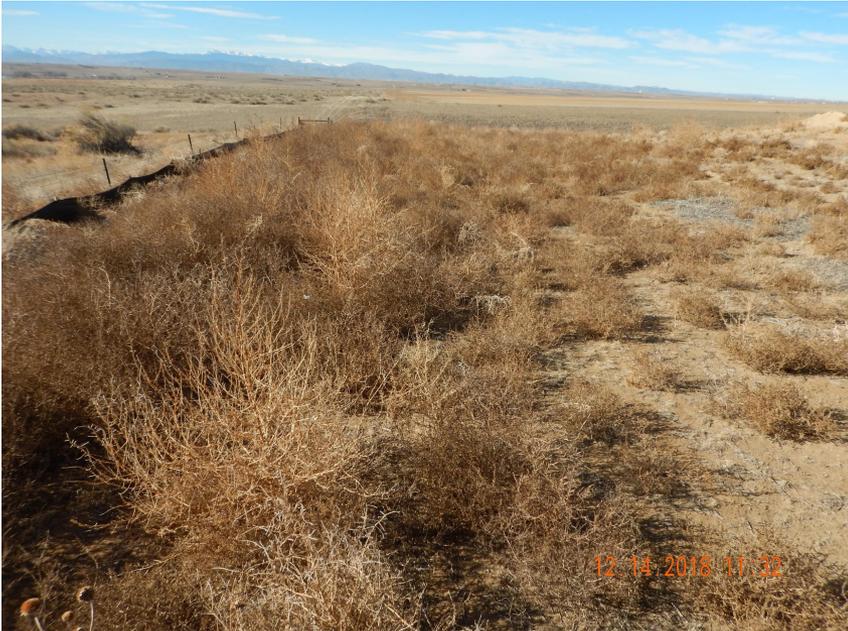
**Photo 3.** Photo taken from the southwestern perimeter of the location, facing West. Operator has failed to control and manage weedy, annual vegetation (Kochia).

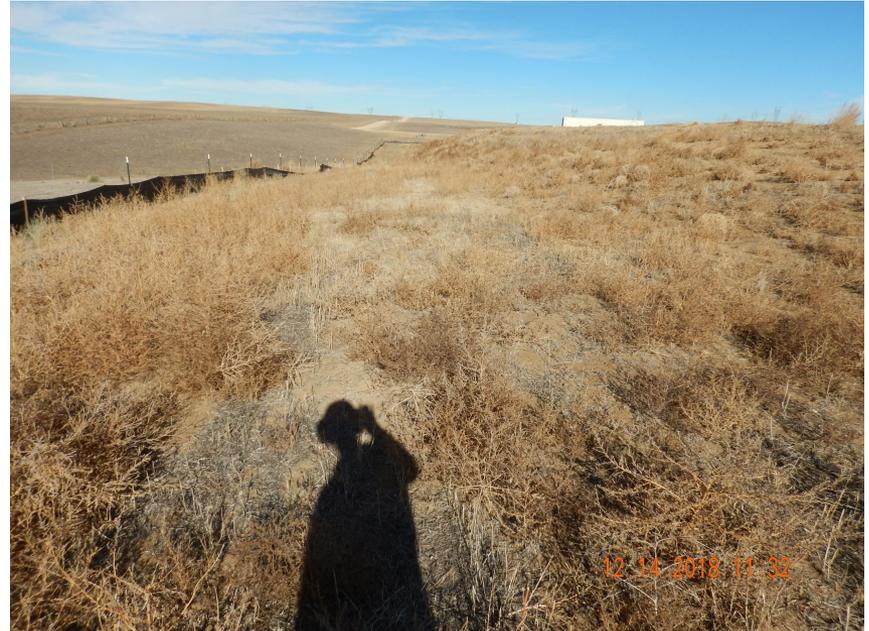
**Photo 4.** Photo taken from the southwestern perimeter of the location, facing North. See comments under Photo 3.

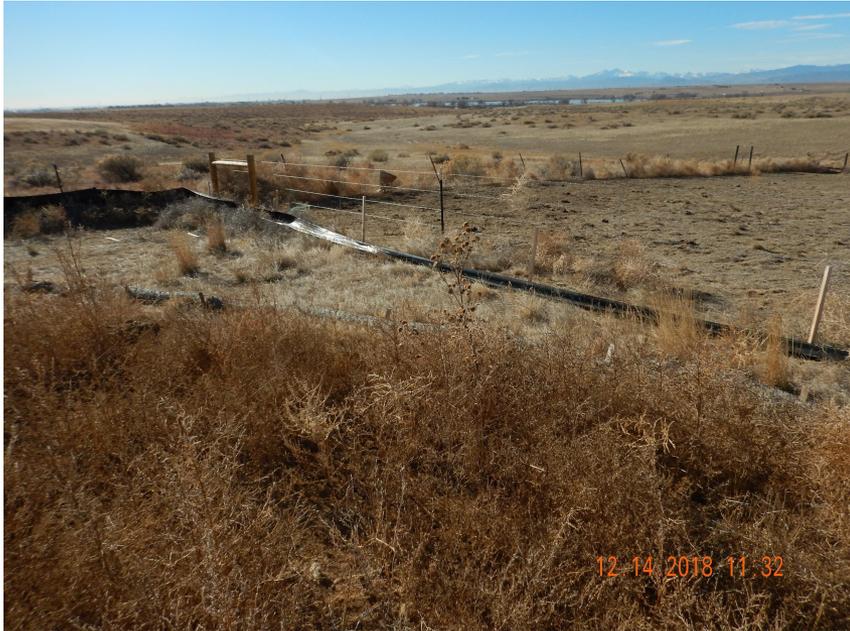
**Photo 5.** Photo taken from the southwestern perimeter of the location, facing Southwest. Silt fence BMP in need of maintenance.

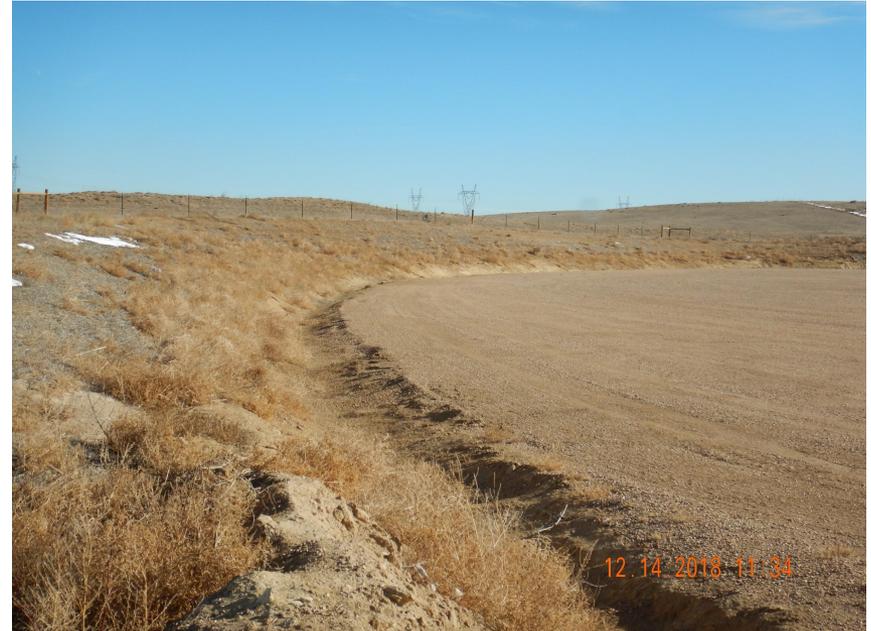
**Photo 6.** Photo taken from the entrance of the location, facing East. Photo illustrates unmanaged Kochia weeds along the cut slope.

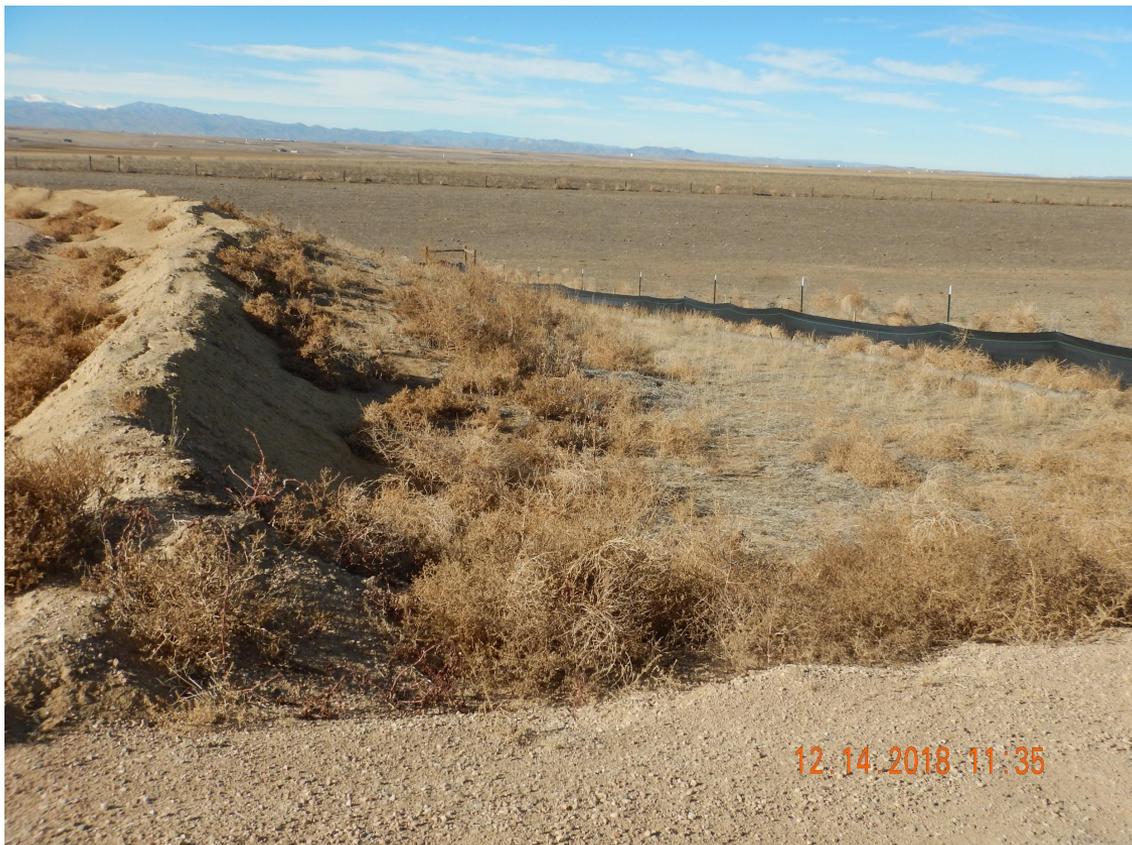
**Photo 7.** Photo taken from the entrance of the location, facing West. See comments under Photo 6.
