Comment: Inspection to assess impact of Spill#459033. Sunny, 40F, no wind. ~14 bbl into lined SPCC for tank battery. ~45 bbl onto surface east of battery. ~50 bbl recovered w vac truck. Soil has been excavated to ~1 ft bgs in area east of tank battery. Soils are stockpiled on bermed HDPE liner.

Inspection Photos
Location Name: XTO Location 316351
11-13-18

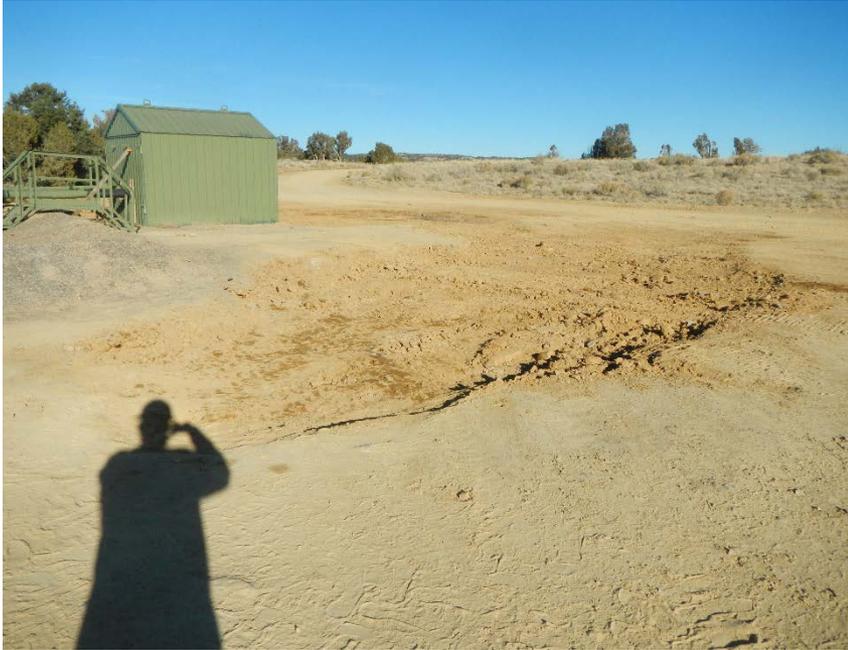
Spill area lookin north

Corrective Action: PER F-19 COA: Assess nature and extent of contamination with confirmation soil samples. Remediate to Table 910-1 standards and provide documentation in another Supplemental F-19 if cleaned up immediately and/or F-27 if extended remediation such as landfarming contaminated soil is required. Landfarming must also be approved by surface owner. Documentation must include a figure showing spill area with sample locations plus laboratory results. Date: 12/20/2018

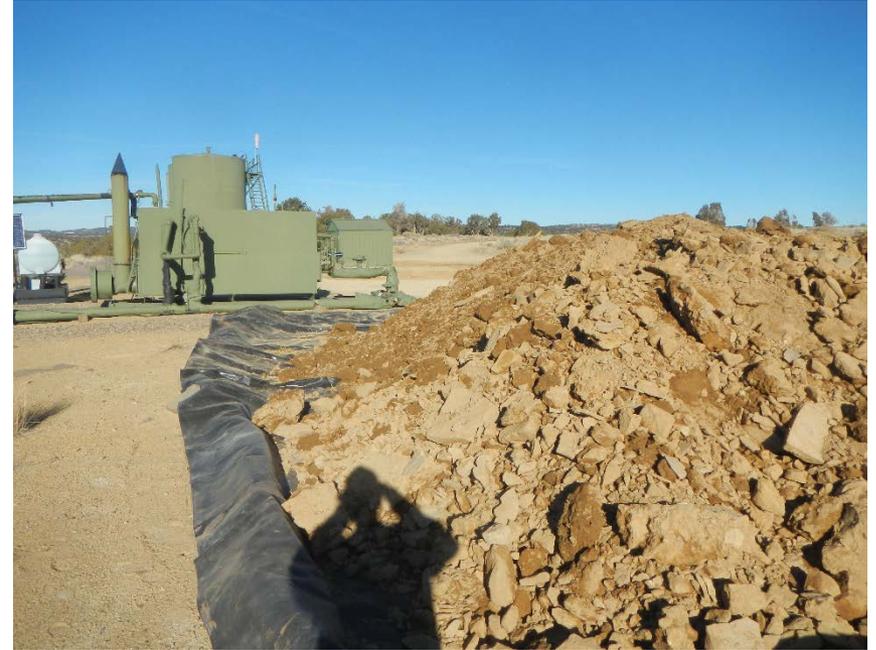
Soil stockpile looking north
