# Final Reclamation Inspection

December 14, 2018

Operator: CHESAPEAKE OPERATING LLC- 16660

API: 05-123-34627

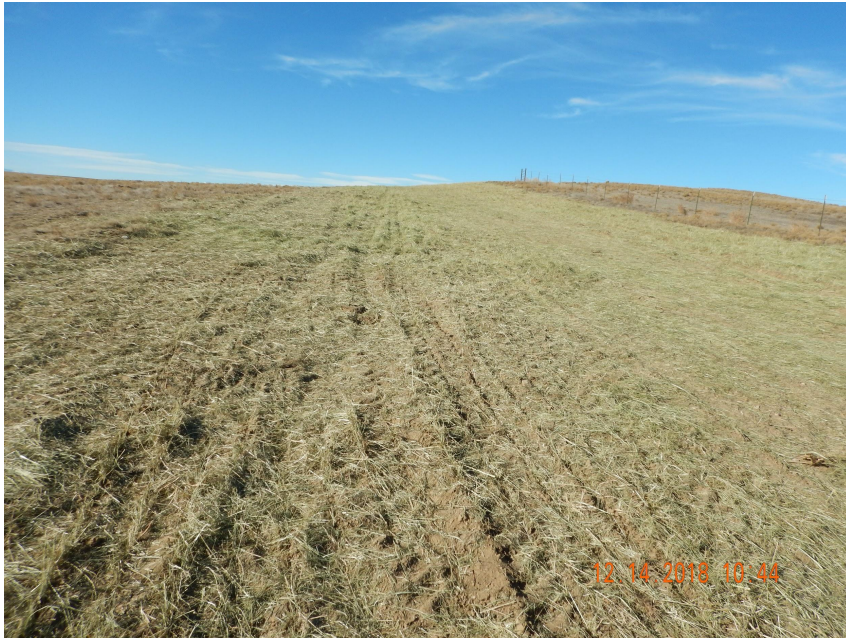
**Photo 1.** Photo taken from a portion of the eastern access road, facing West. Operator has performed final reclamation activities throughout the entire access road and well location.

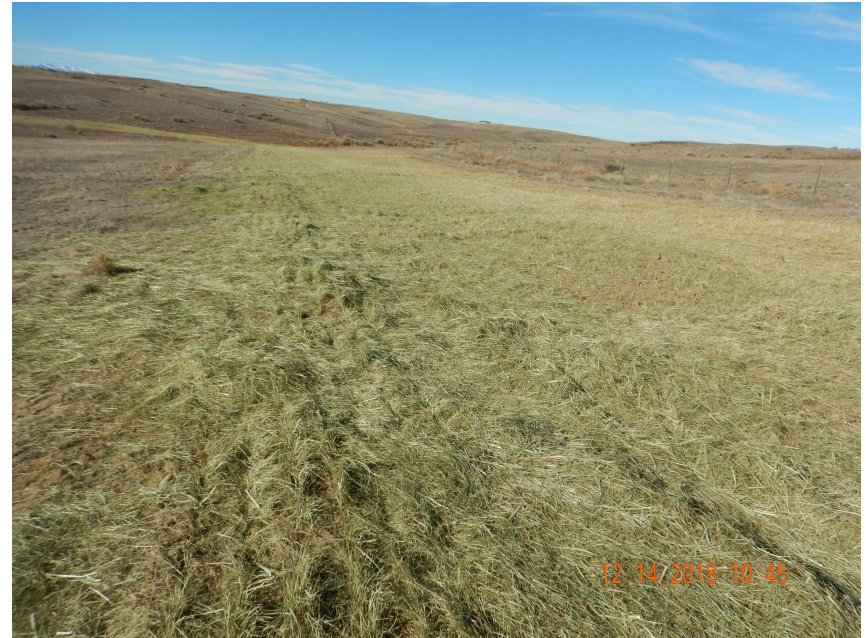
**Photo 2.** Photo taken from a portion of the central access road, facing West. See comments under Photo 1.

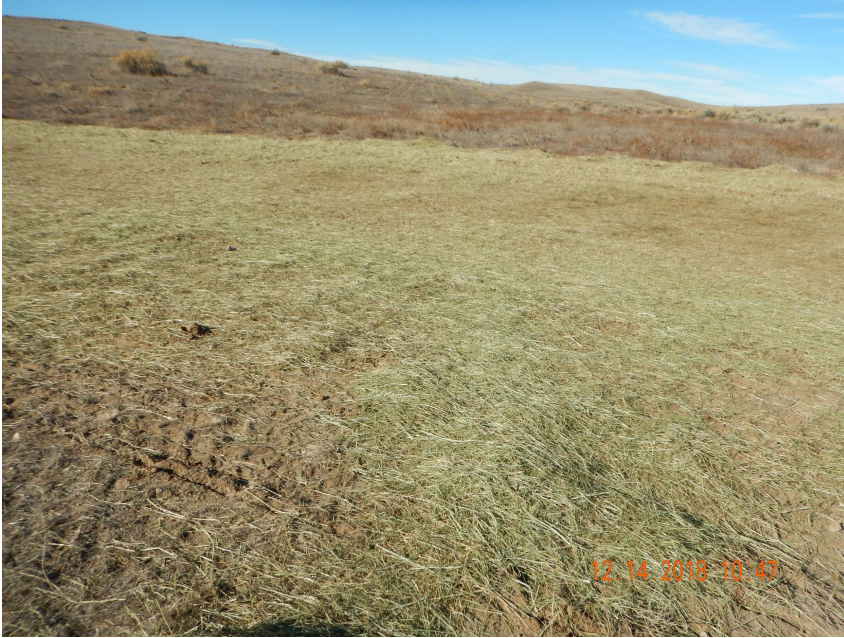
**Photo 3.** Photo taken from a portion of the access road that crossed an intermittent stream, facing Northwest. See comments under Photo 1.

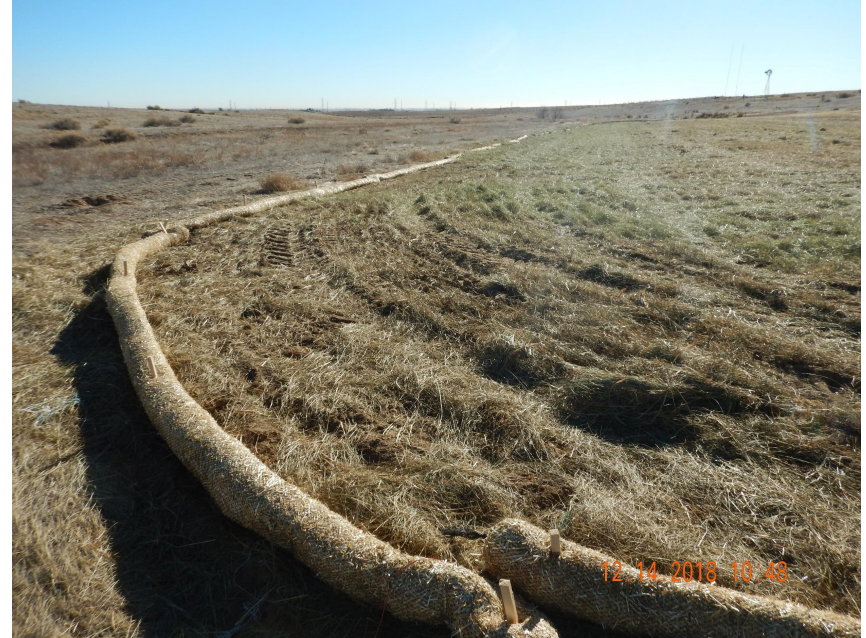
**Photo 4.** Photo taken from northeast well pad, facing South. See comments under Photo 1. Operator installed straw wattle BMPs but did not properly install BMP (i.e., wattles should have been trenched to properly function).

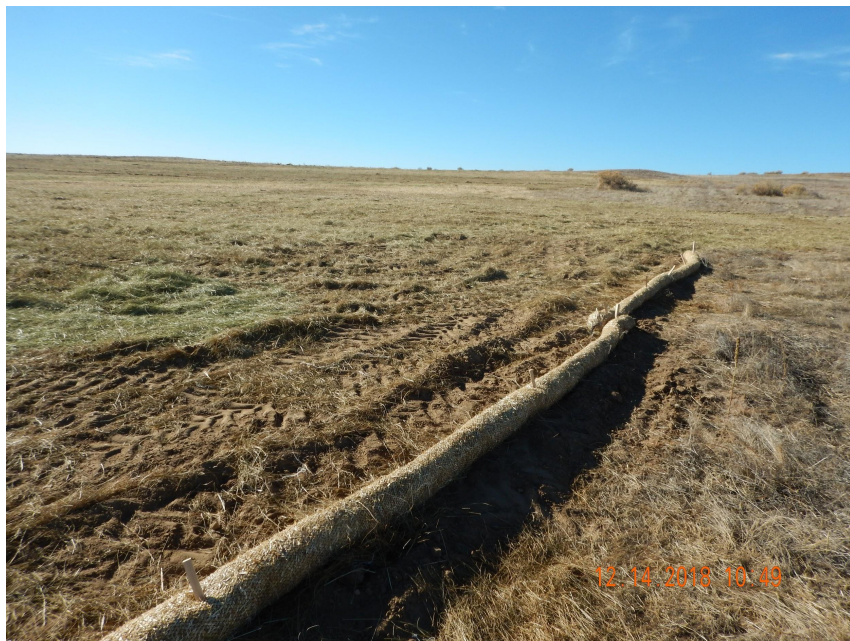
**Photo 5.** Photo taken from northeast well pad, facing West. See comments under Photo 4.

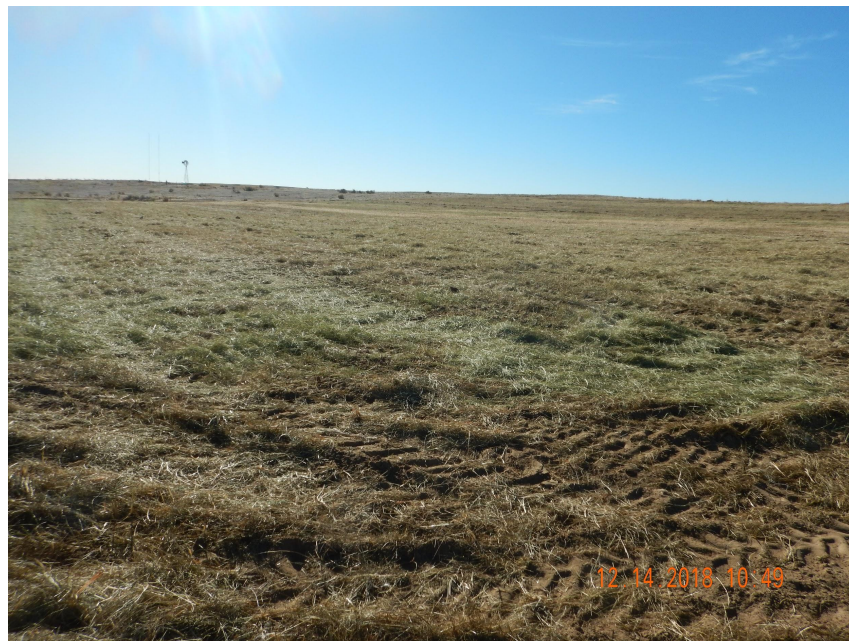
**Photo 6.** Photo taken from central well pad, facing South. See comments under Photo 1.
