Inspection Photos

Operator: BP Production

API: 05-067-07981

Date: 11/29/2018

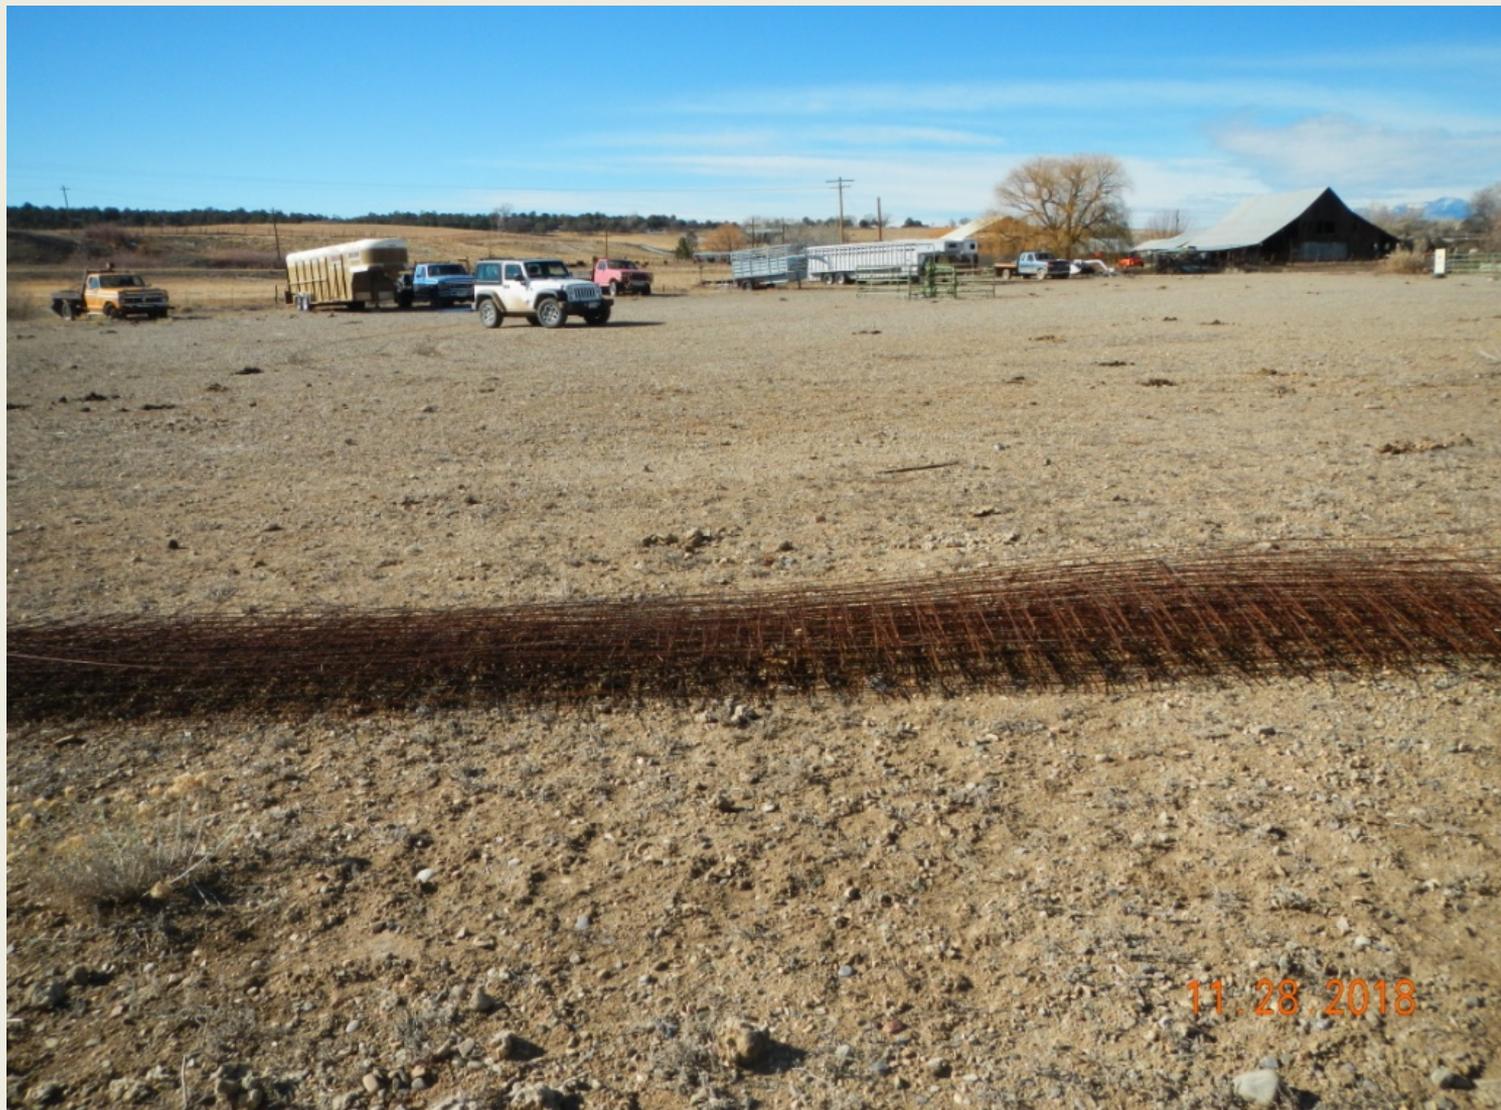
Photo 1. View of the project area from the northeastern corner facing center. Interim reclamation is not conducted.

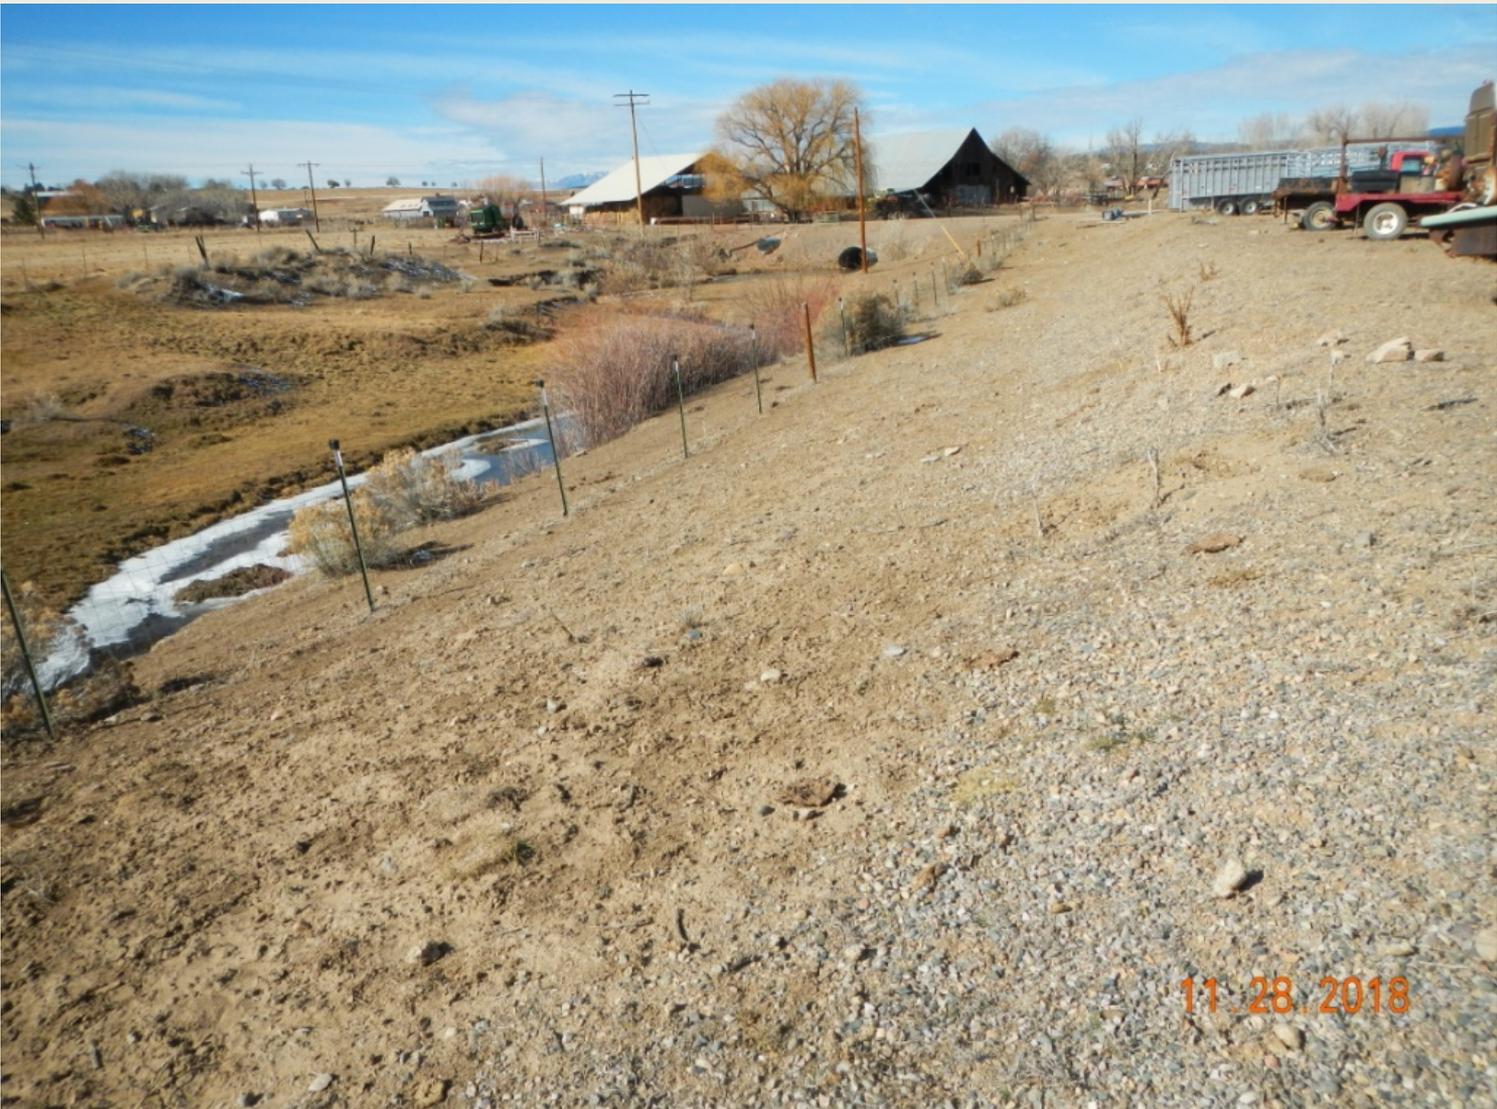
Photo 2. View of the southern project area from the southeastern corner facing westward. Revegetation is sparse and appears grazed.

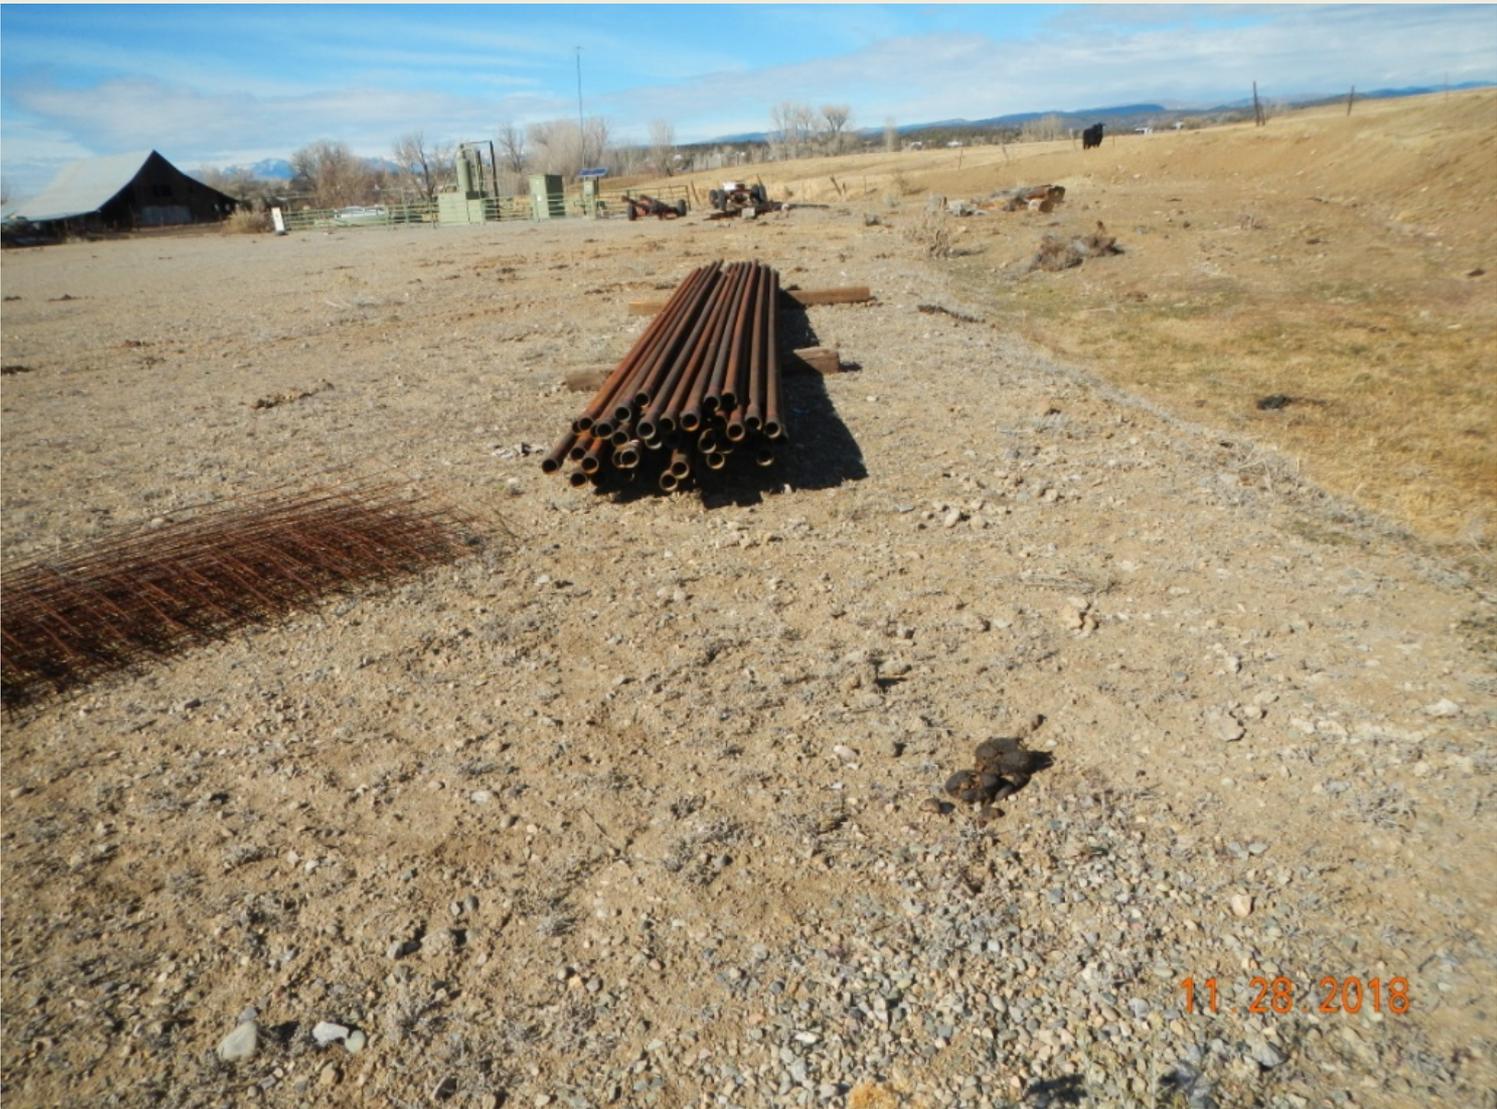
Photo 3. View of the northern project area from the northeastern corner facing westward. Tubing and other debris present within the northeastern project area.

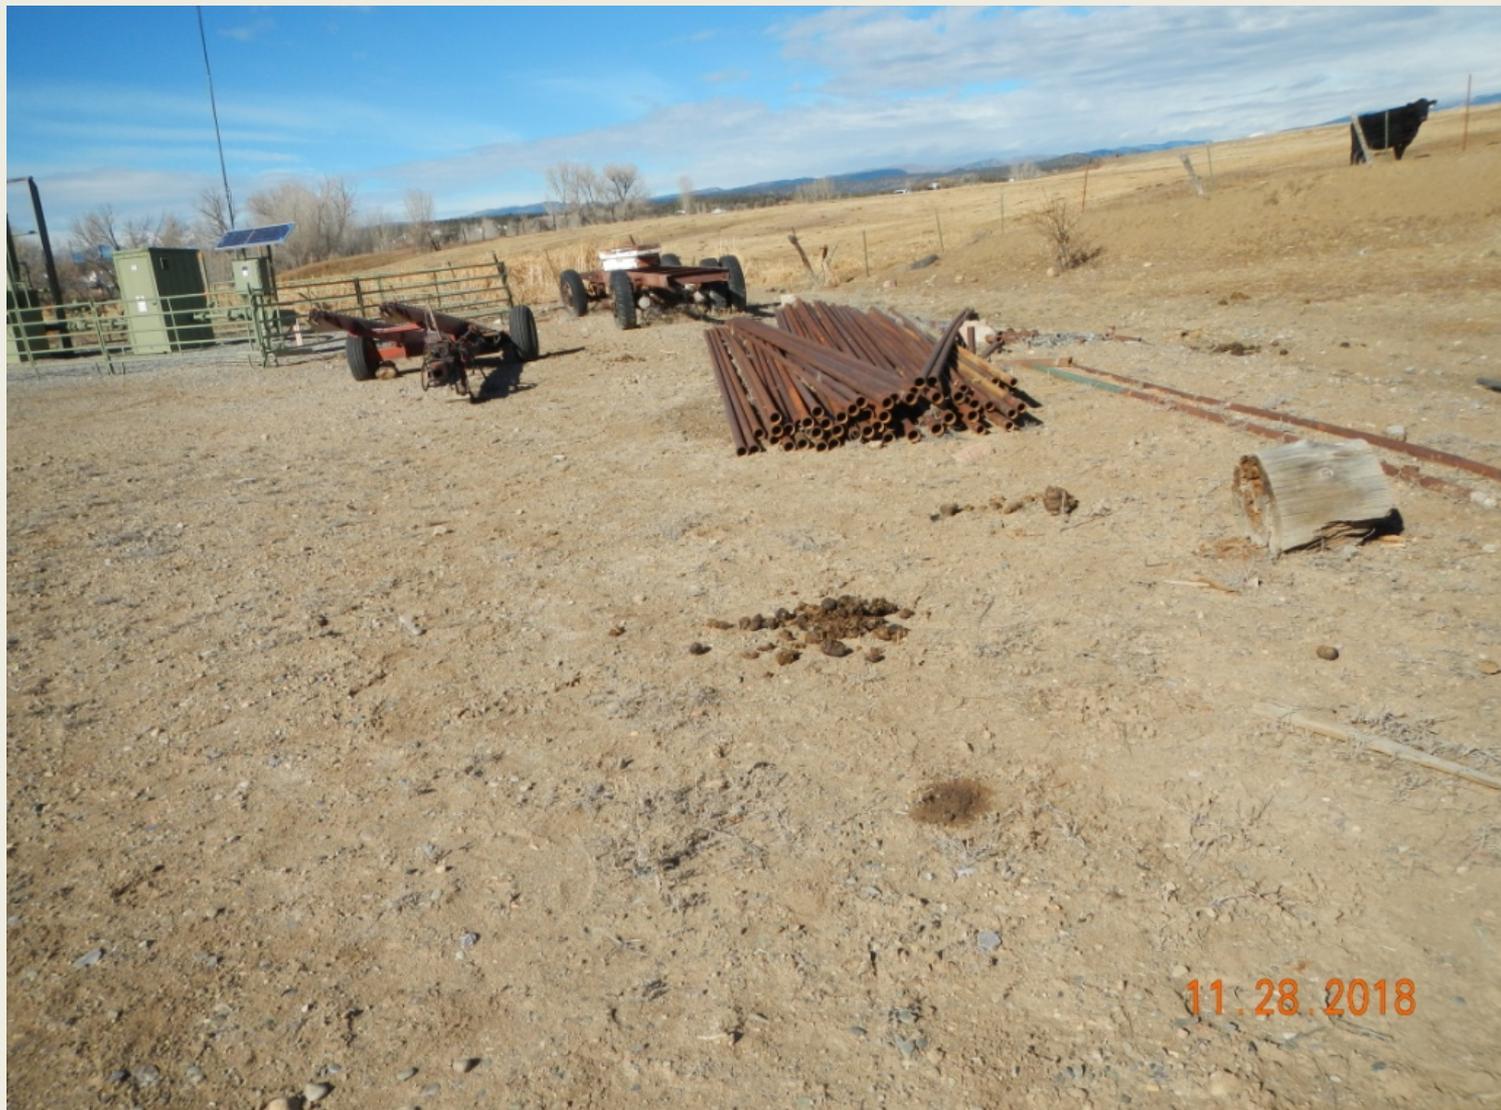
Photo 4. View of more tubing and what appears to be surface owner equipment and debris within the northern project area.
