Inspection Photos

Operator: Rim Operating

API: 05-067-09286

Date: 11/30/2018

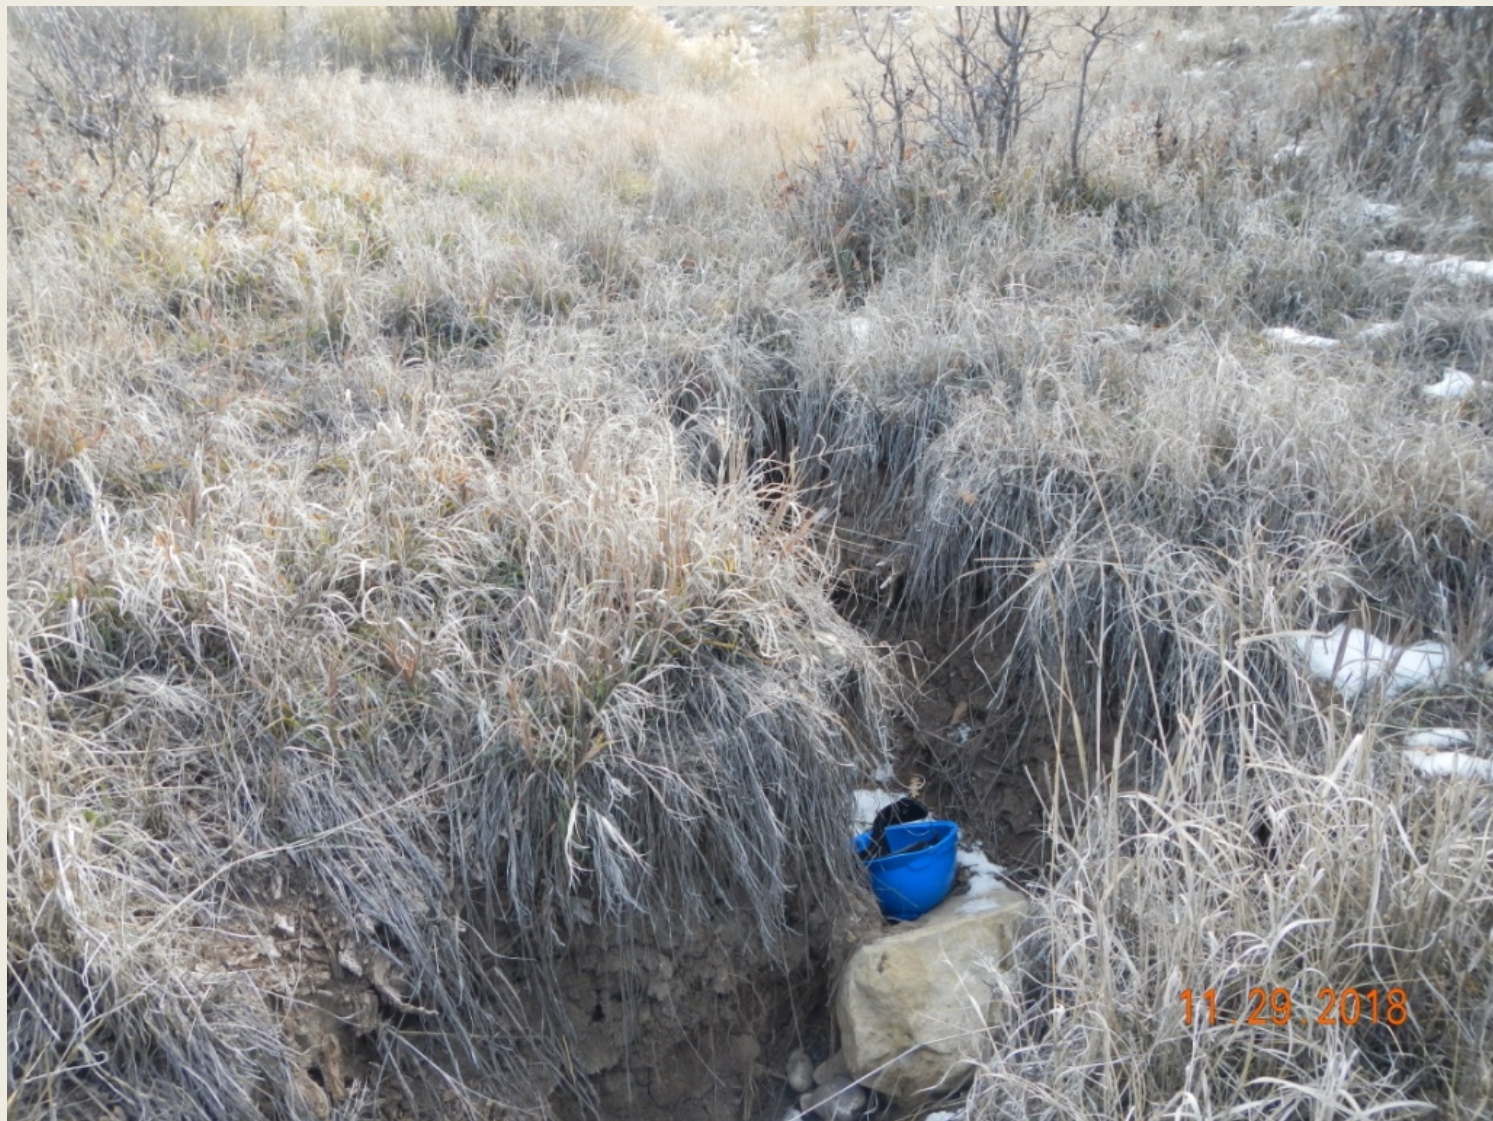
Photo 1. View of erosional channel within the southwestern project area, not stabilized. Erosion not addressed.

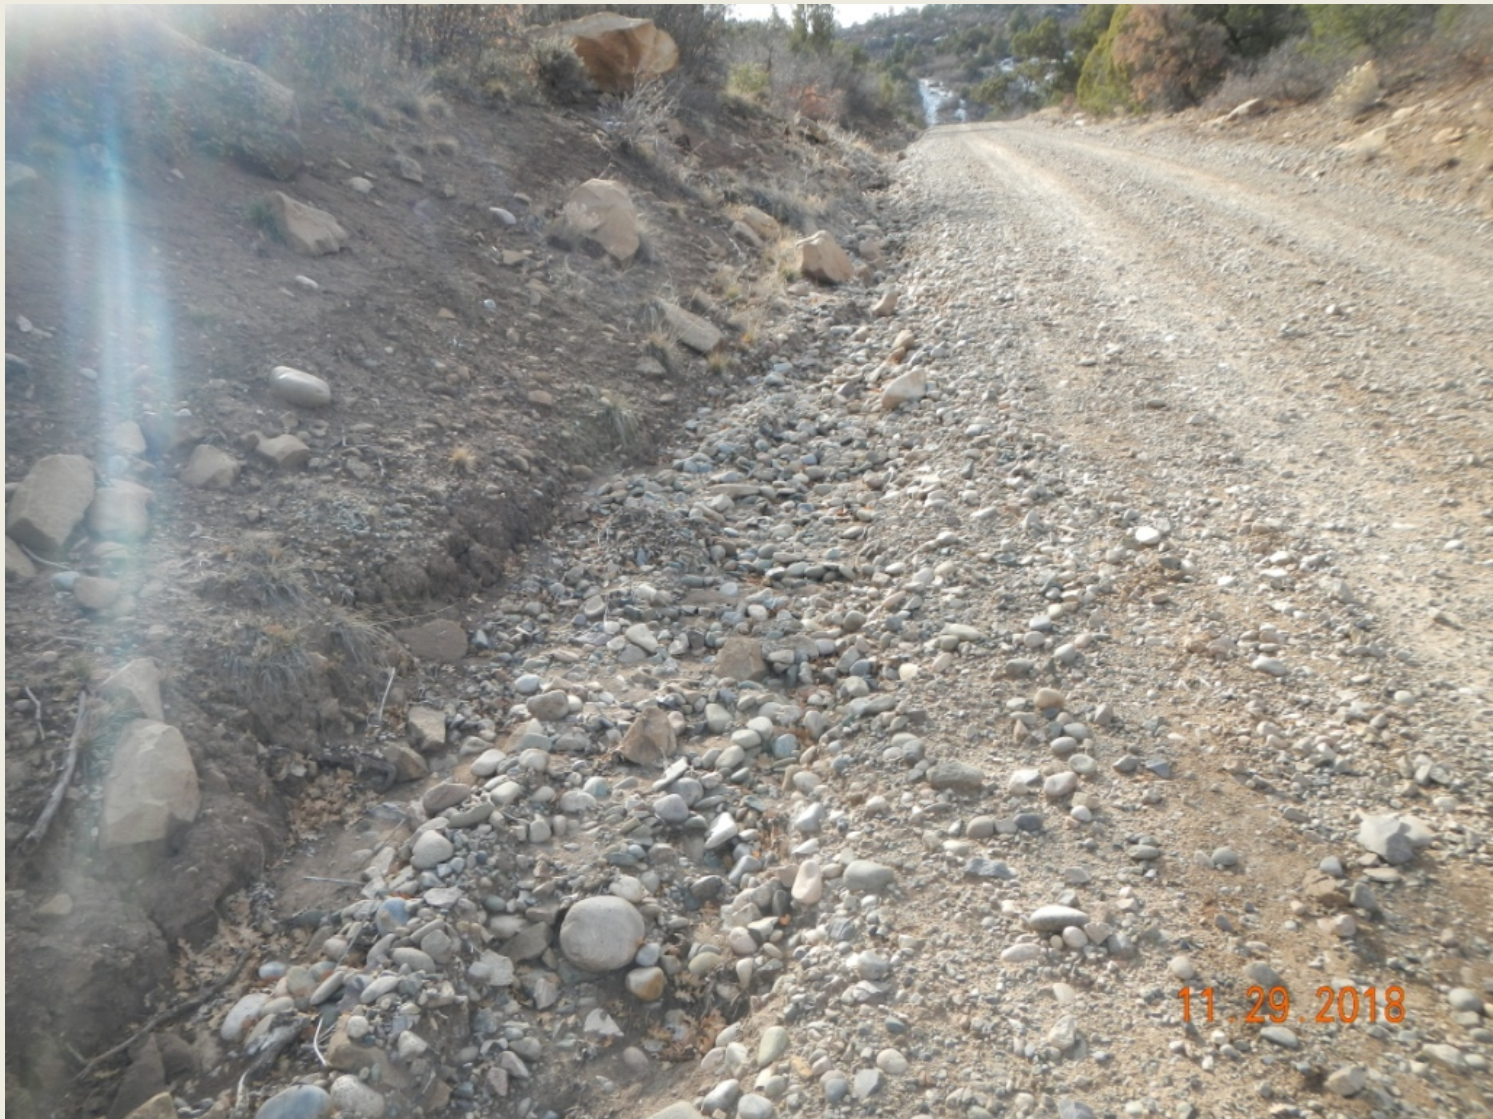
Photo 2. View of erosion occurring along the access road. Stormwater controls are needed.

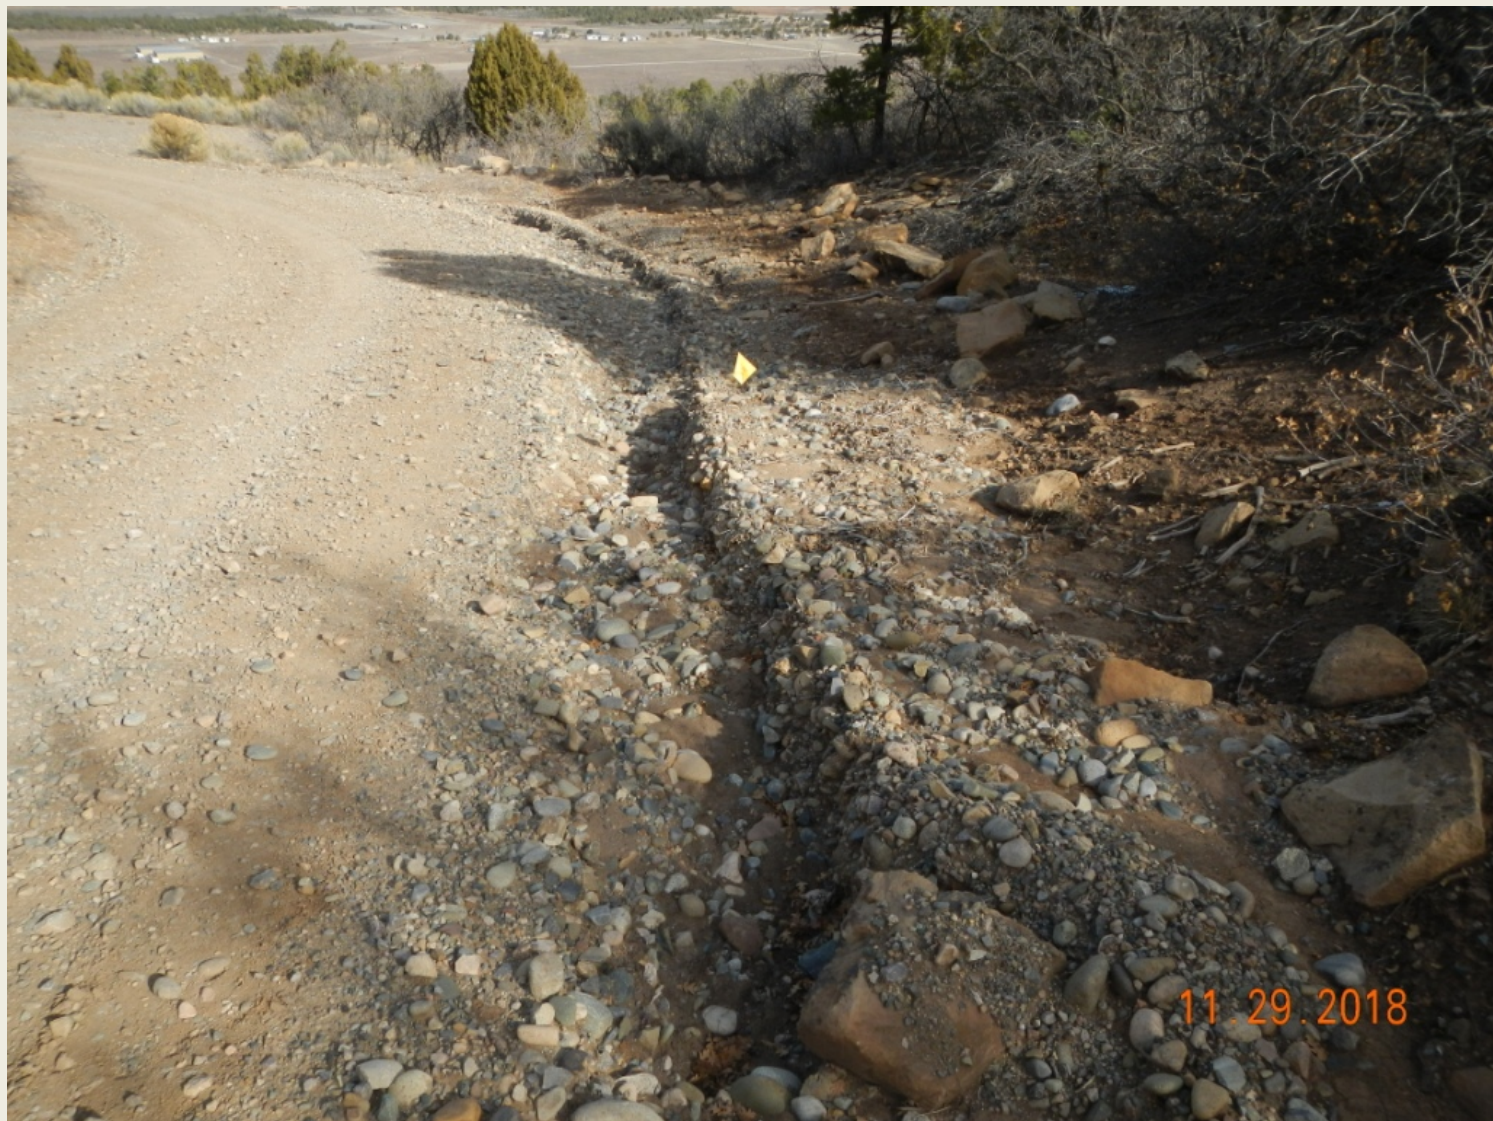
Photo 3. Another view of erosion occurring along the access road where rock and sediment transport and deposition is occurring.

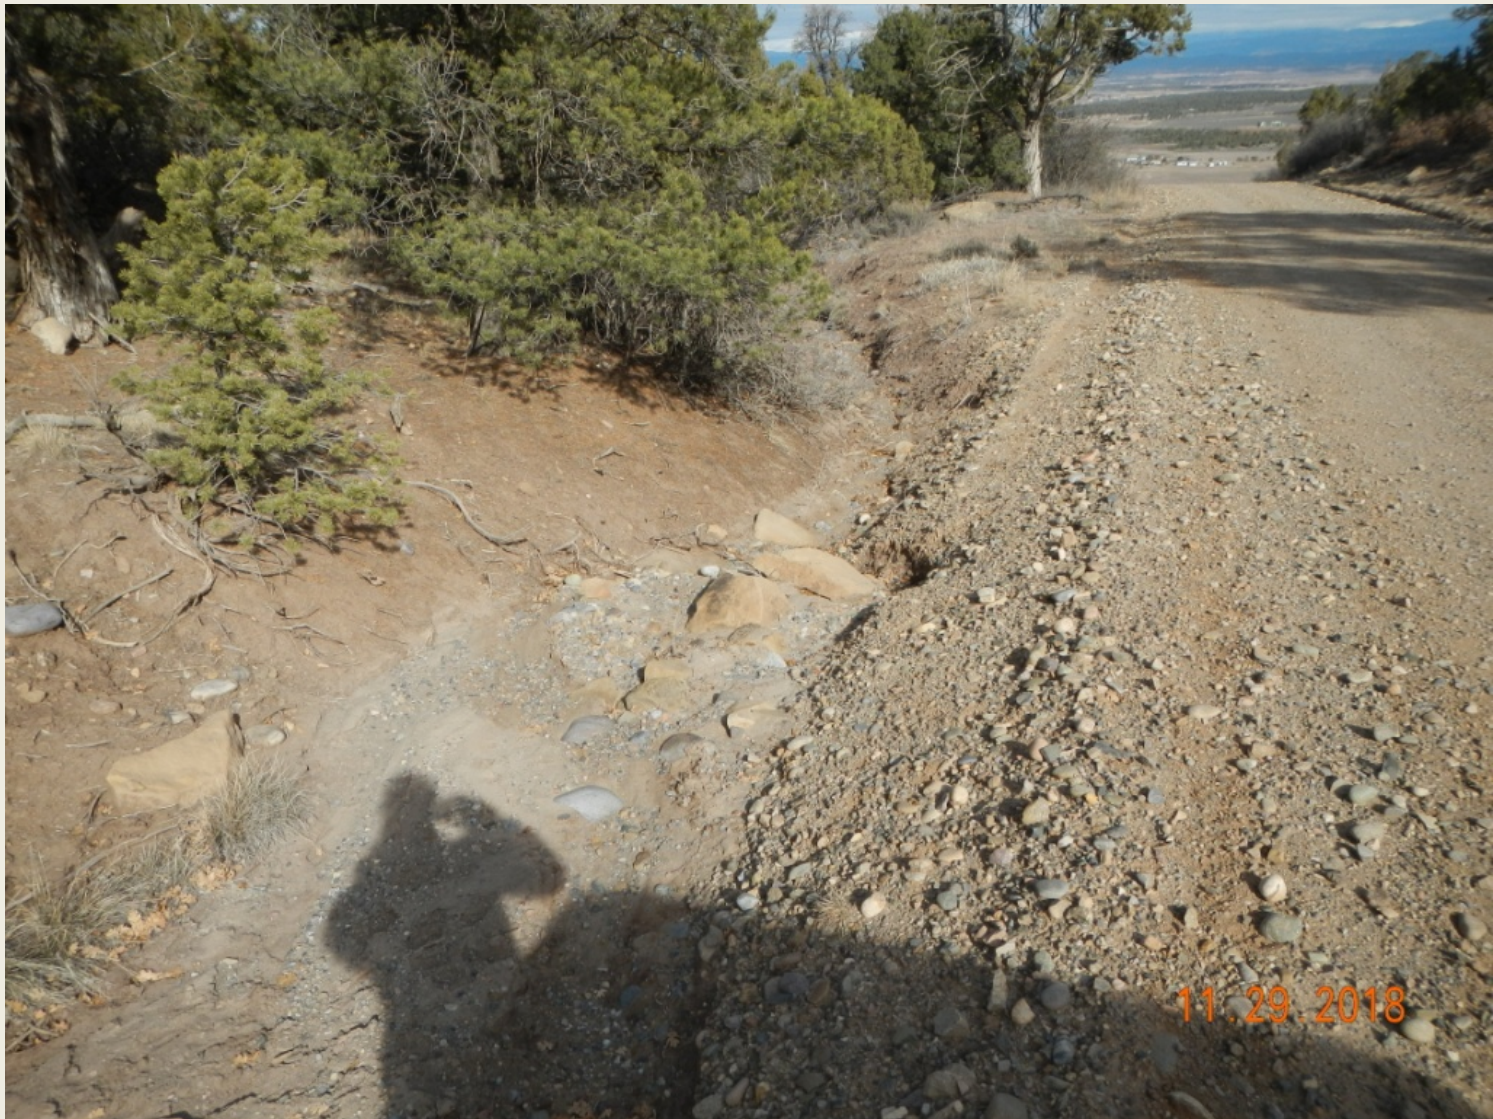
Photo 4. View of erosion occurring near the beginning of the access road. Stormwater controls are needed to stabilize erosional downcutting, and sediment transport.
