Inspection Photos

Operator: WESCO OPERATING INC - 95520

Location ID: 317056

Inspection Doc. Number: 682504293

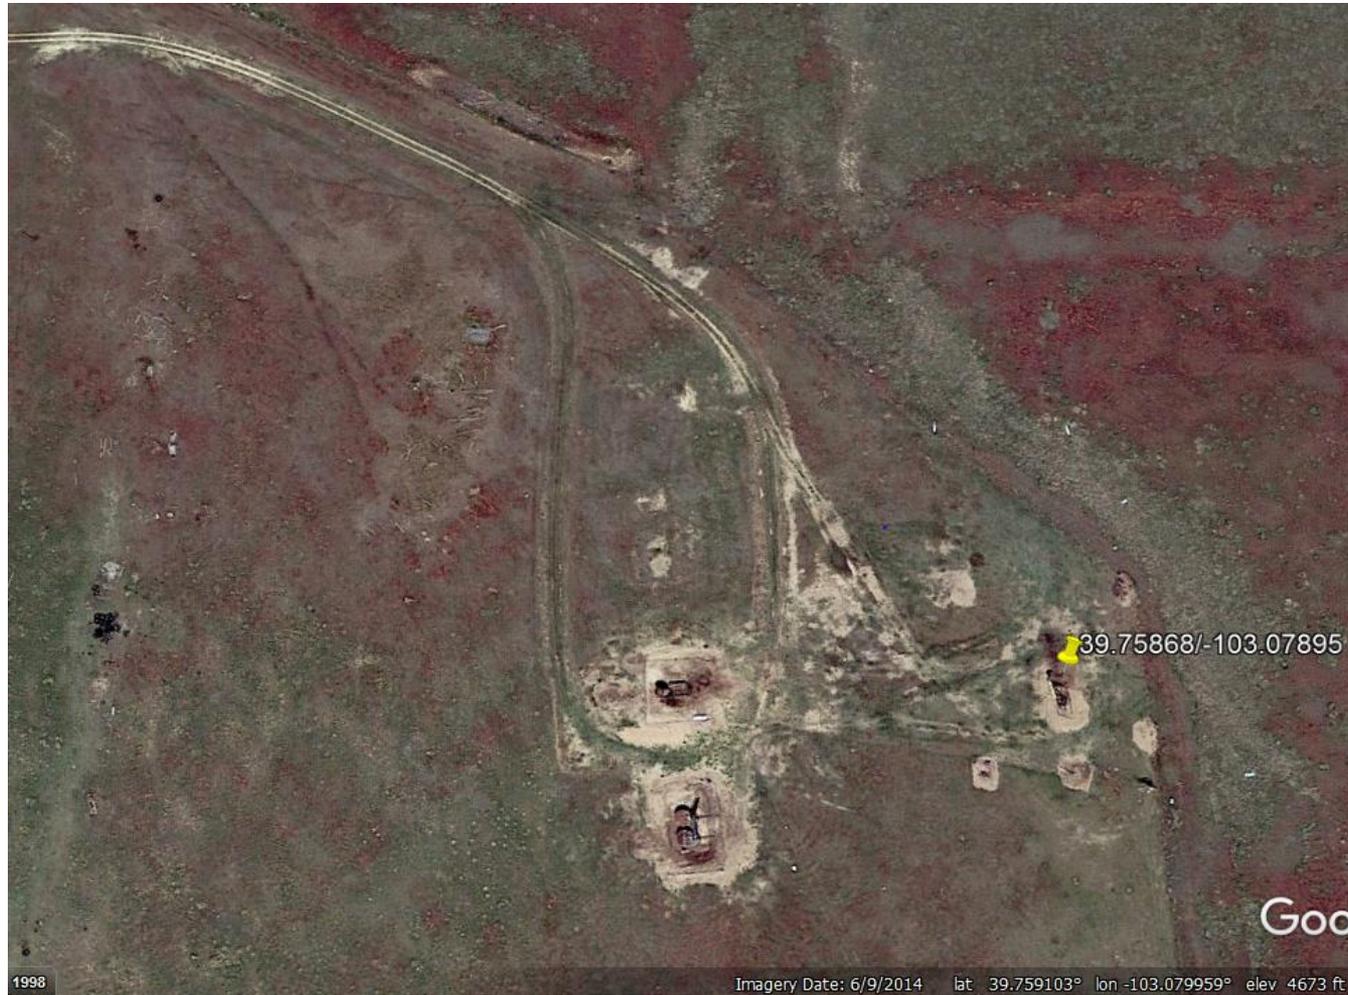
Photo 1: 2014 Google Earth aerial imagery. Photo shows location (well and battery) and access road prior to plugging and abandonment.

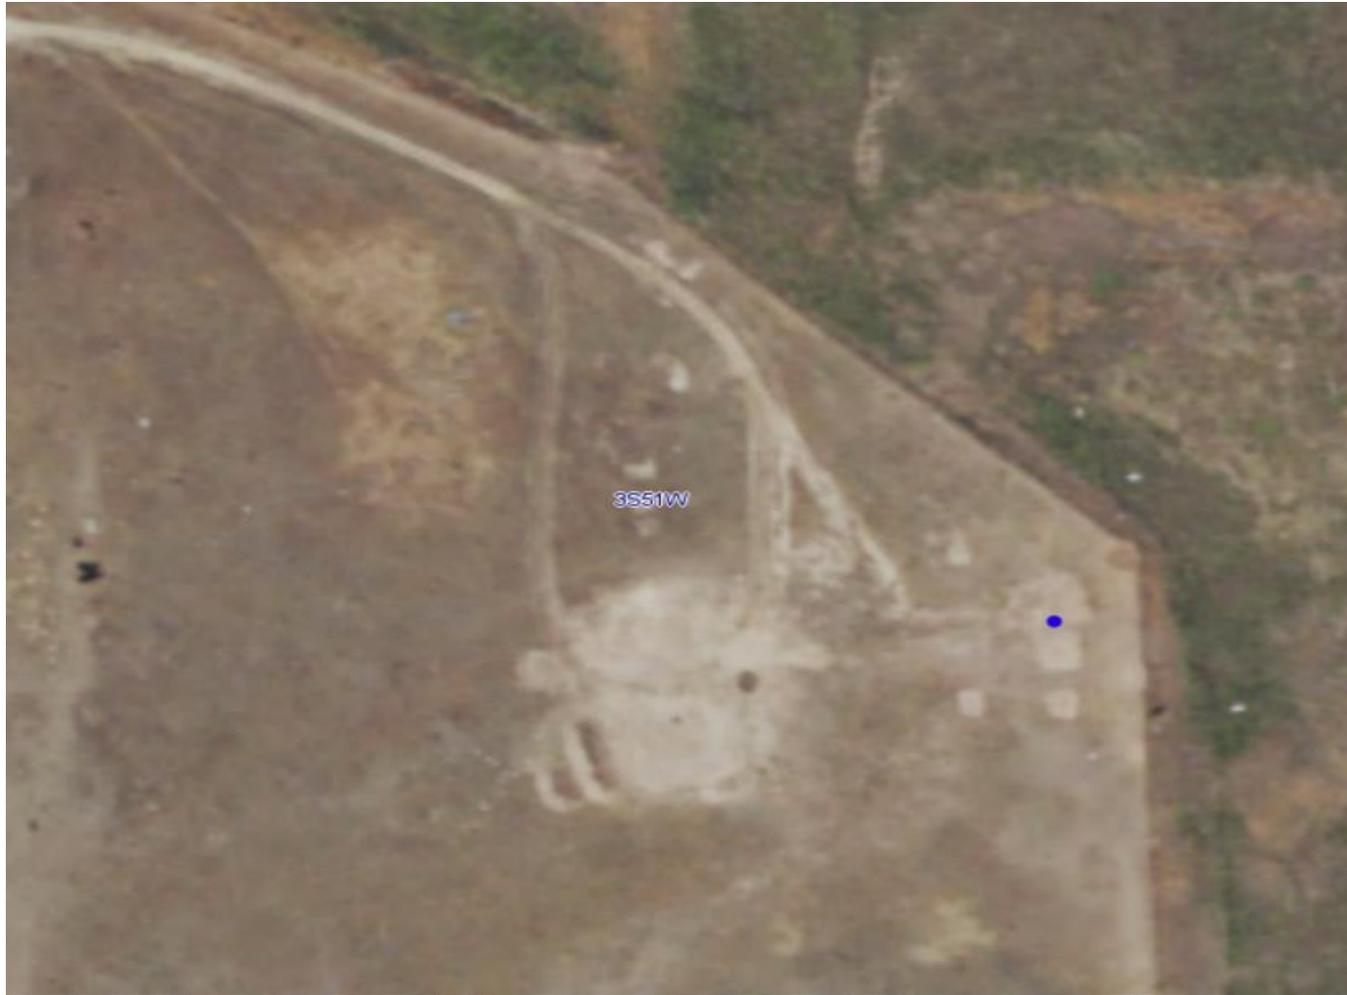
Photo 2: 2017 COGIS aerial imagery. Photo shows location (well and battery) and access road post plugging and abandonment.

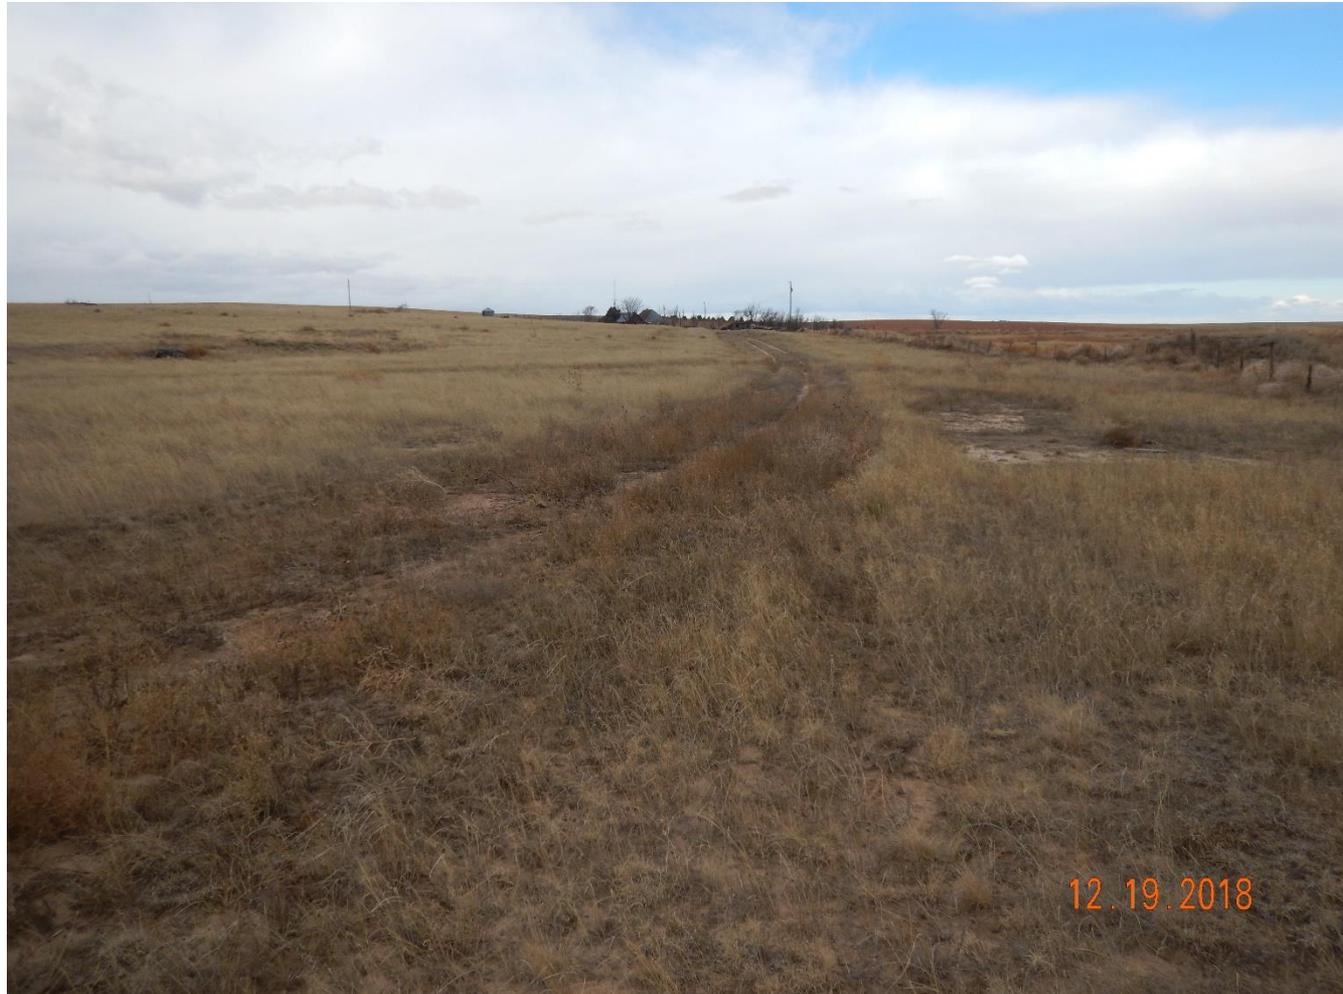
Photo 3: Photo taken from the access road, facing northwest. Photo shows access road remains and that compaction alleviation, recontouring, regrading and revegetation activities appear to have been conducted

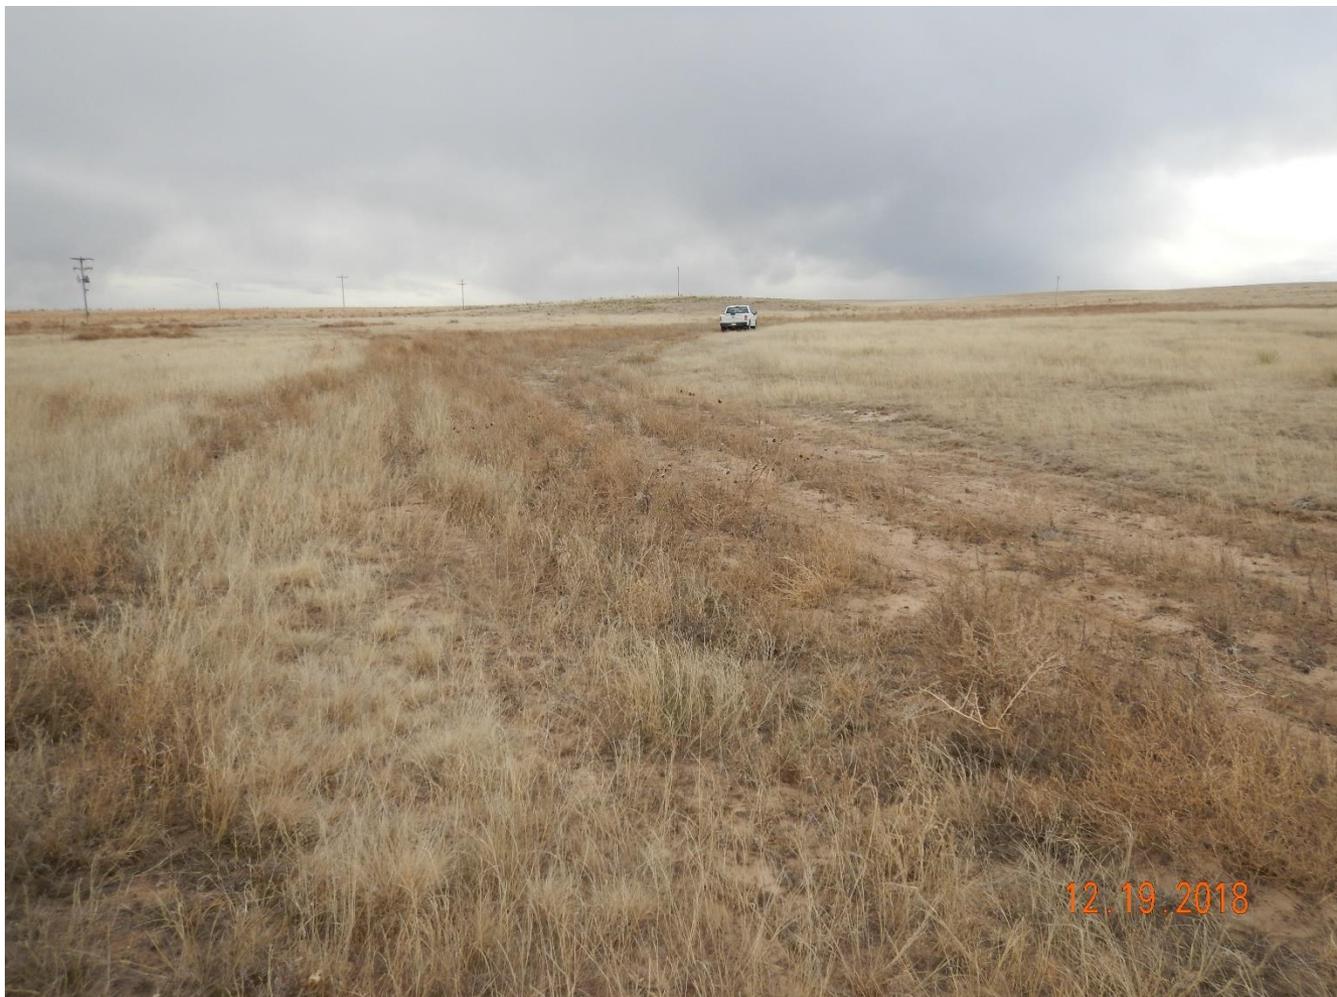
Photo 4: Photo taken from the access road, facing southwest. Photo shows access road remains and that compaction alleviation, recontouring, regrading and revegetation activities appear to have been conducted

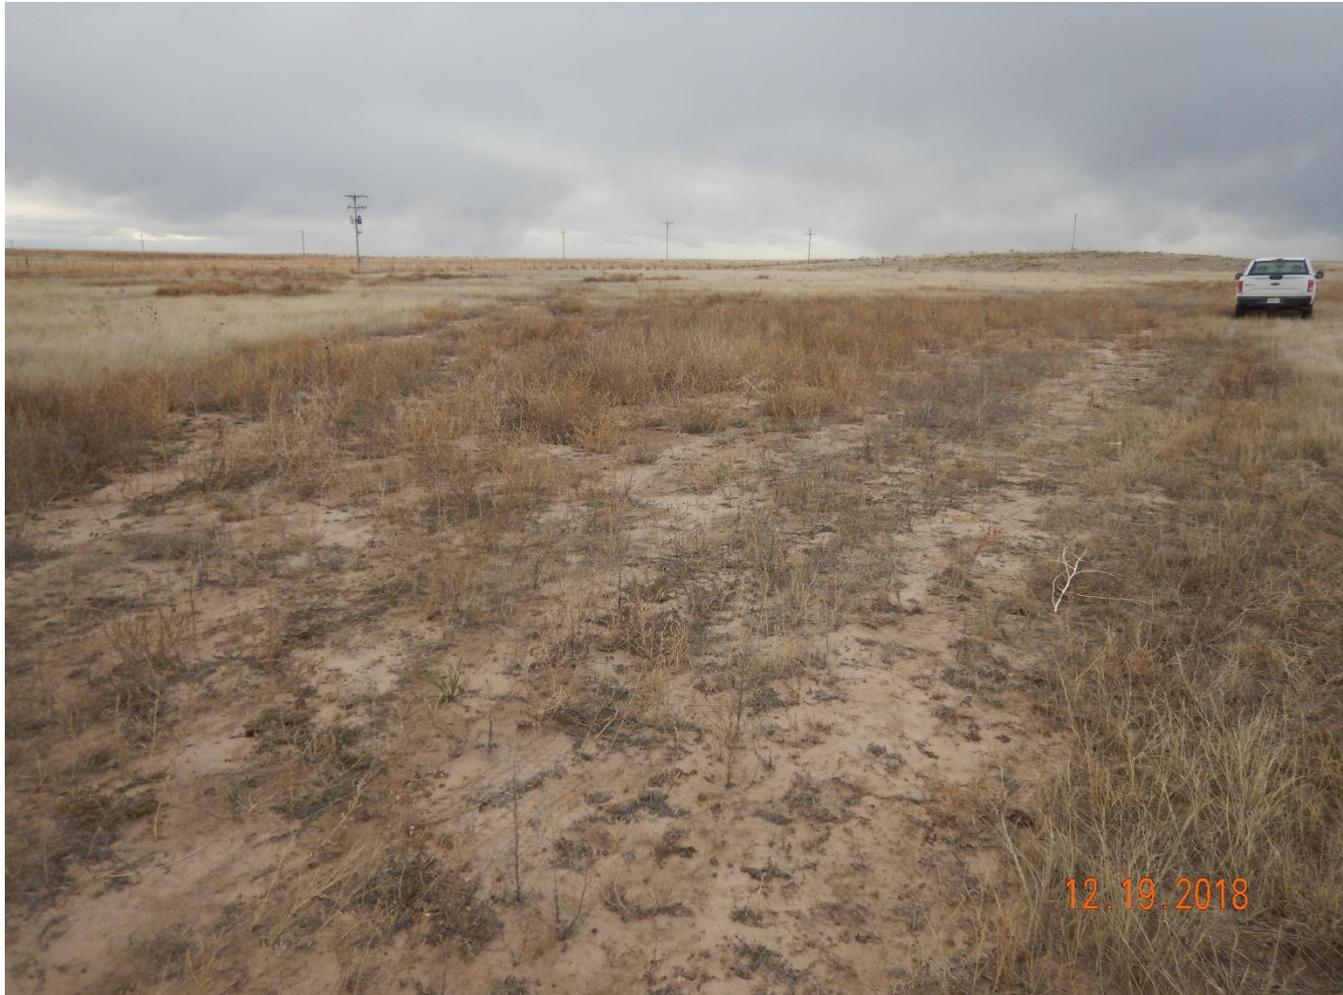
Photo 5: Photo taken from the north end of the location, facing south. Photo shows location remains predominantly bare and exposed soil. Vegetation observed was undesirable weedy plant species such as Kochia and Russian thistle. Very little desirable perennial vegetative germination or establishment observed.

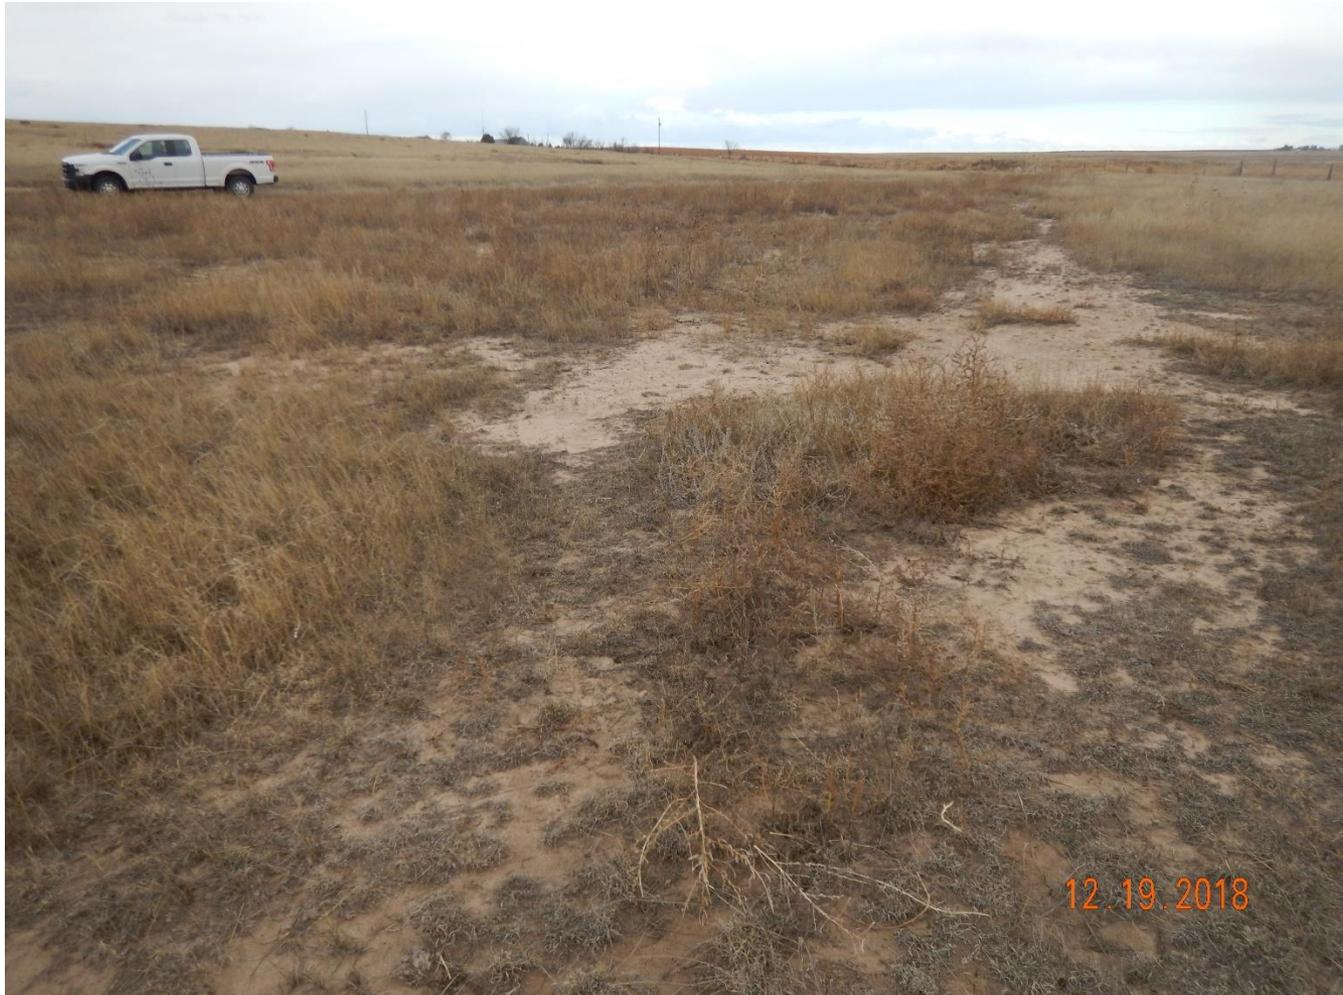
Photo 6: Photo taken from the north end of the location, facing southwest. See comments under photo 5.

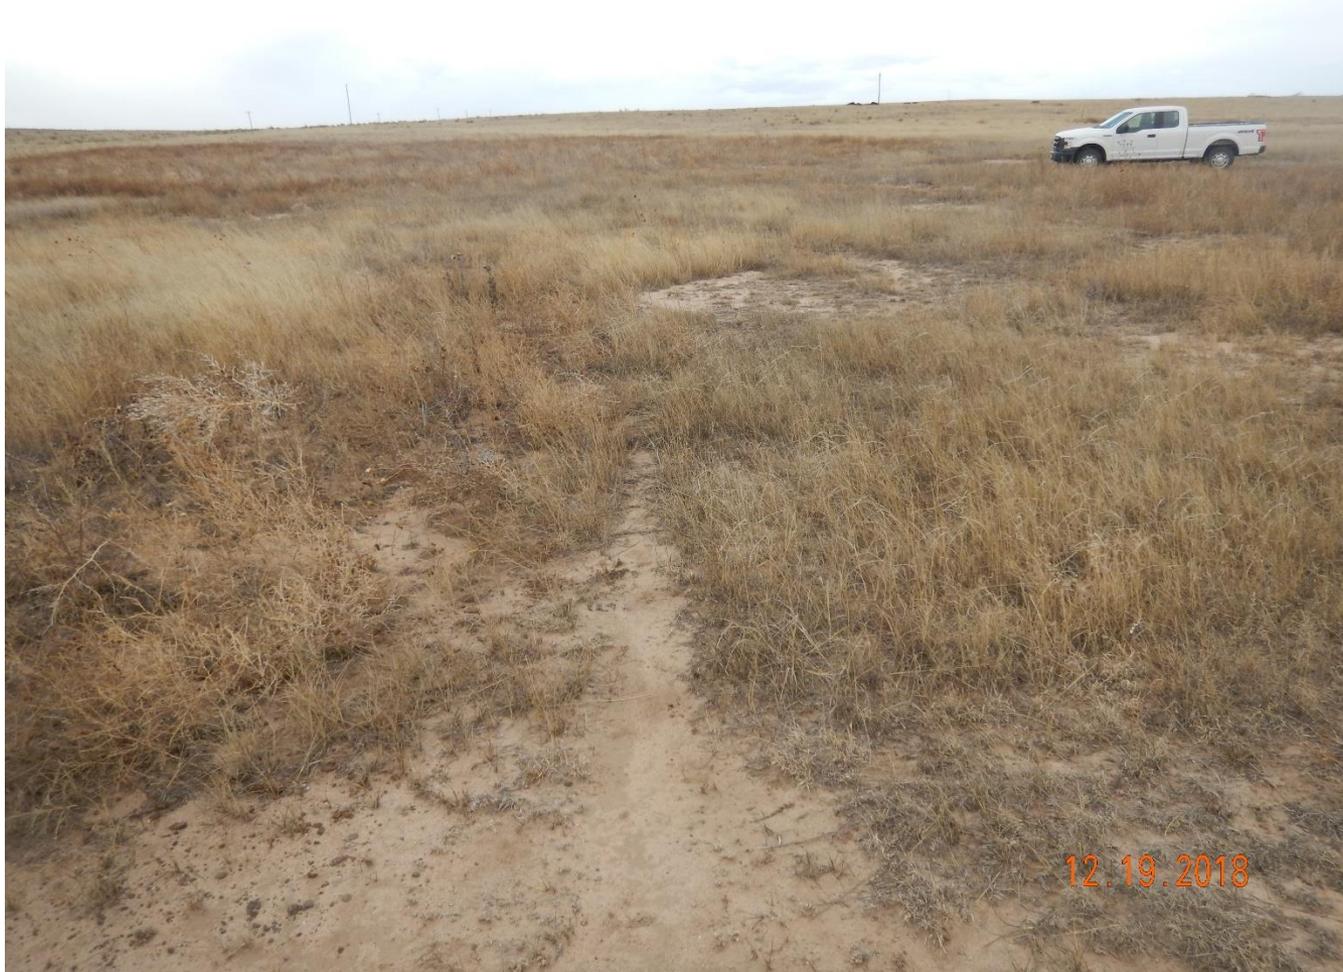
Photo 7: Photo taken from the north end of the location, facing east. See comments under photo 5.

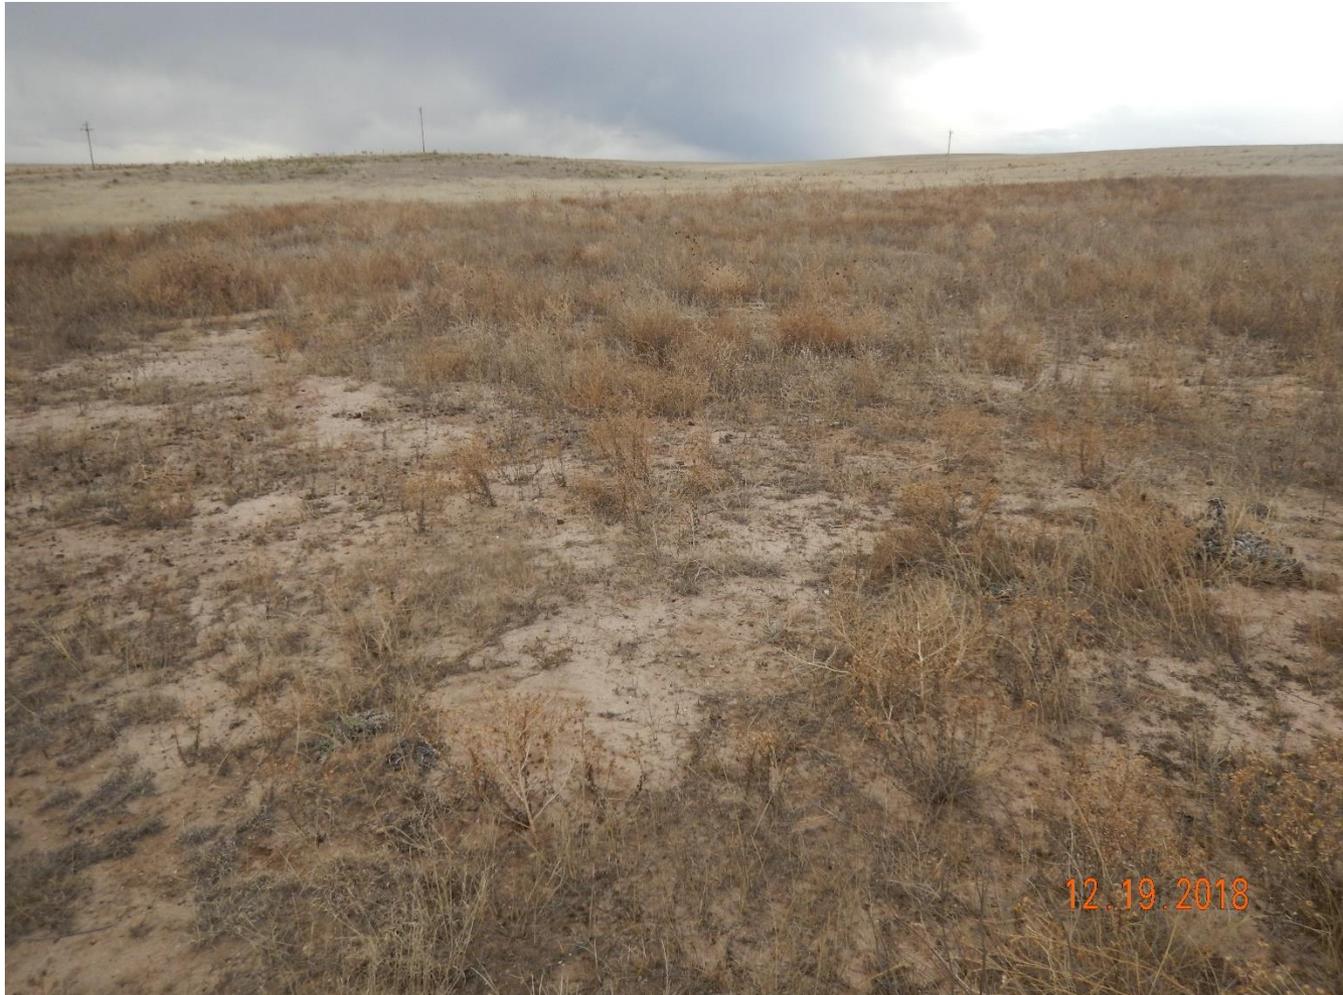
Photo 8: Photo taken from the north end of the location, facing south. See comments under photo 5.

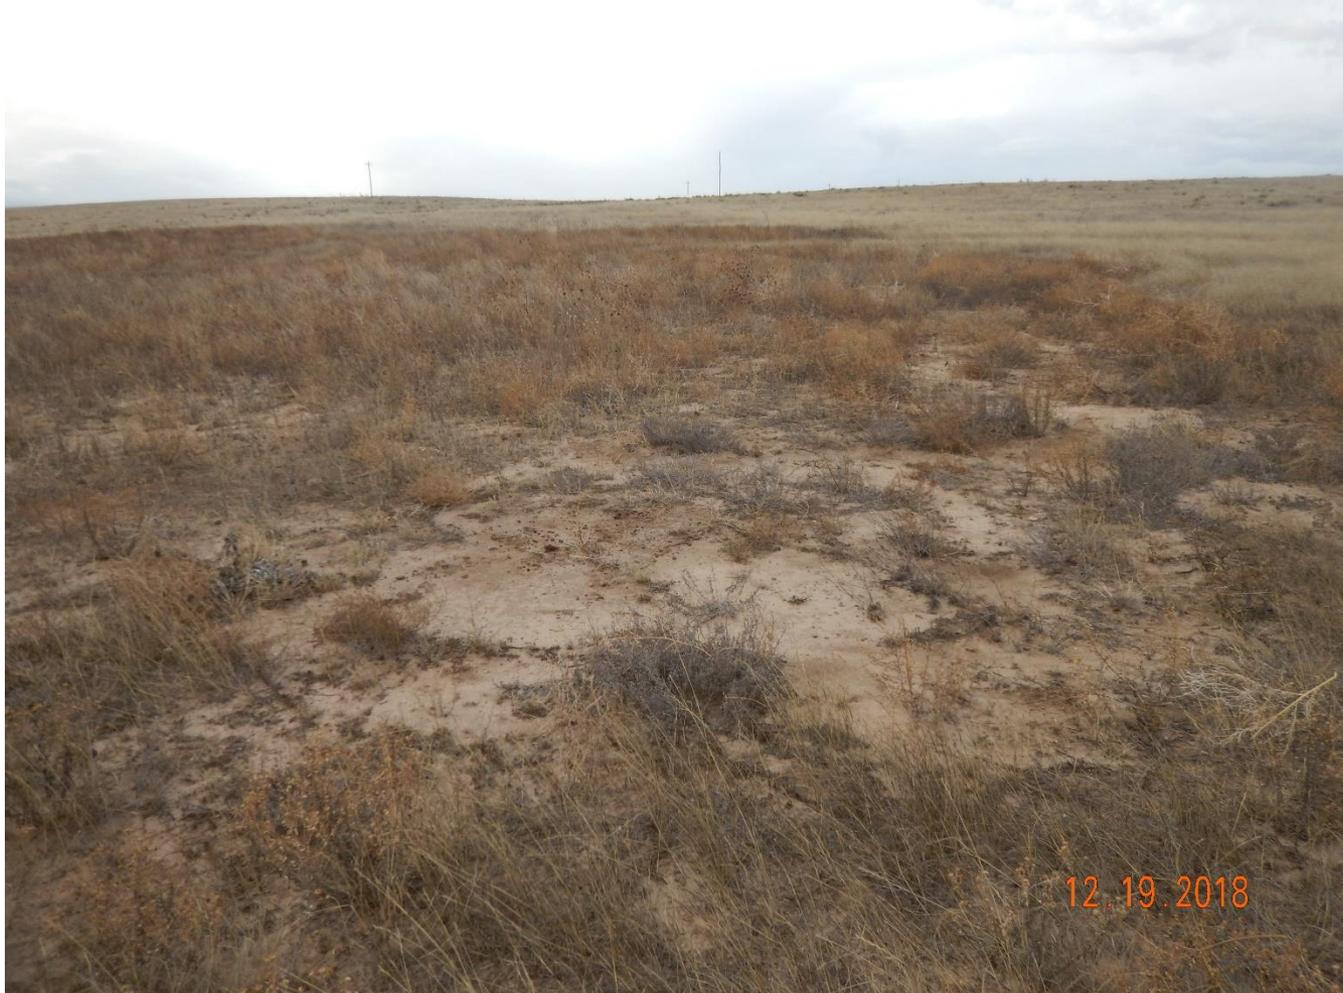
Photo 9: Photo taken from the north end of the location, facing west. See comments under photo 5.

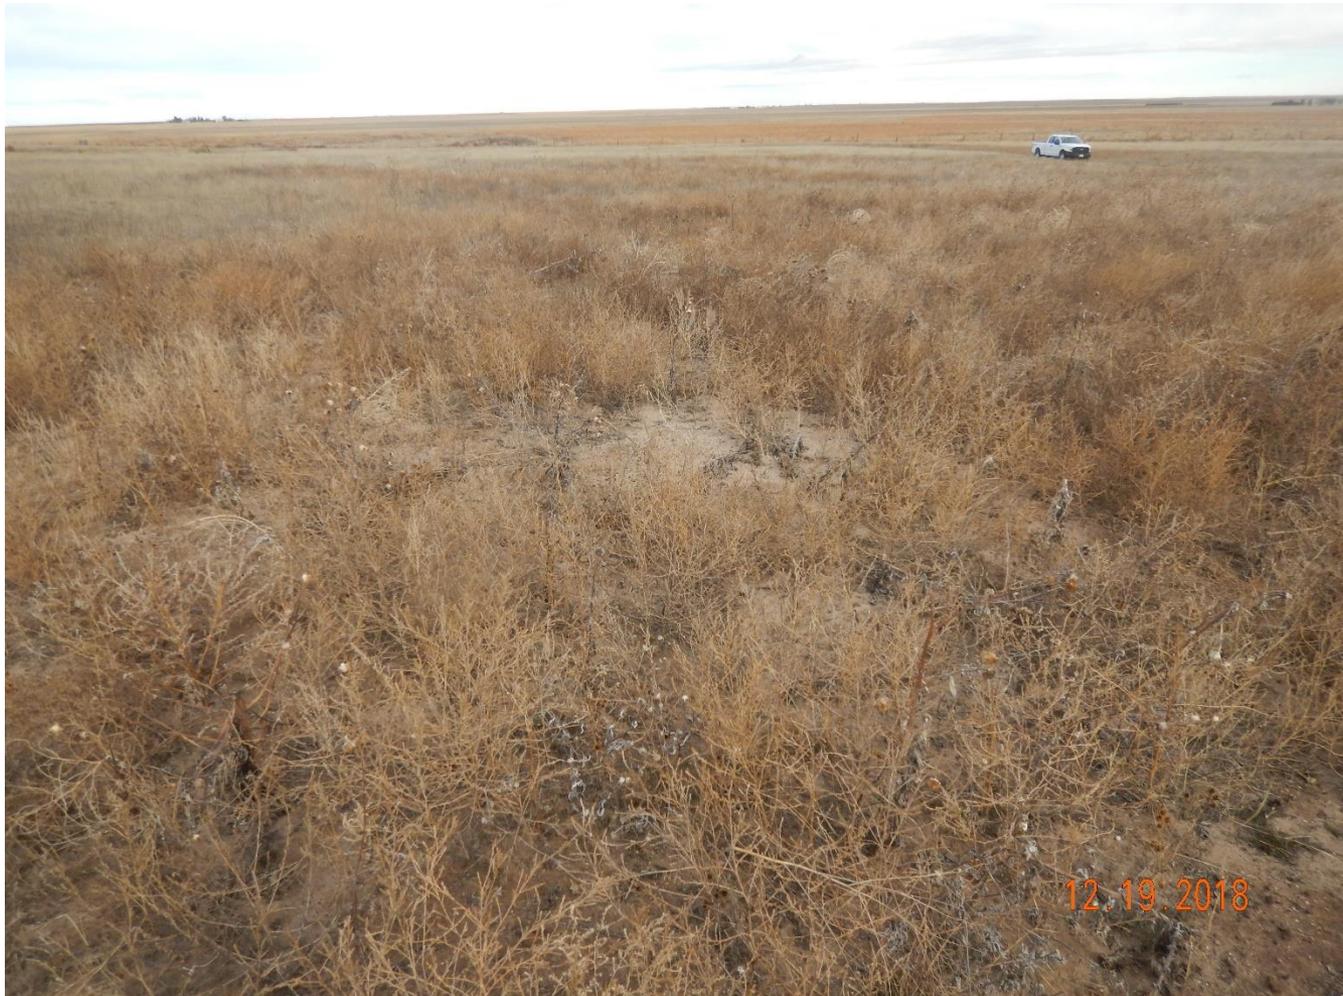
Photo 10: Photo taken from the west end of the location, facing northeast. See comments under photo 5.

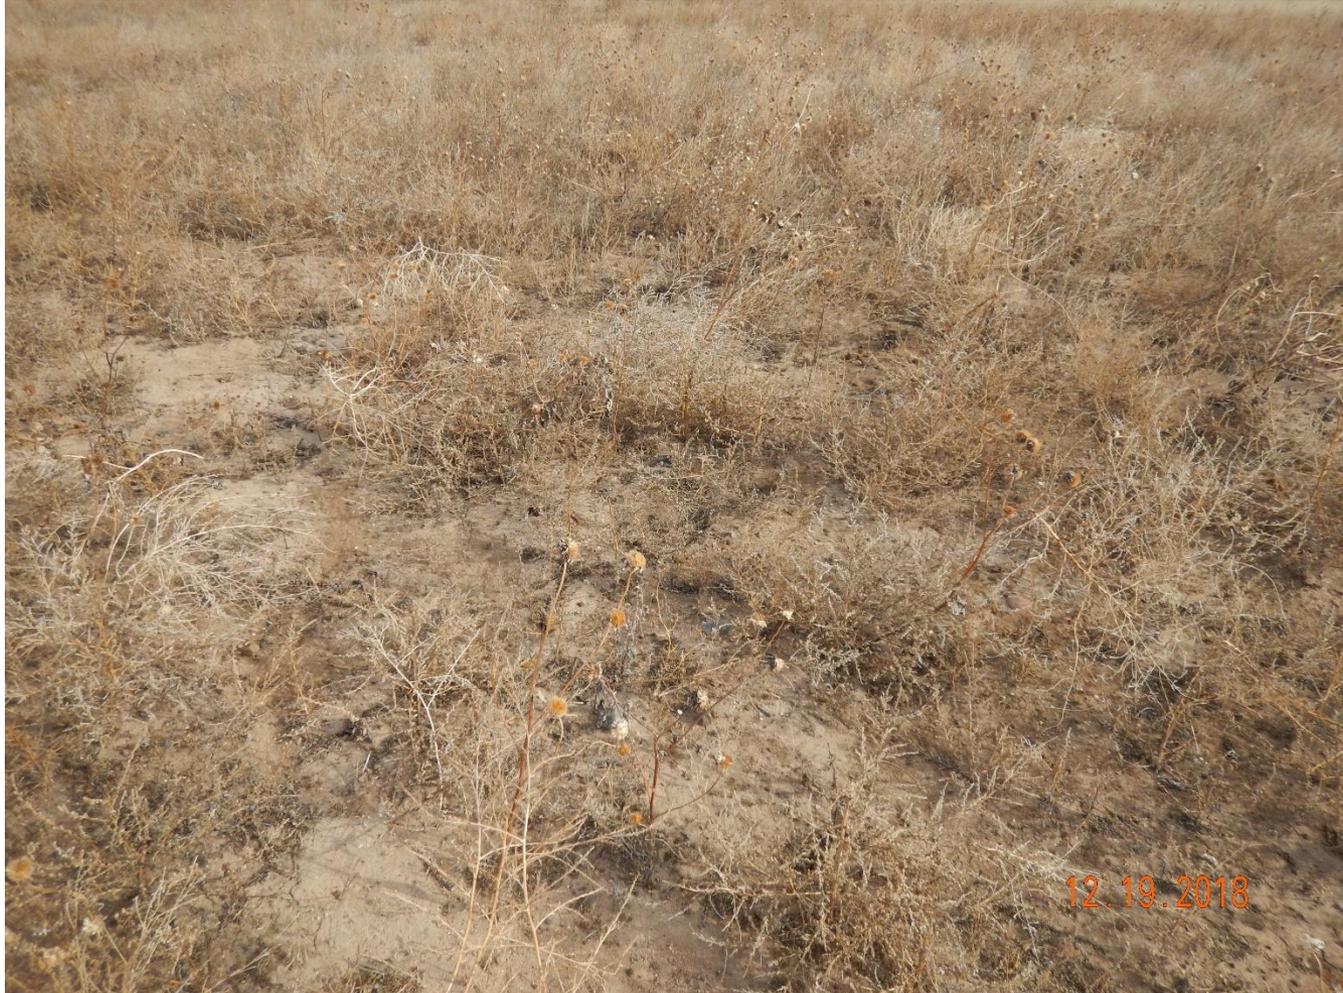
Photo 11: Photot taken from the west end of the location. Photo shows vegetation observed was undesirable weedy plant species such as Kochia and Russian thistle. Very little desirable perennial vegetative germination or establishment observed.

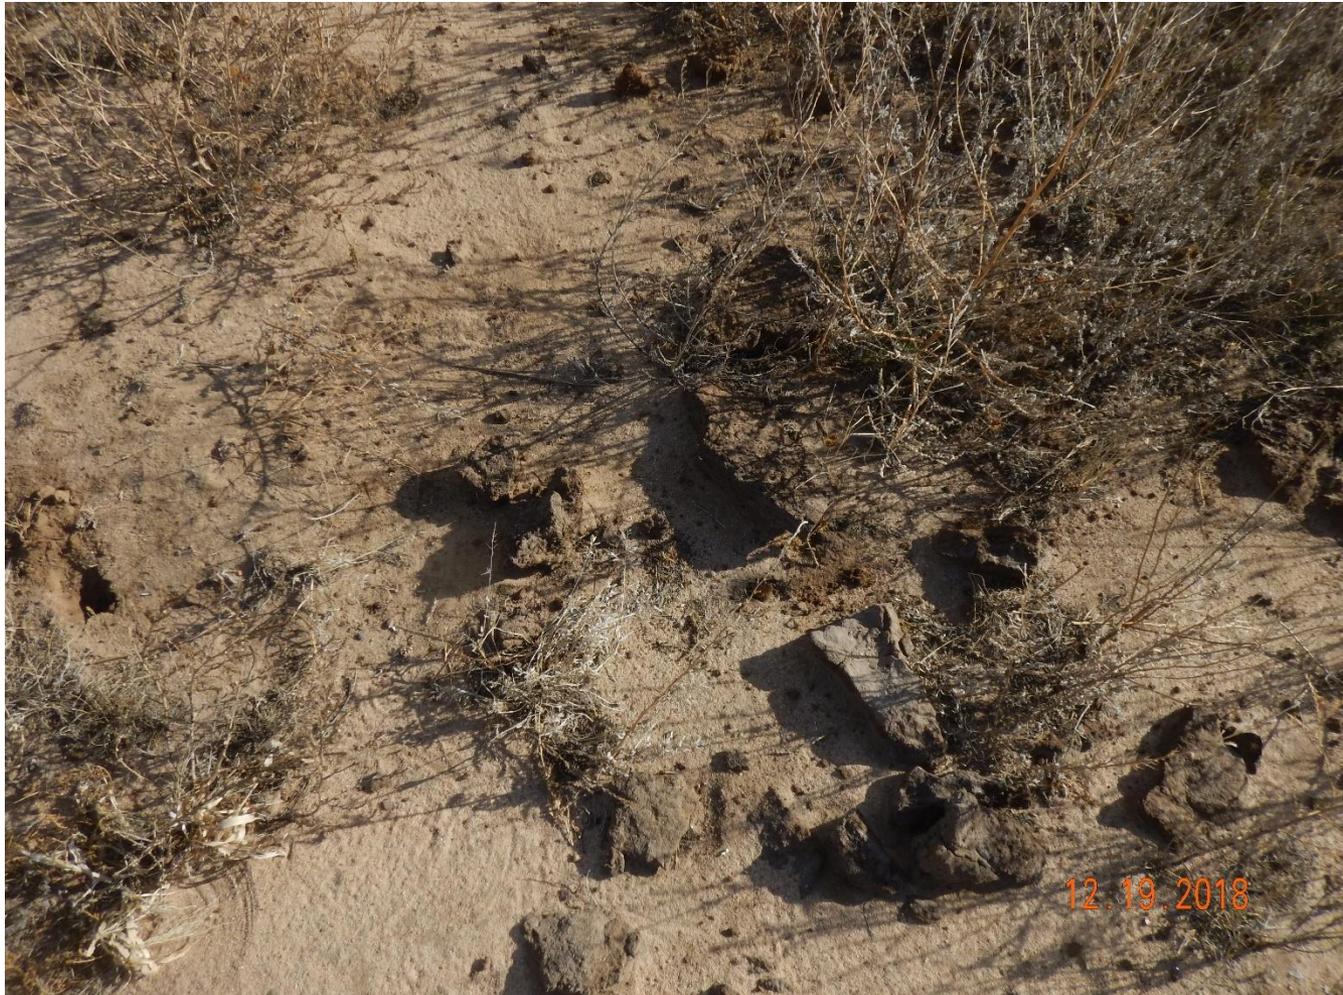
Photo 12: Photo taken from the location. Photo shows contaminated soils. Contaminated soils were observed throughout the location.

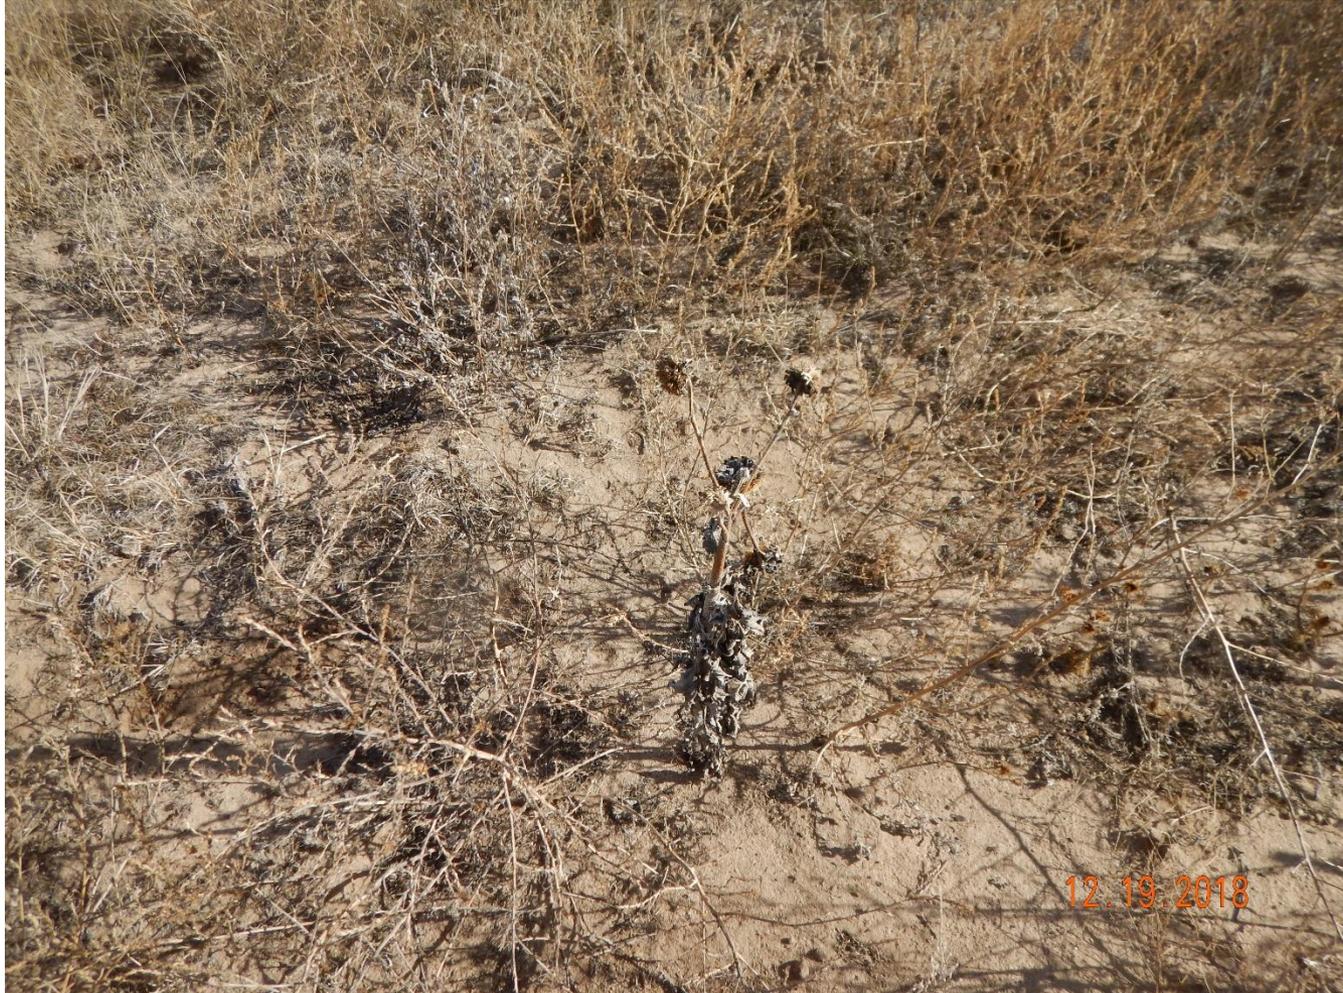
Photo 13: Photo taken from the location. Photo shows remnants of a Musk thistle. This is a Colorado State listed noxious weed that was observed throughout the eastern areas of the location.

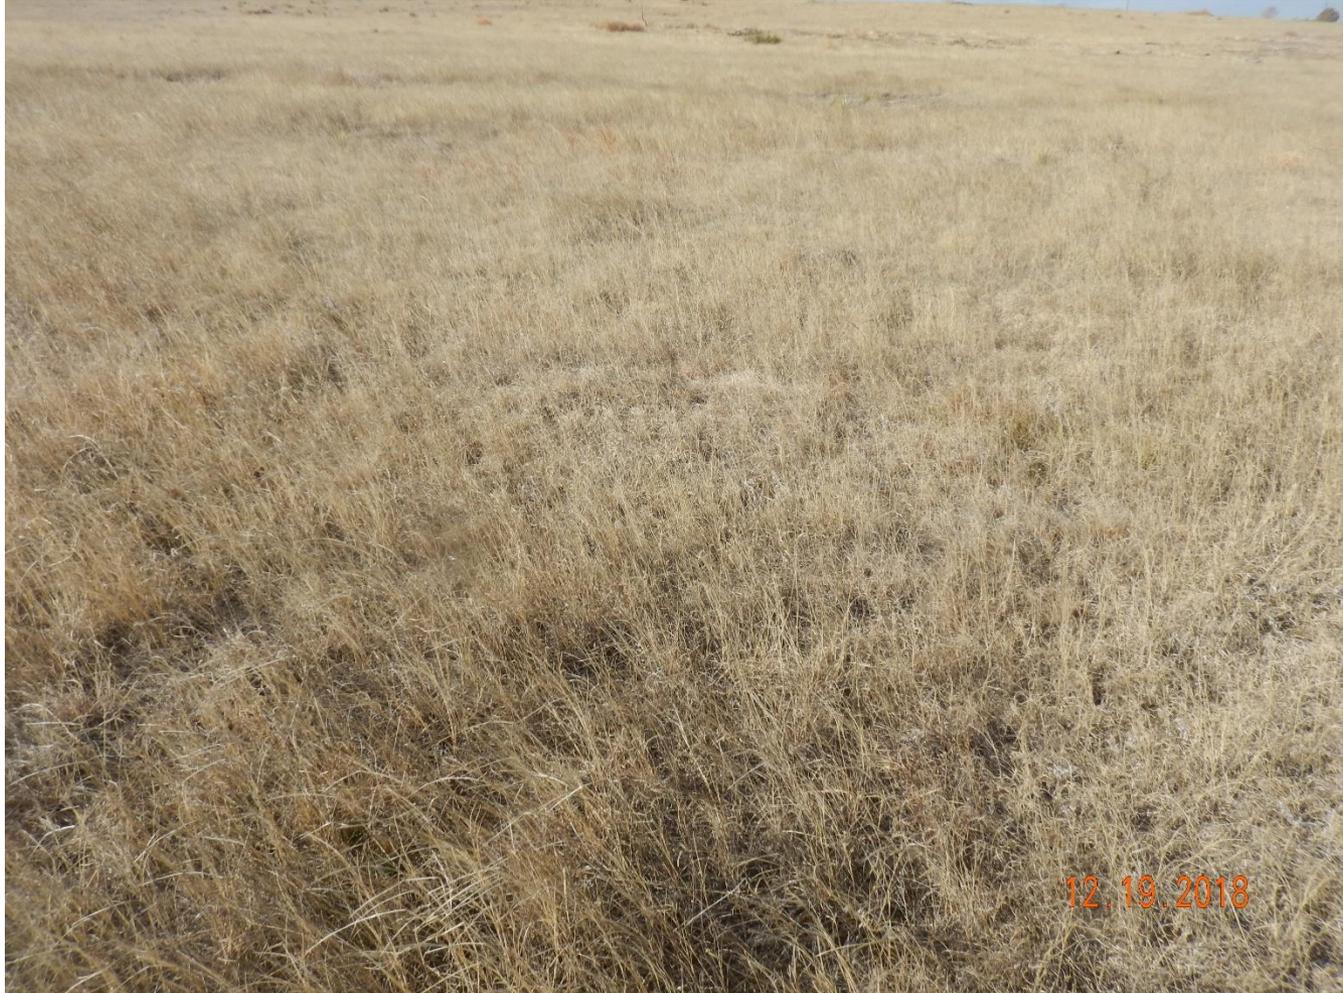
Photo 14: Photo of the adjacent reference area. Reference vegetation is predominantly Blue grama, Buffalo grass, Sand Dropseed, Western Wheat, etc... Location is not reflective of reference.
