Inspection Photos  
Operator Name: TEP ROCKY MOUNTAIN LLC  
Location ID: 460195

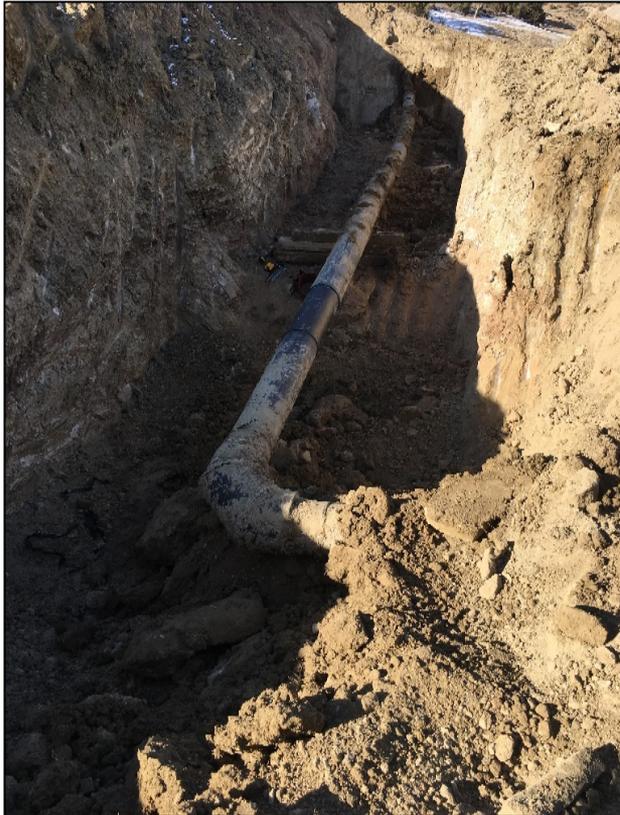
Flowline with section cut out where leak was found

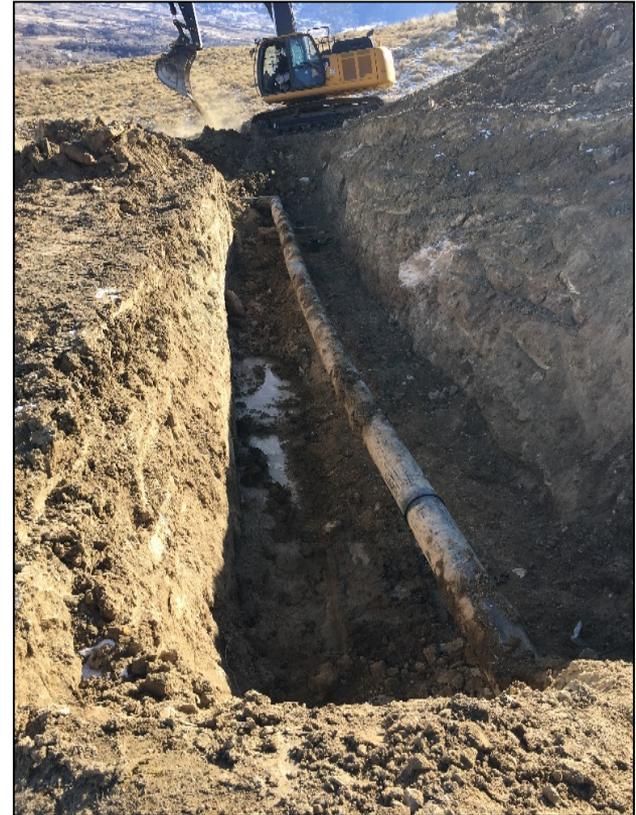
Flowline pictured in excavation

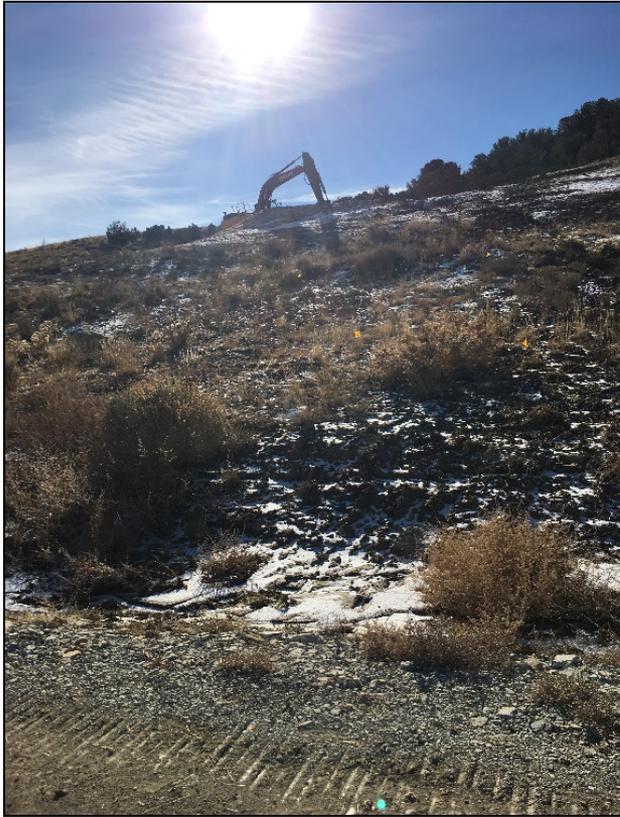
**Fluid traveled down hillside ~400 feet, Track hoe at release point**

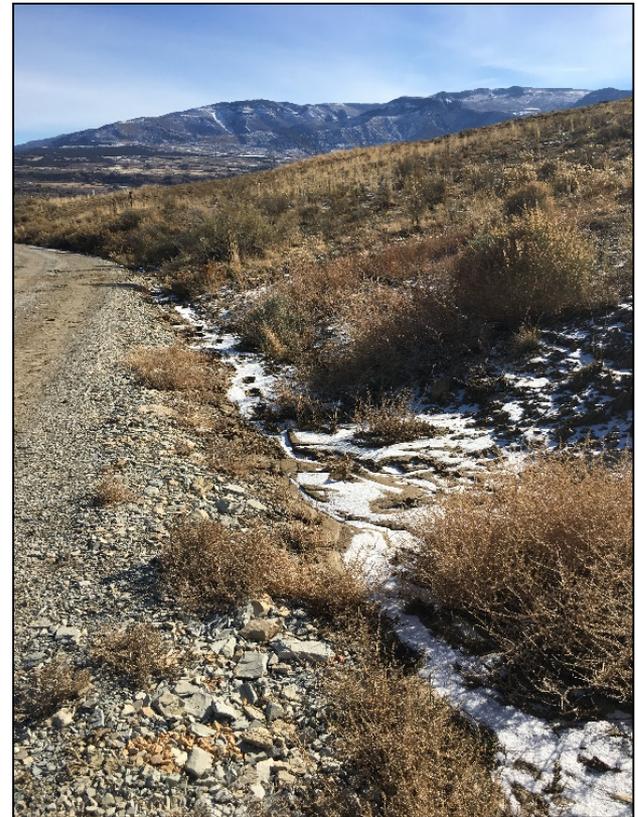
**Ditch fluid traveled down ~800 feet**

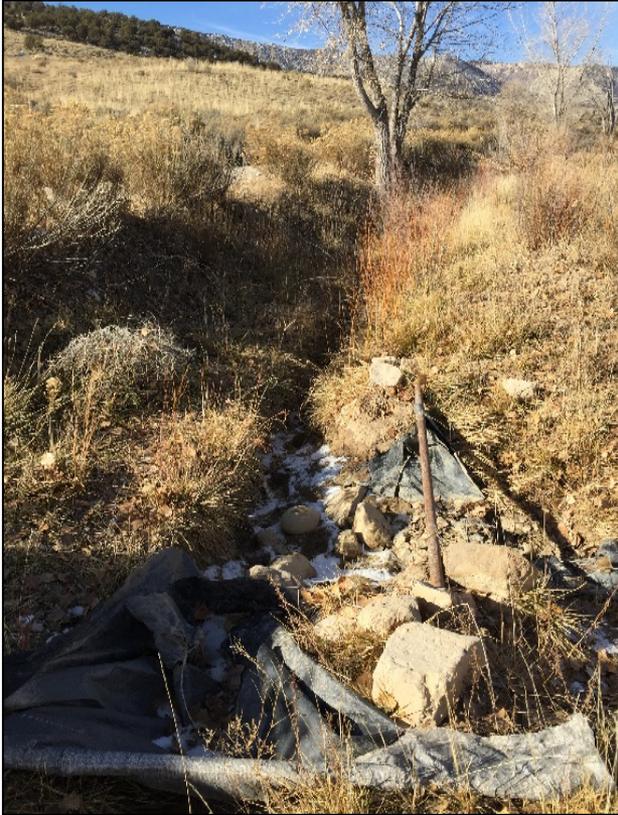
**Ditch fluid traveled down ~800 feet**

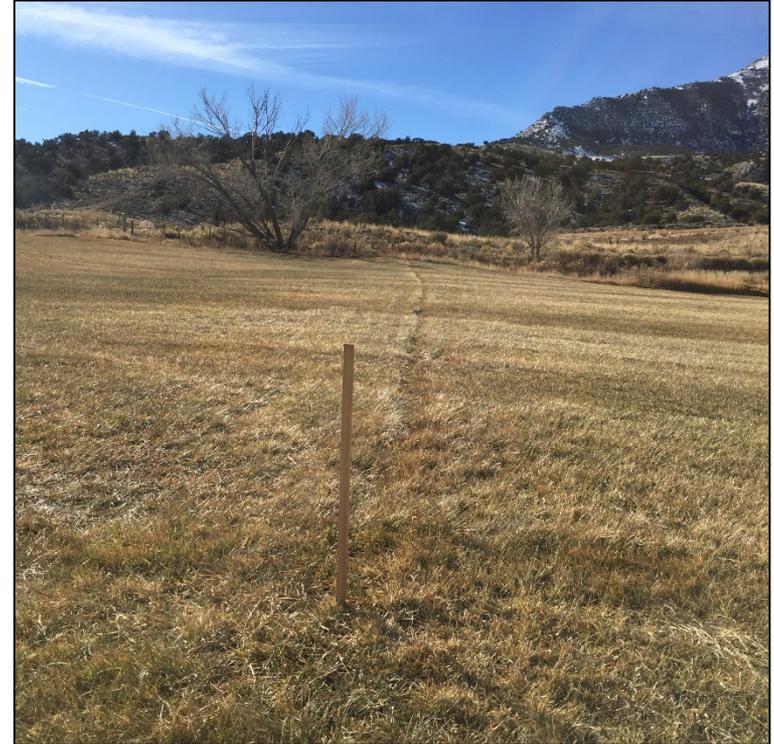
**Path fluid took in field, ~250 feet**  
**Stake represents end point of fluid movement**

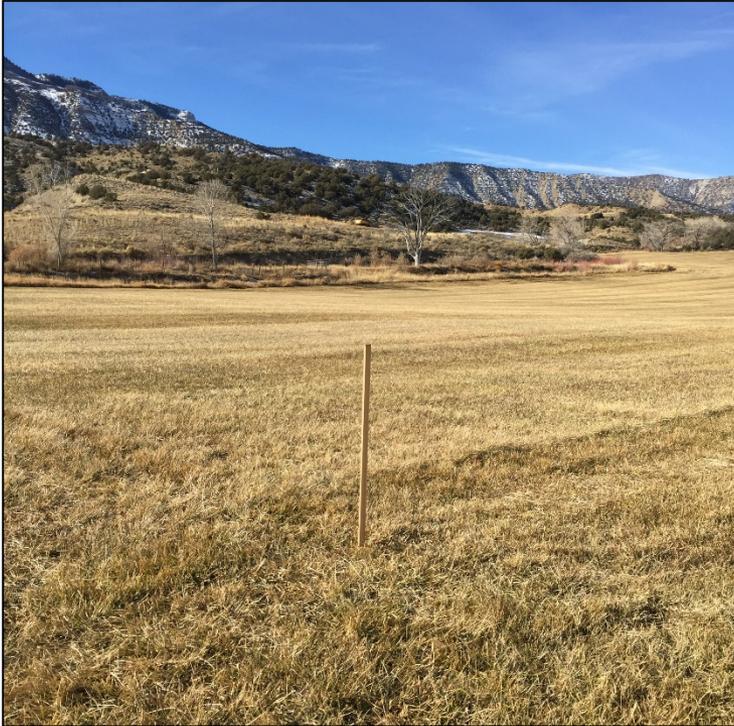
**End point with Track hoe on hillside at start point**

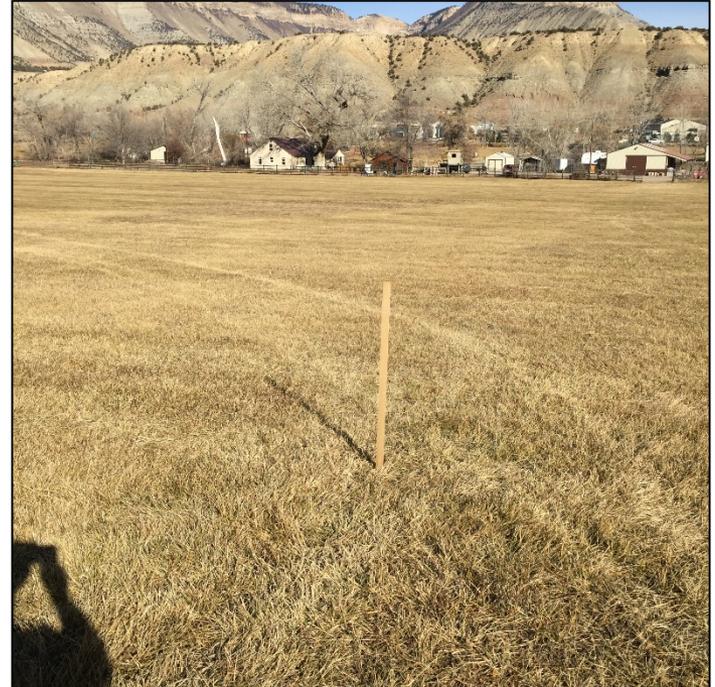
**Stake represents end point of fluid**
