Inspection Photos

Operator: FOUNDATION ENERGY
MANAGEMENT LLC - 10112

Location ID: 447523

Inspection Doc. Number: 682504335
Weld County, CO

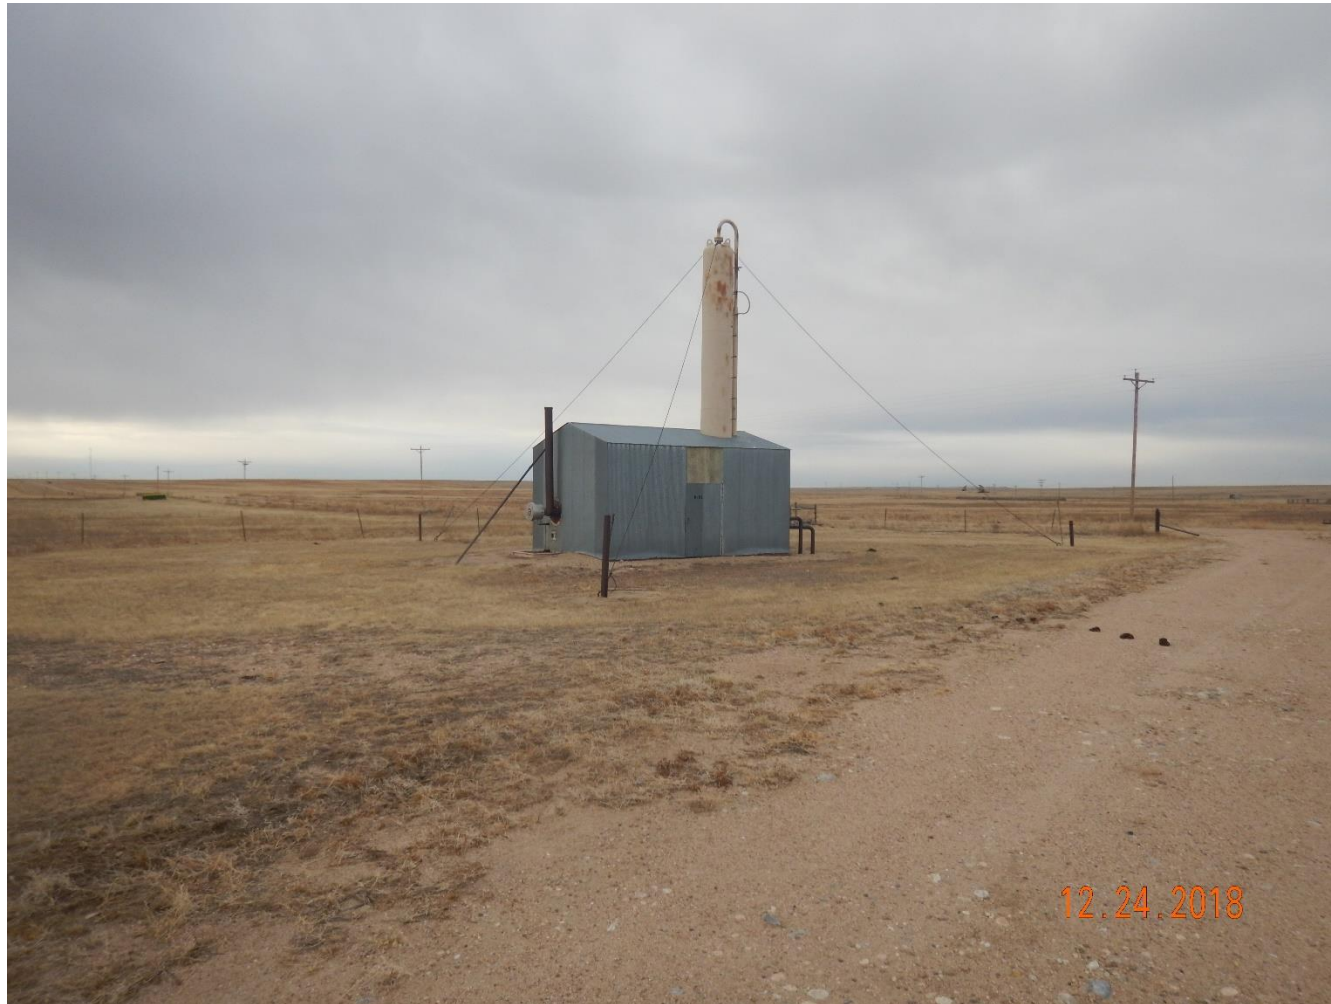
Photo 1: Photo taken from the south end of location, facing southwest. Previous inspections required operator to conduct final reclamation. Photo shows that oil and gas facilities/equipment/trash debris remains on location. Photo also shows access road remains. Unable to find evidence that final reclamation has been conducted in accordance with 1004 rules and requirements.

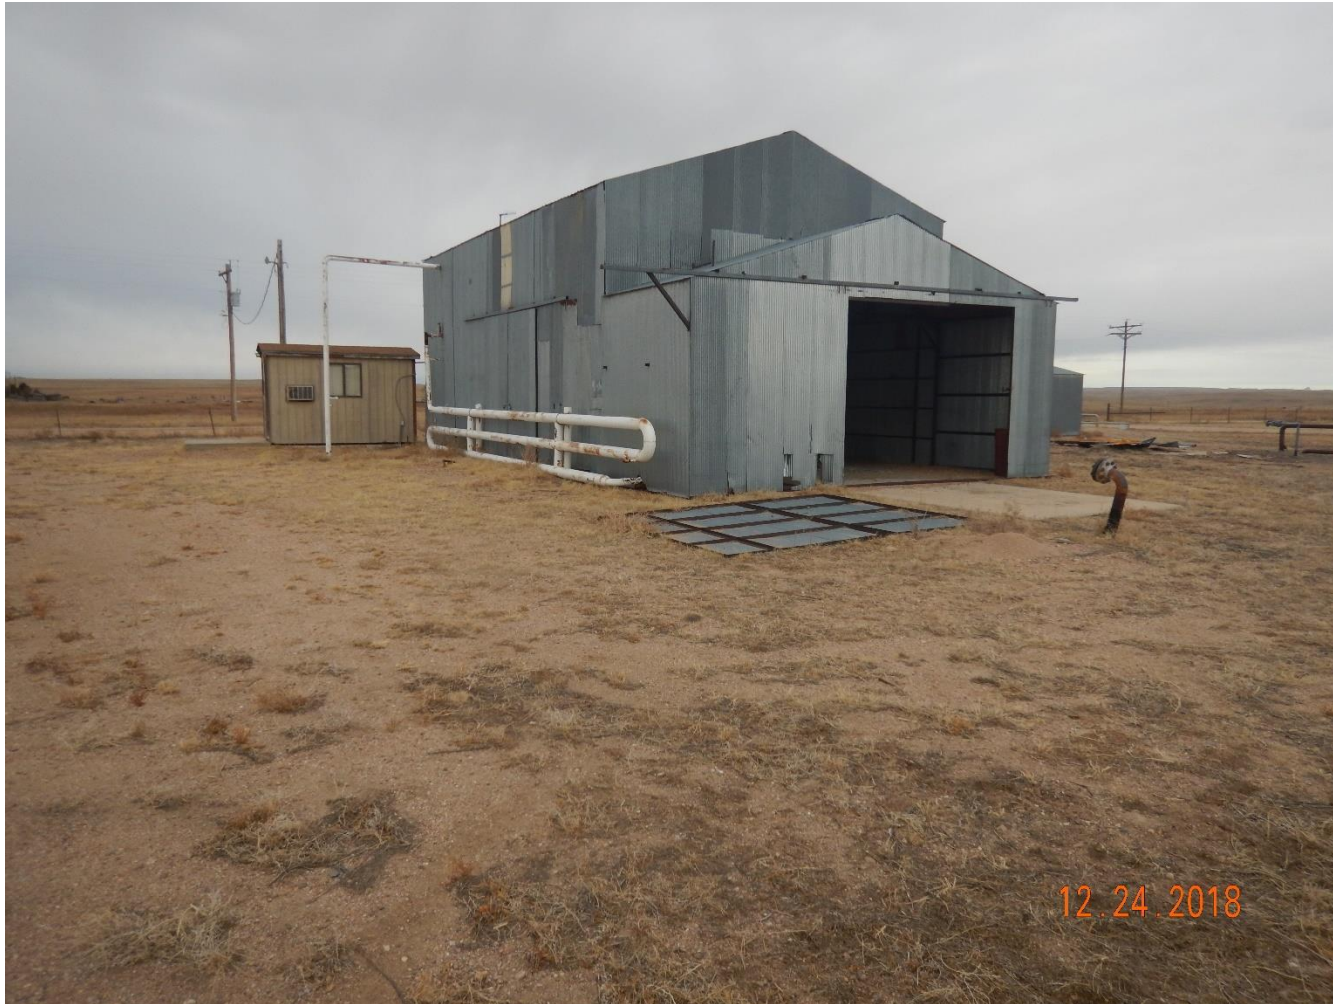
Photo 2: Photo taken from the south end of location, facing northwest. See comments under photo 1.

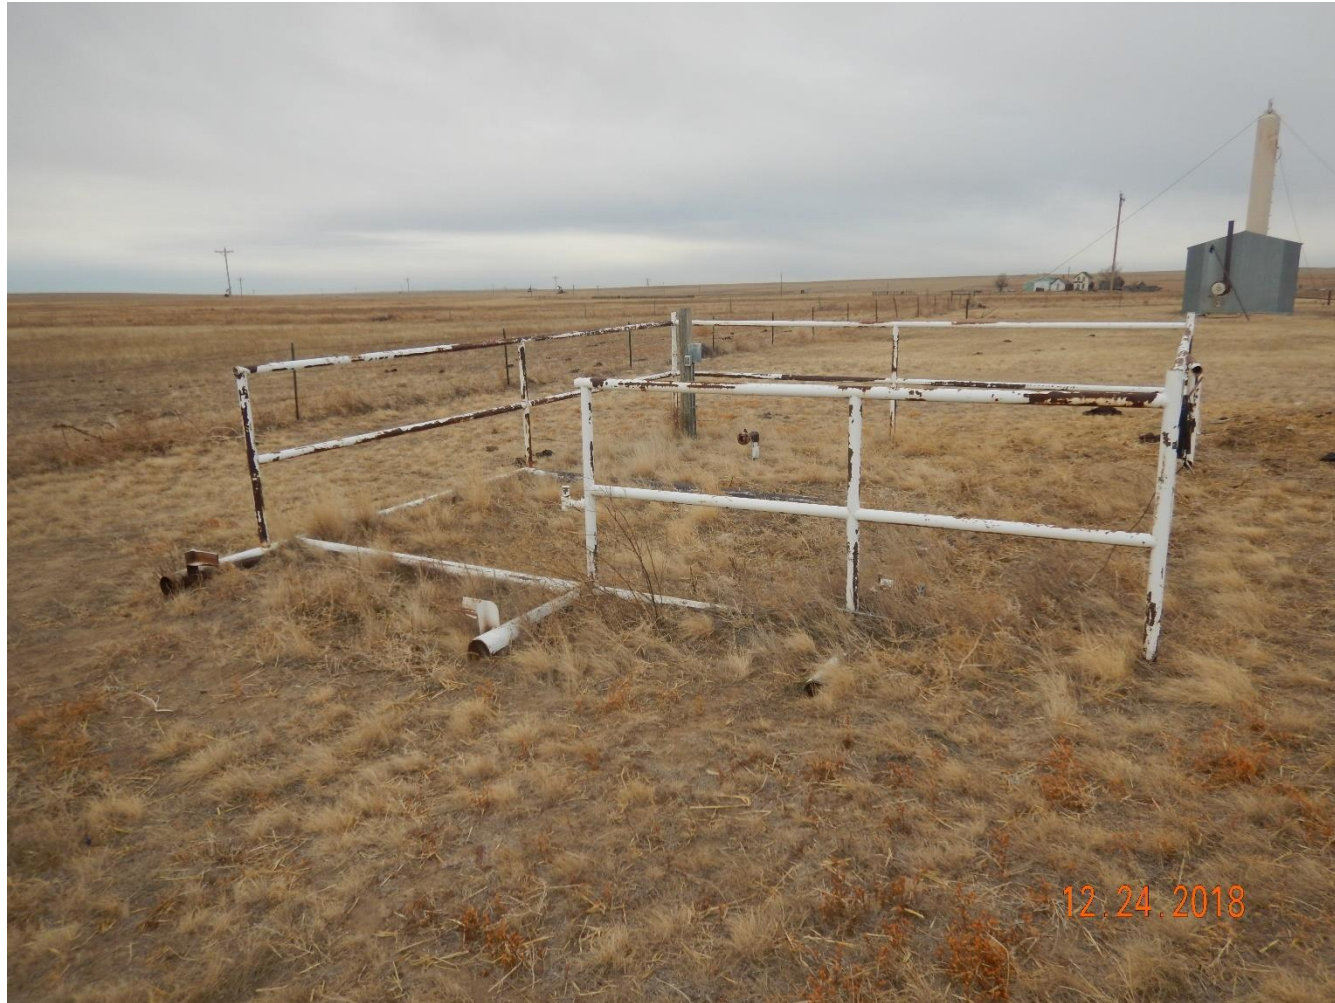
Photo 3: Photo taken from the south end of location, facing west. See comments under photo 1.

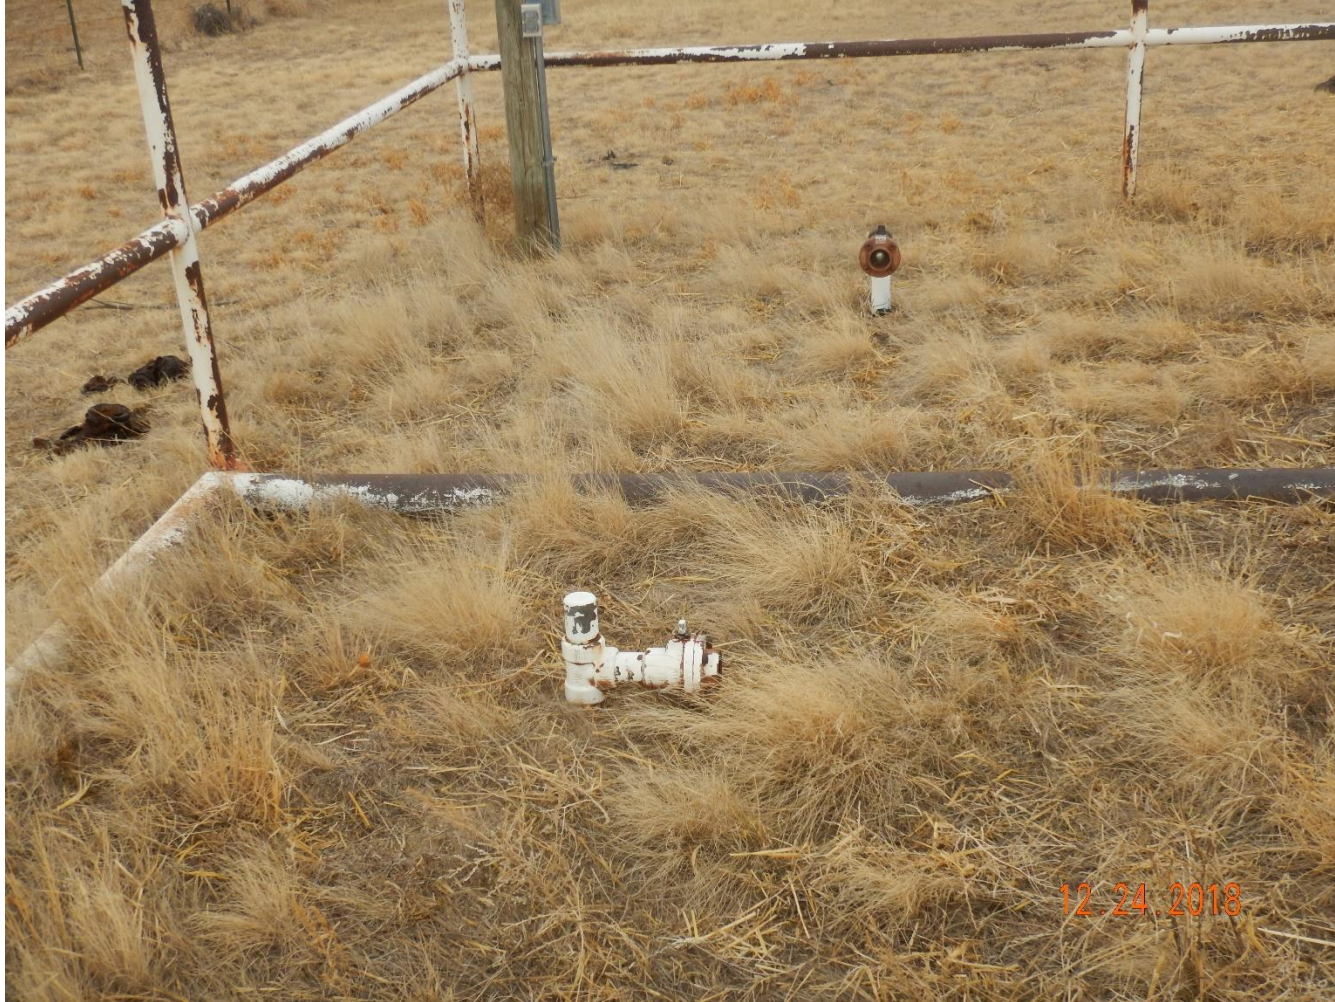
Photo 4: Continued from photo 3. Photo shows abandoned risers remains on the location

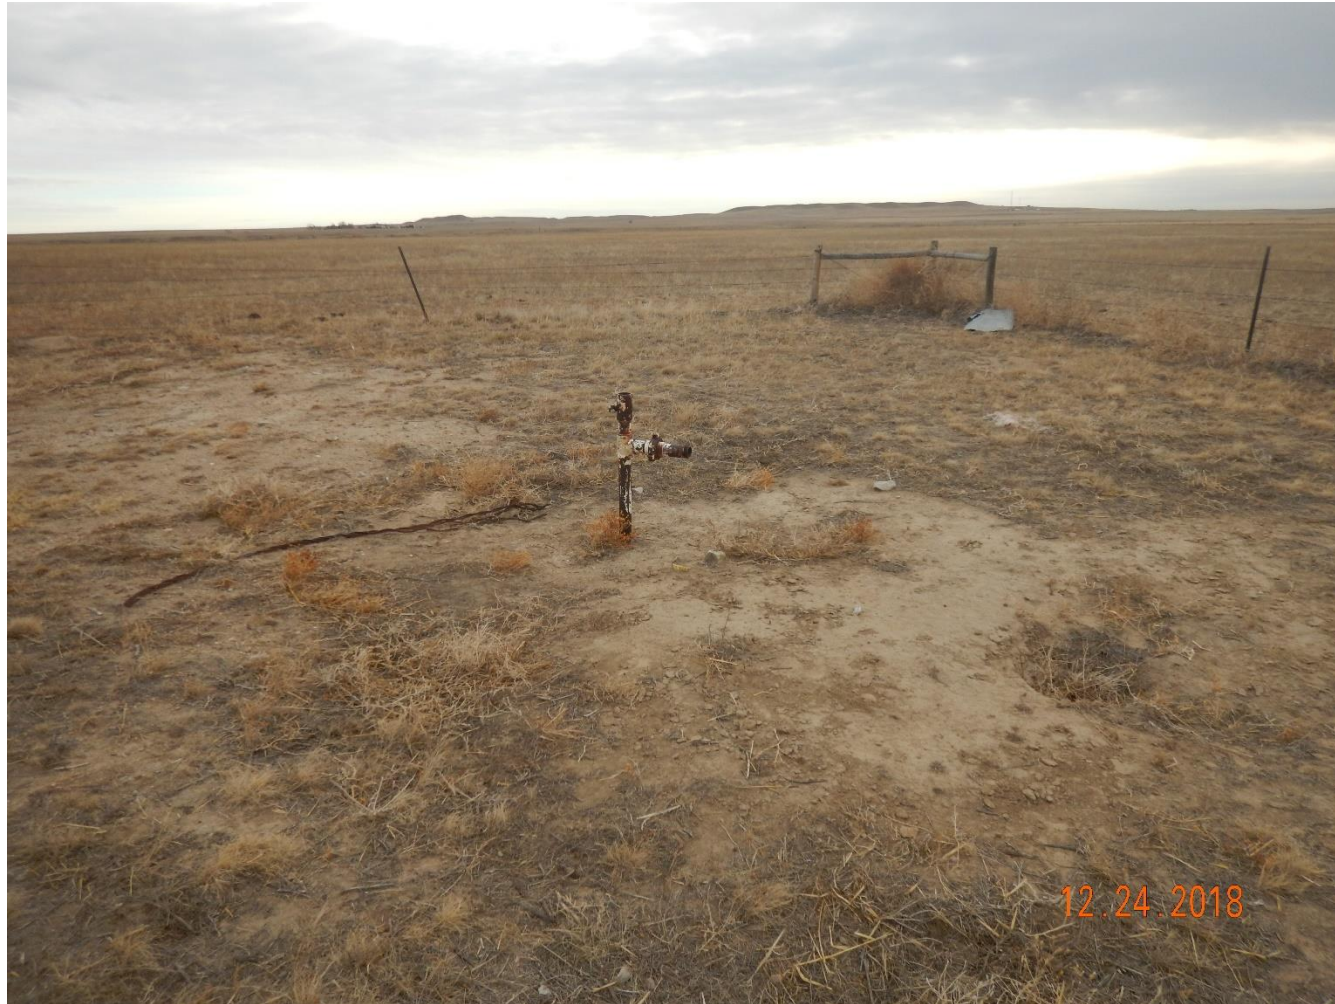
Photo 5: Photo taken from the southeast end of the locating, facing east. Photo shows abandoned riser and cable remaining on the location

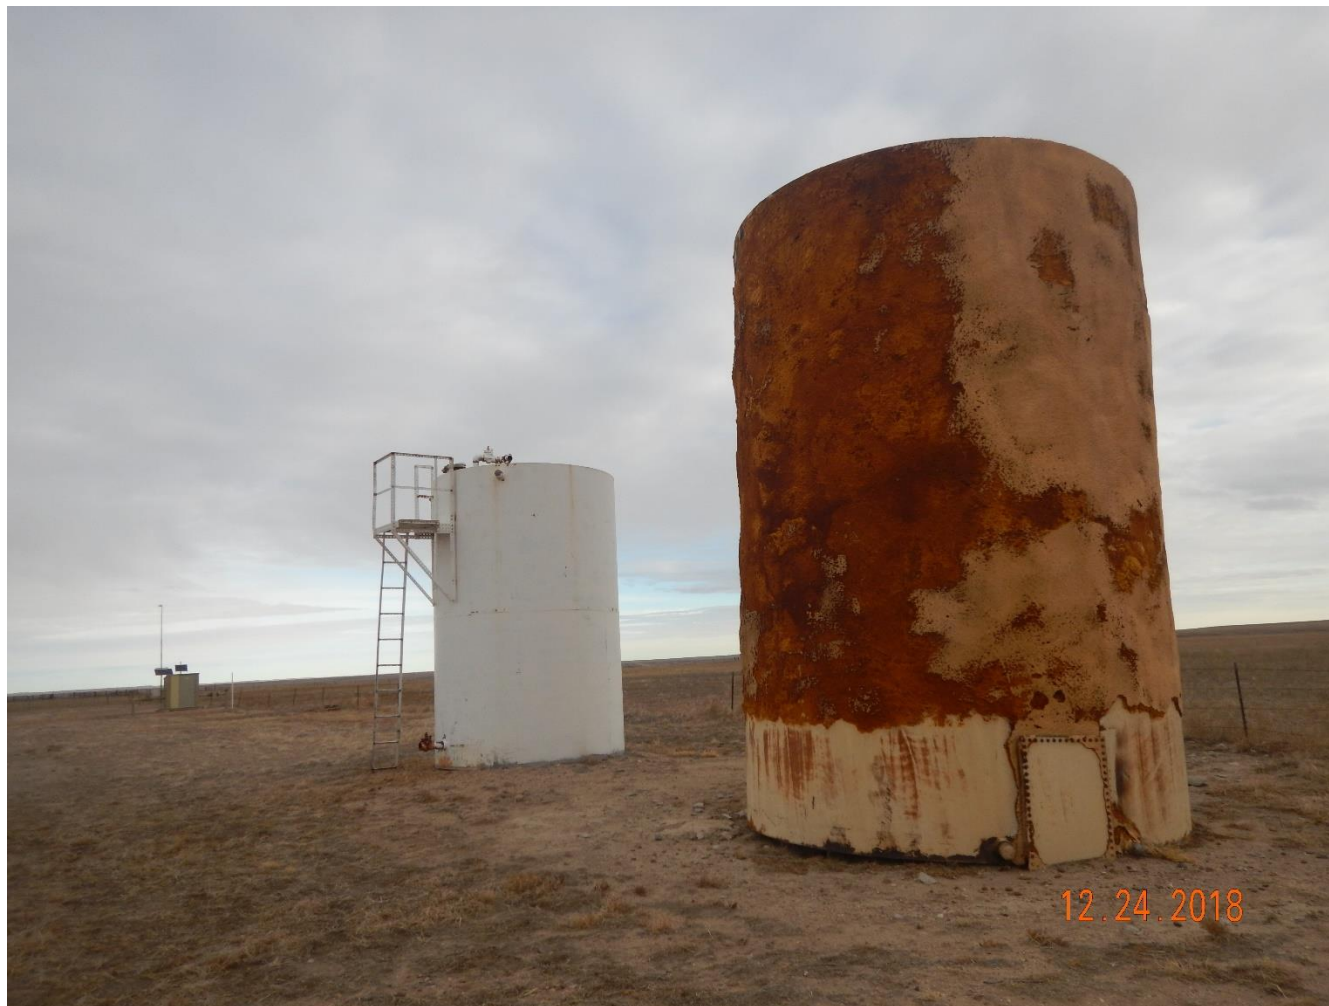
Photo 6: Photo taken from the southeast end of location, facing north. Previous inspections required operator to conduct final reclamation. Photo shows that oil and gas facilities/equipment/trash debris remains on location. Unable to find evidence that final reclamation has been conducted in accordance with 1004 rules and requirements.

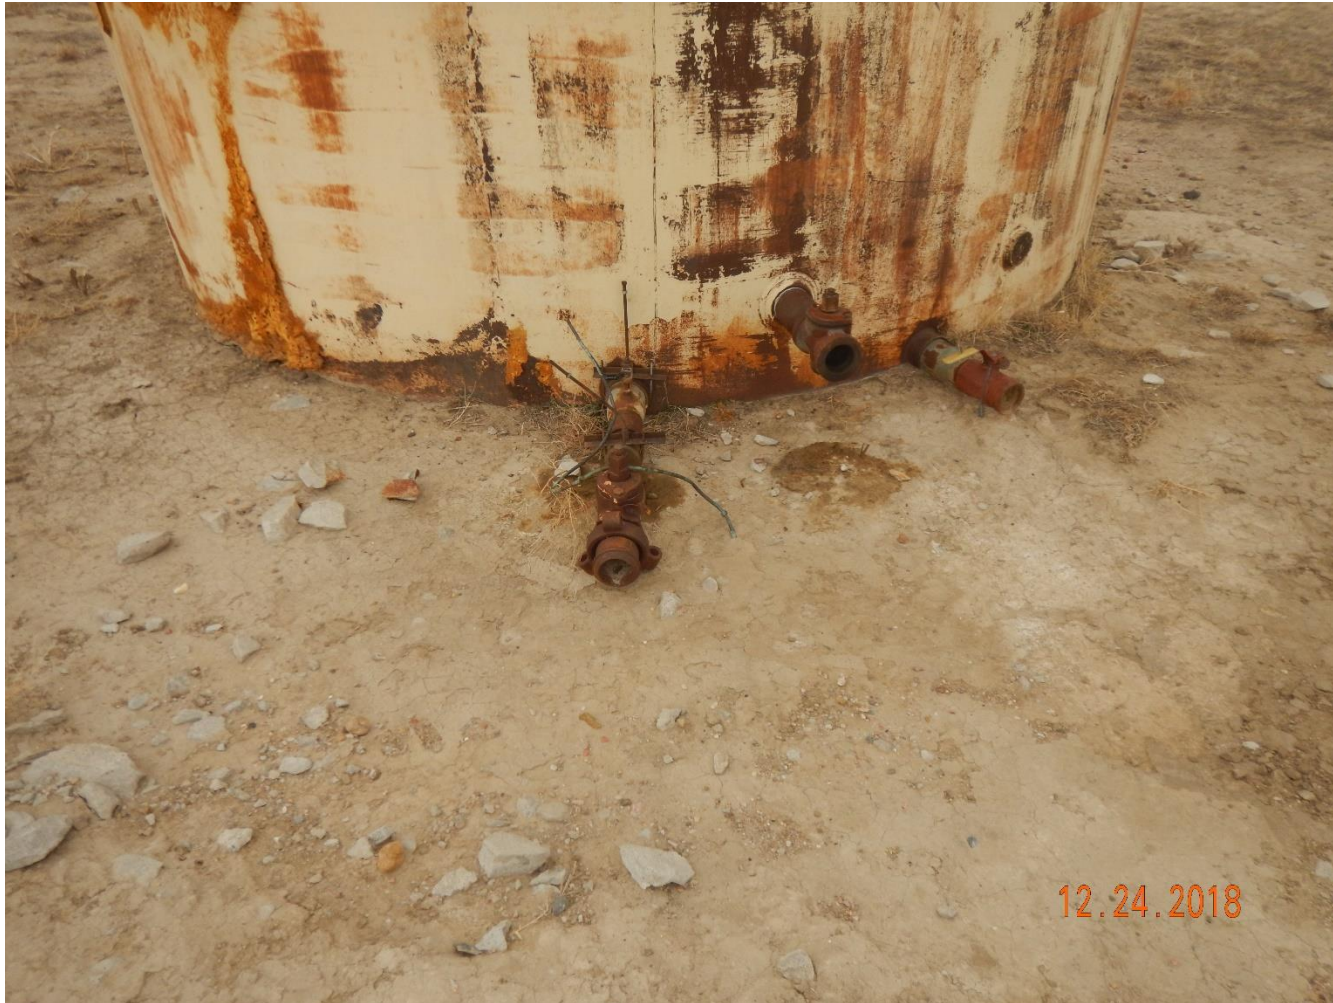
Photo 7: Continued from photo 6. Photo shows contaminated soil due to chemical discharge from the tanks have not been cleaned or removed.

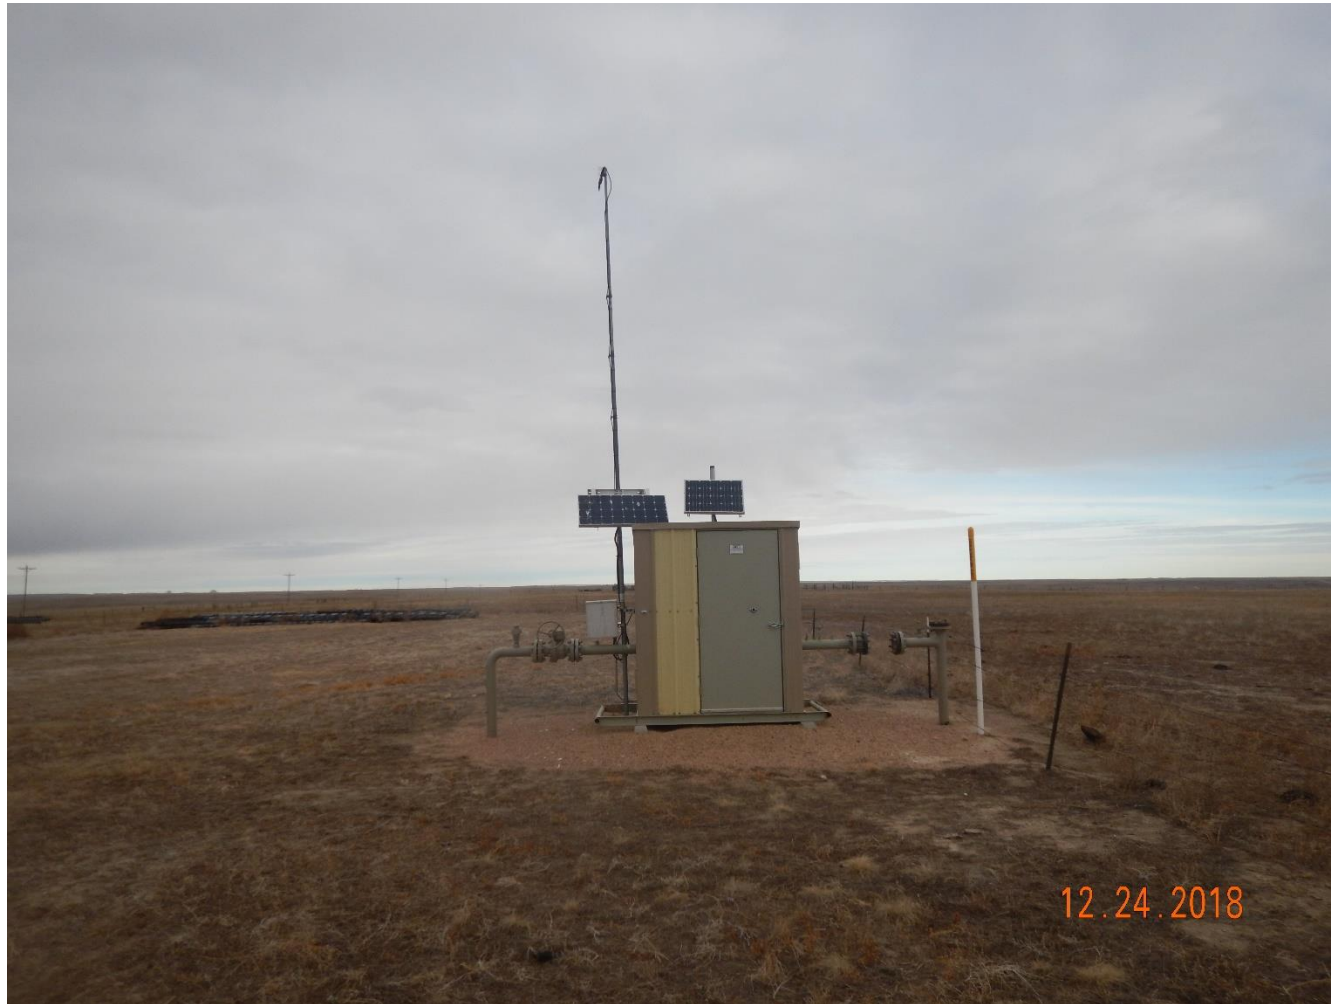
Photo 8: Photo taken from the west end of the location, facing north. Previous inspections required operator to conduct final reclamation. Photo shows that oil and gas facilities/equipment/trash debris remains on location. Unable to find evidence that final reclamation has been conducted in accordance with 1004 rules and requirements.

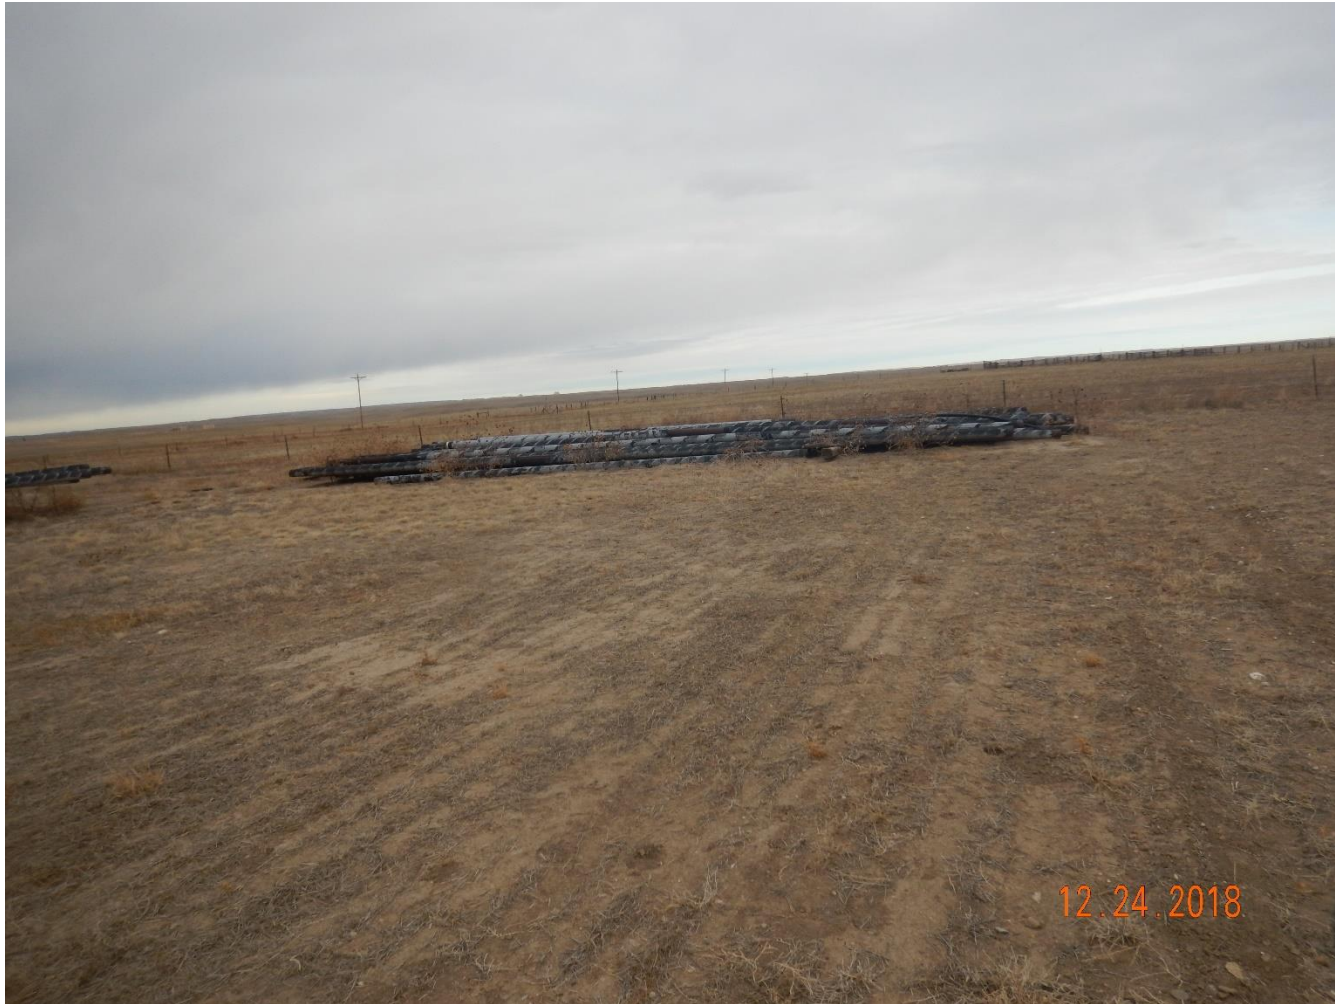
Photo 9: Photo taken from the north end of the location, facing north. See comments under photo 8.

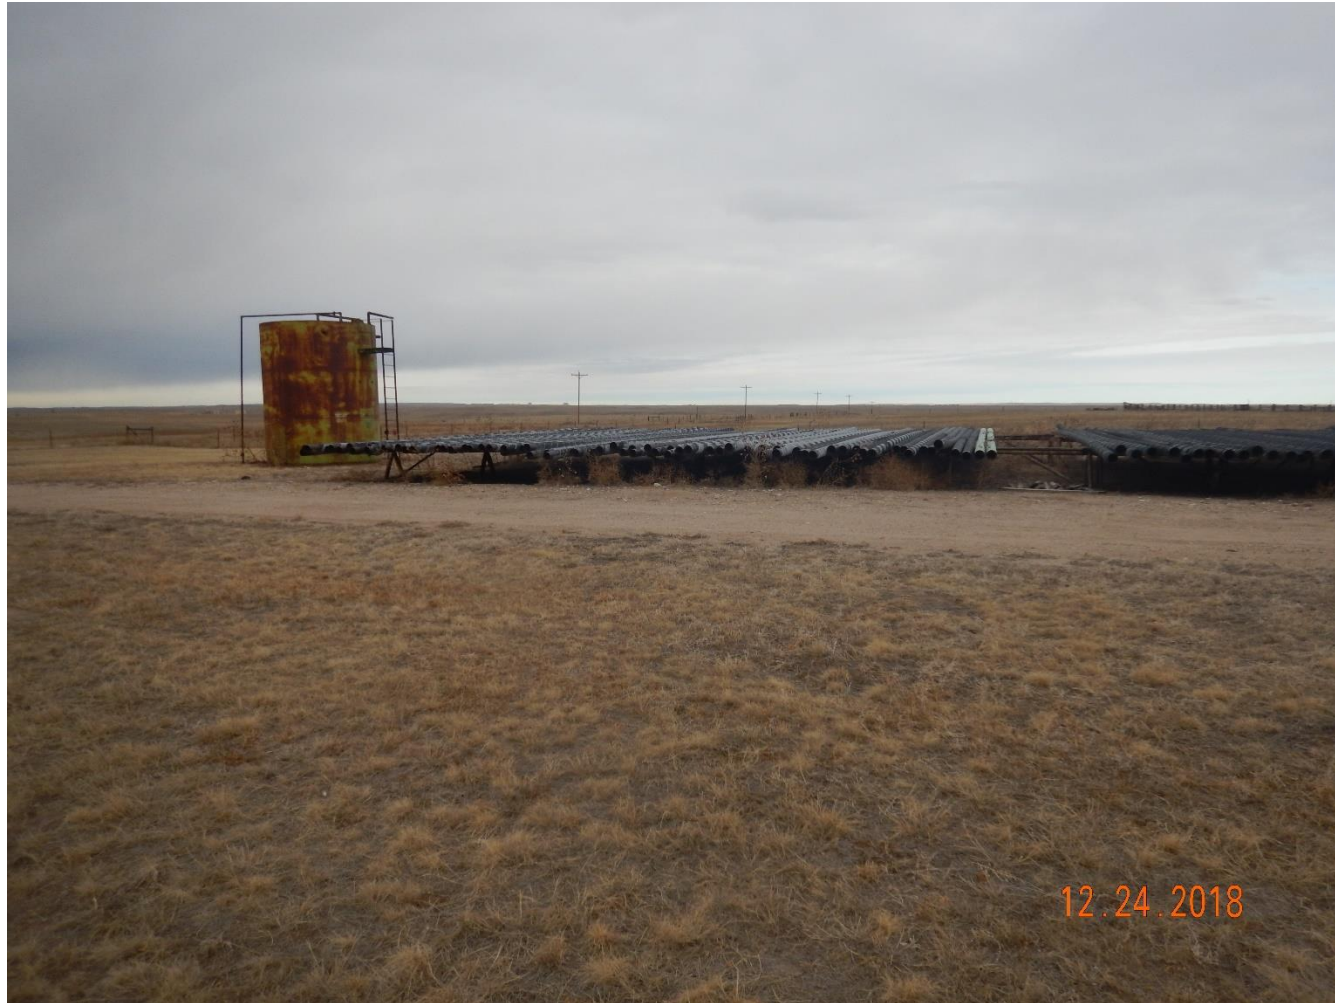
Photo 10: Photo taken from the north end of the location, facing north. See comments under photo 8.

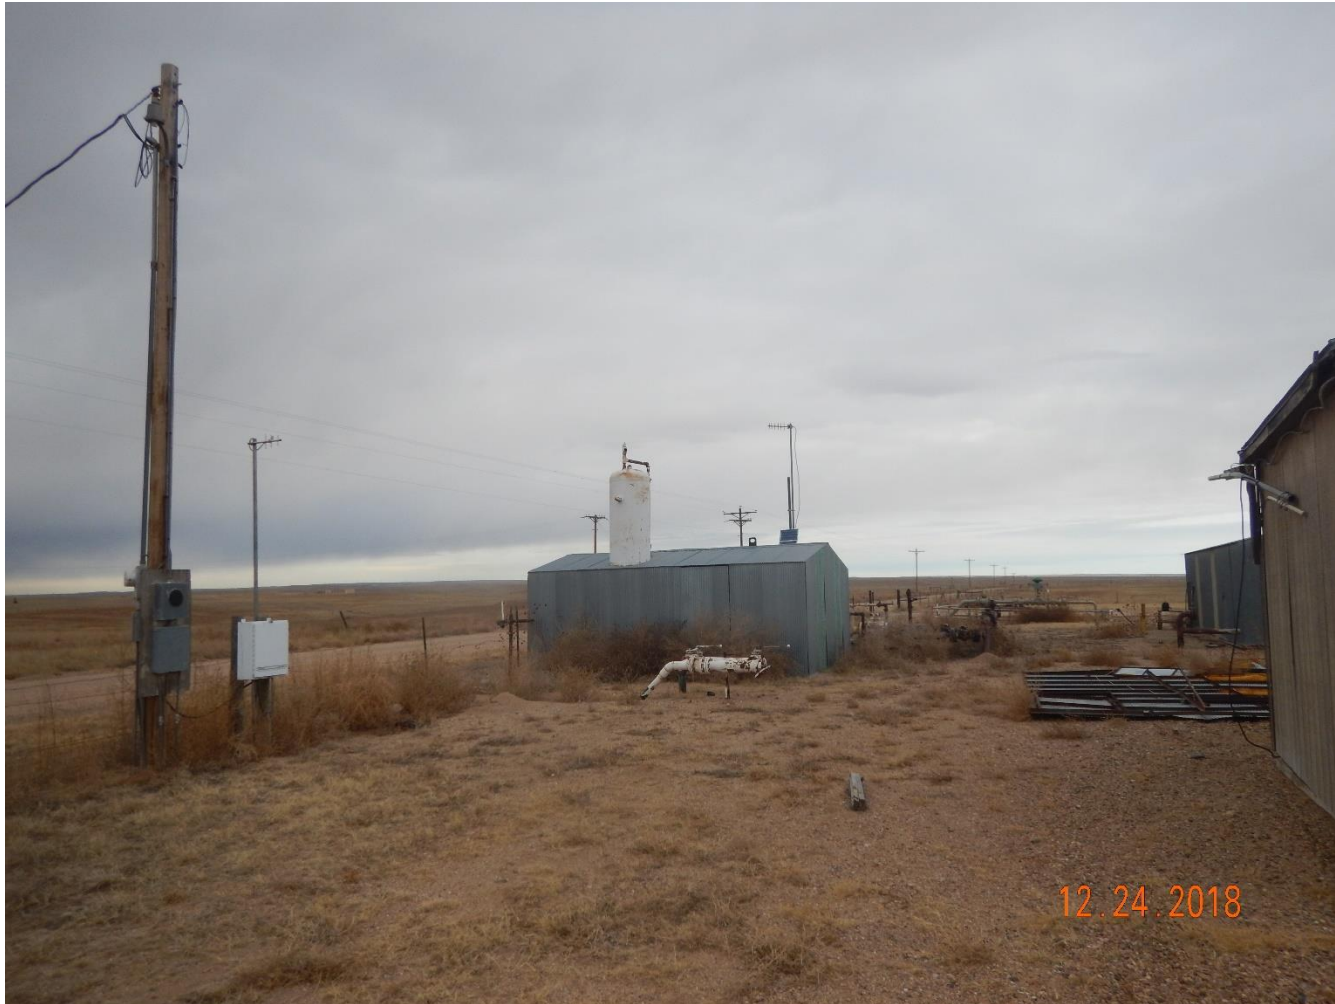
Photo 11: Photo taken from the west end of the location, facing north. See comments under photo 8.
