Construction and Stormwater Inspection

December 24, 2018

Operator: NOBLE ENERGY INC- #100322

Location ID: 456174

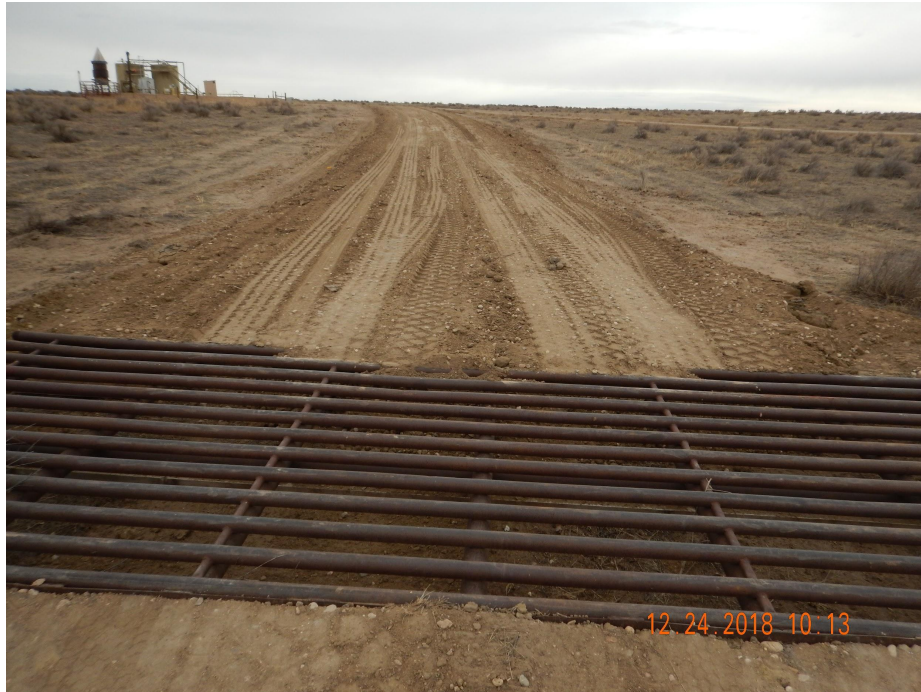
Photo 1. Photo taken from the northeastern entrance to location, facing East. Operator is in-process of stabilizing the access road. Cattle guard is likely intending to keep cattle out but may also serve as a vehicle tracking device BMP.

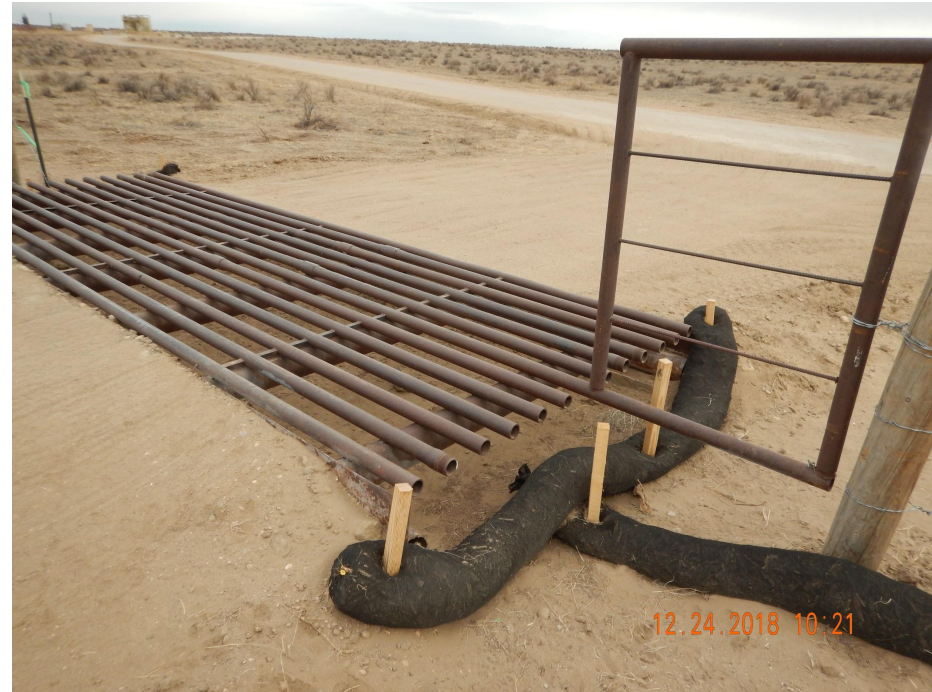
Photo 2. Photo taken from the southeastern entrance to location, facing East. See comments under Photo 1.

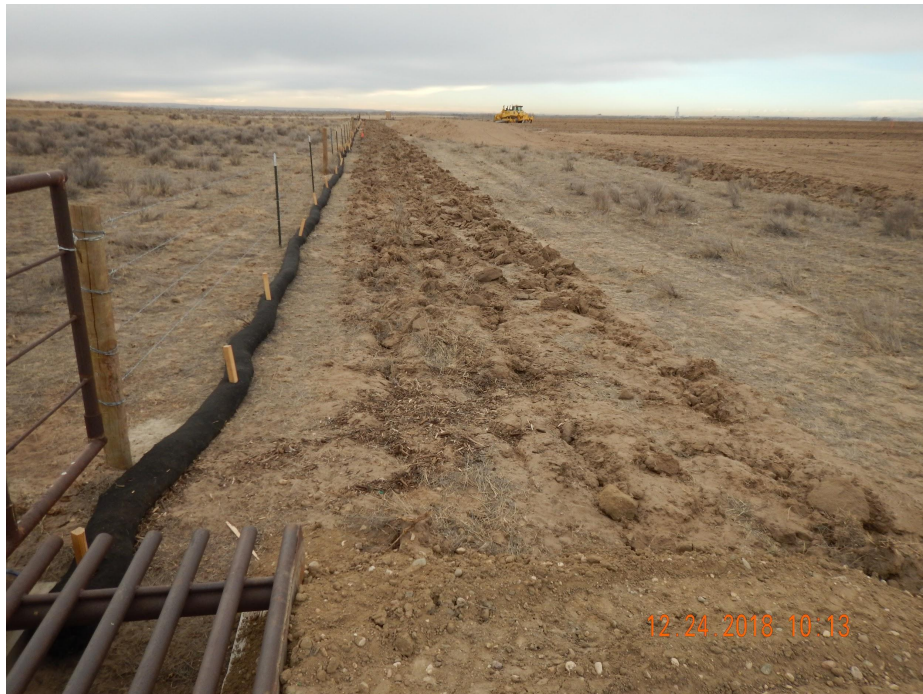
Photo 3. Photo taken from the northeastern entrance to the location, facing South. Operator has installed temporary stormwater BMPs (surface roughening and filtrex wattles) around the entire perimeter of the location during construction operations.

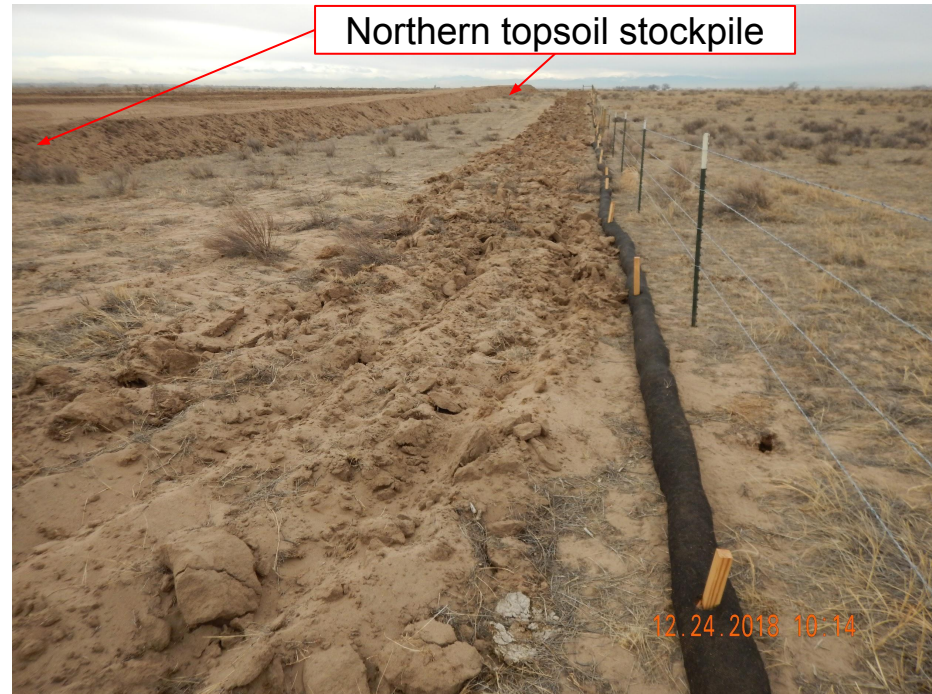
Photo 4. Photo taken from the northeast perimeter of the location, facing West. See comments under Photo 3.

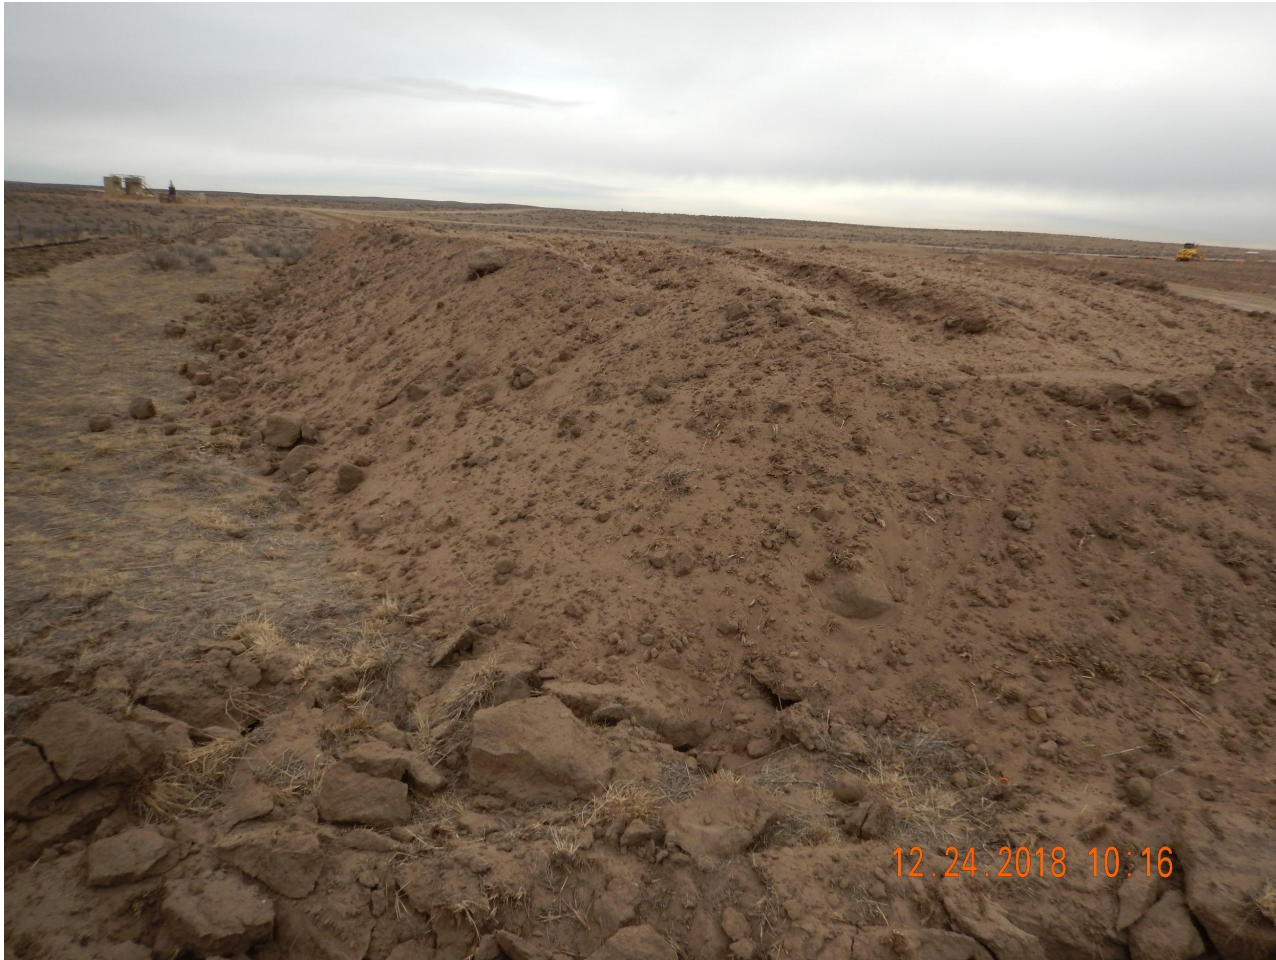
Photo 5. Photo taken from the northwest perimeter of the location, facing East. Photo illustrates the topsoil stockpile that shall be stabilized from wind and water erosion and protected from weed establishment.

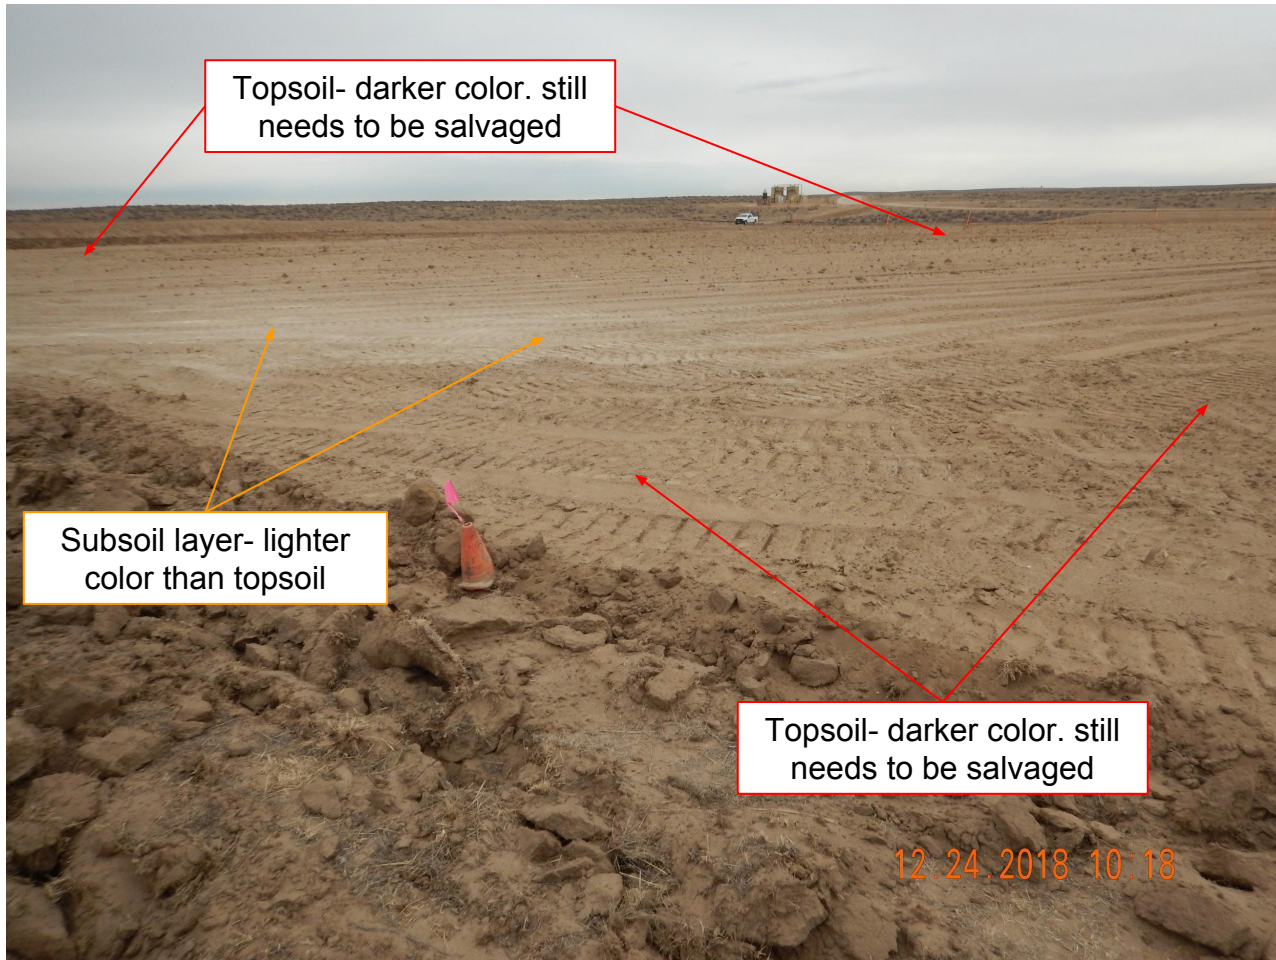
Photo 6. Photo taken from the western perimeter of the location, facing Northeast. Photo illustrates topsoil that still needs to be salvaged from the northern and southern well pad area.

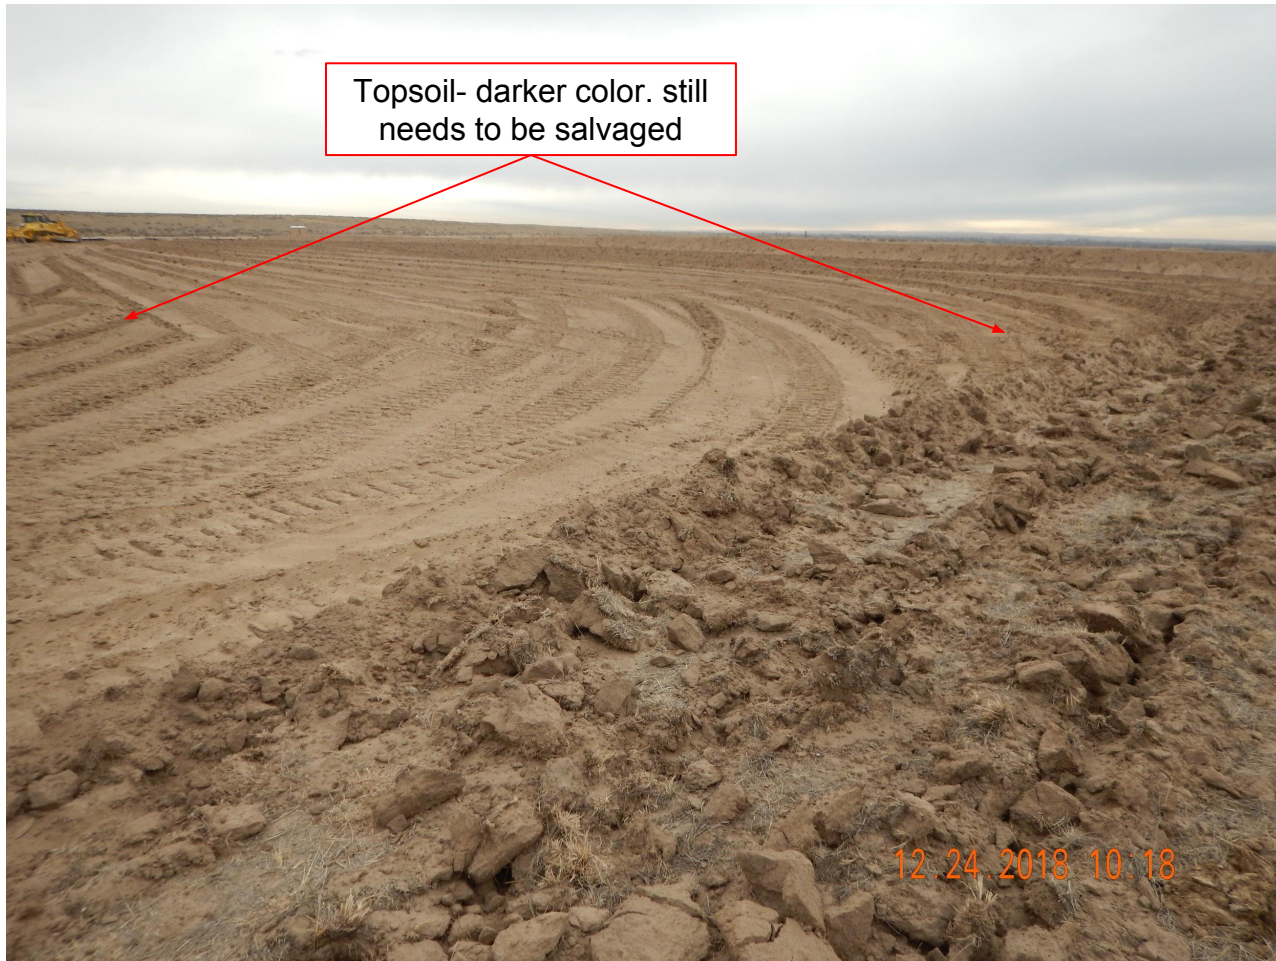
Photo 7. Photo taken from the southwestern perimeter of the location, facing Southeast. Photo illustrates topsoil that still needs to be salvaged from the southern well pad area.

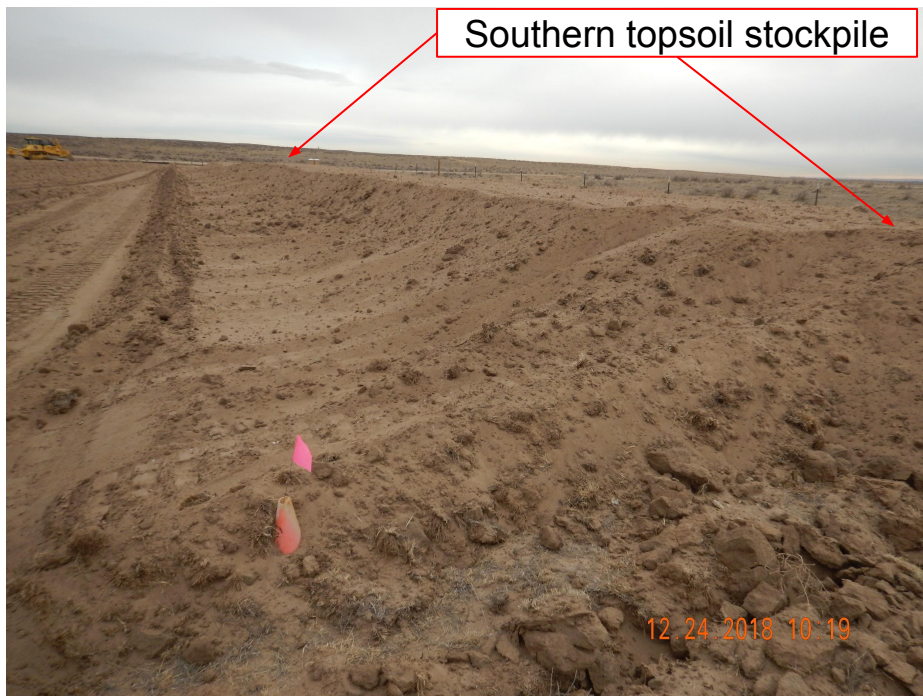
Photo 8. Photo taken from the southwestern perimeter of the location, facing East. See comments under Photo 5 and 6.

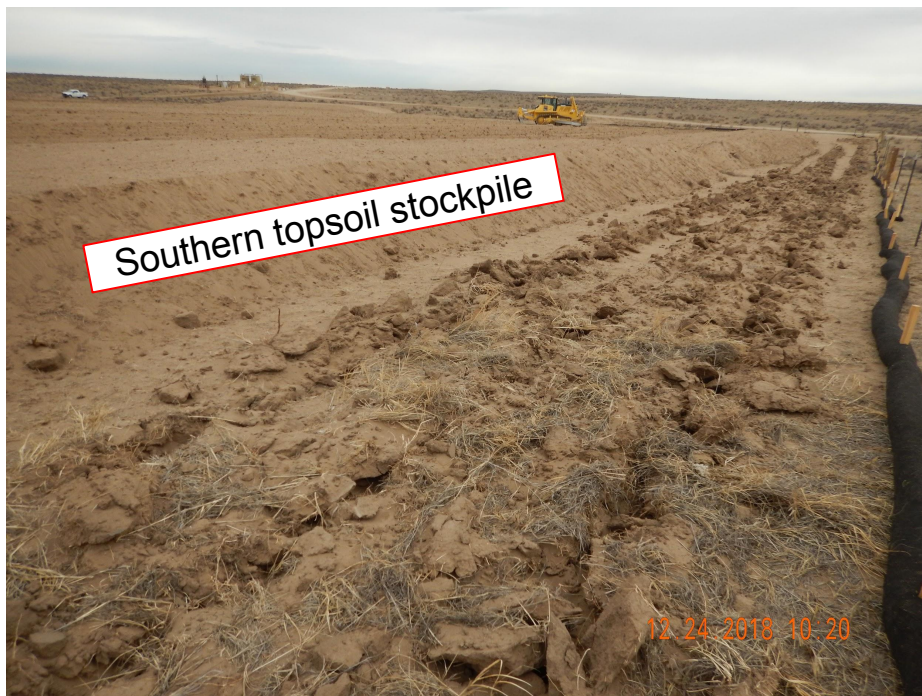
Photo 9. Photo taken from the southern perimeter of the location, facing East. See comments under Photo 3.

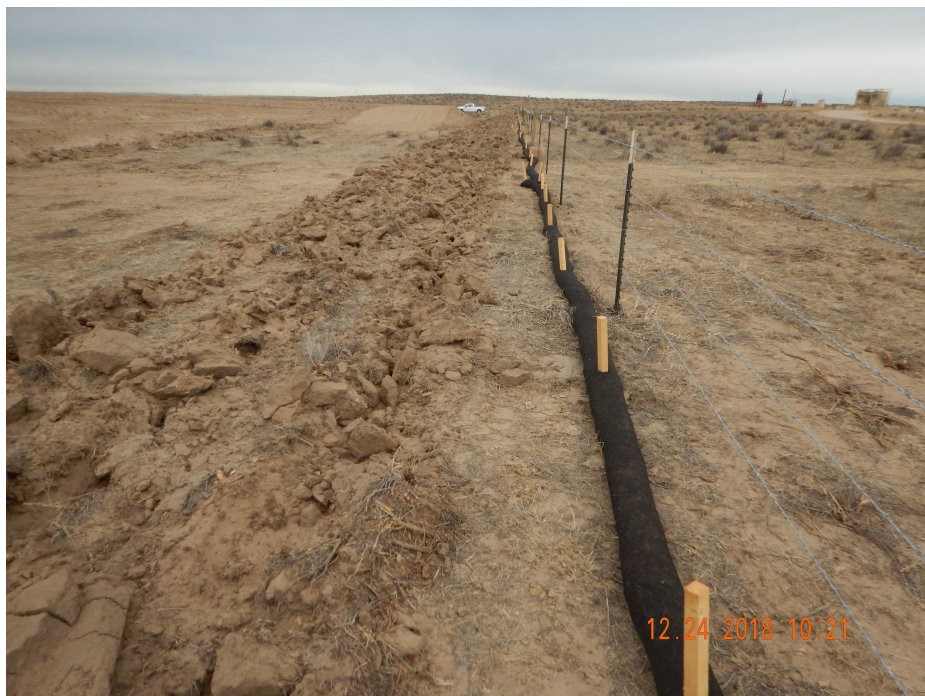
Photo 10. Photo taken from the southeastern perimeter of the location, facing North. See comments under Photo 3.

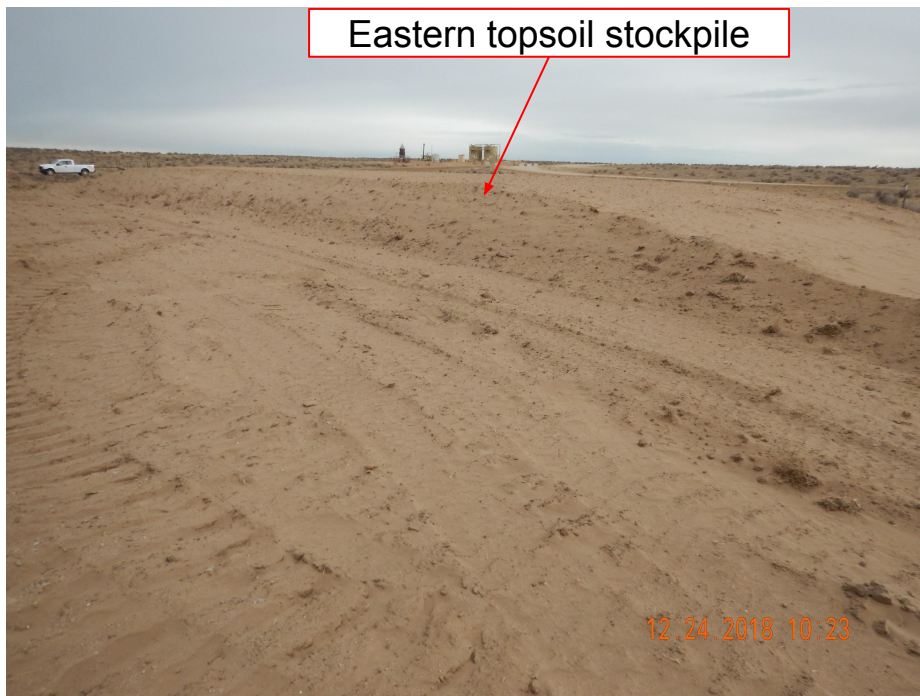
Photo 11. Photo taken from the eastern perimeter of the location, facing Northeast. Photo illustrates the eastern topsoil stockpile.

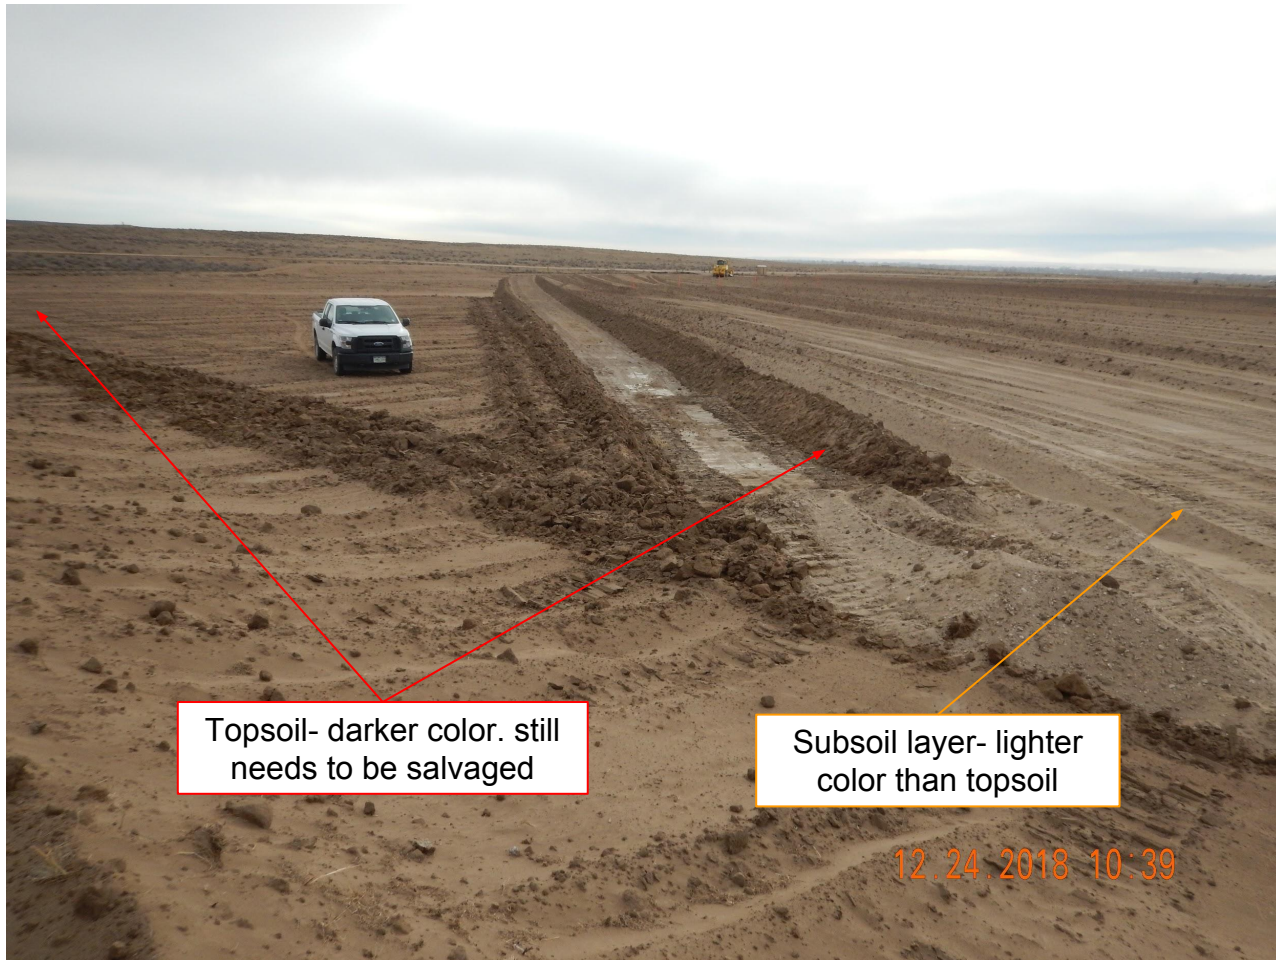
Photo 12. Photo taken from the northwestern topsoil stockpile, facing Southeast. Photo further demonstrates topsoil that still needs to be salvaged and the subsoil layer.

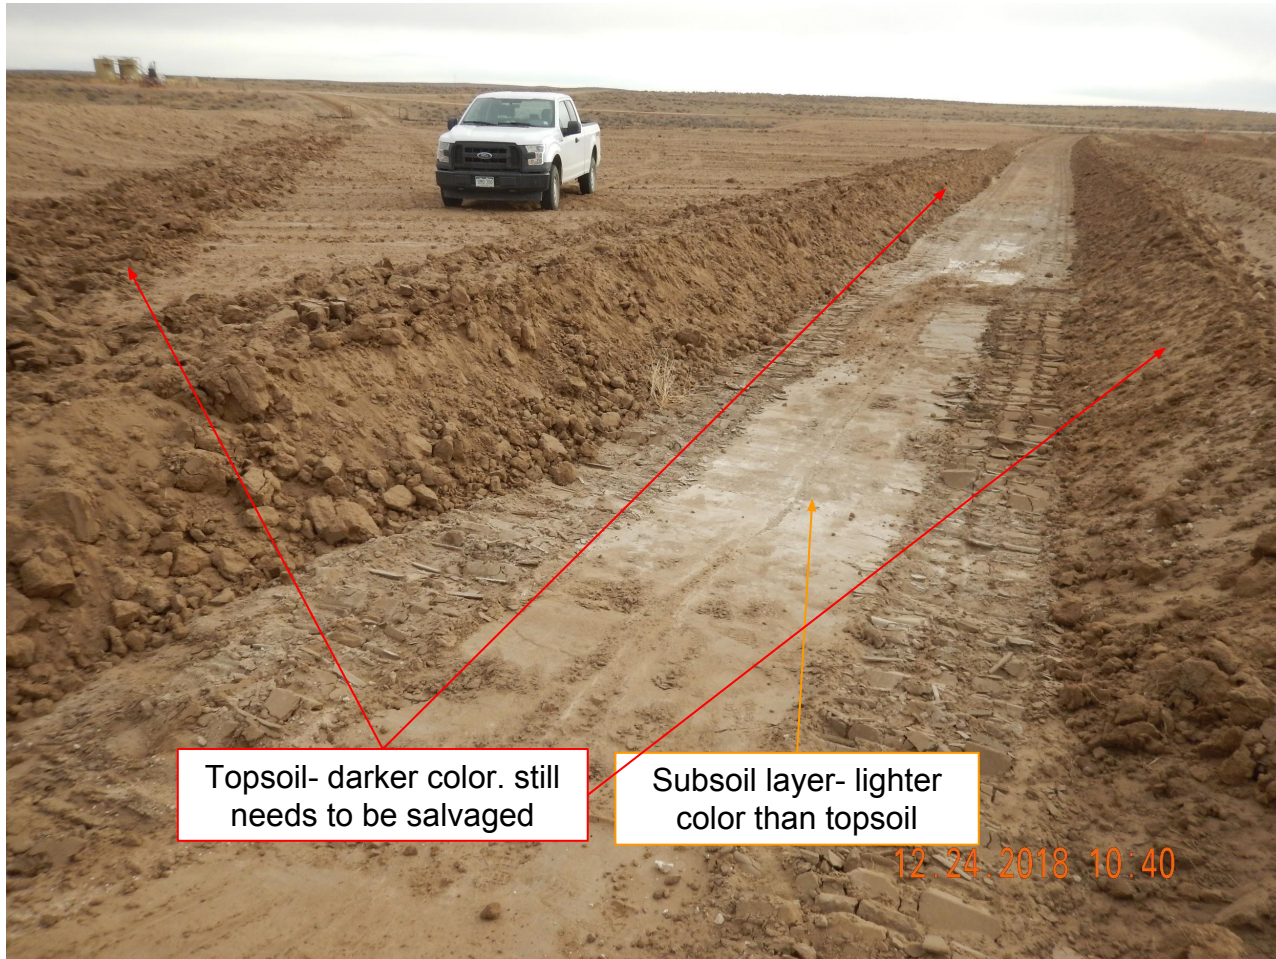
Photo 13. Photo taken from the northwestern well pad area, facing East. Photo further demonstrates topsoil that still needs to be salvaged and the subsoil layer.

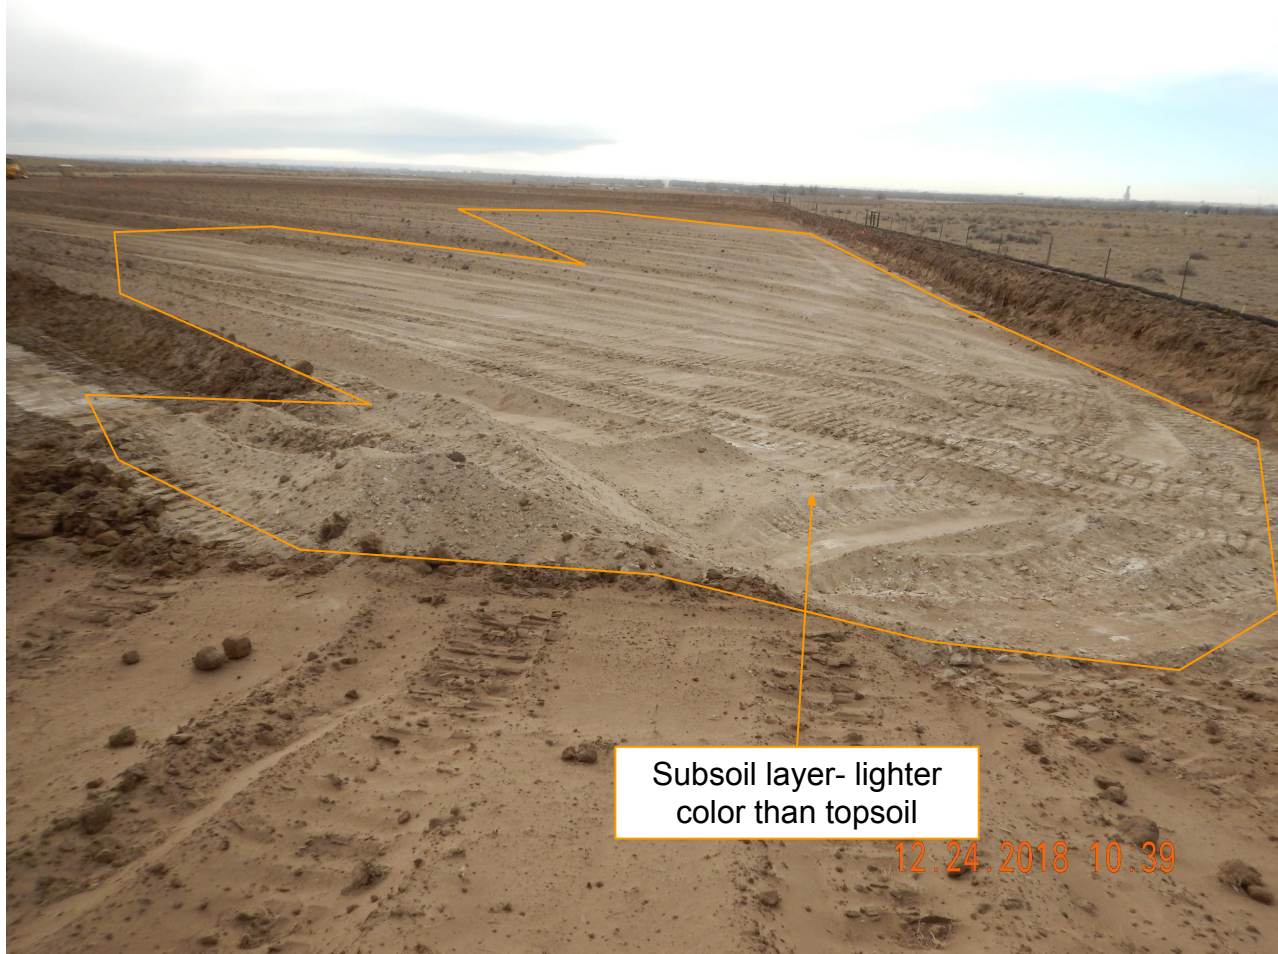
Photo 14. Photo taken from the northwestern well pad area, facing South. Photo further demonstrates the subsoil layer which is differentiated from the darker topsoil layer. An approximate area is shown above where the Operator has salvaged off topsoil.

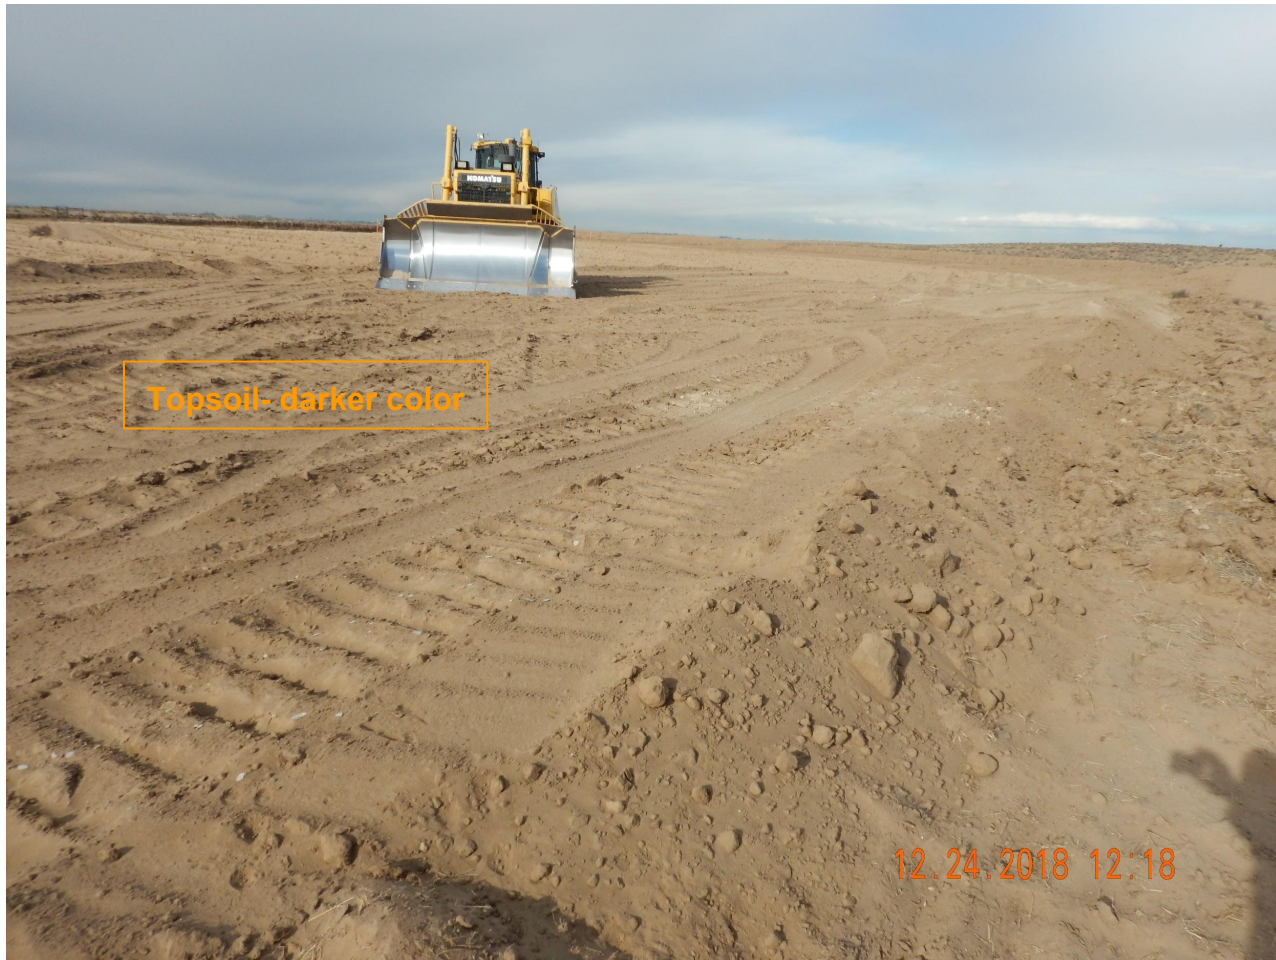
Photo 15. Photo taken from the southeastern well pad area, facing North. Appears topsoil is being used as fill material.
