Inspection Photos
Location Name: Parker #2
Location ID: 333125

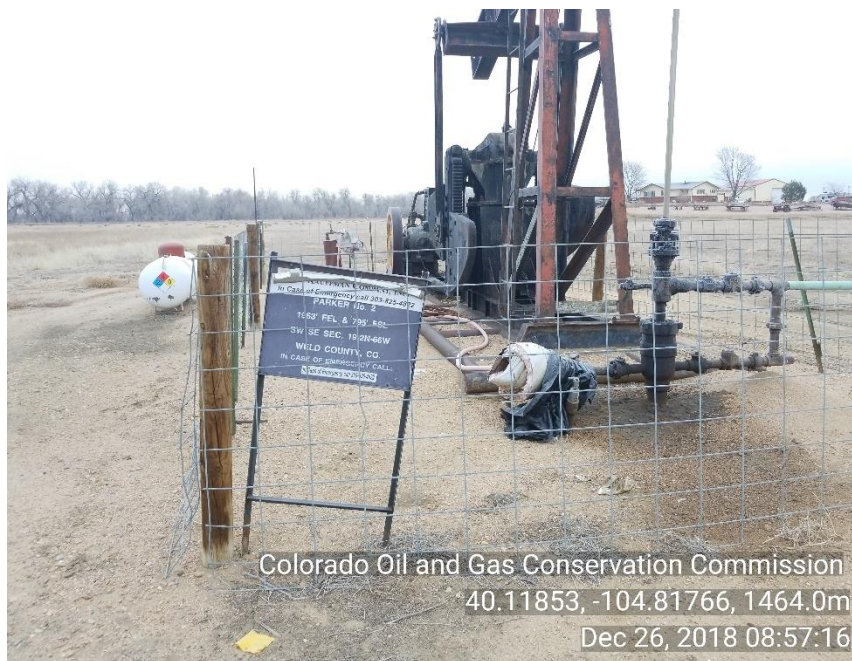
Photo 1 WH

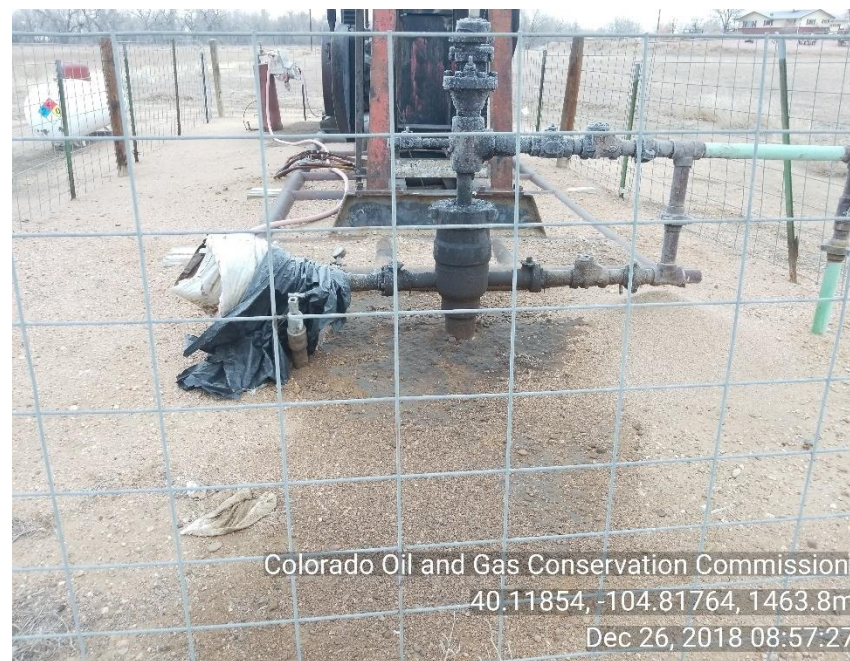
Photo 2 Stained soil WH

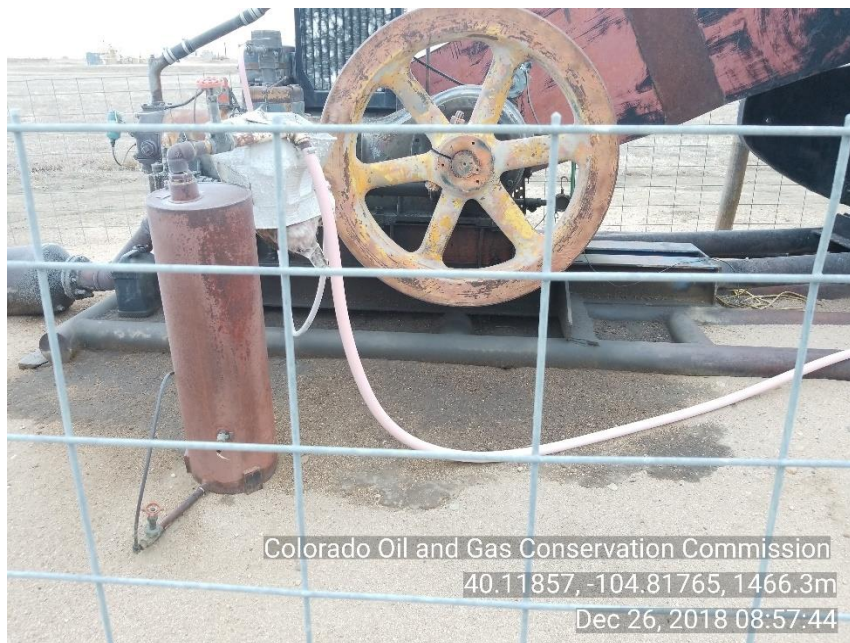
Photo 3 Stained soil PU motor

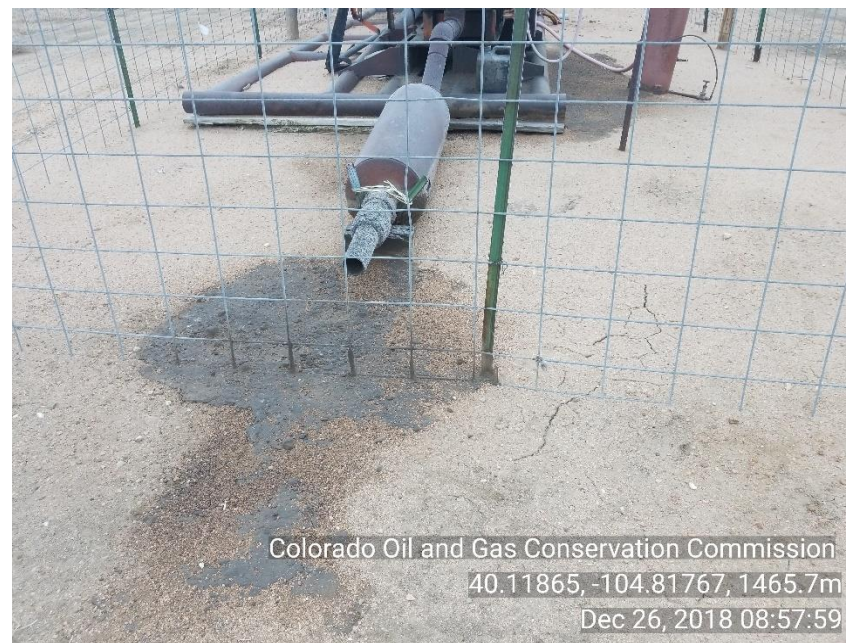
Photo 4 Stained soil PU exhaust

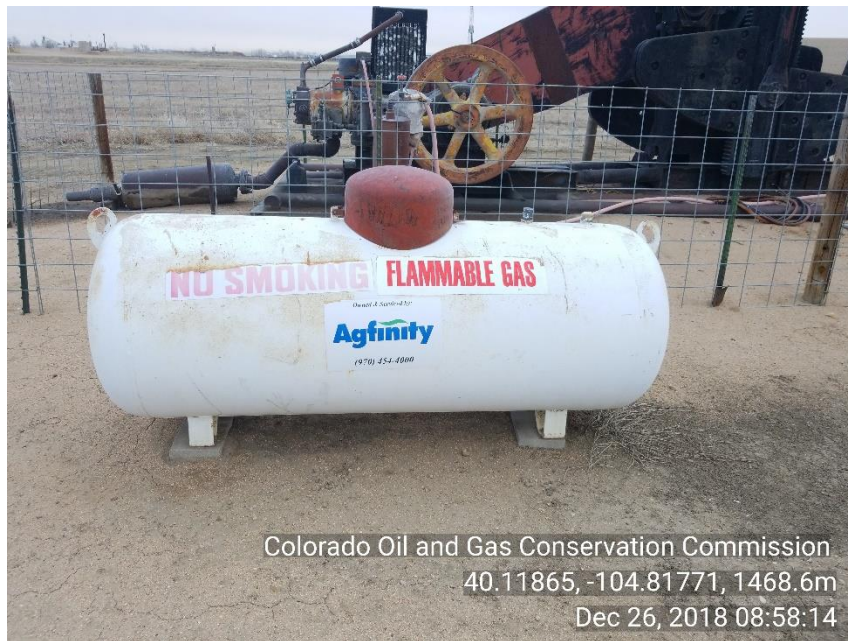
Photo 5 Propane tank Unused equipment
