**Inspection Photos**  
**Location Name: Parker #1**  
**Location ID: 336465**

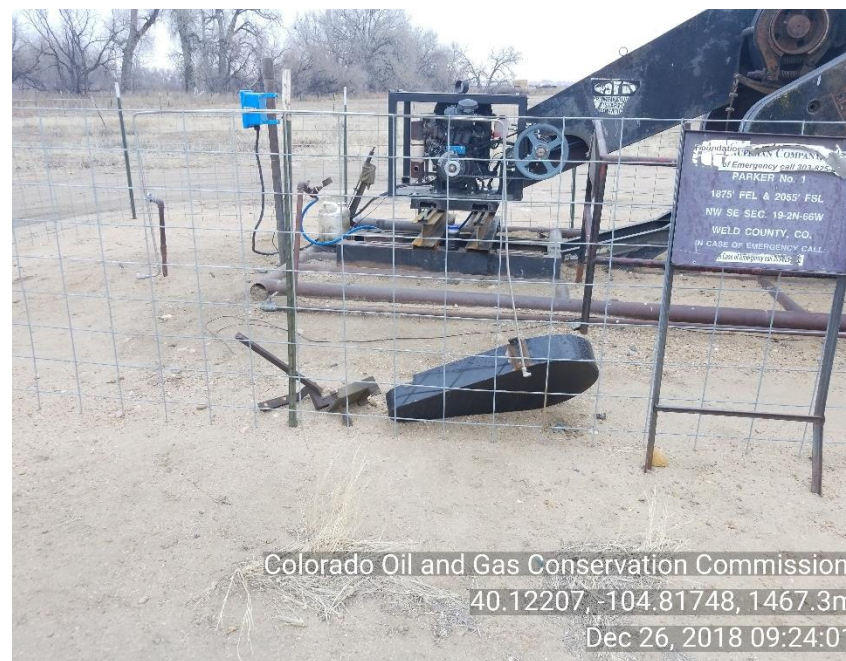
**Photo 2 Unused equipment**

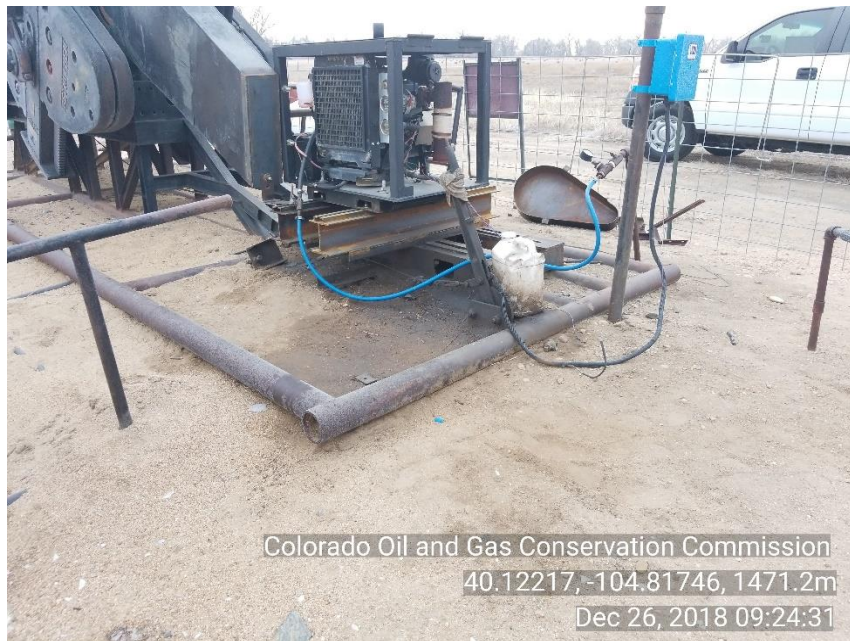
**Photo 3 Stained soil PU motor**

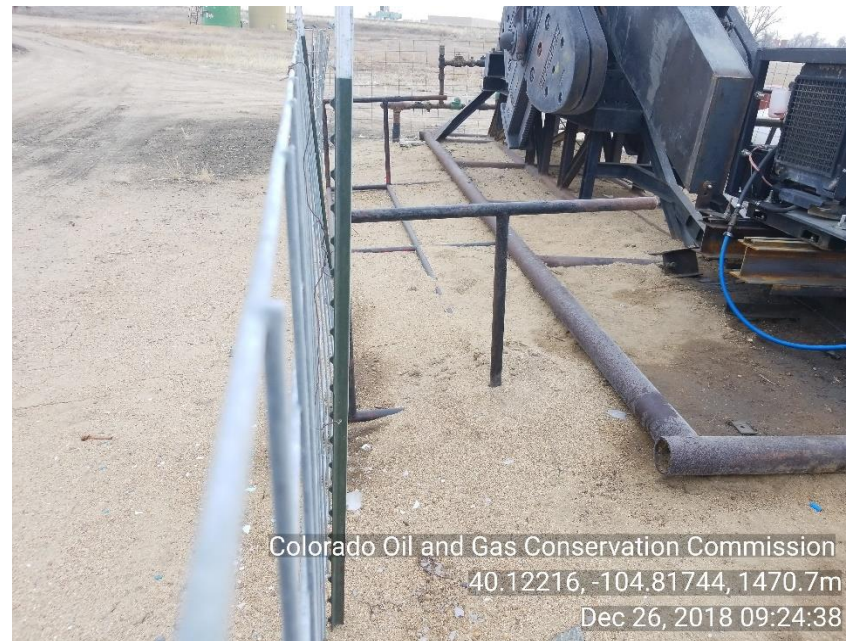
**Photo 4 Unused equipment (Fence)**

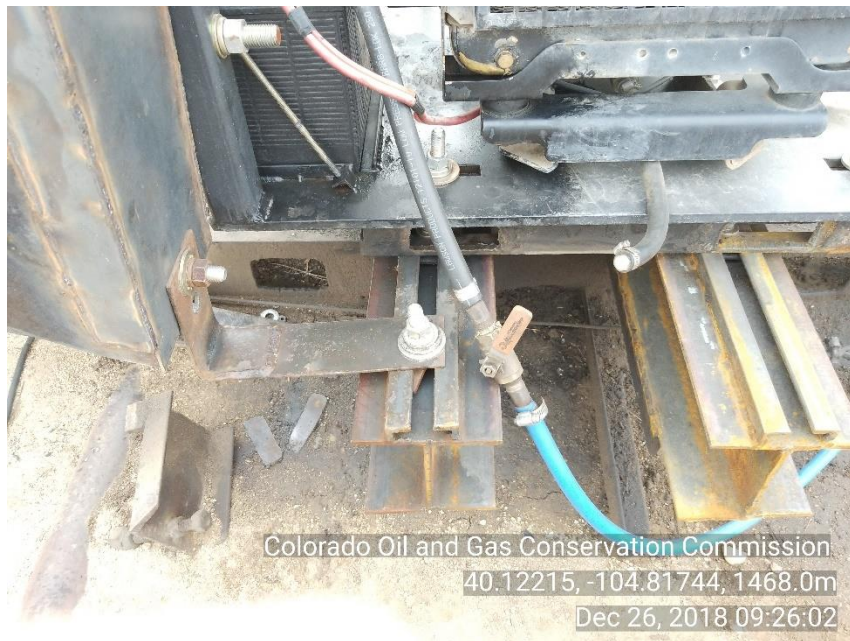
**Photo 5 fuel gas leak on VLV**

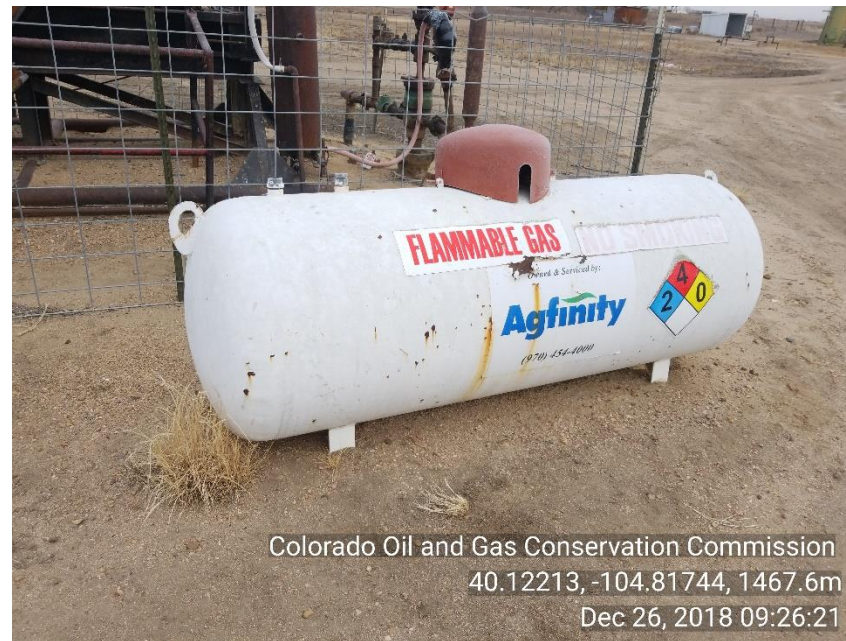
**Photo 6 Unused equipment Propane tank**

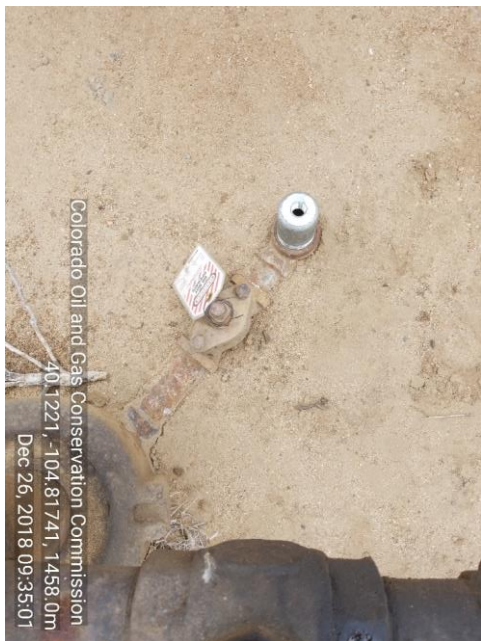
**Photo 7 Pull plug does not have plug**

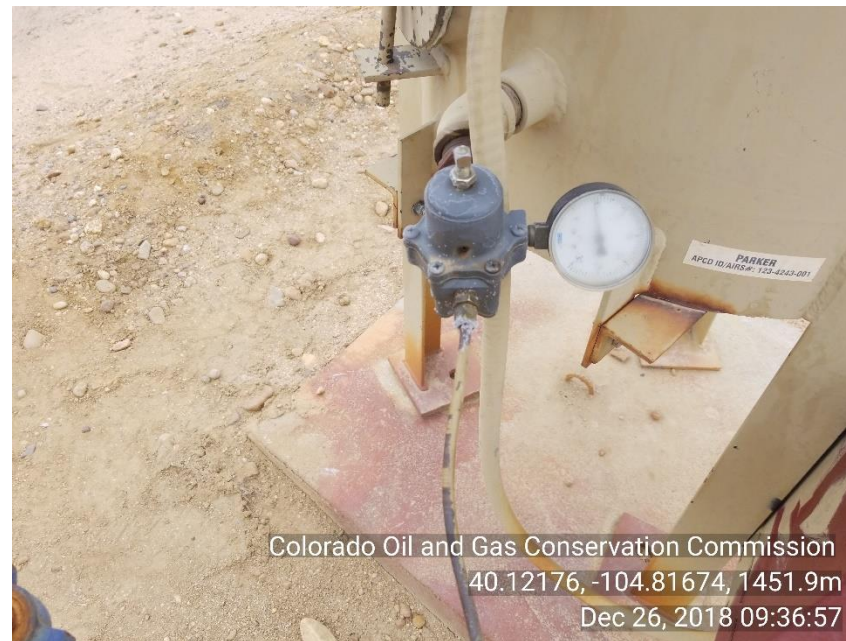
**Photo 8 Leaking fuel gas line to ECD**

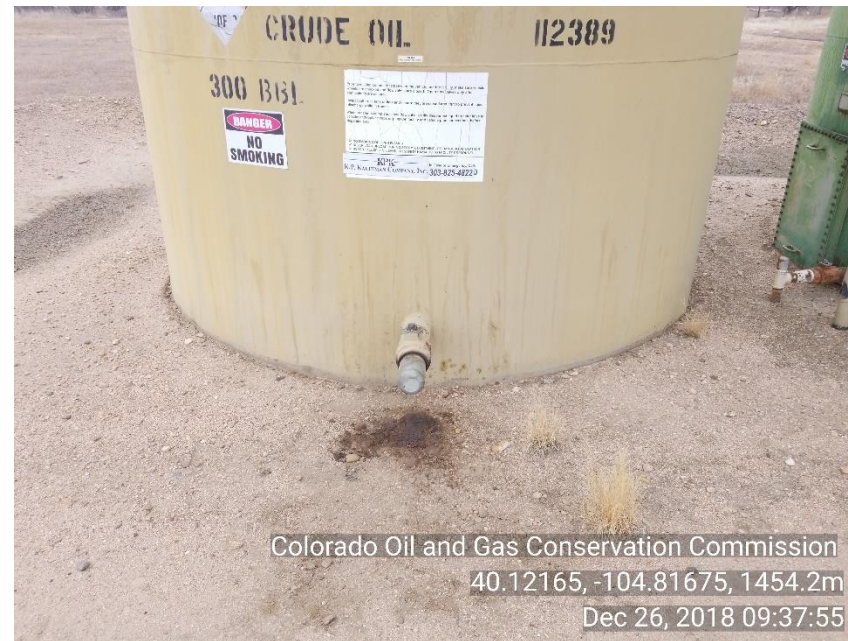
Photo 10 Stained soil crude oil tank
