Inspection Photos
Location Name: Millard #43-30
Location ID: 333199

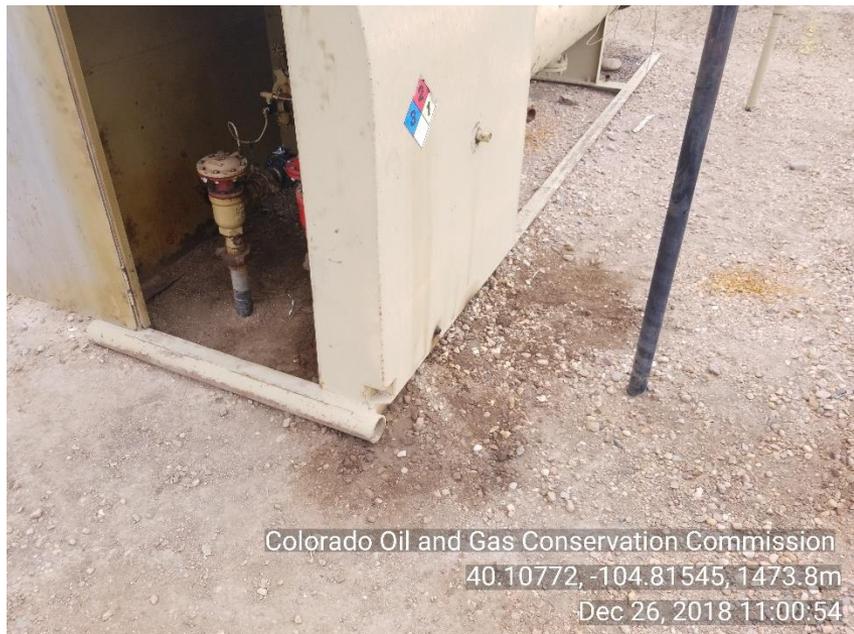
Photo 3 Stained soil outside SEP

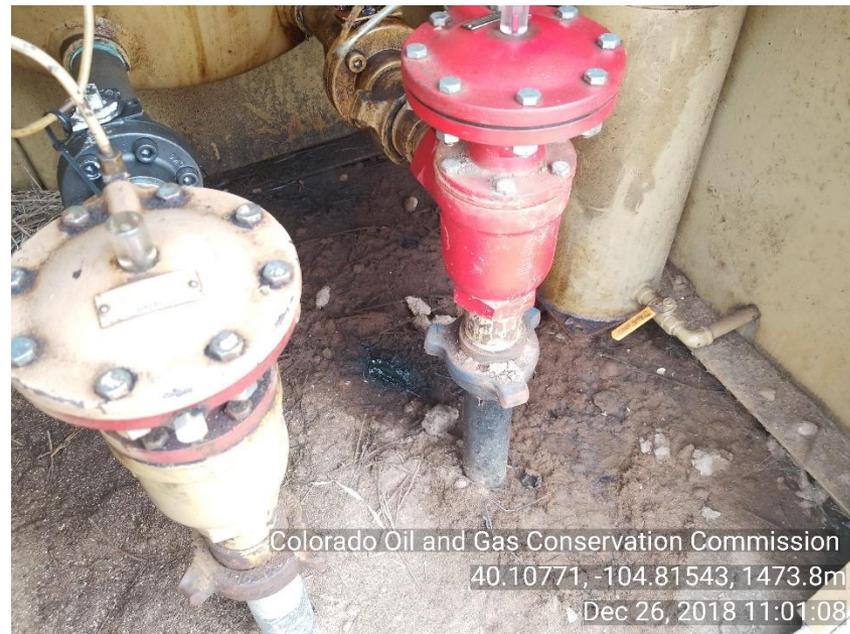
Photo 4 Stained soil inside SEP

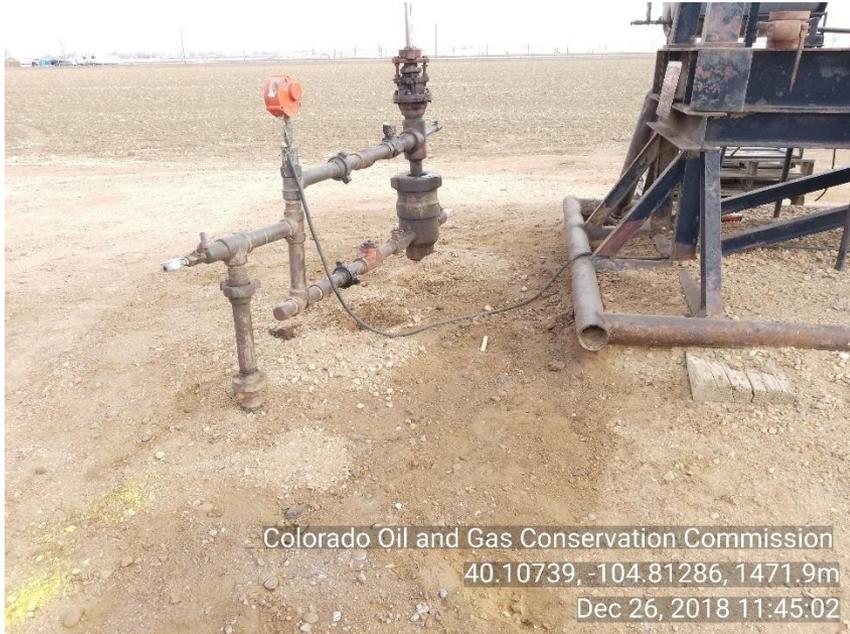
Photo 5 Stained soil at WH
