Inspection Photos

Location Name: Homer Deep Unit 7-23

Location ID: #436835 Spill/Release ID: #460341

Inspection Date: December 27, 2018

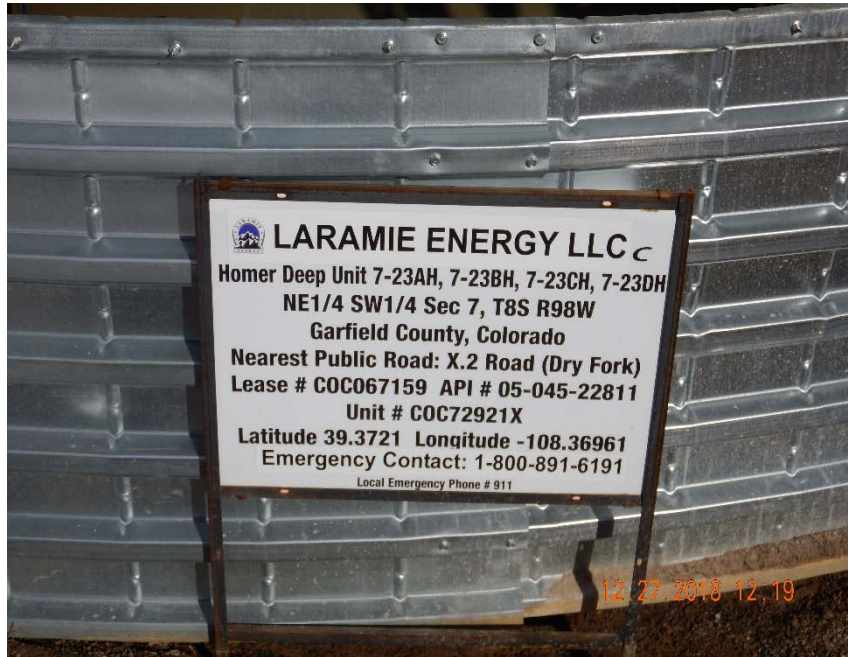
Photo #1 – Sign located at tank battery.

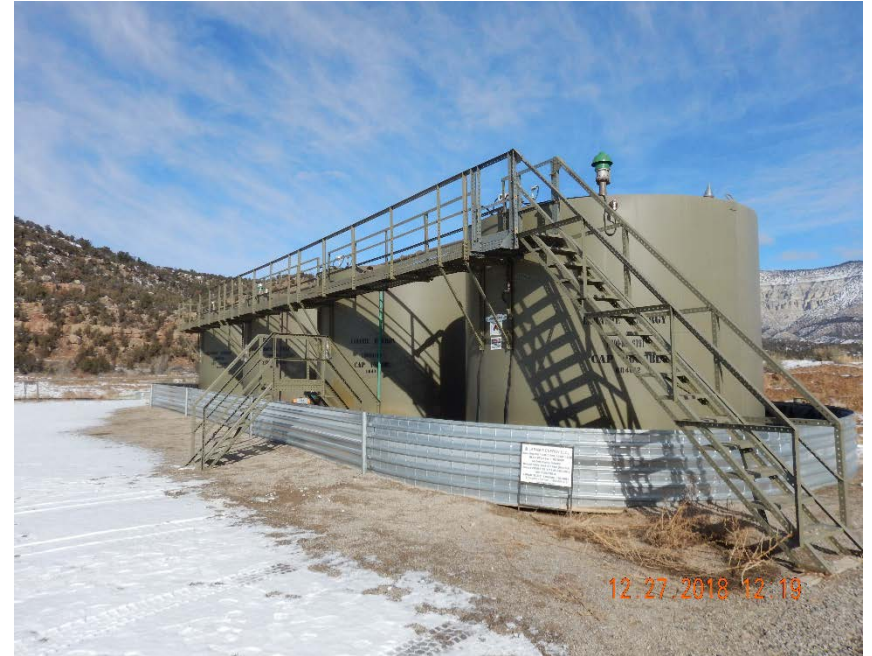
Photo #2 – View of tank battery/spill location from southwest.

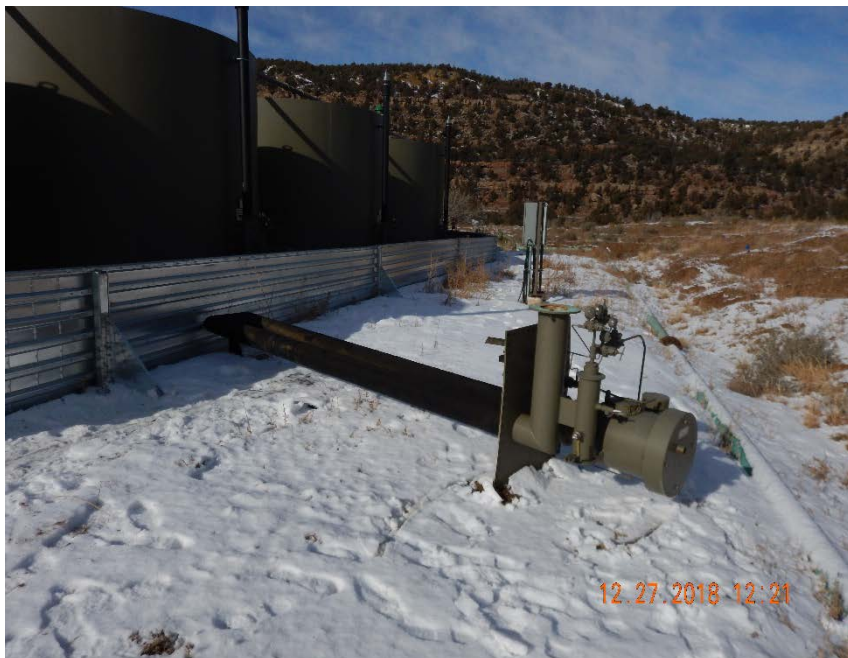
Photo #3 – View of tank heater, surface flowline, and ditch east of tank battery.

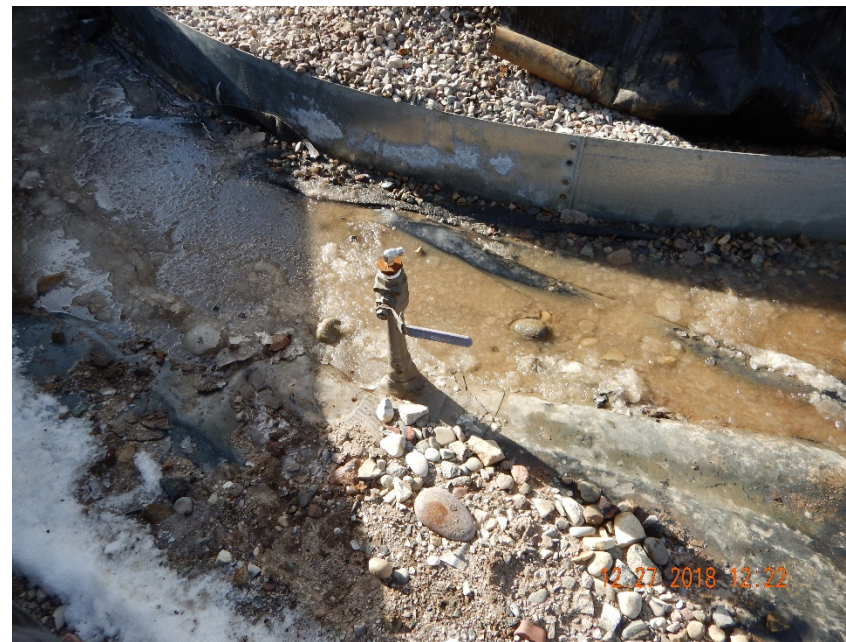
Photo #4 – 1" flowline riser protruding through liner at south end of tank battery.

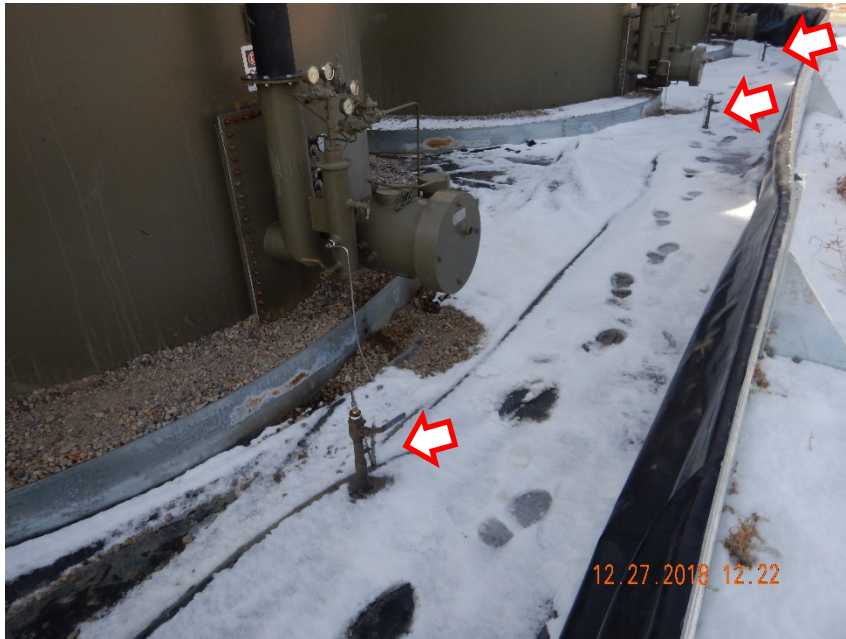
Photo #5 – Additional 1" flowline risers protruding through liner along east side of tank battery.

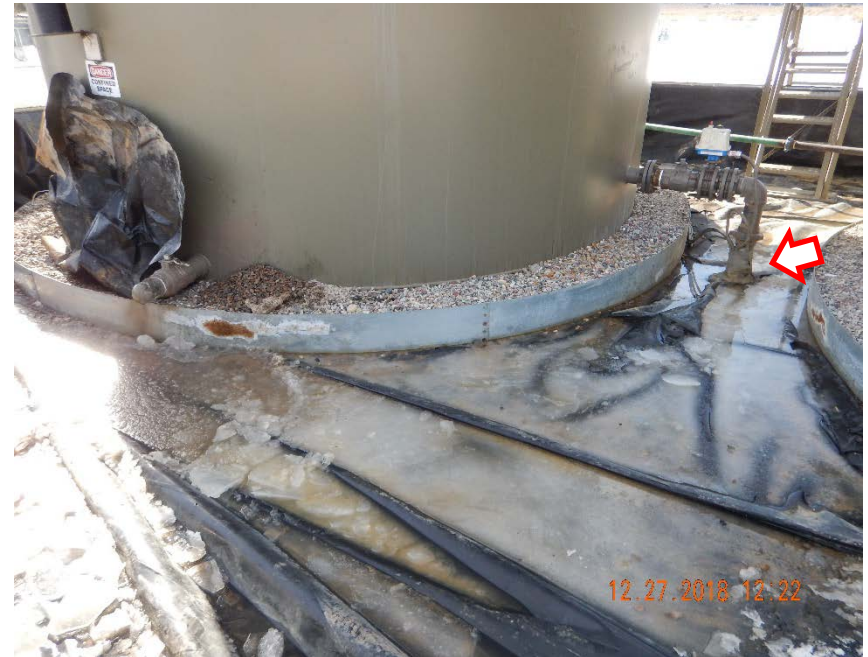
Photo #6 – Flowline riser and electrical conduit protruding through liner north of produced water AST. Note: other ASTs in tank battery had the same flowline configuration.

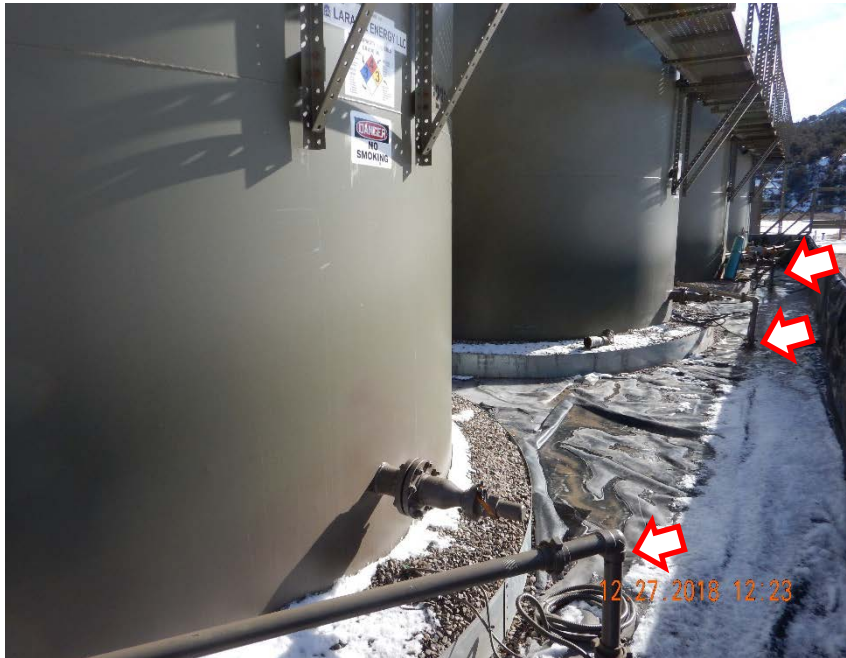
Photo #7 – 2" Flowline risers protruding through liner on west side of tank battery.

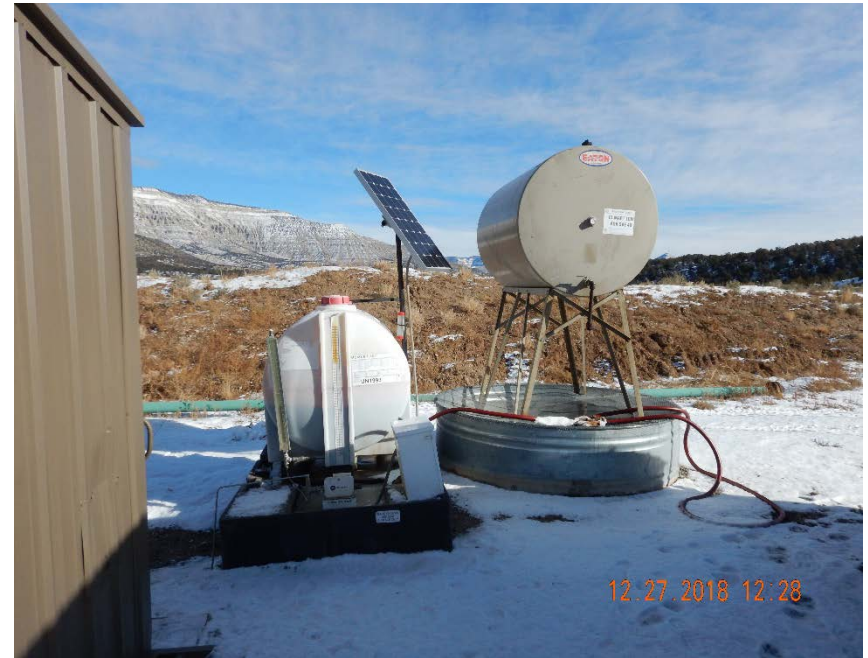
Photo #8 – Chemical storage tanks with secondary containment devices located south of tank battery.

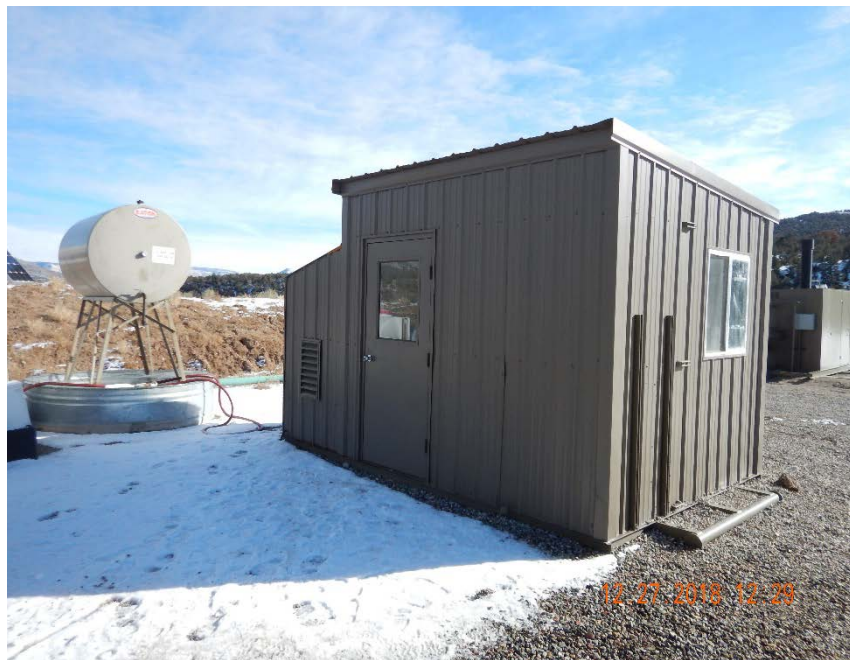
Photo #9 – Shed located south of tank battery.

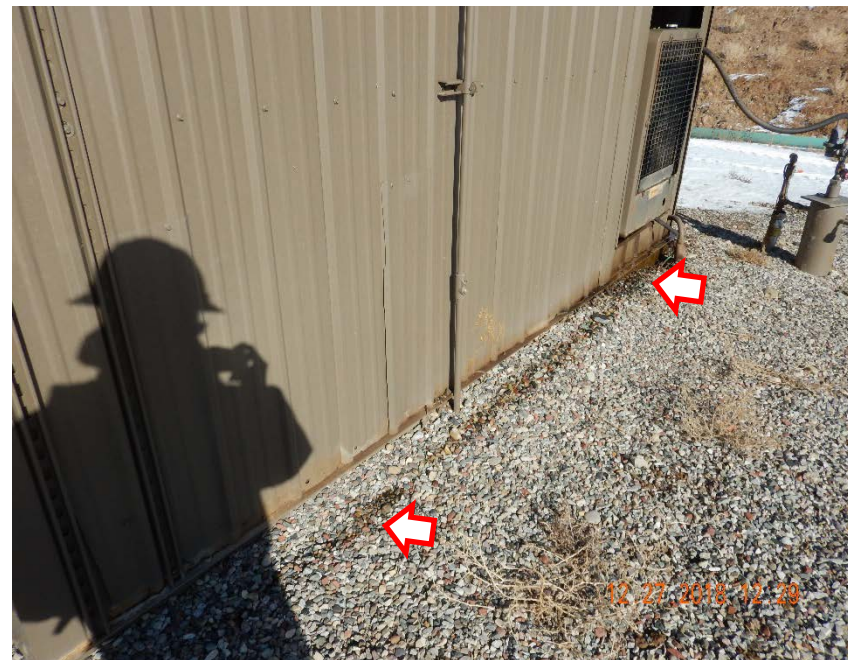
Photo #10 – Oil-stained gravel on southeast side of shed.

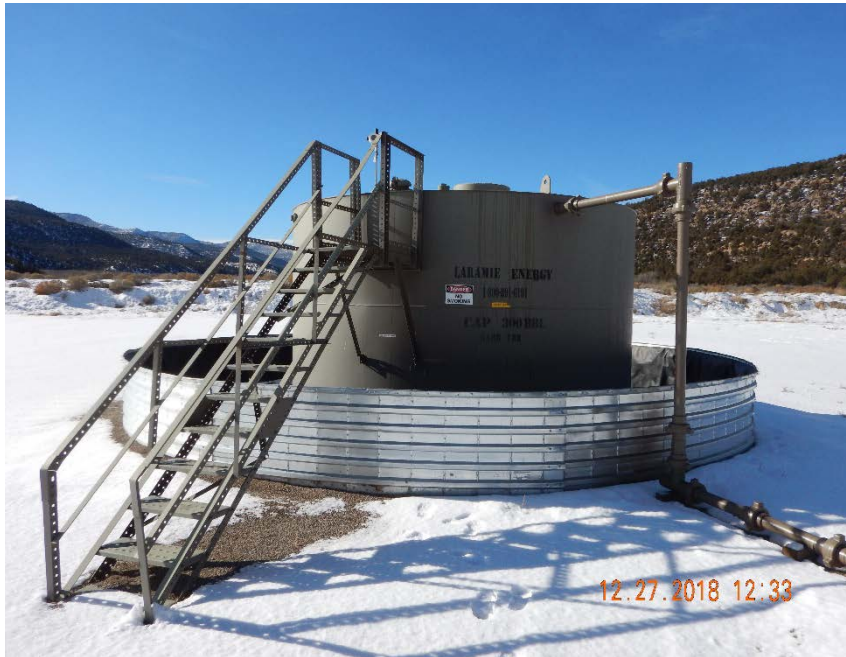
Photo #11 – 300 bbl sand tank inside of metal SPCC, located west of wellheads.

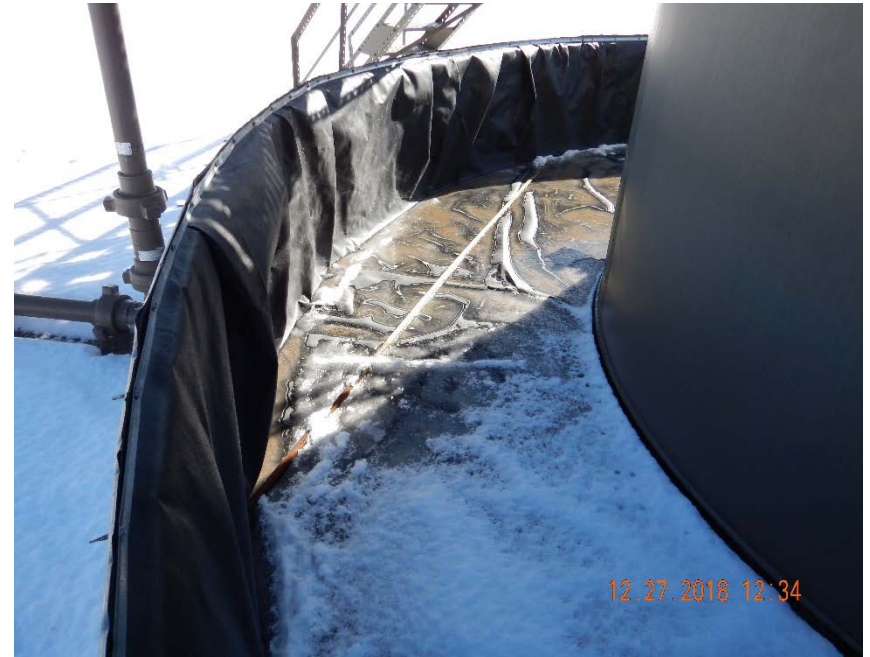
Photo #12 – Metal rod stored inside of east side of sand tank SPCC.

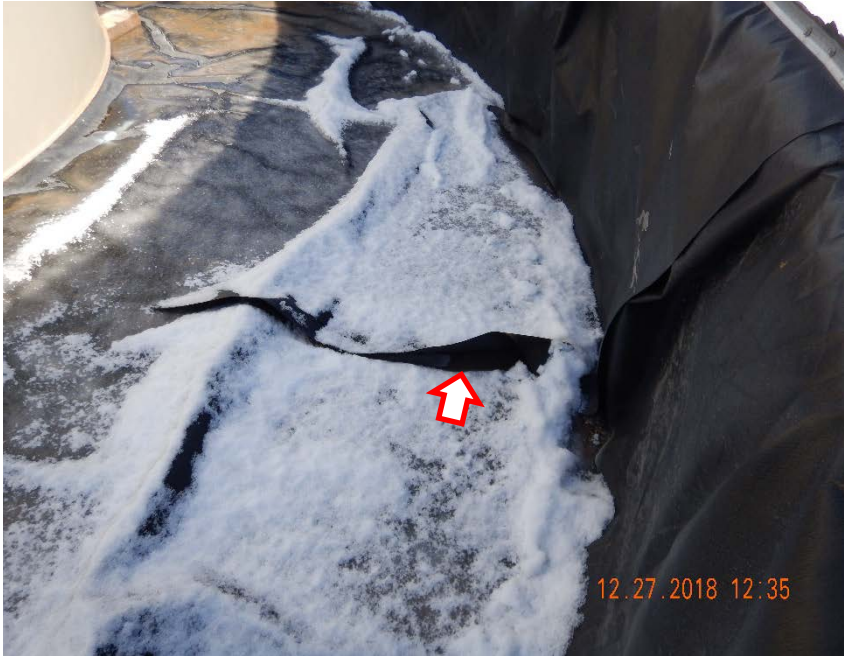
Photo #13 – Gap observed between liner panels inside southeast corner of sand tank SPCC.

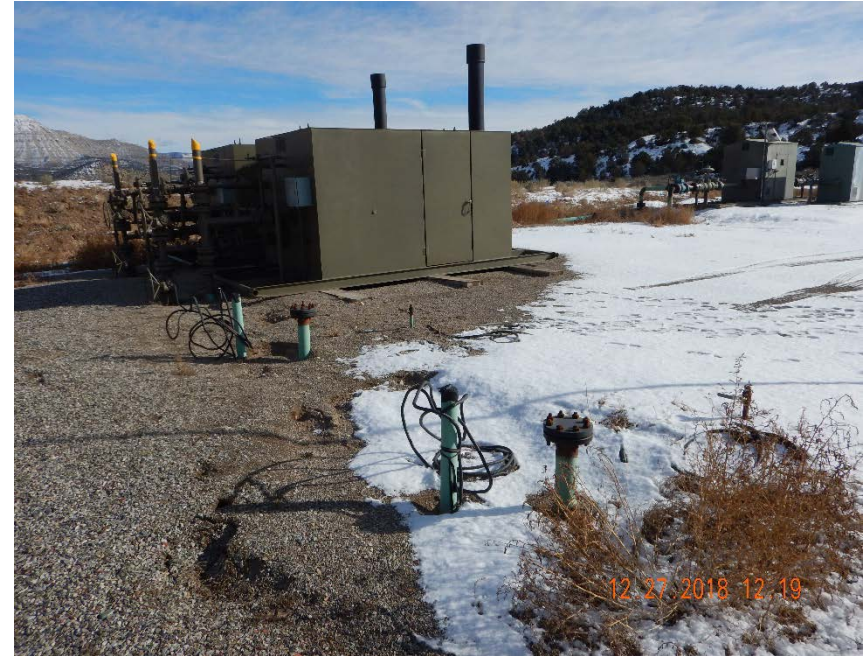
Photo #14 – Unused flowline risers observed west of separators.

See R. Murray's 12/27/2018 Integrity Inspection for corrective actions related to flowlines and flowline risers.

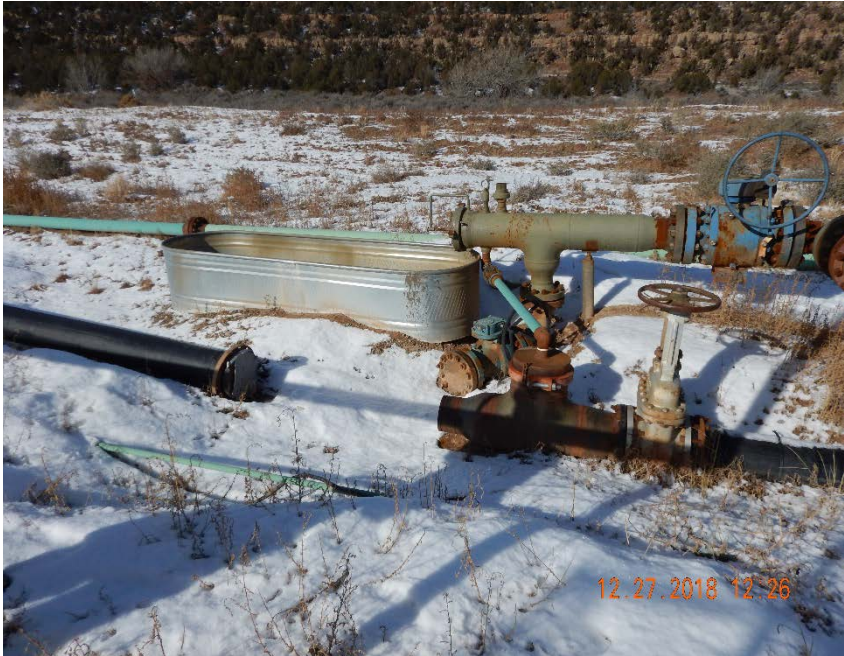
Photo #15 – Pig station and surface flowlines located north of crude oil/produced water tank battery.

See R. Murray's 12/27/2018 Integrity Inspection for corrective actions related to flowlines and flowline risers.

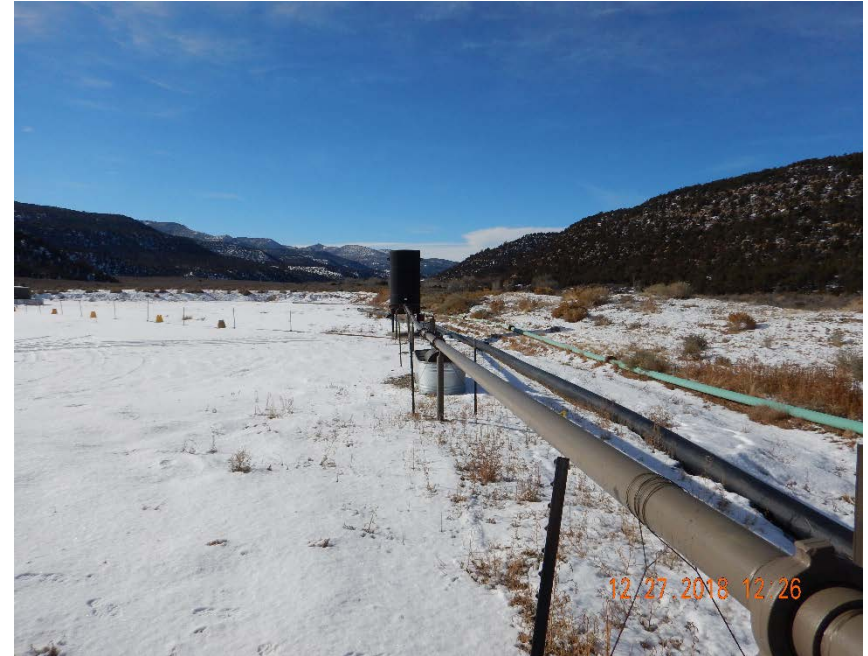
Photo #16 – ECD and surface flowlines located along north side of well pad.

See R. Murray's 12/27/2018 Integrity Inspection for corrective actions related to flowlines and flowline risers.
