**Inspection Photos**  
**Location Name: JW POWEL #23-35**  
**Location ID: 459837**

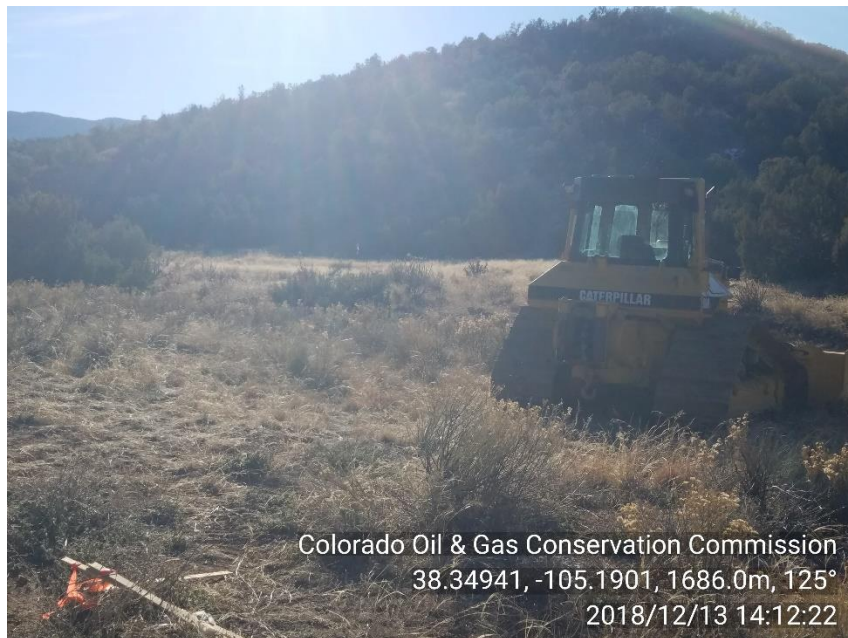
**PHOTO 2: ROW PRIOR TO CONSTRUCTION**

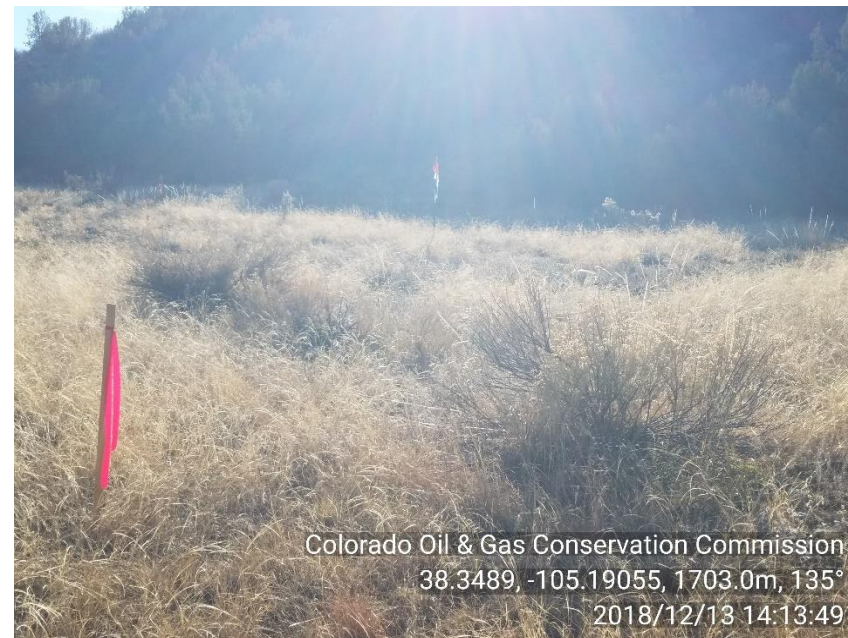
**PHOTO 3: LOCATION PRIOR TO CONSTRUCTION**

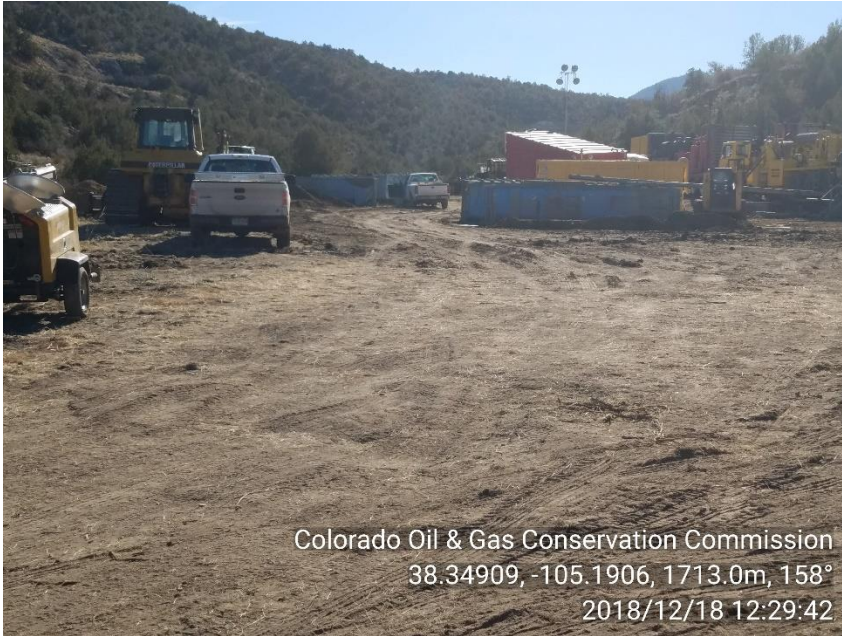
**PHOTO 5: NO BERMS ON LOWER SIDE OF LOCATION**

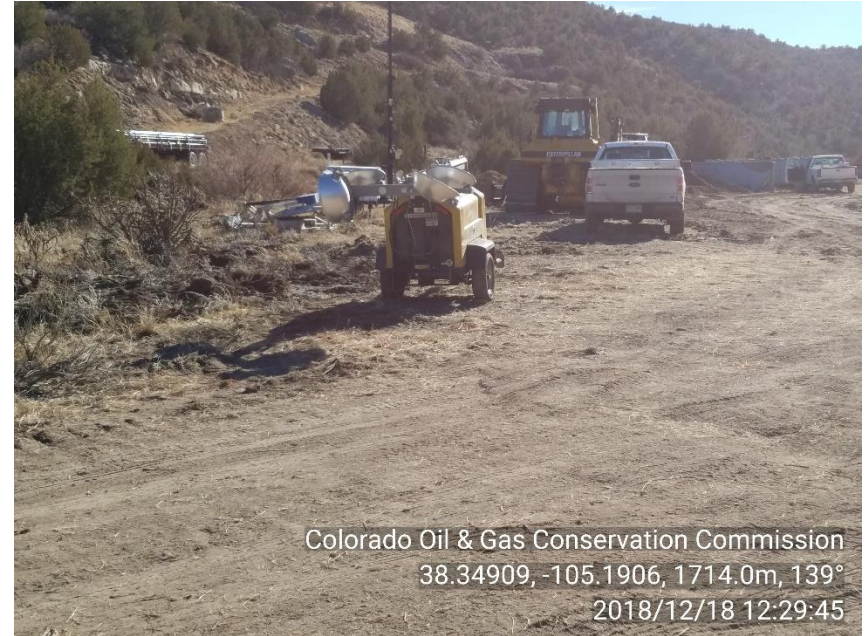
**PHOTO 6: NO BERMS ON LOWER SIDE OF LOCATION**

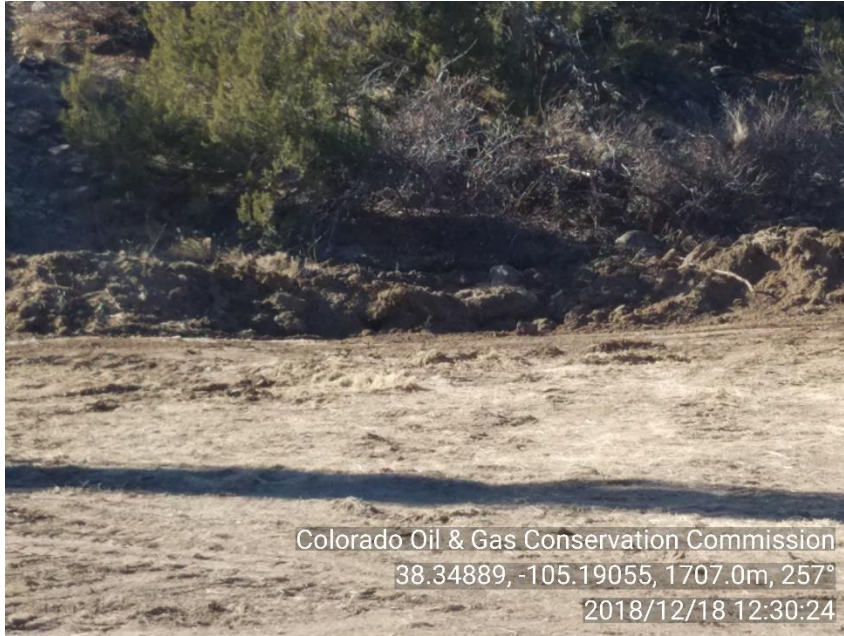
**PHOTO 7: DITCH FOR STORM WATER DRAINAGE OF UP HILL SIDE  
OF LOCATION DOES NOT RUN CONTINUOUS ACROSS LOCATION**
