Inspection Photos

Operator: BP America

API: 05-067-08794

Date: 12/19/2018

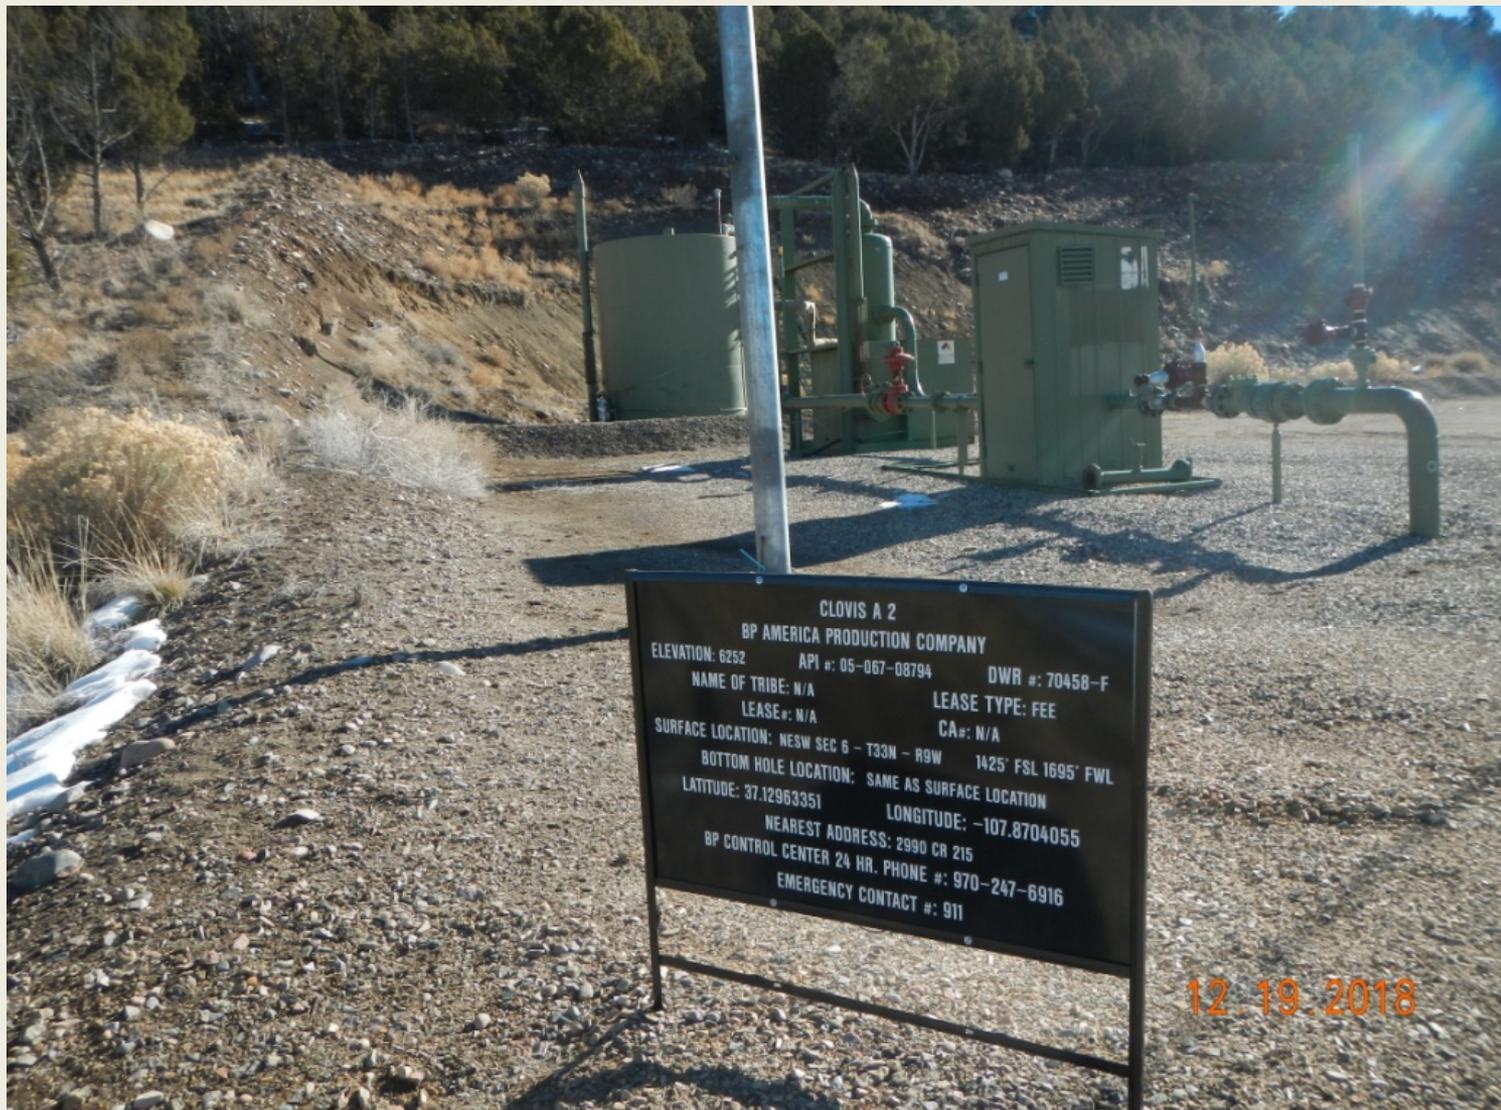
Photo 1. View of the northeastern project area from the well pad entrance facing eastward.

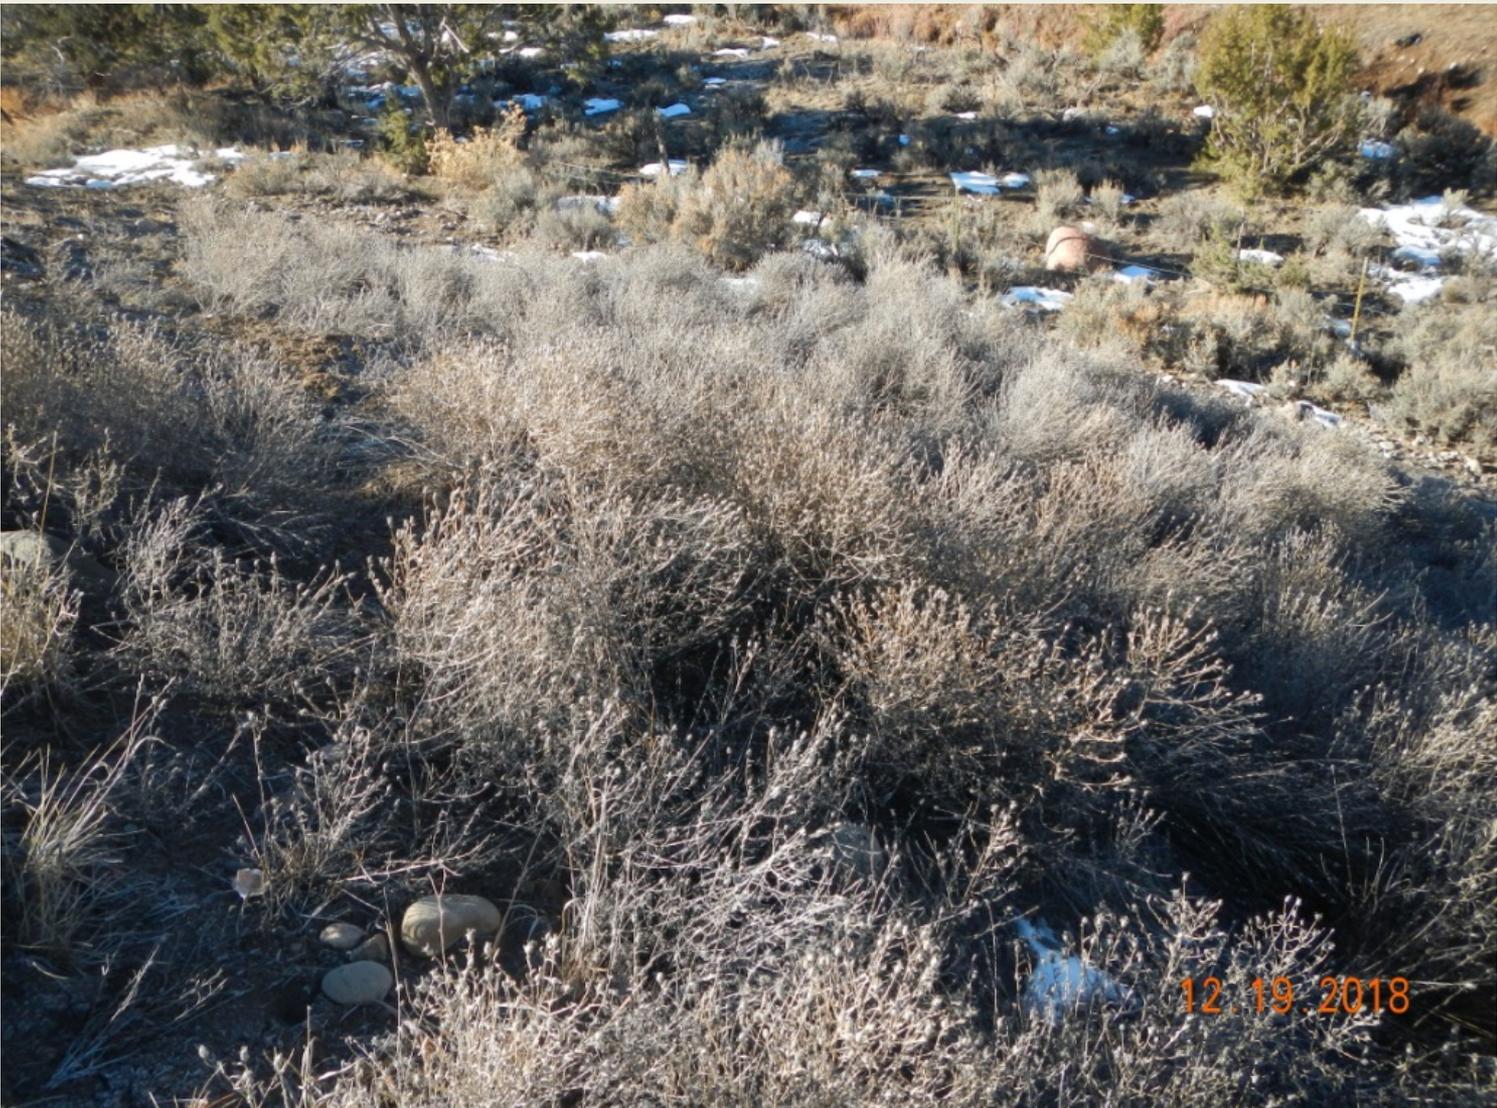
Photo 2. View of Russian knapweeds (*Rhaponticum repens*) within the northwestern portion of the project area. Thousands of individuals observed here and in other portions of the project area.

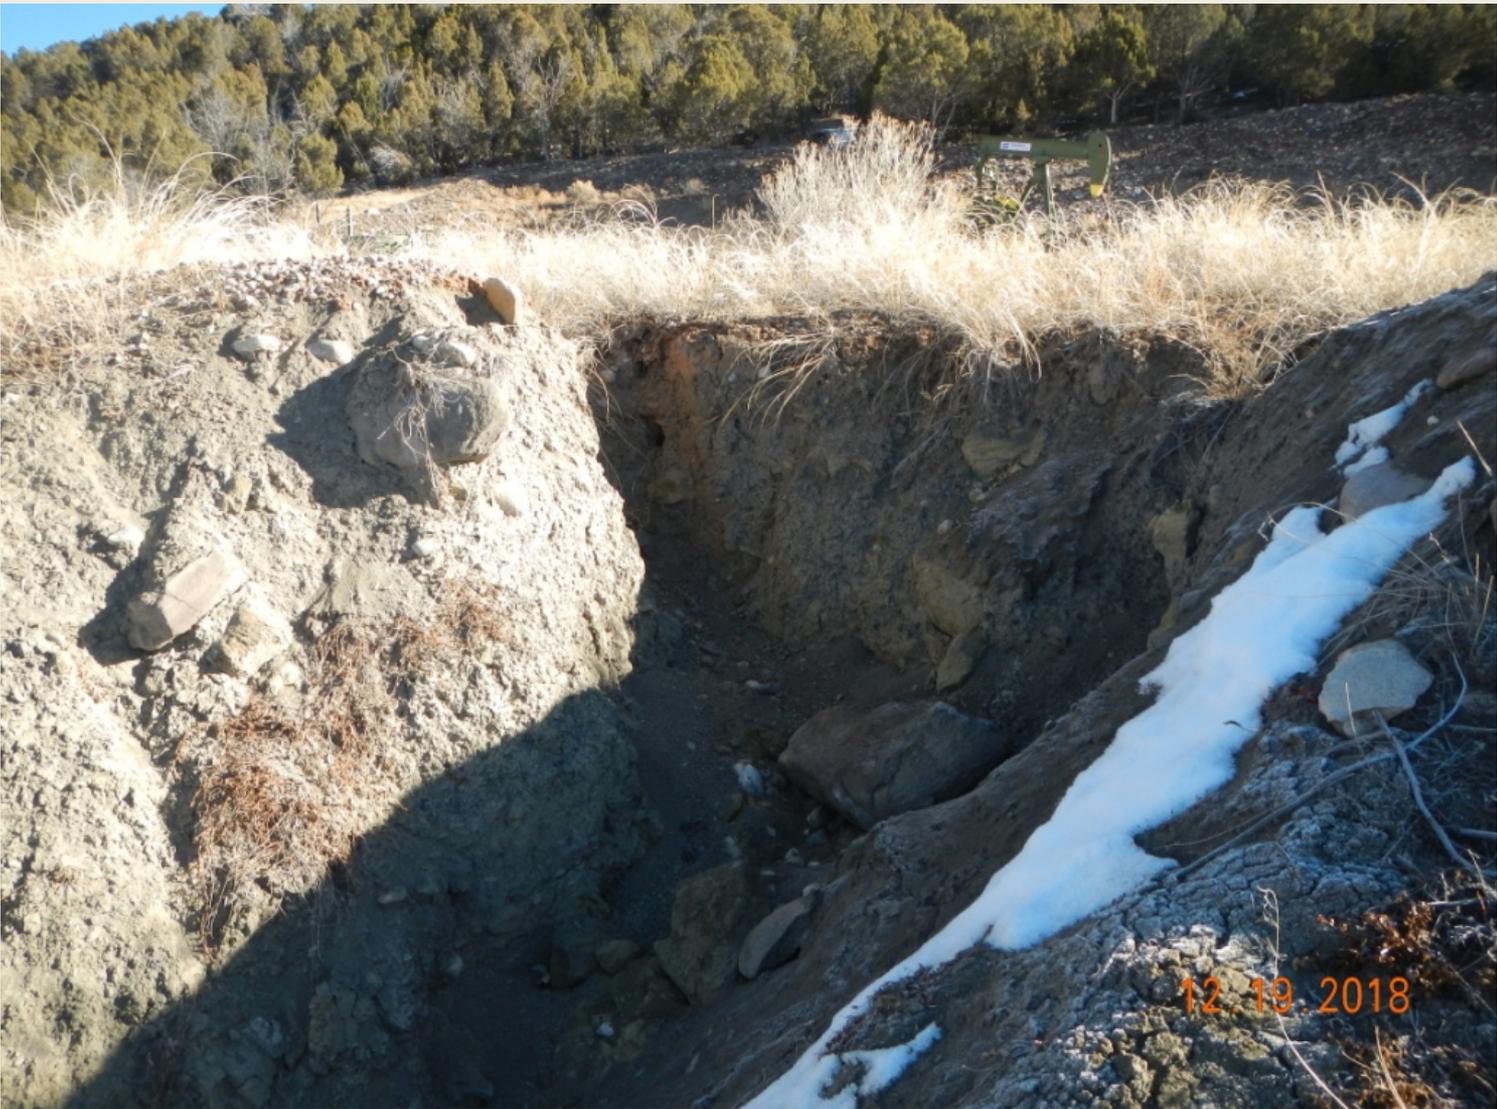
Photo 3. View of an erosional channel approximately 6 feet wide and deep within the western fill slope.

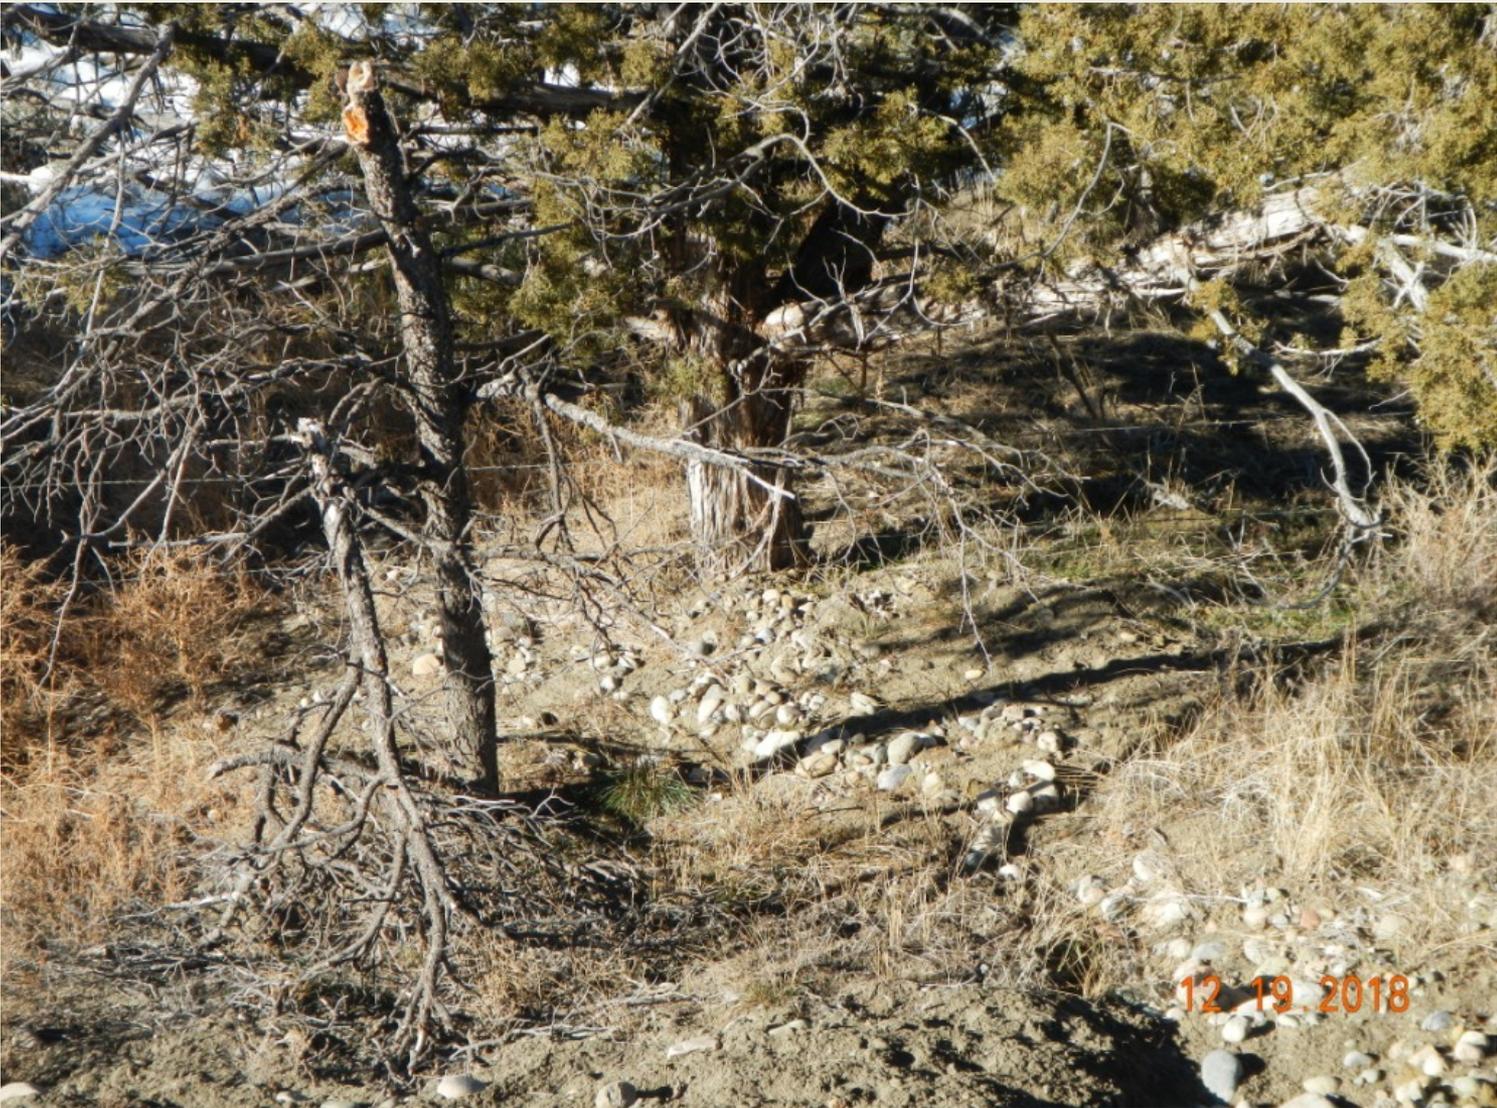
Photo 4. View of sediment deposition downstream from the erosional channel, flowing out of the project area, into an irrigation ditch along the western edge of the project area.

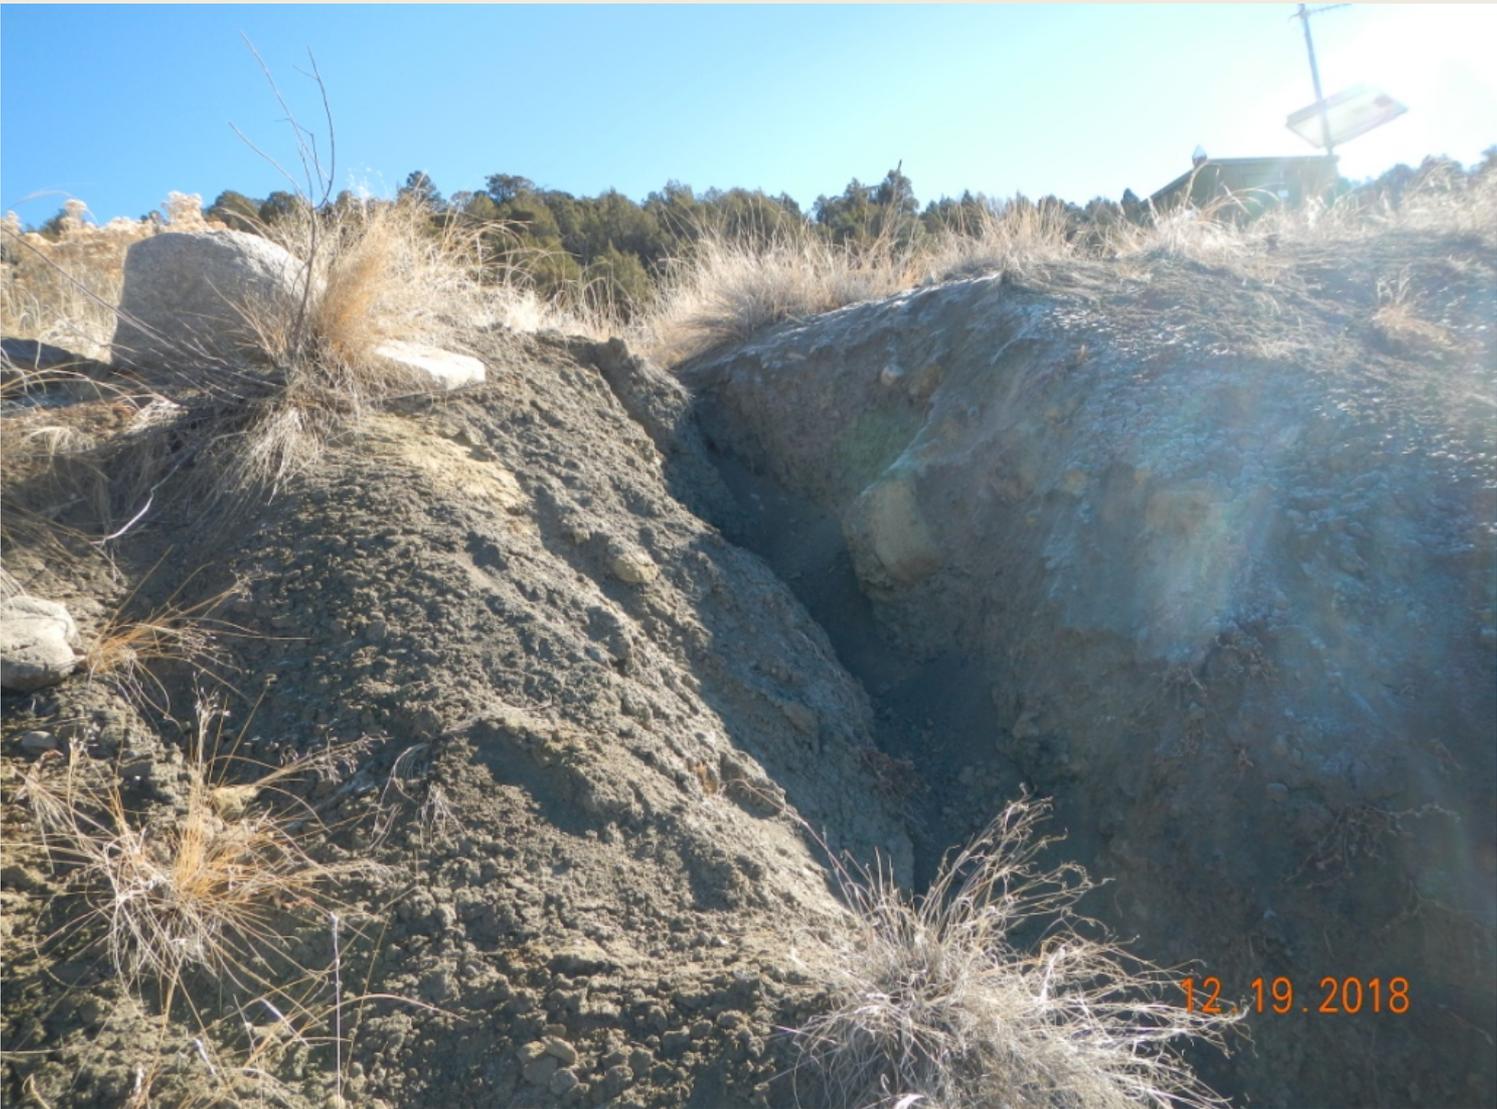
Photo 5. View of another erosional channel within the western fill slope approximately 4 feet wide and deep.

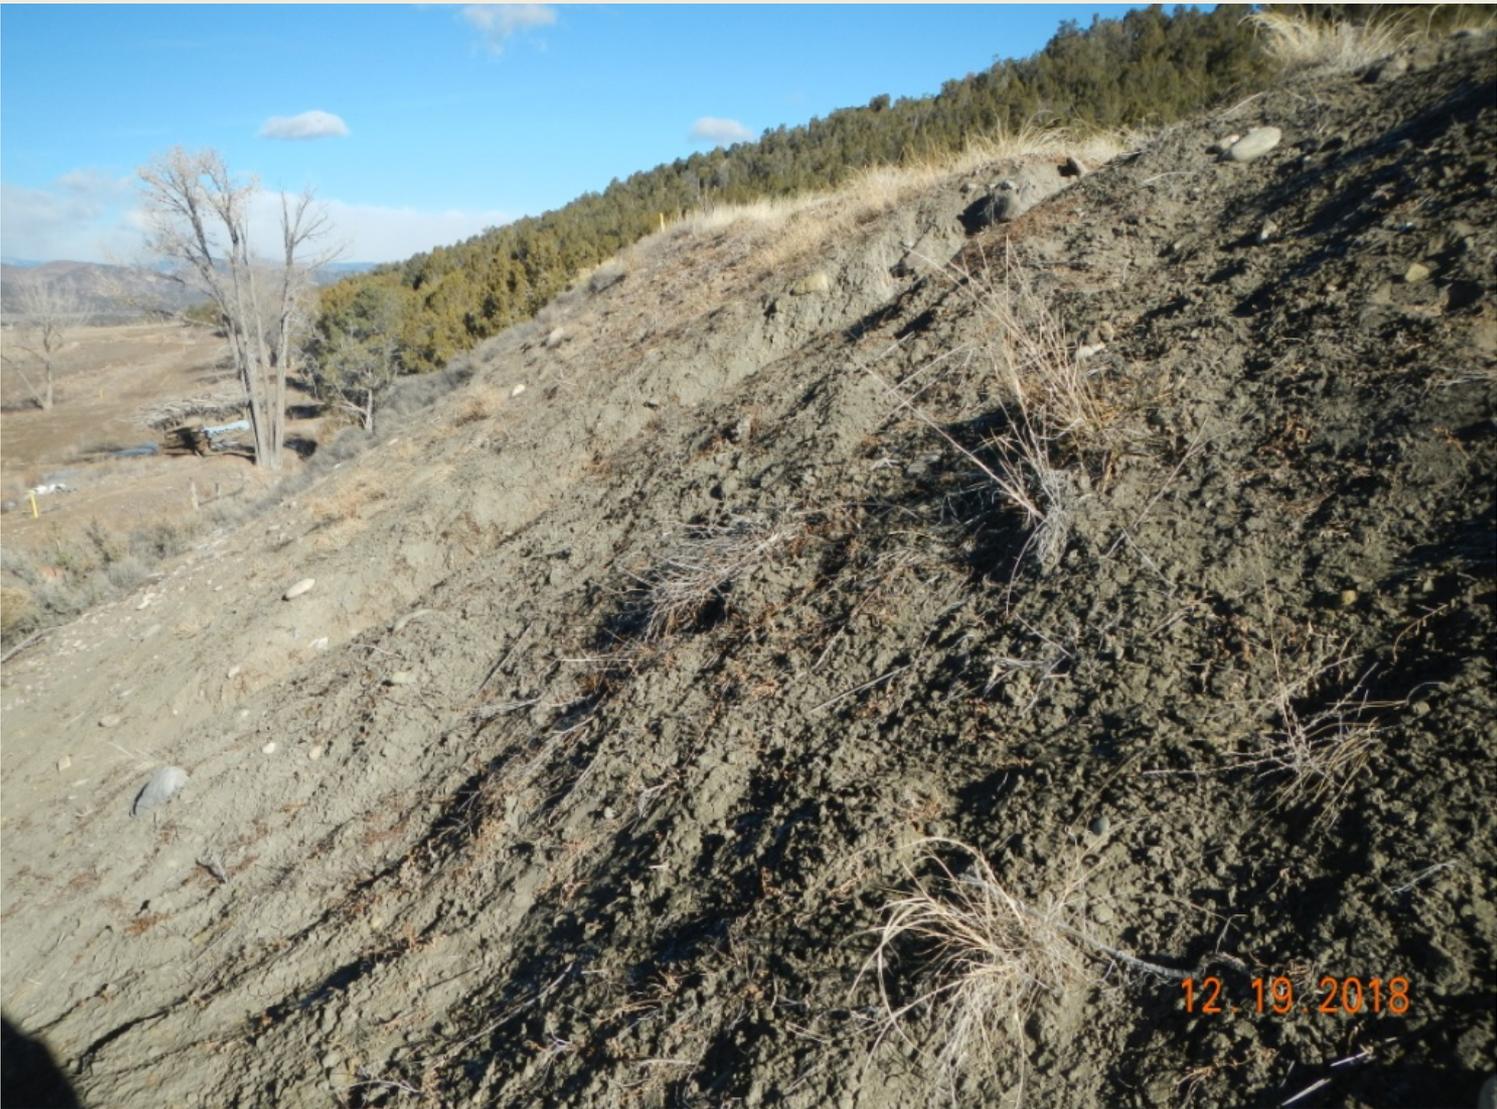
Photo 6. View of the western fill slope from the southwestern edge facing northward. Poor revegetation on fill slope.

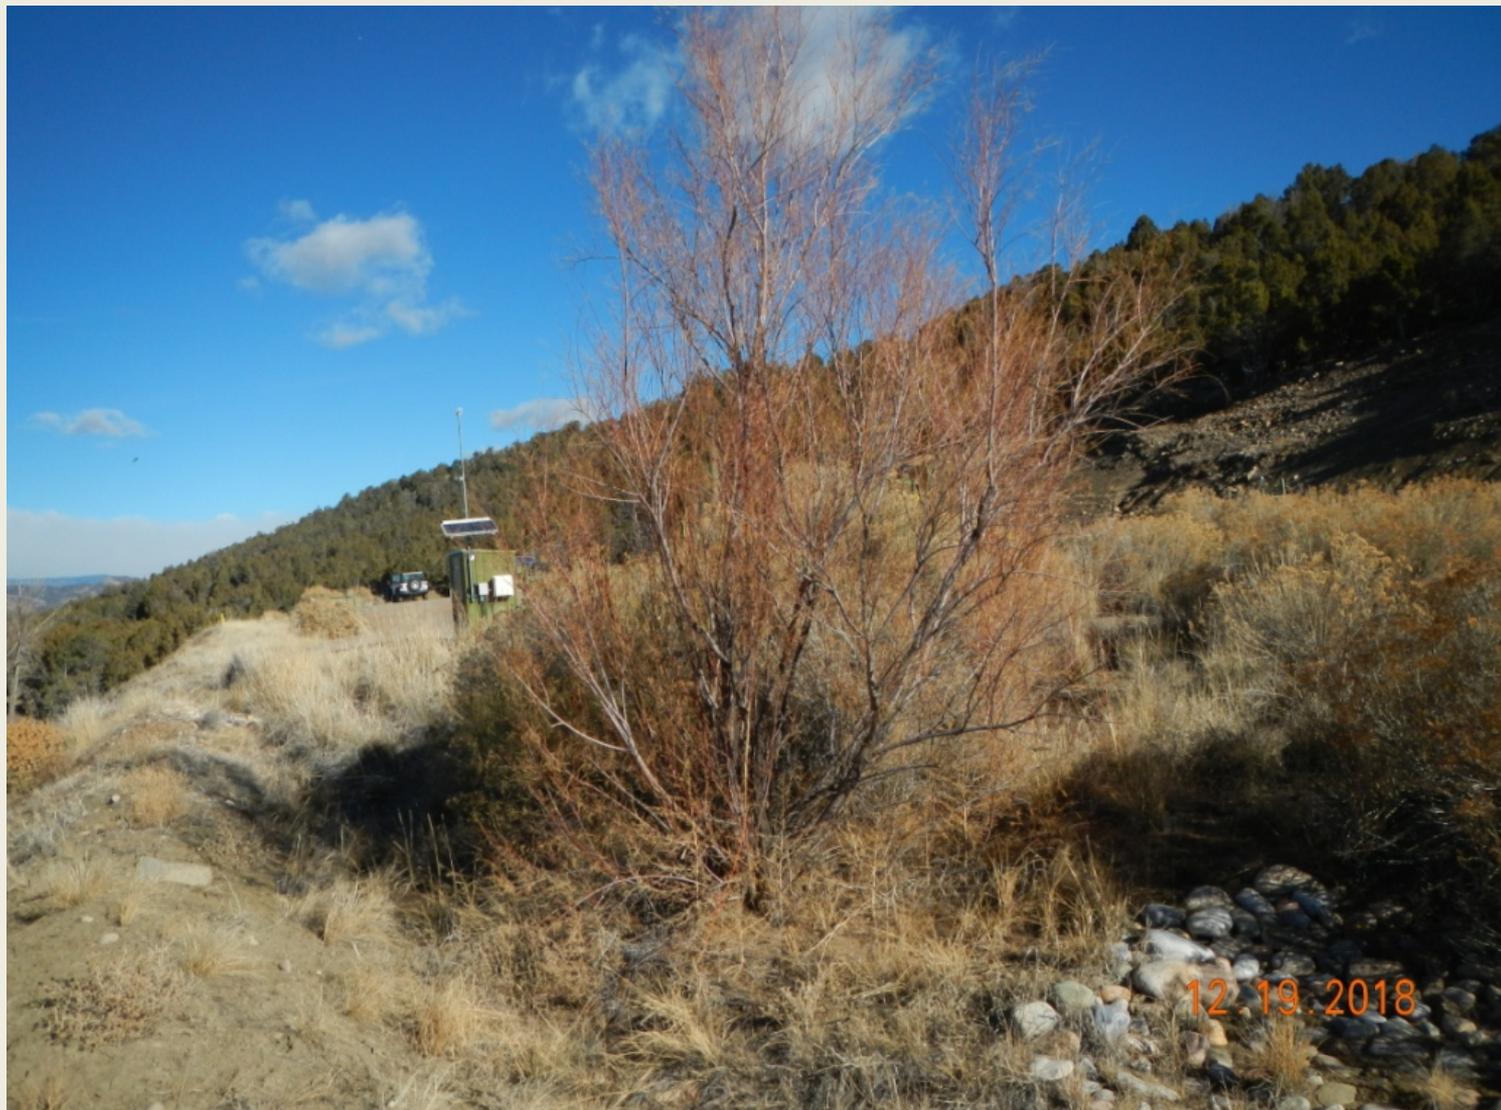
Photo 7. View of salt cedar tree (*Tamarix* sp.) within the southwestern corner of the project area.

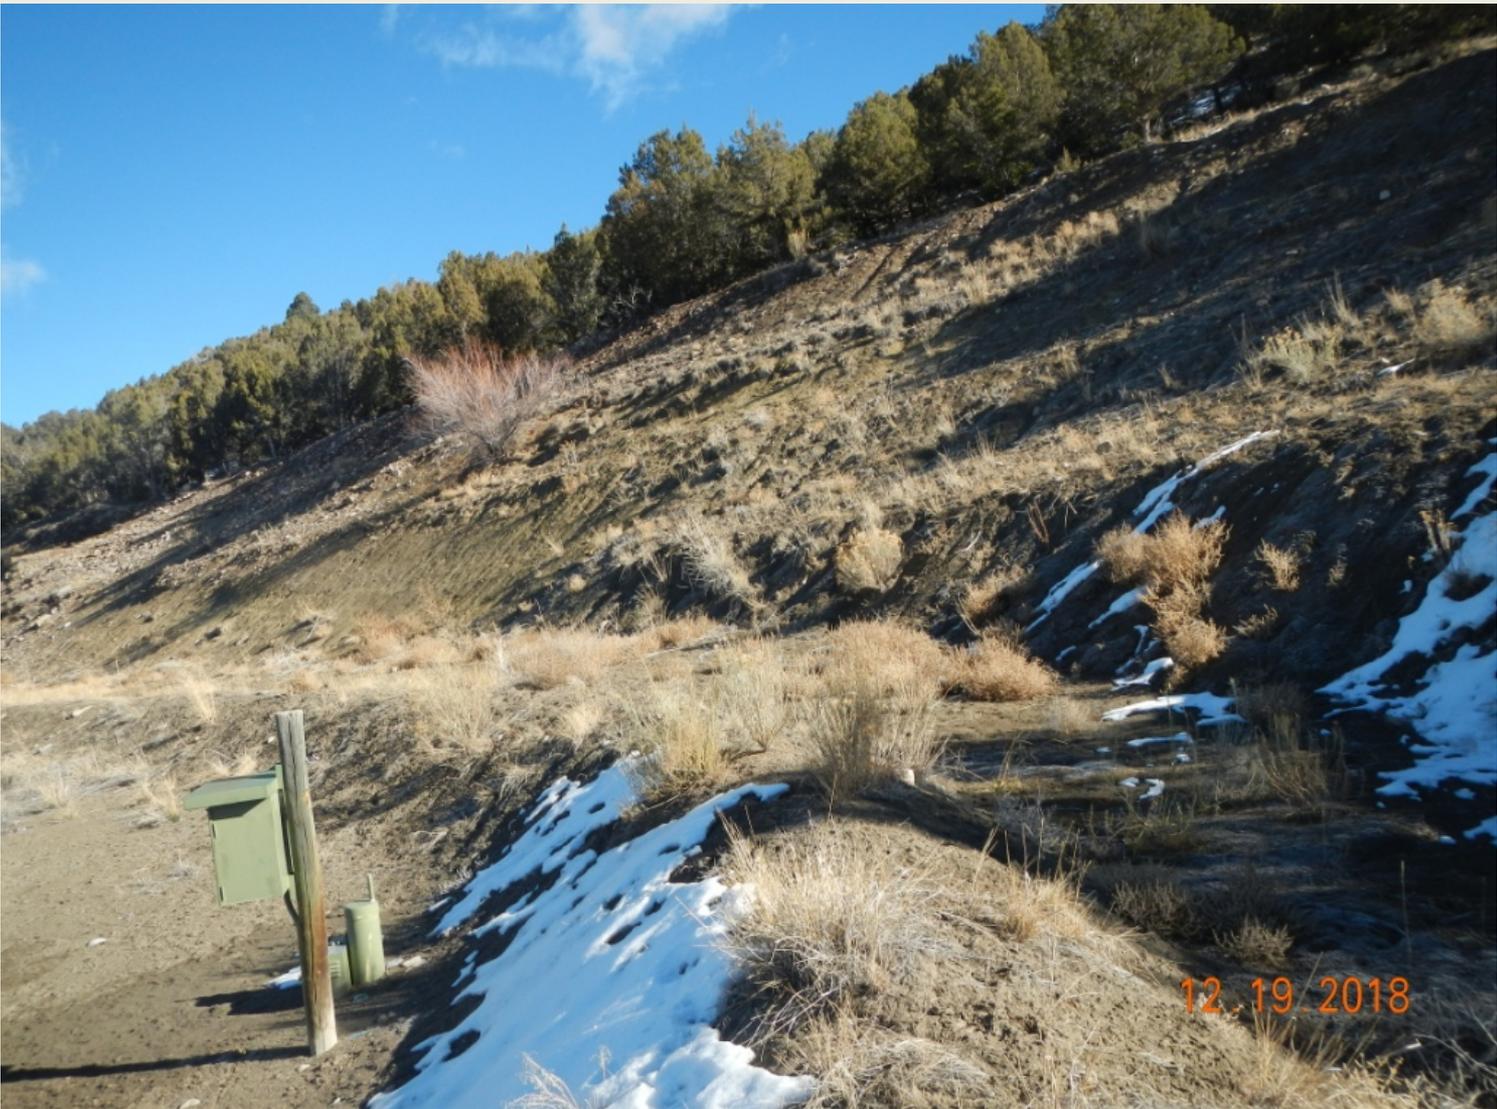
Photo 8. View of the eastern project area from the southeastern corner facing northward. Another salt cedar is growing on the cut-slope.

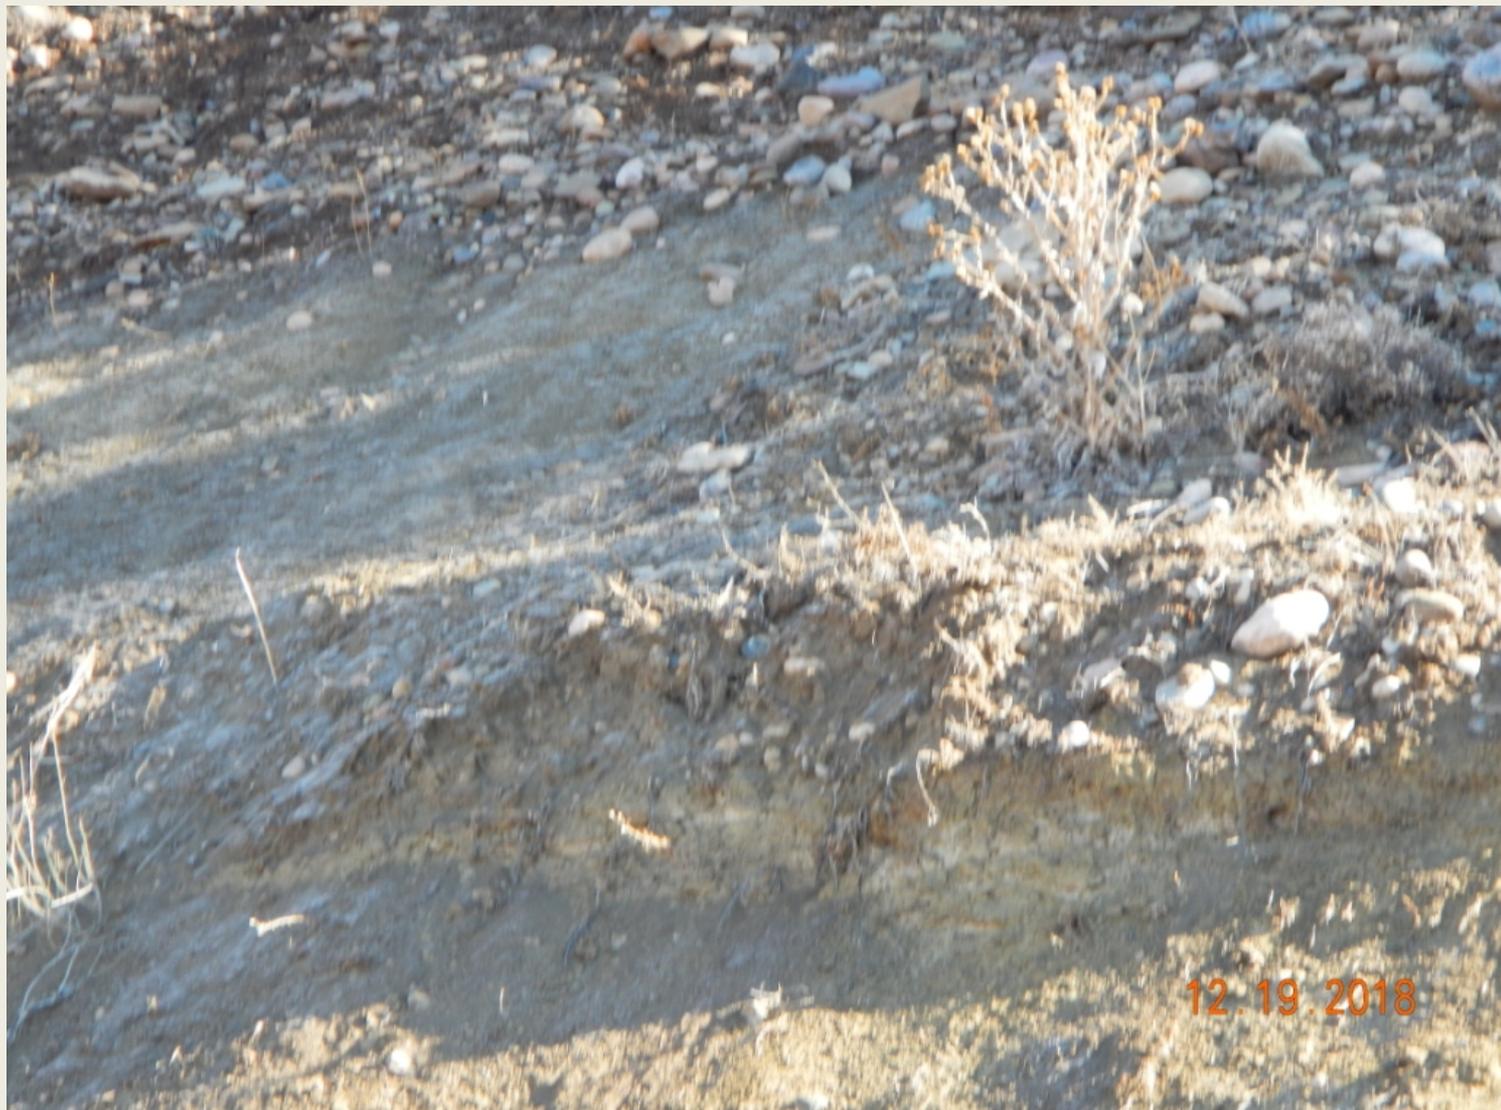
Photo 9. View of Scotch thistles (*Onopordum acanthium*) on the cut-slope. Approximately 500 Canada and Scotch thistles growing within the northeastern project area.

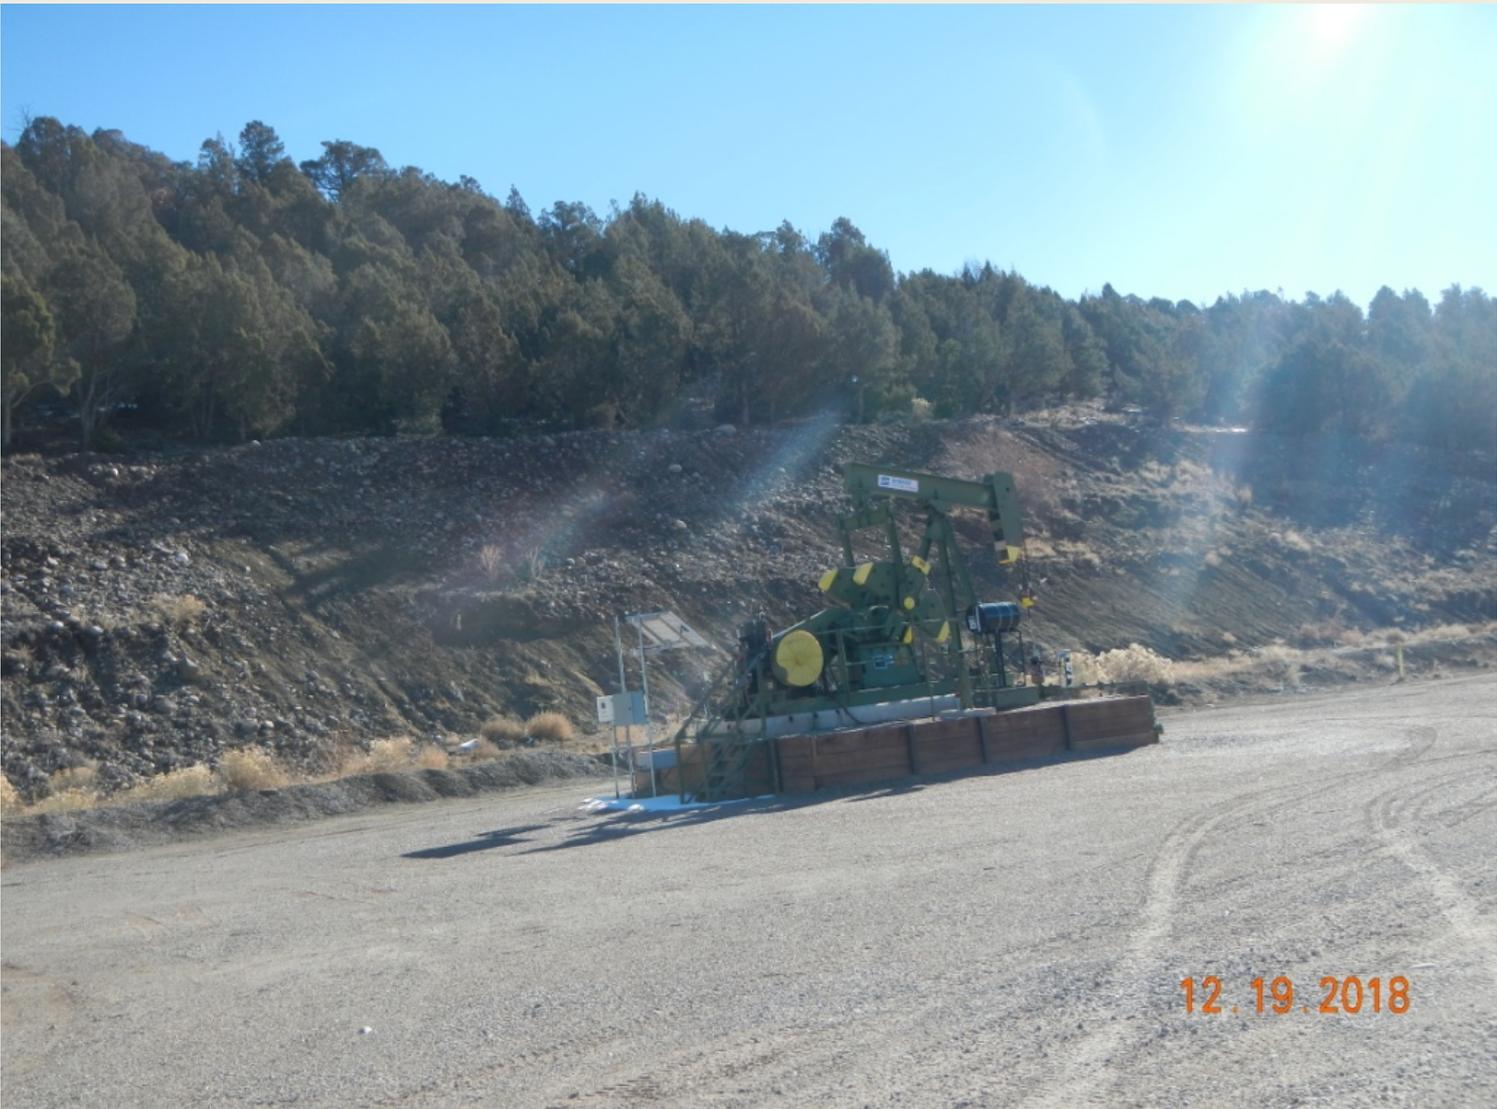
Photo 10. View of the project area from the northwestern corner facing center.
