Inspection Photos

Operator: Logos Operating

API: 05-067-08161

Date: 12/19/2018

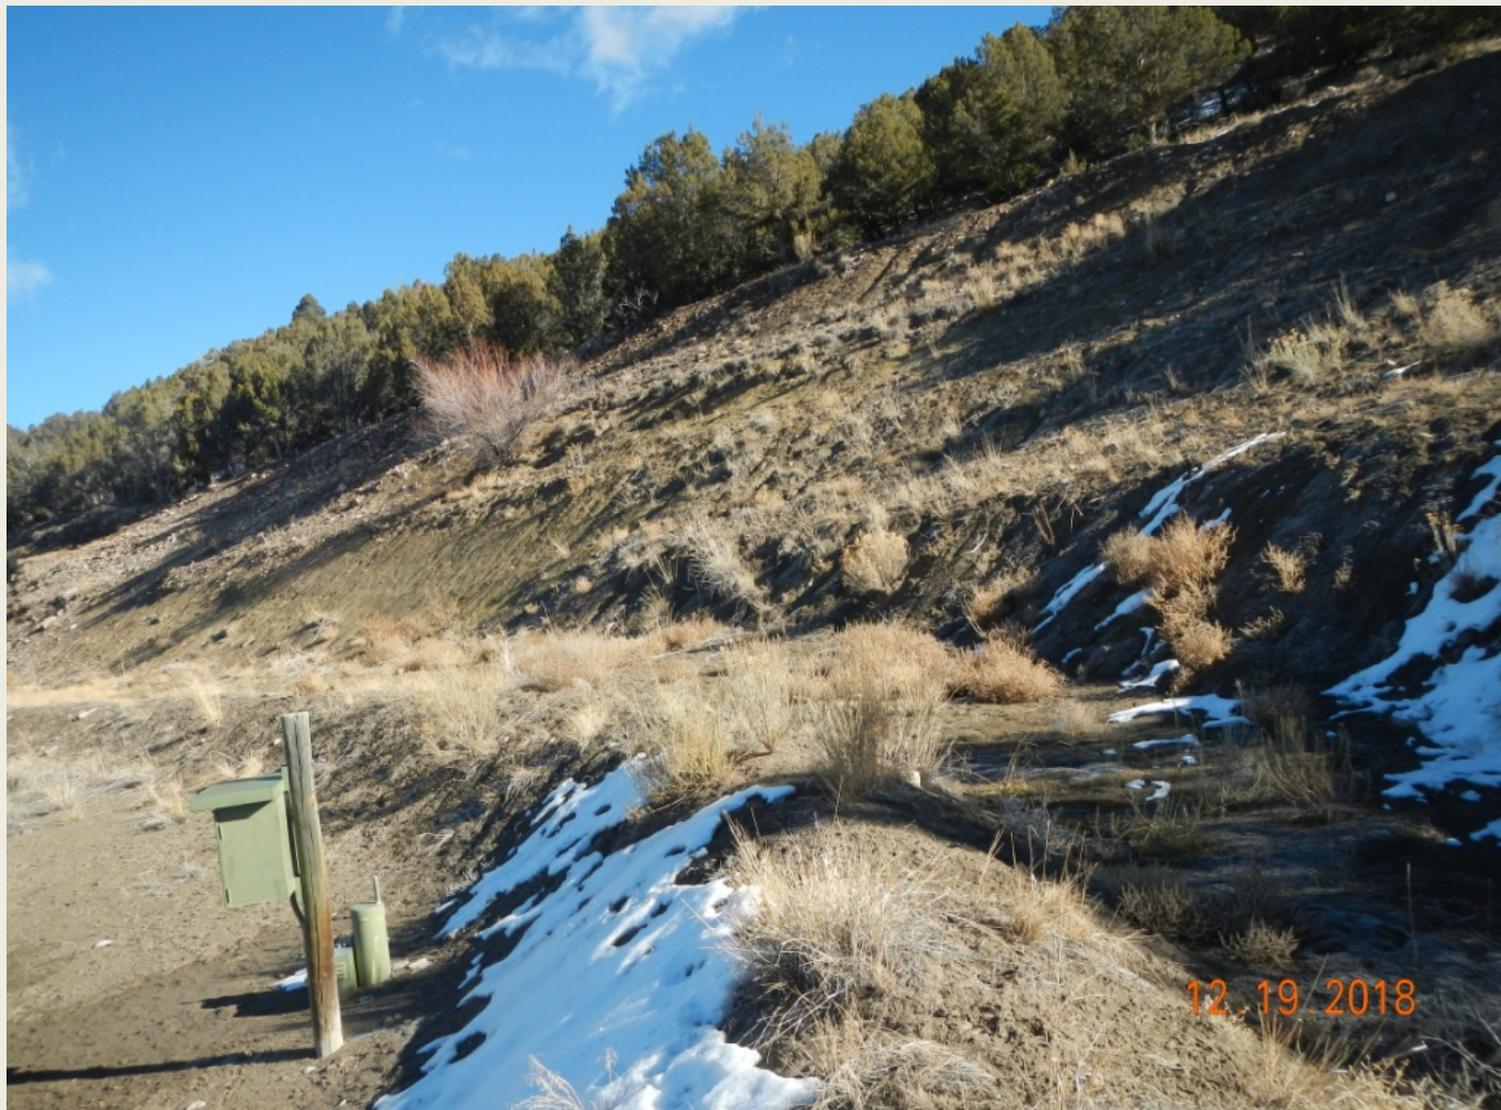
Photo 7. View of the eastern project area from the southeastern corner facing northward. Another salt cedar is growing on the cut-slope.
