Inspection Photos

Operator: Hilcorp Energy

API: 05-067-09461

Date: 12/19/2018

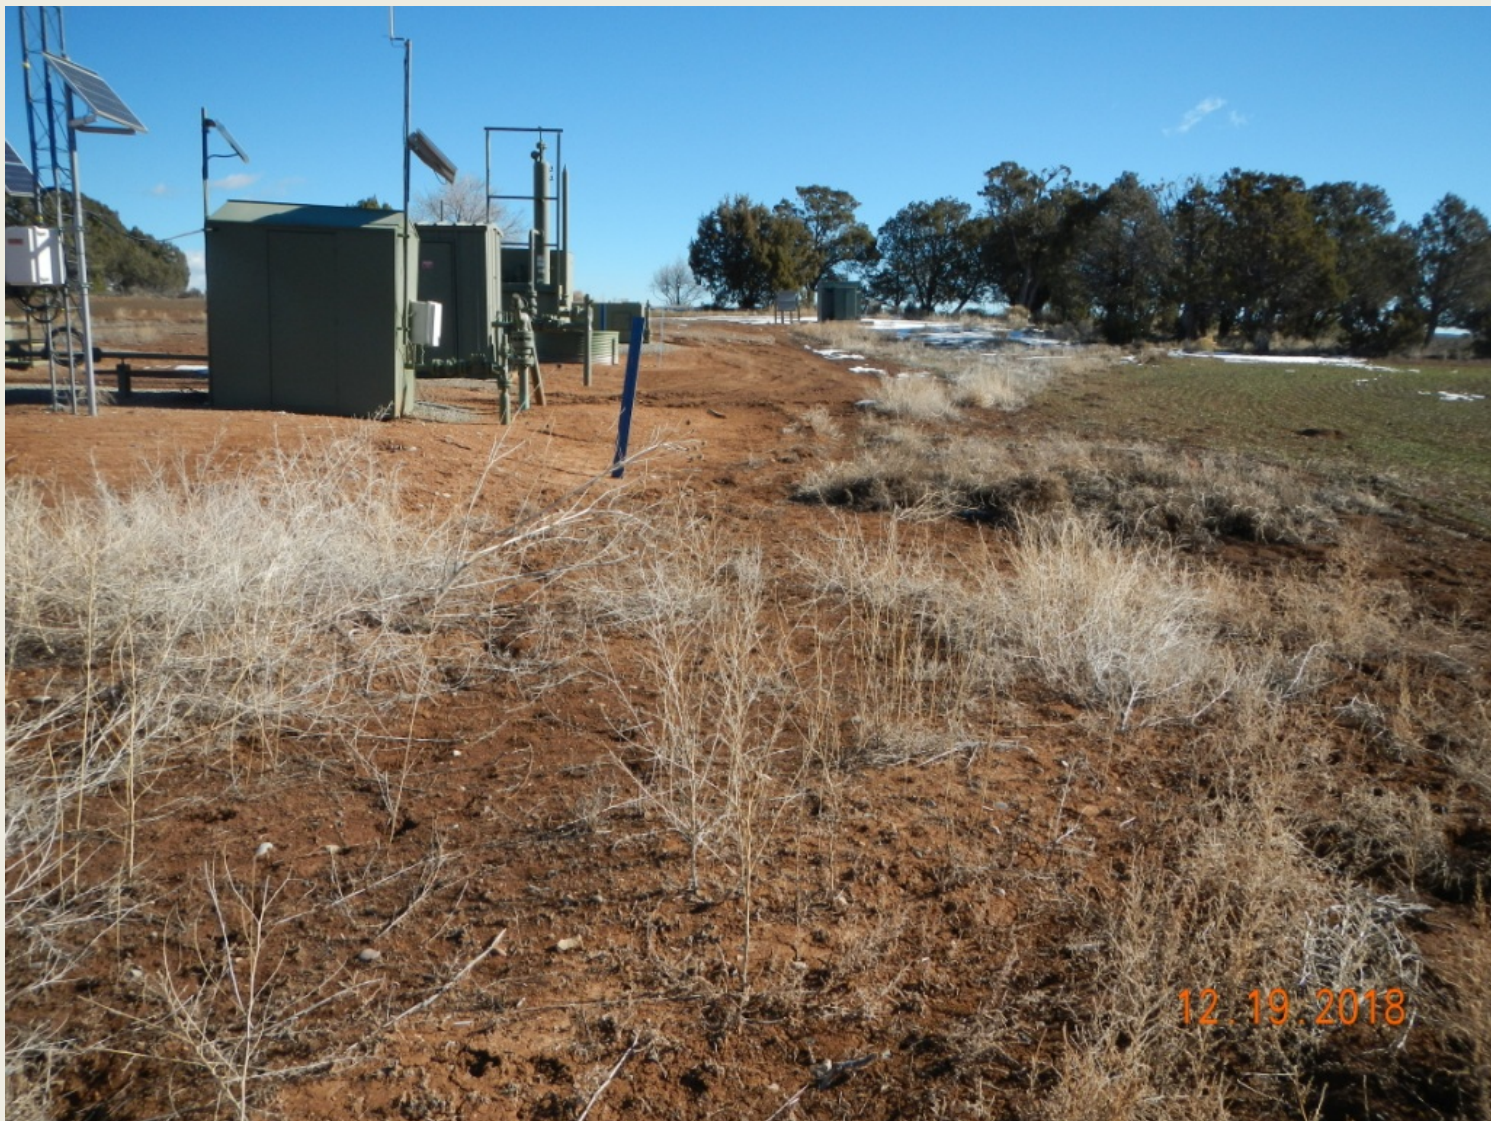
Photo 1. View of the southern project area from the southwestern corner facing eastward.

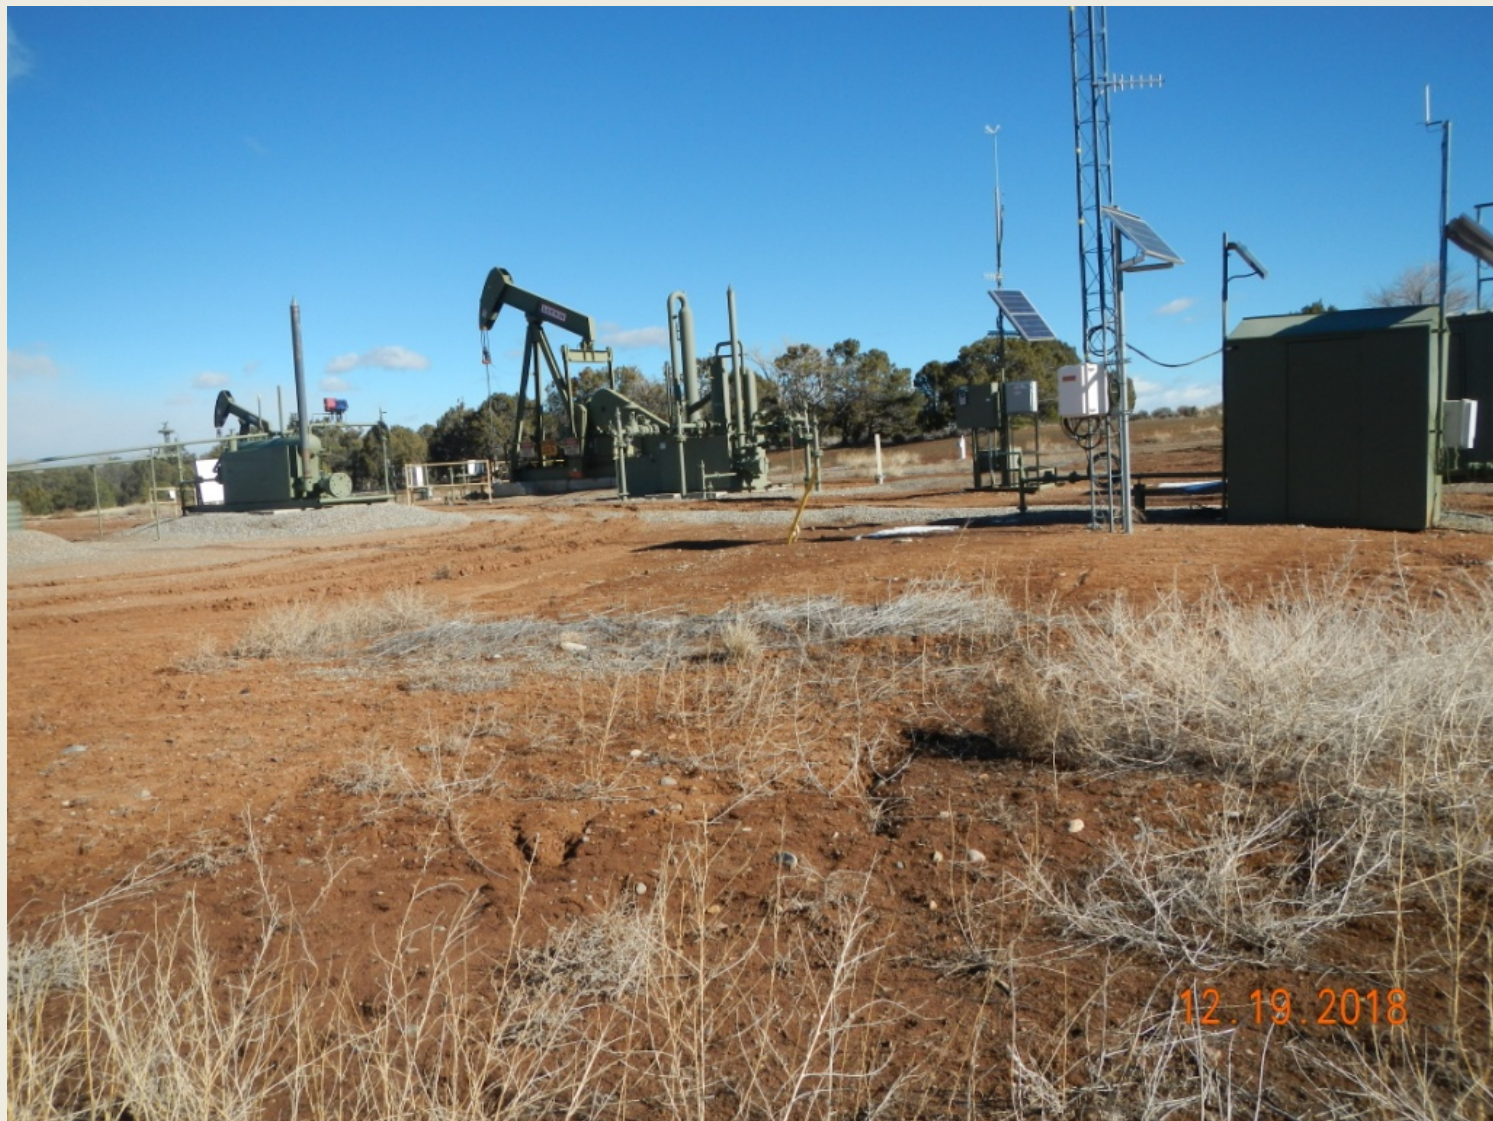
Photo 2. View the eastern project area from the southwestern corner facing center.

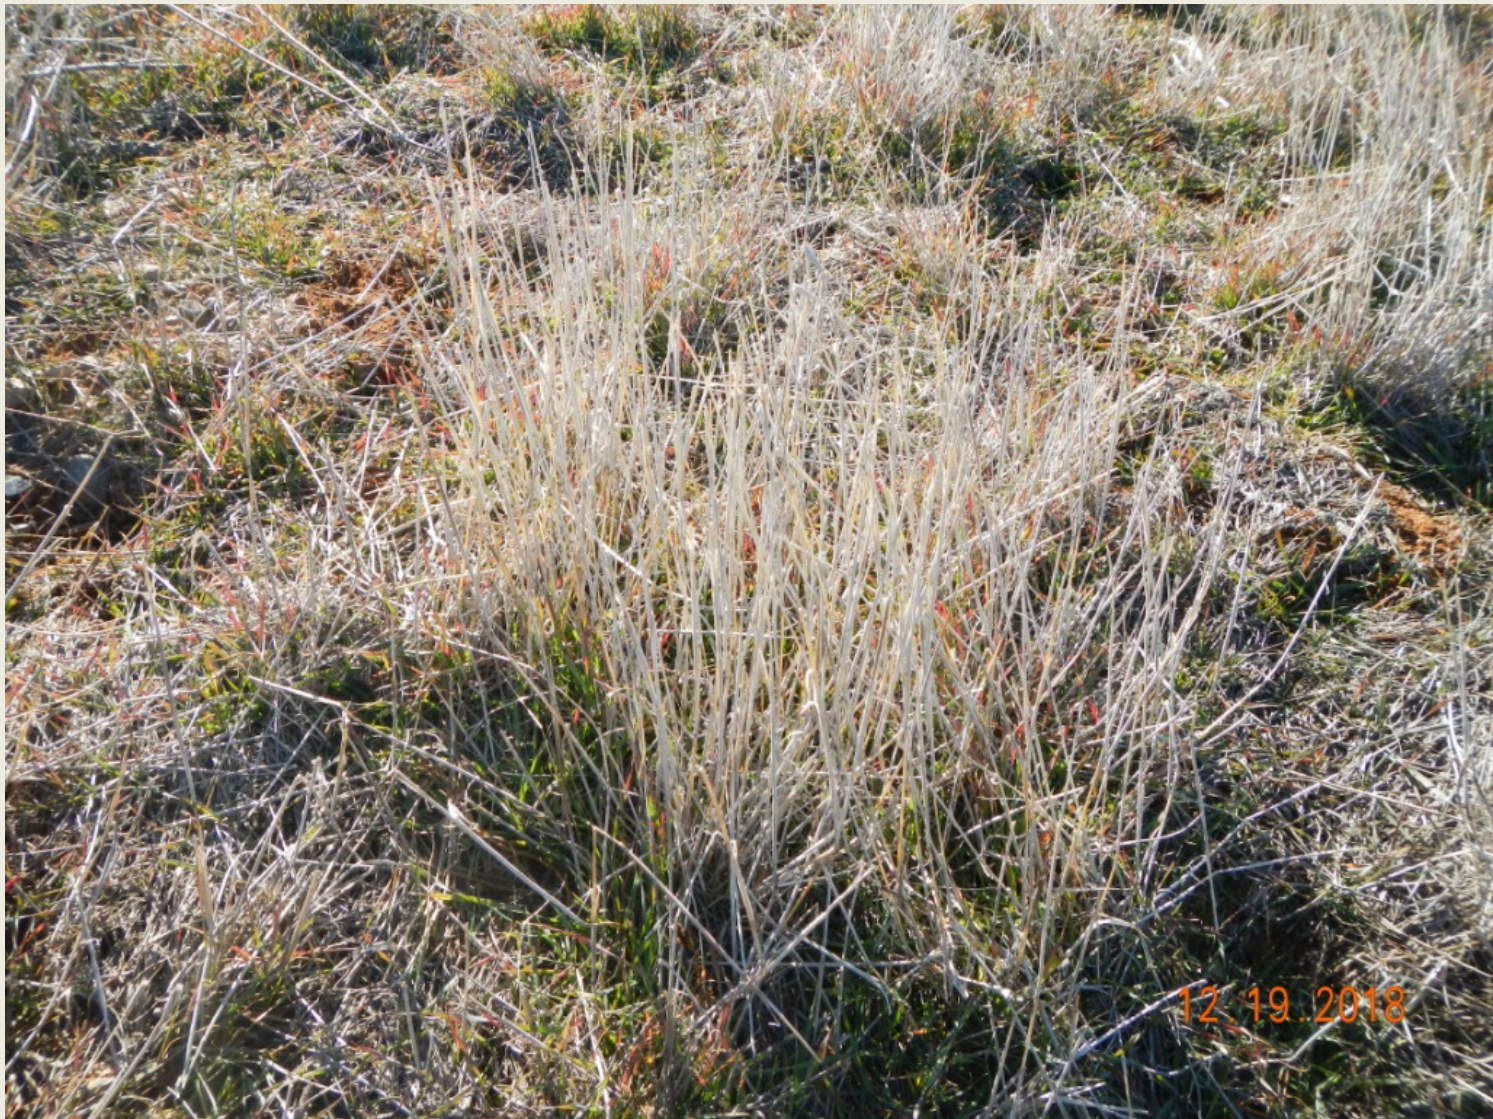
Photo 3. View of jointed goatgrass (*Acroptilon repens*) within the northwestern project area. Also present within the northeastern project area.

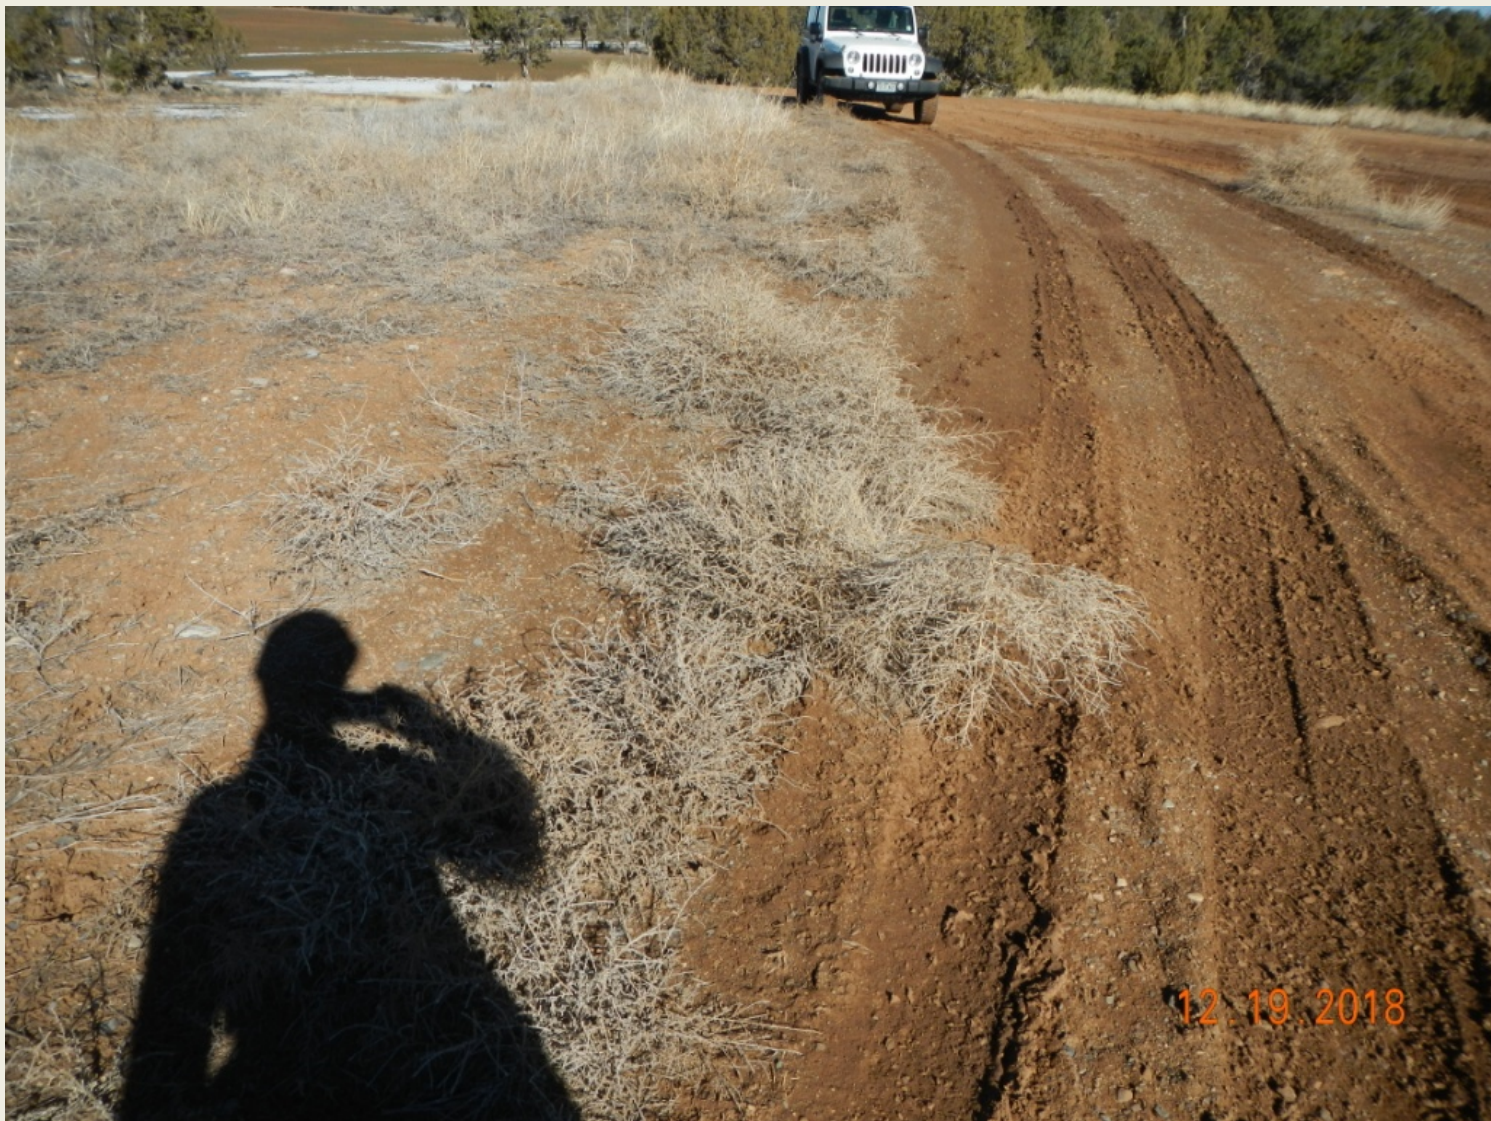
Photo 4. View of kochia debris within the western project area. Debris needs to be removed and properly disposed of.

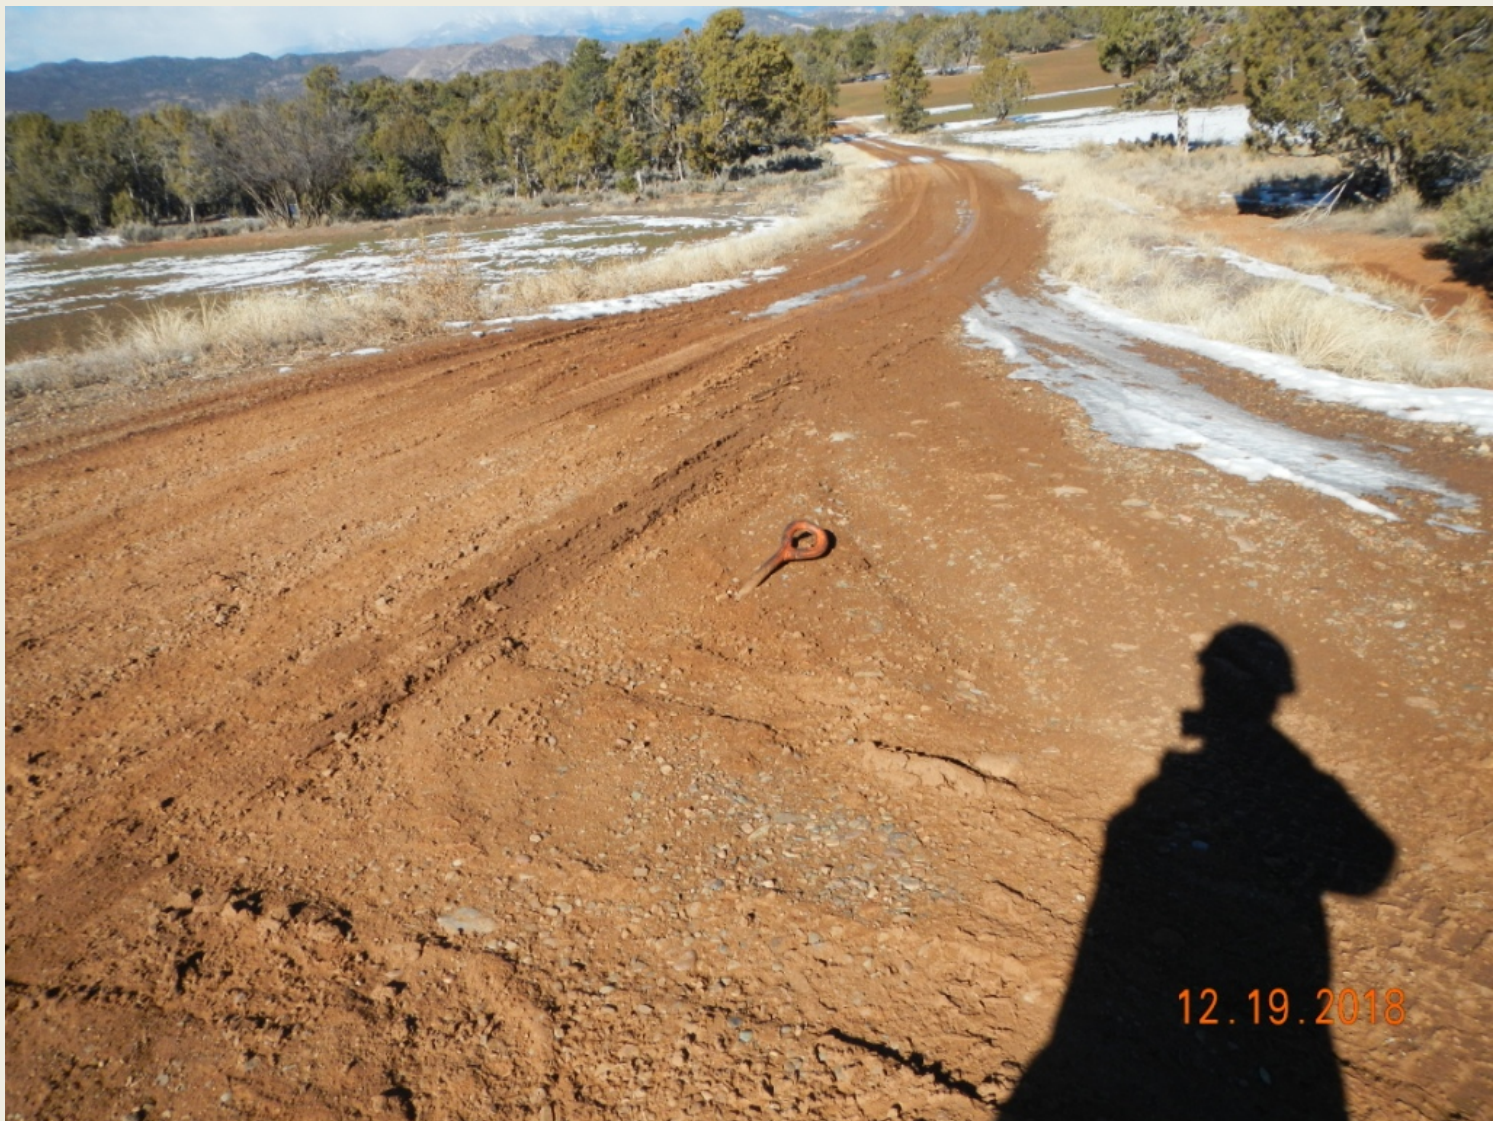
Photo 5. View of unmarked anchor at the northern entrance to the project area.
