# Inspection Photos

Operator: MURFIN DRILLING COMPANY INC -  
61650

Location ID: 387013

Inspection Doc. Number: 682504357  
Lincoln County, CO

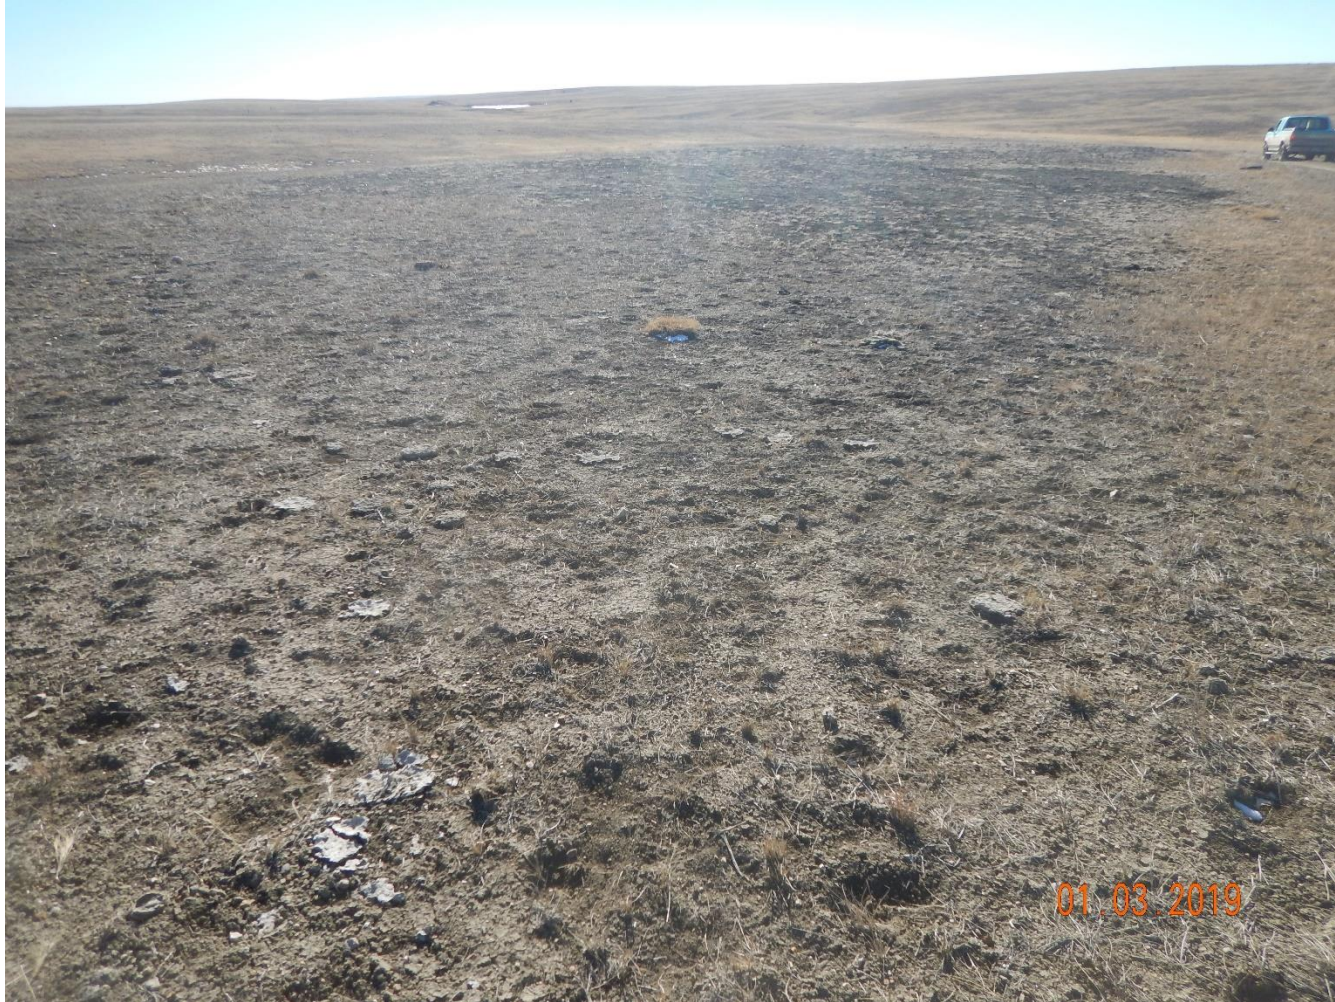
**Photo 1:** Photo taken from the northwest end of the location, facing southwest. Photo 1-3 provide and overview of the location. Photo shows location remains predominantly bare and exposed soil; location does not meet reclamation requirements.

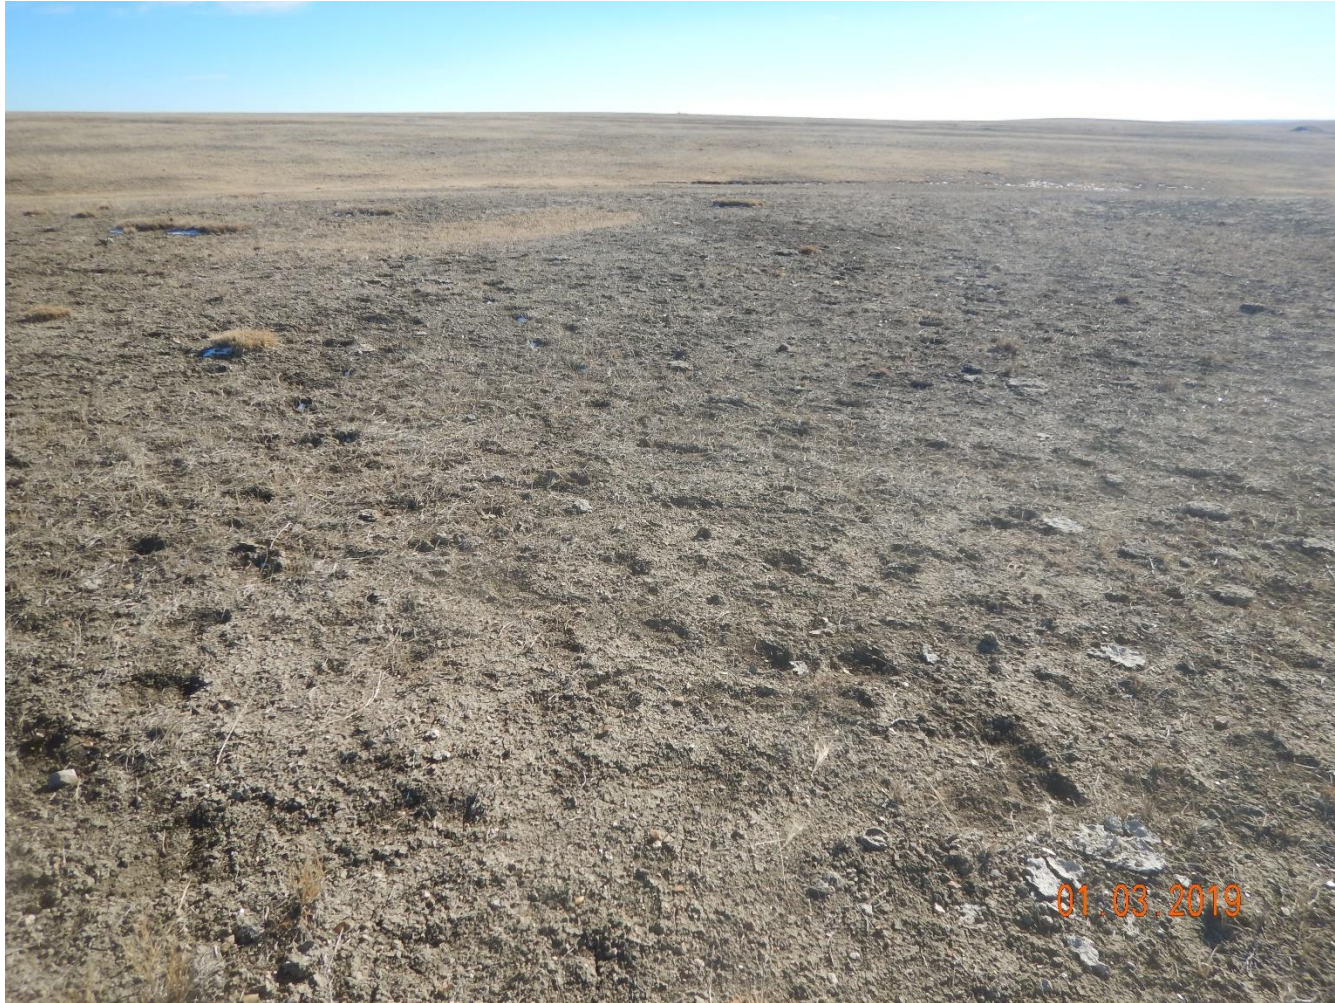
**Photo 2:** Photo taken from the northwest end of the location, facing south. Photo 1-3 provide an overview of the location. Photo shows location remains predominantly bare and exposed soil; location does not meet reclamation requirements.

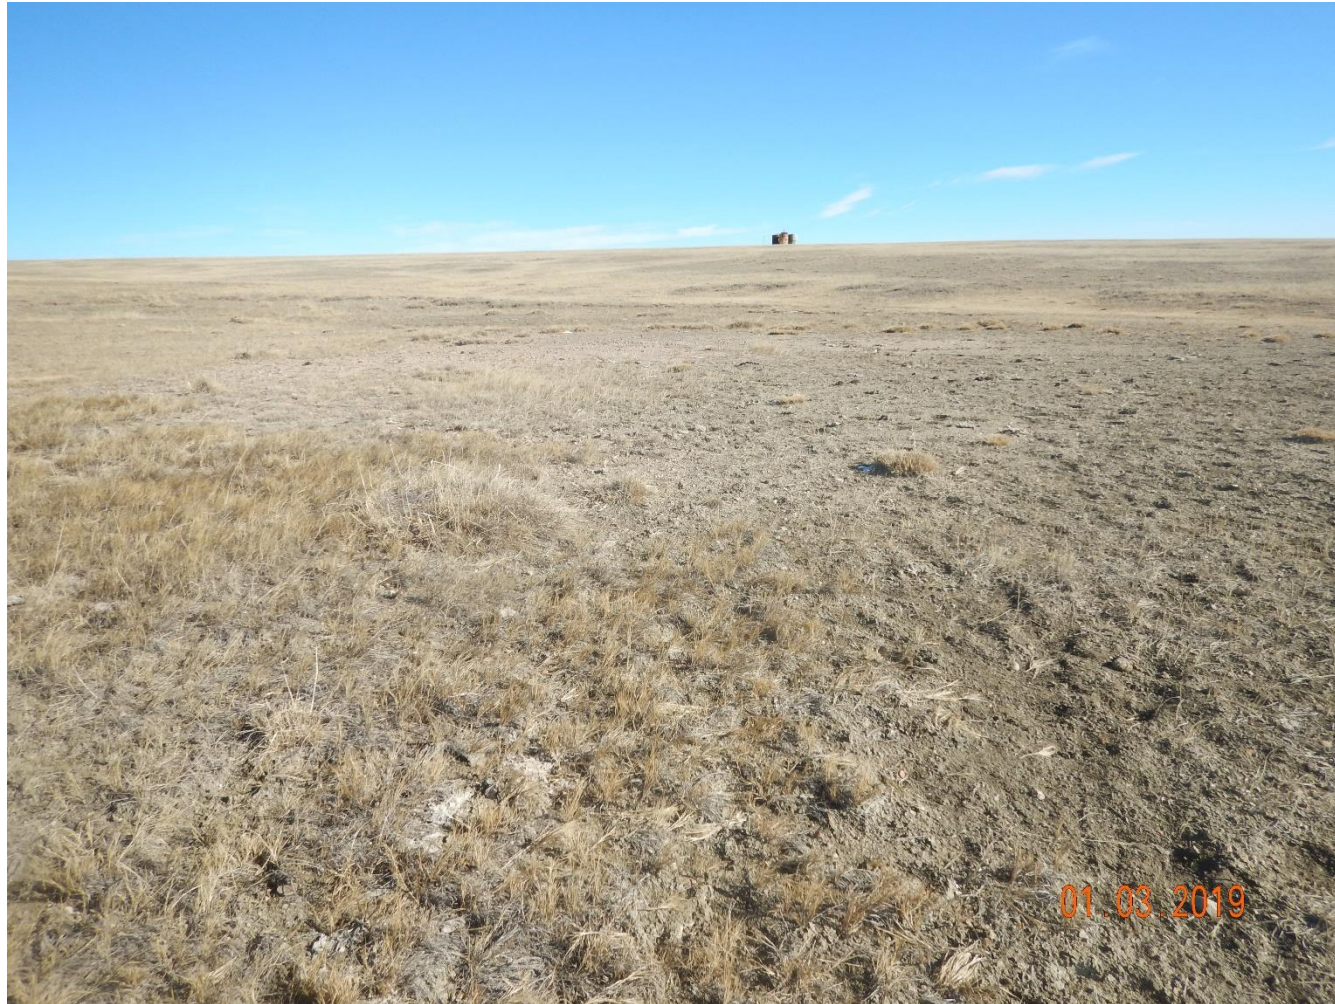
**Photo 3:** Photo taken from the northwest end of the location, facing east. Photo 1-3 provide an overview of the location. Photo shows location remains predominantly bare and exposed soil; location does not meet reclamation requirements.

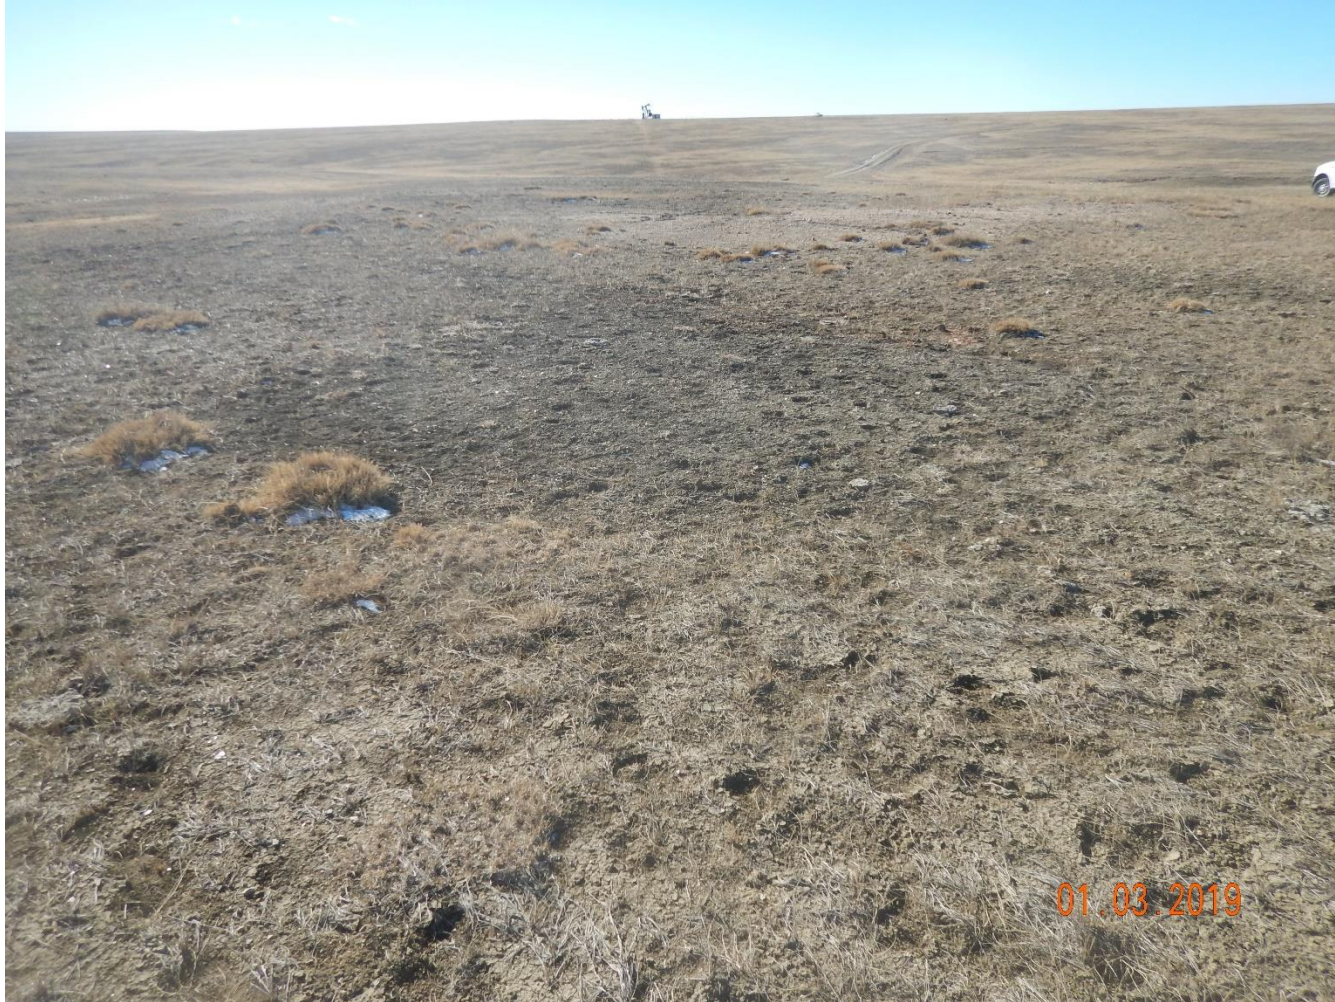
**Photo 4:** Photo taken from the north end of the location, facing southwest. Photo shows location remains predominantly bare and exposed soil; location does not meet reclamation requirements.

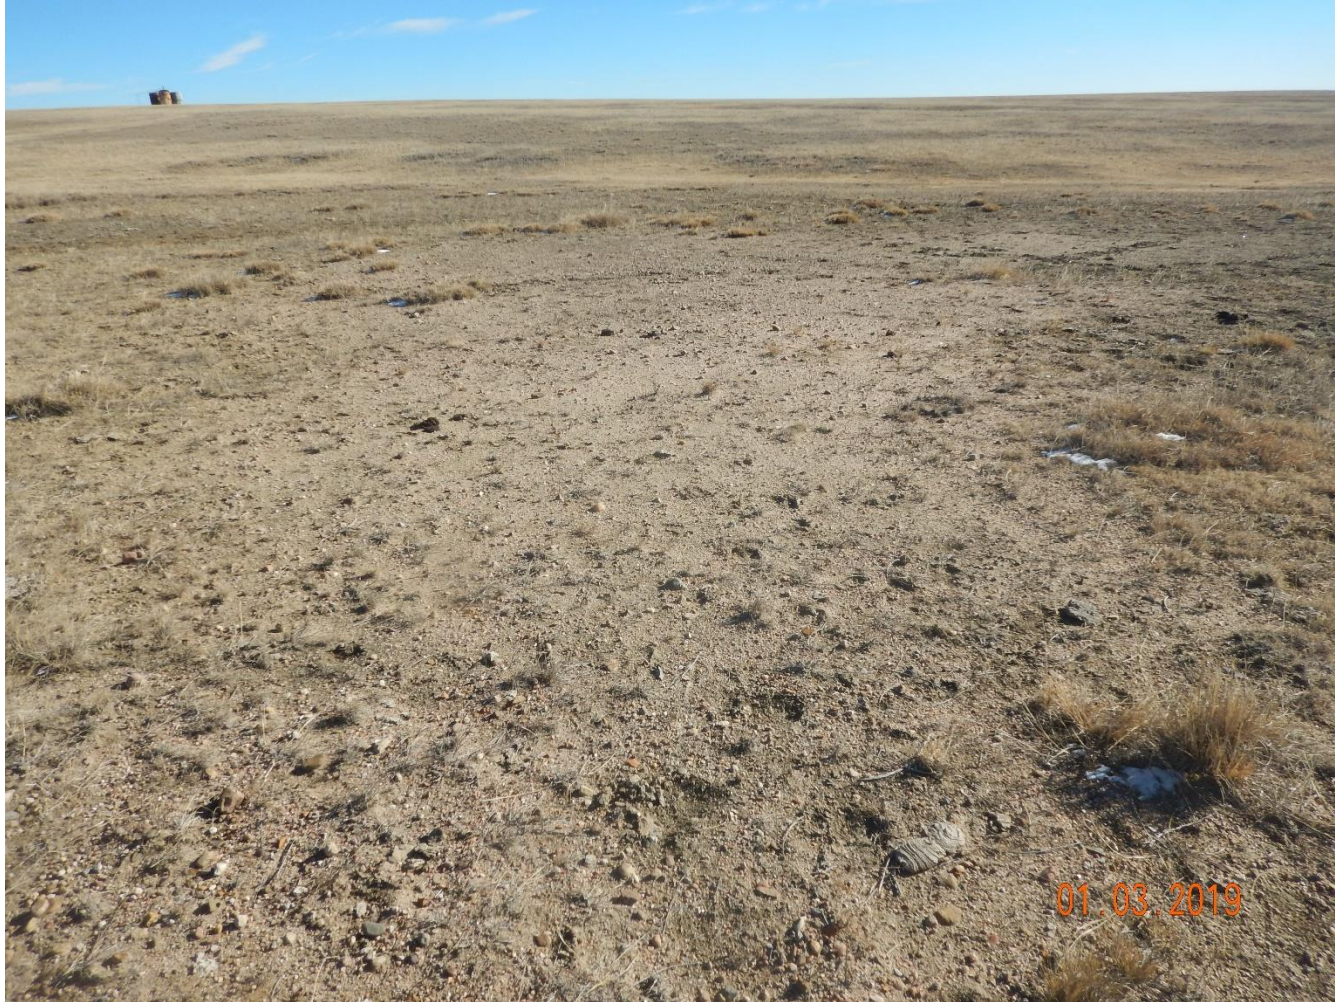
**Photo 5:** Photo taken from the southwest end of the location, facing east. Photo shows location remains predominantly bare and exposed soil; location does not meet reclamation requirements.

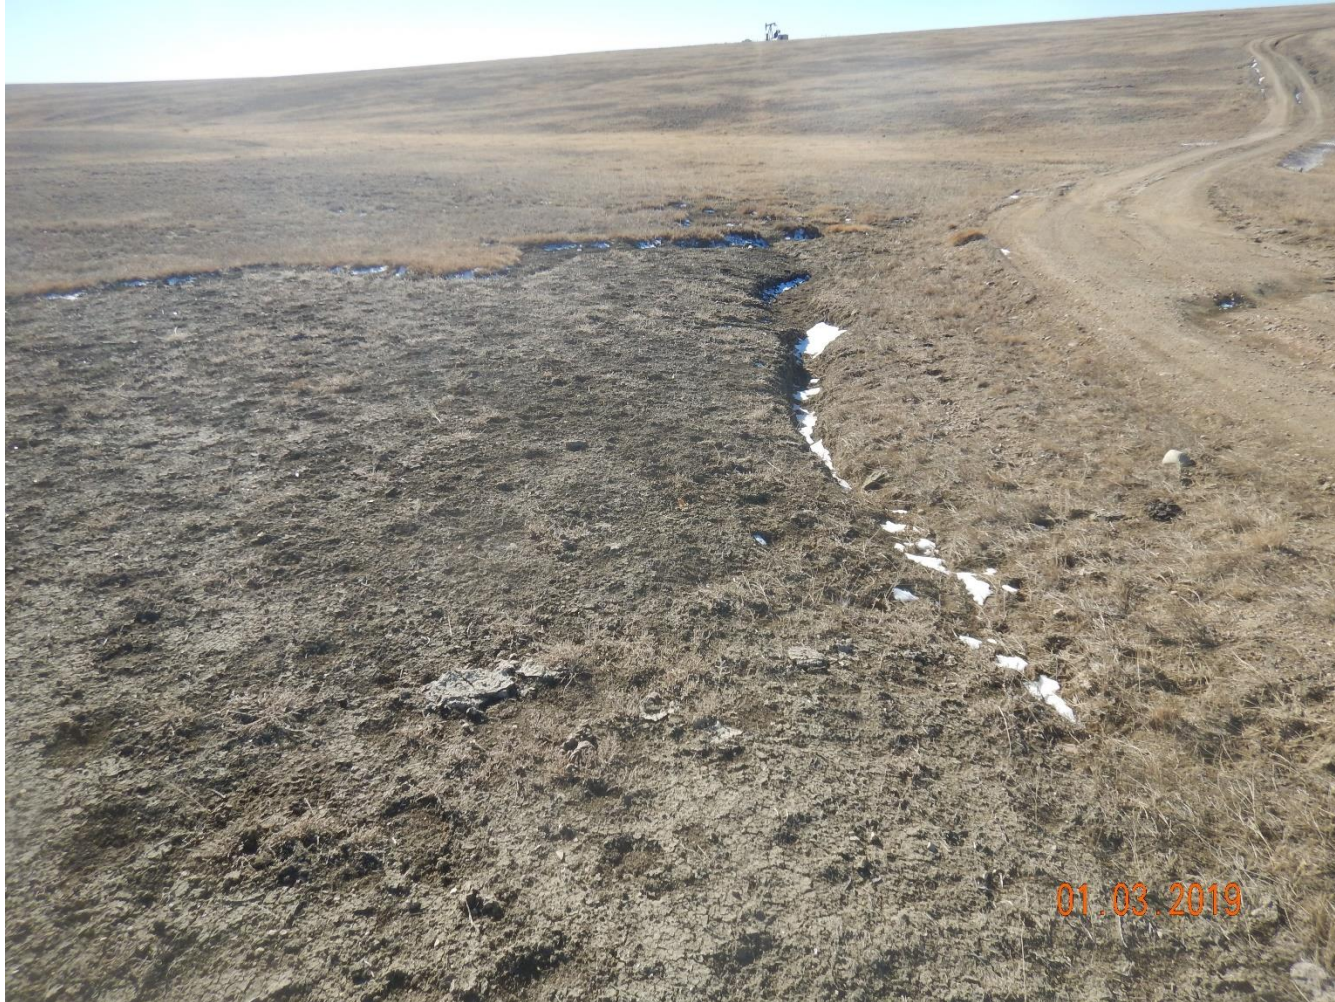
**Photo 6:** Photo taken from the southwest end of the location, facing southwest. Photo shows stormwater runoff from location causing erosion degradation.

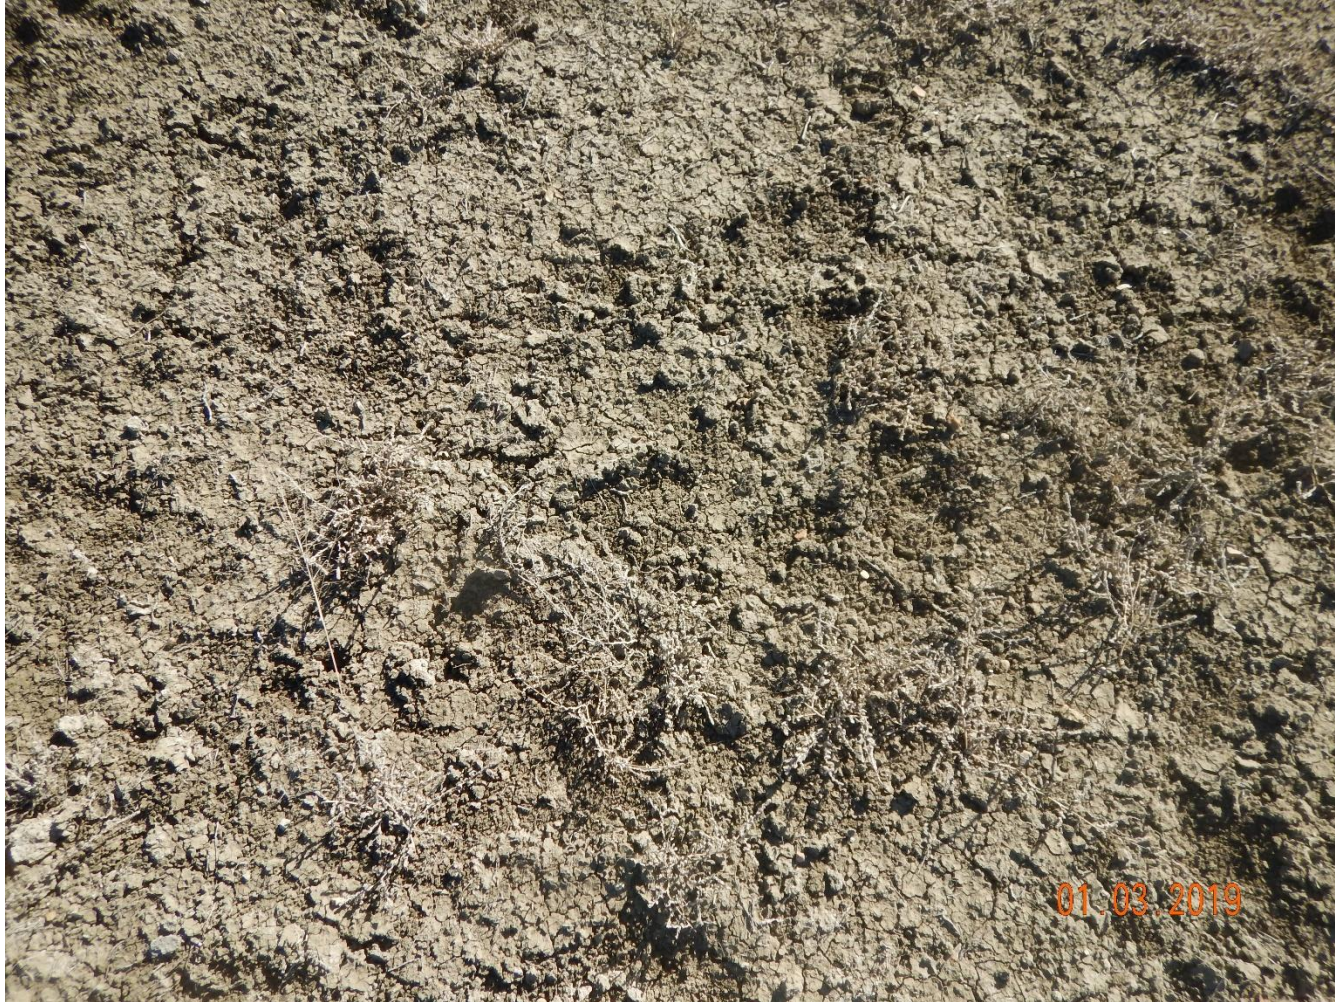
**Photo 7:** Photo taken from location. Photo shows location remains predominantly bare and exposed soil.

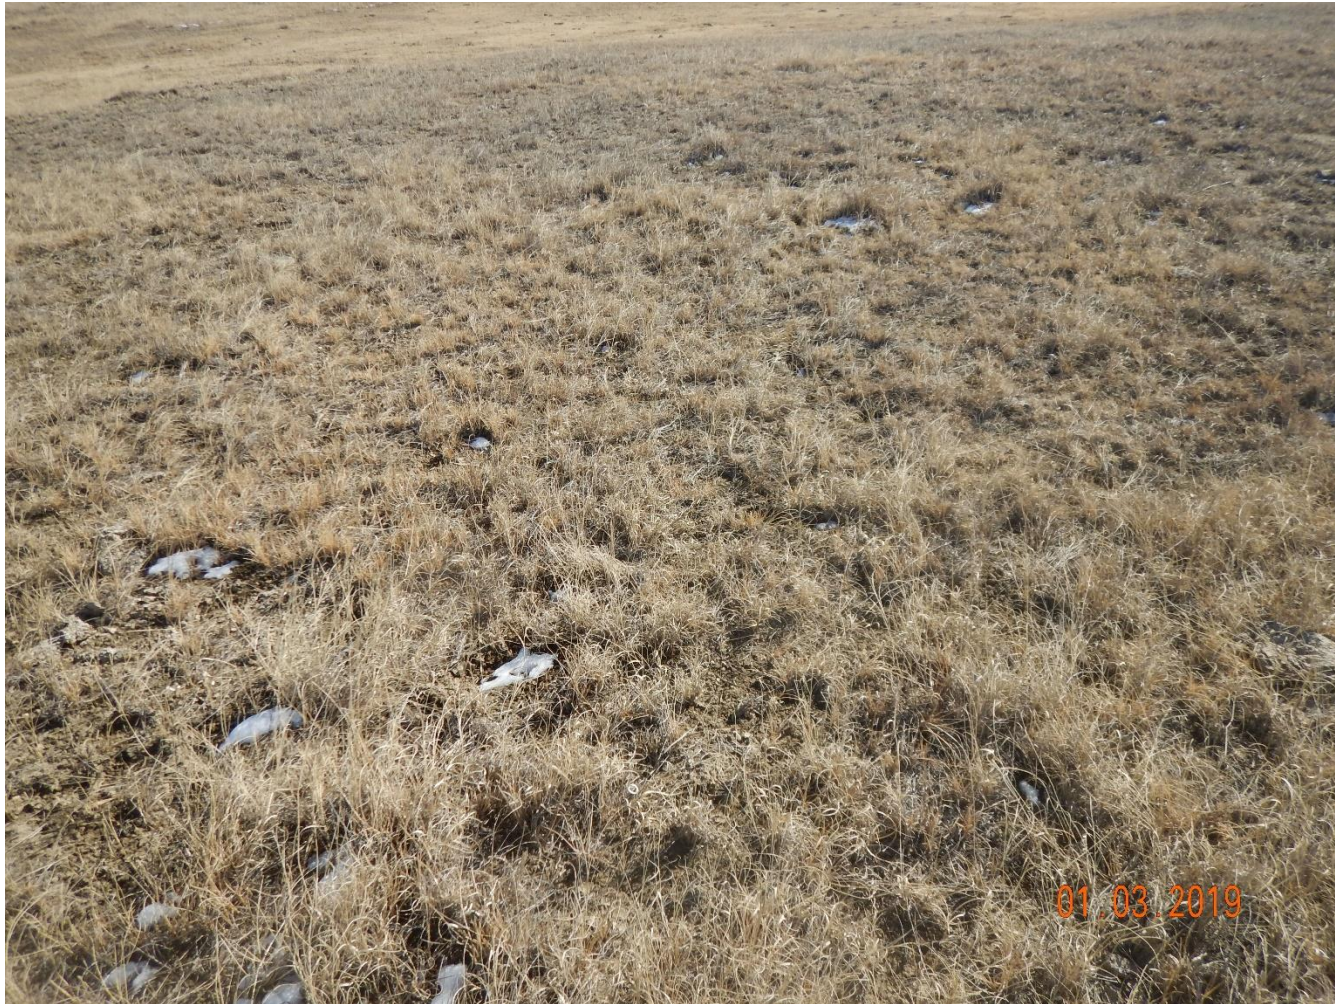
**Photo 8:** Photo taken from the adjacent reference area. Photo shows reference vegetation. Vegetation observed includes Blue grama, Buffalo grass, Wester wheat, Purple threeawn, sand dropseed, etc...
