**Inspection Photo (s)**  
**Double B ranch 18-44A**  
**API # 05-045-18782**  
**Inspection # 689302912**

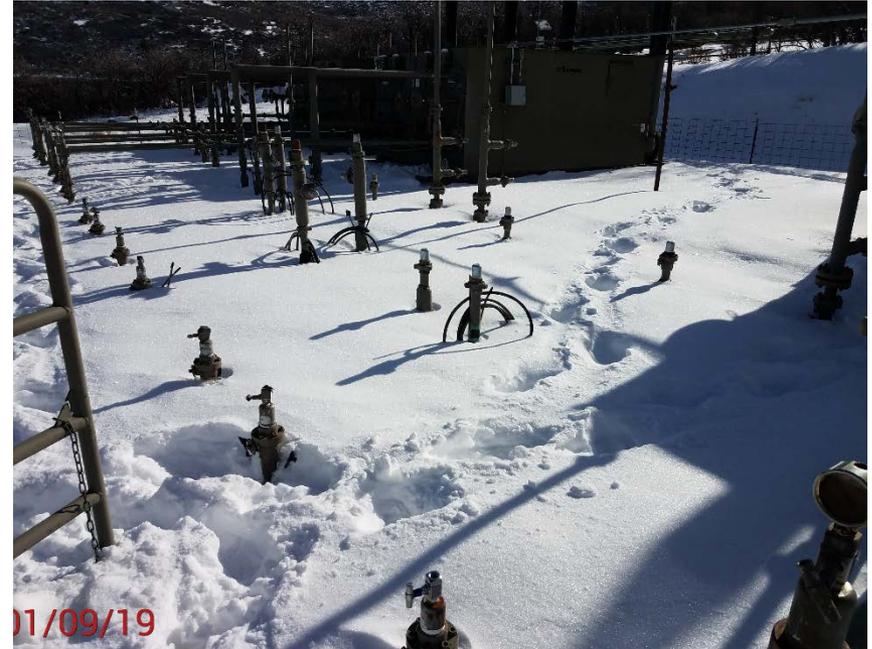
**Location Photo #4, Several unmarked flow line risers.**
