Inspection Photos
Location Name: FRONT RANGE 44-10
Location ID: 308430

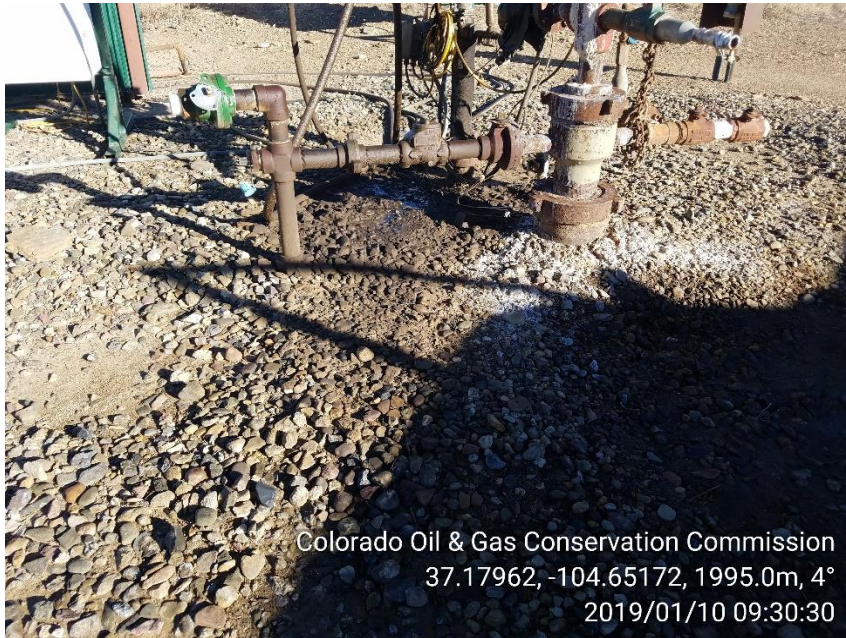
**PHOTO 3: STAINED SOIL UNDER DRIVEHEAD MOTOR
AROUND WELLHEAD**

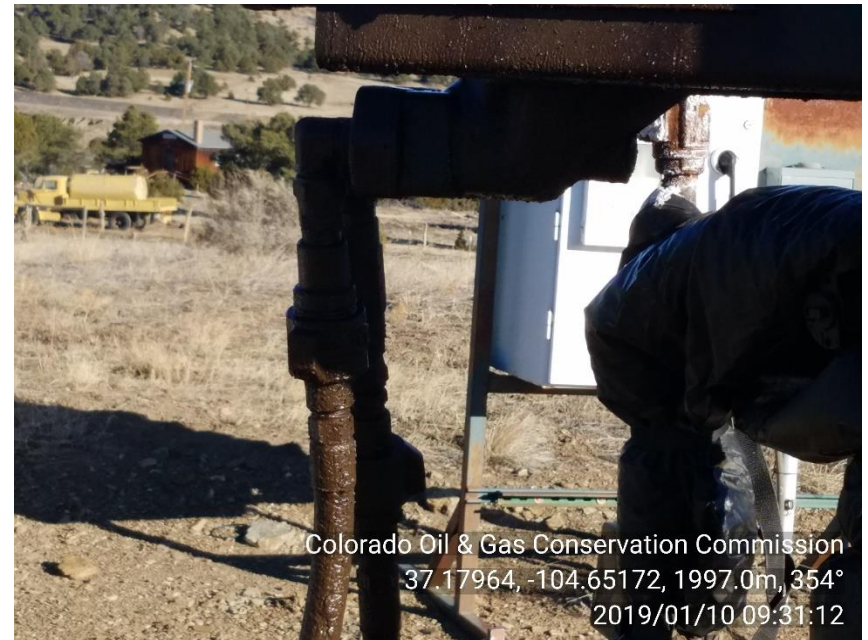
**PHOTO 4: HYDRAULIC LINES ARE SATURATED INDICATING A
POSSIBLE LEAK**

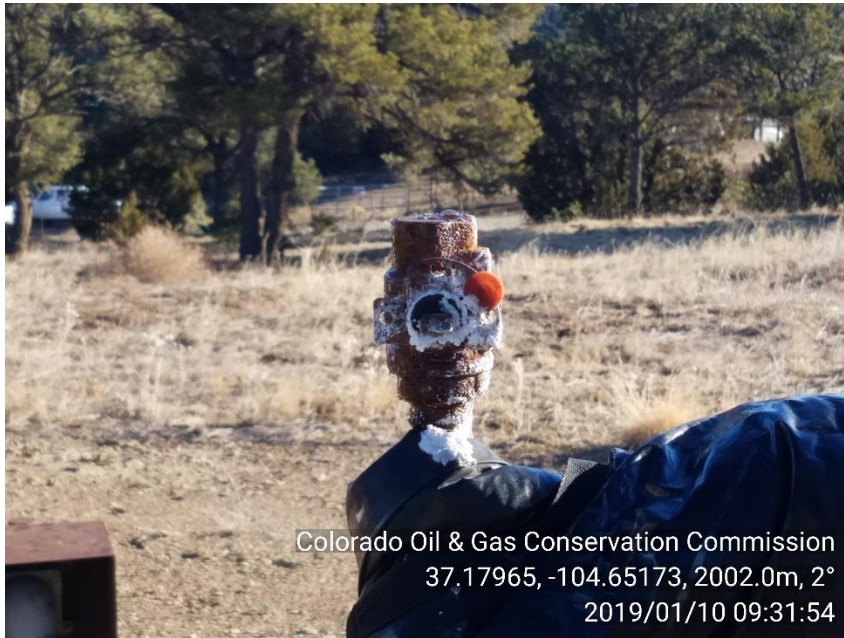
**PHOTO 5: APPEARS TO BE LEAKING VALVE ON SALES LINE
ATTACHED TO WELLHEAD**

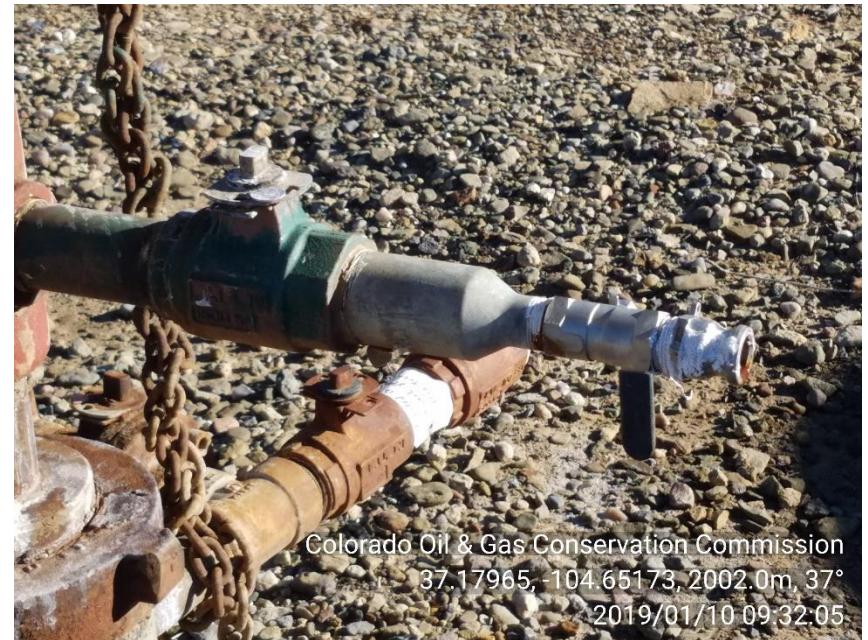
PHOTO 6: LEAKING 1" VALVE ON TBG HEAD

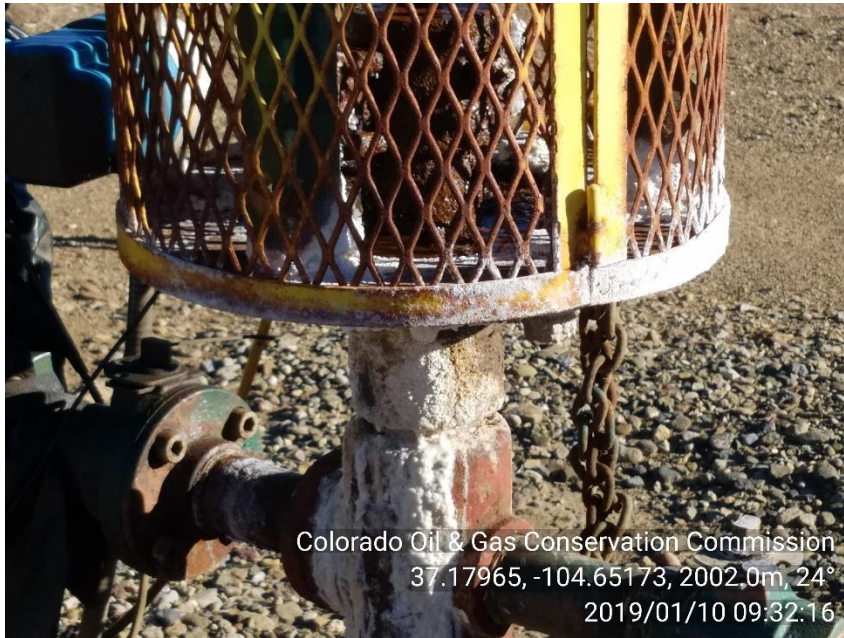
PHOTO 7: APPEARS THAT PACKING ON DRIVEHEAD IS LEAKING

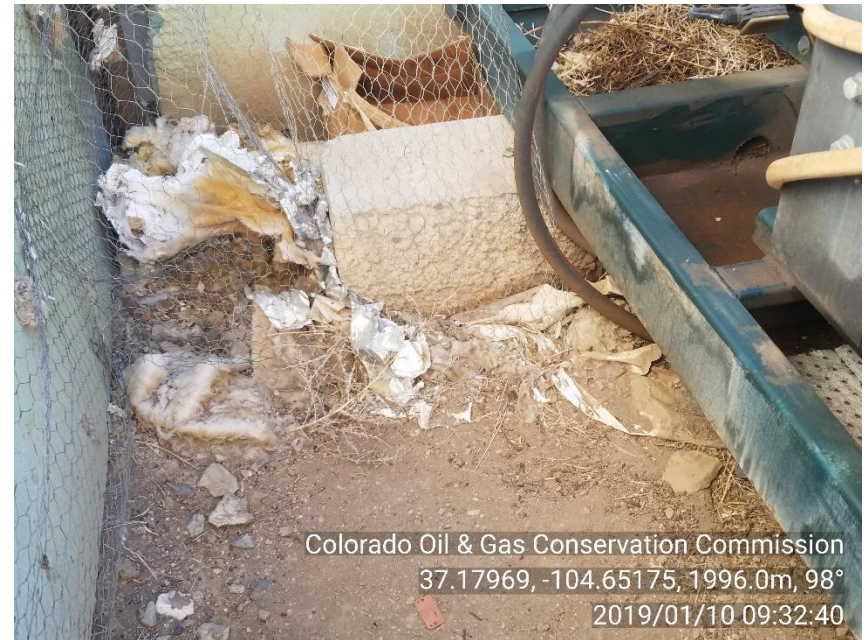
PHOTO 8: TRASH INSIDE SOUND WALLS NEAR DRIVE MOTOR
