## Inspection Photos

Location Name: Boies-62S98W 28SESE (#C-28P) Pad

Location ID: #335879

Inspection Date: January 11, 2019

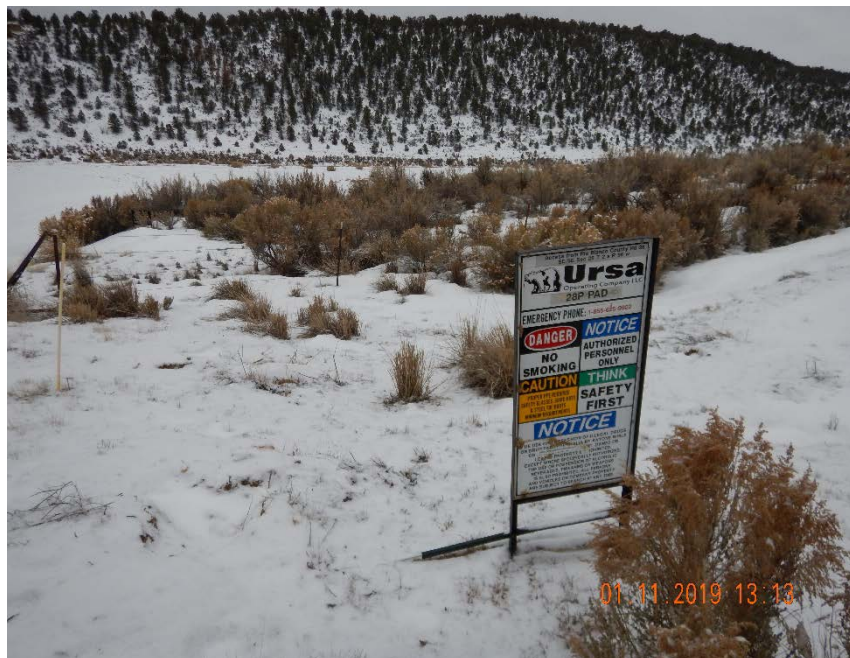
Photo #1 – Facility sign located at access road (NE corner of pad).

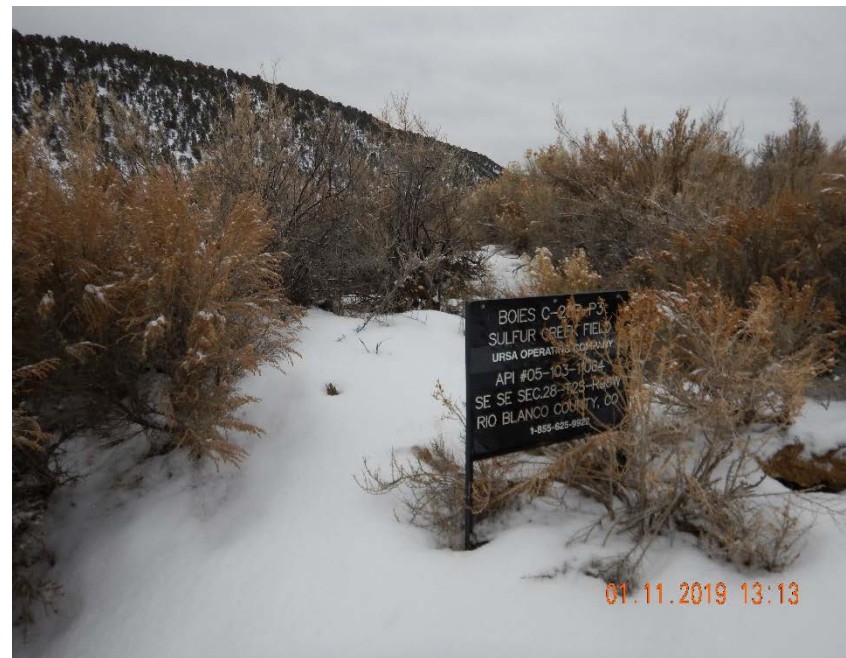
Photo #2 – Well sign located north of pad.

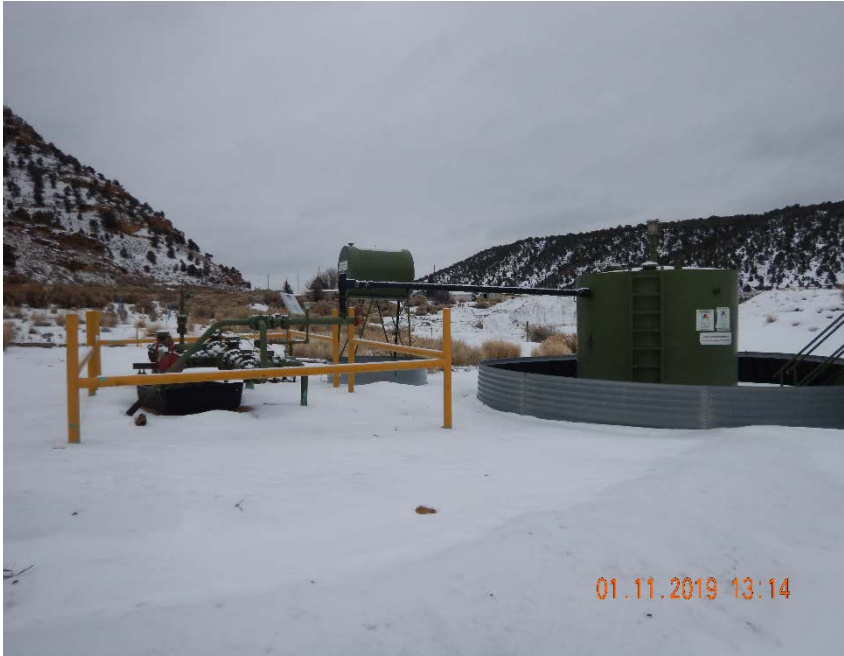
**Photo #3 – Pigging station, methanol tank, and 90 bbl produced water AST located at NE corner of pad.**

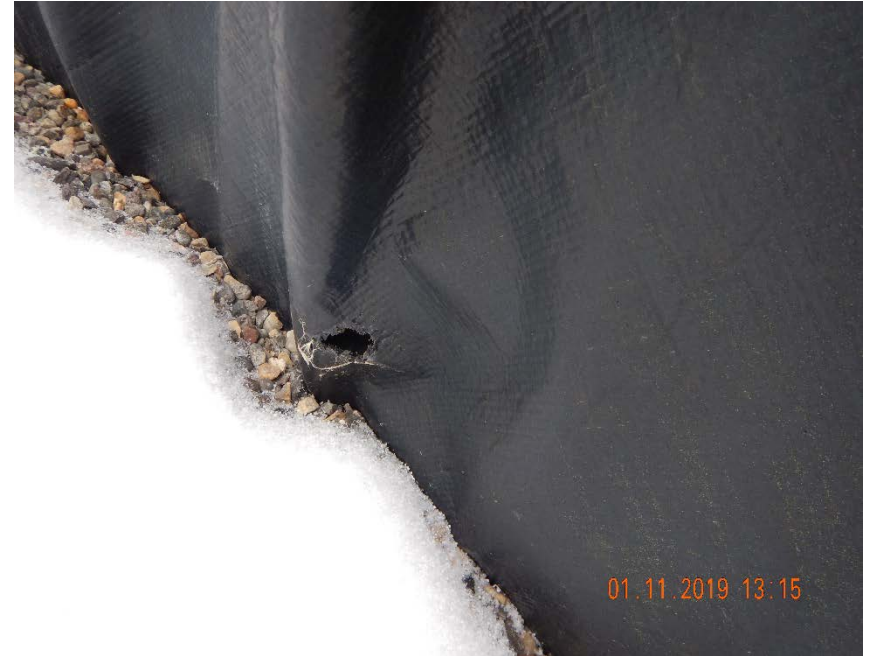
**Photo #4 – Small hole in NW corner of metal SPCC liner for 90 bbl produced water AST.**

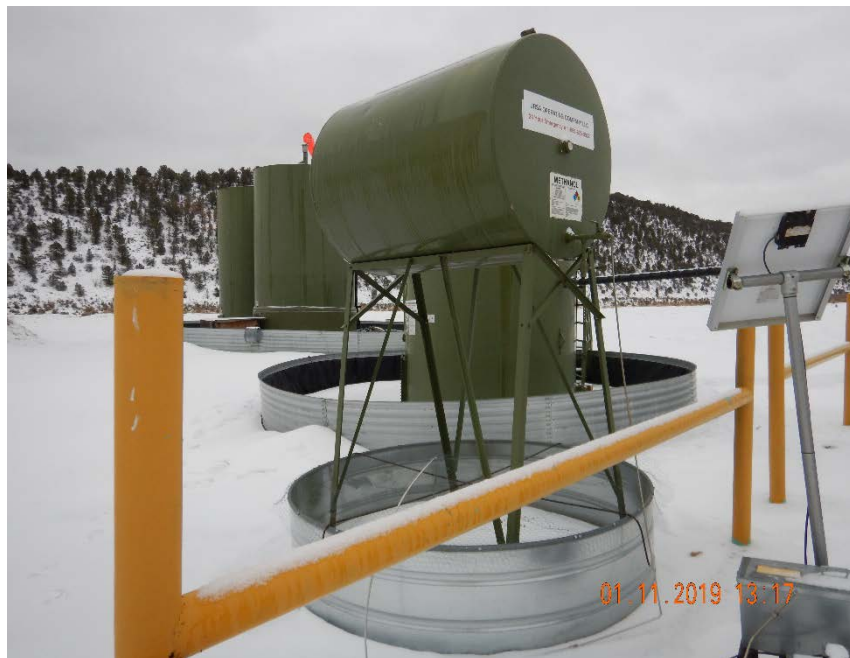
**Photo #5 – Methanol tank inside of secondary containment.**

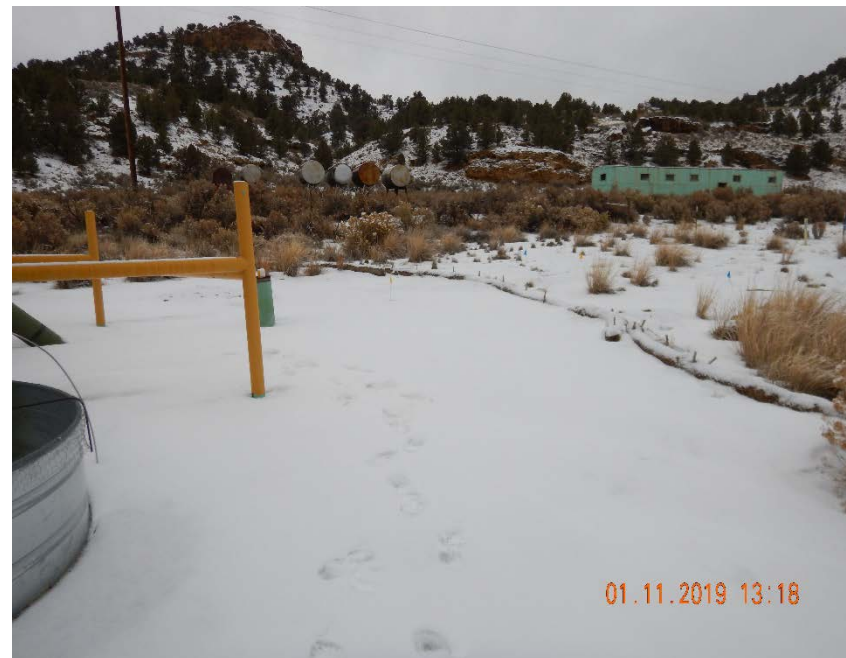
**Photo #6 – Straw wattle, seen here at NE corner of pad, extends along east side of pad.**

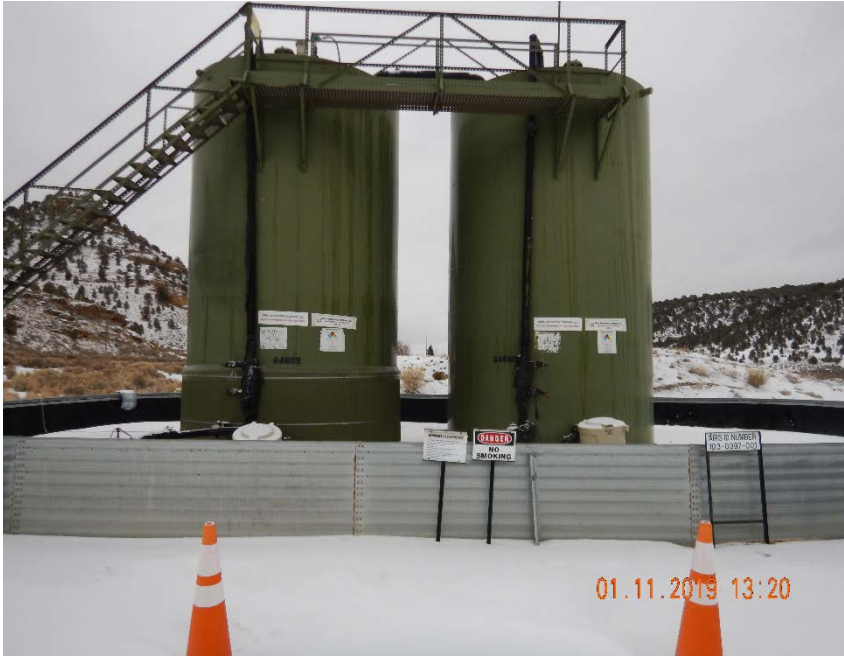
**Photo #7 – 400 bbl steel ASTs inside of lined, metal SPCC contain produced water (left tank) and condensate (right tank).**

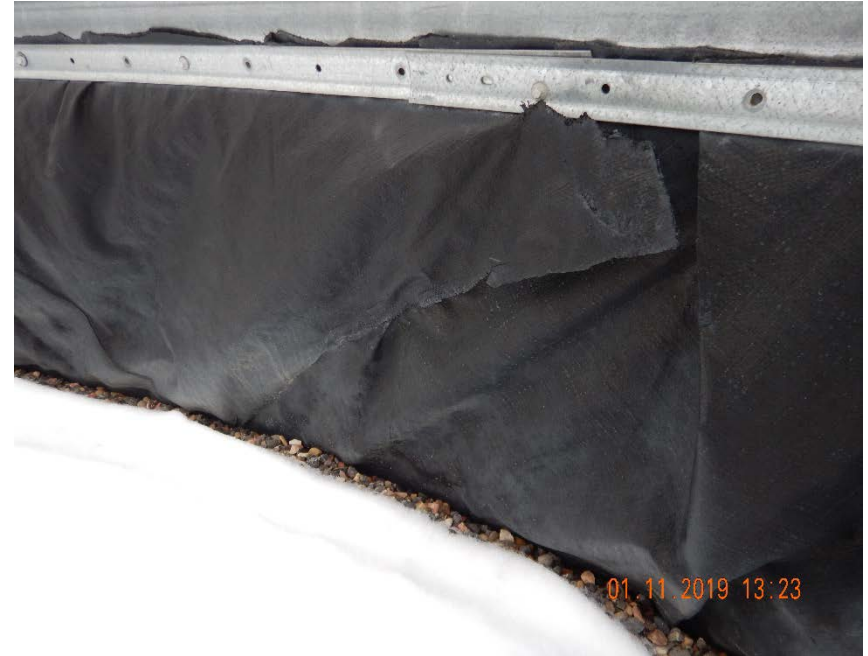
**Photo #8 – Tear in liner for 400 bbl ASTs was observed on south end of SPCC.**

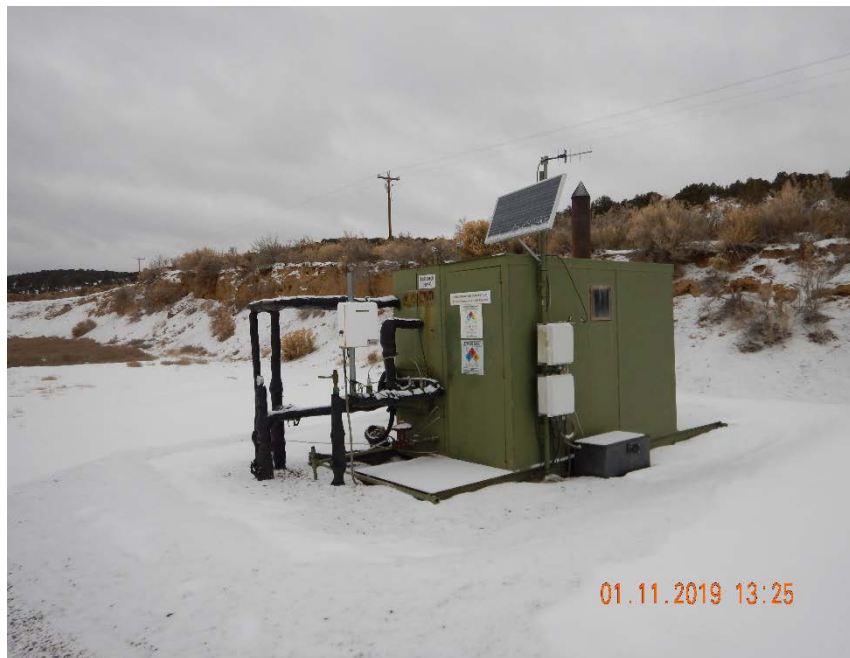
**Photo #9 – Horizontal heated separator located on north side of pad.**

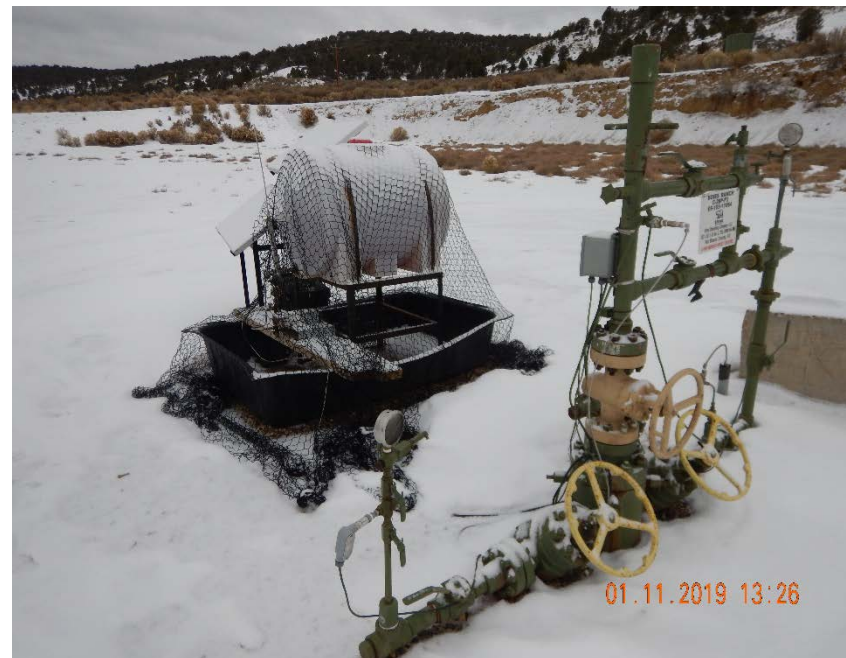
**Photo #10 – View of wellhead and day tank with secondary containment device.**

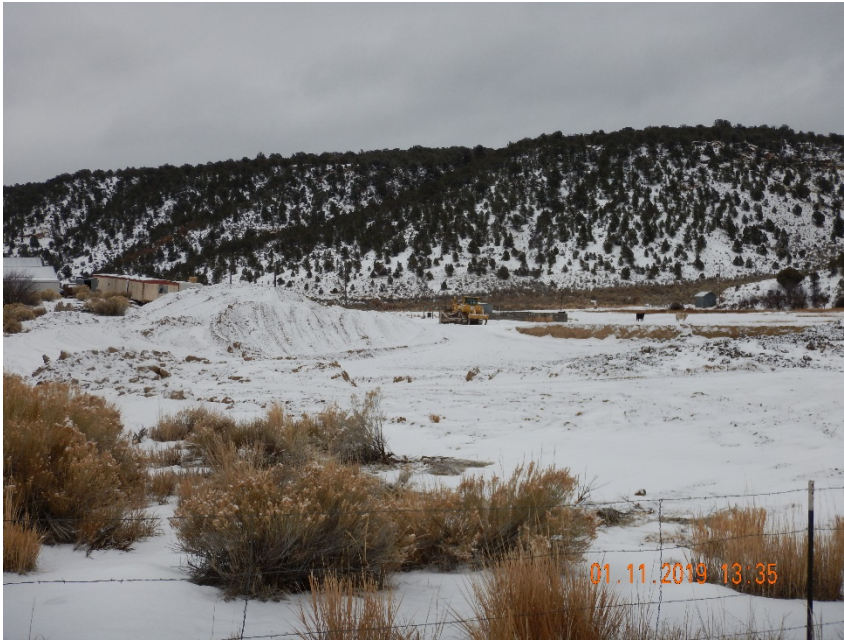
**Photo #11 – View into excavation on land adjacent to pad on the east side. Operator had requested COGCC permission to store cuttings in this area.**

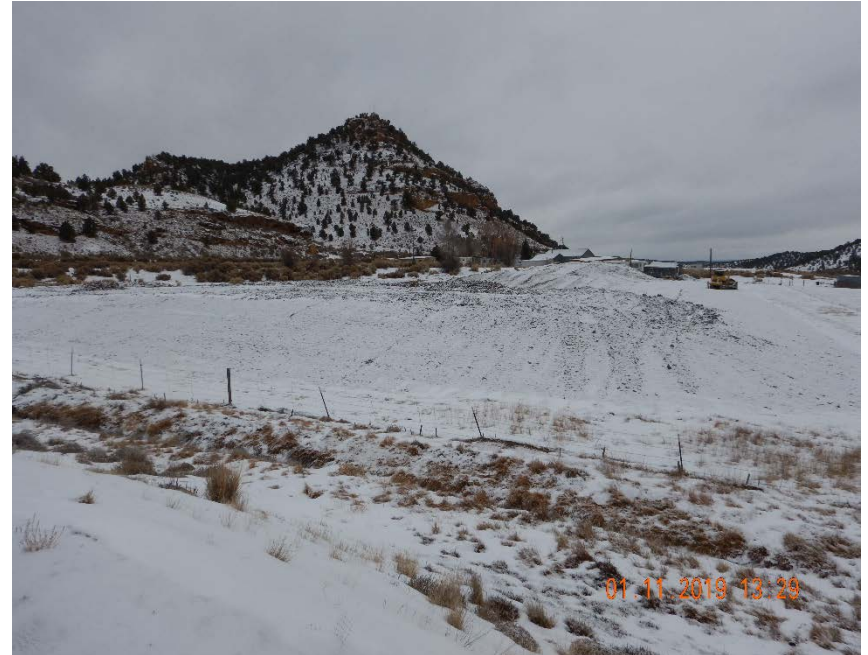
**Photo #12 – View of southwest corner of proposed cuttings management area.**
