Inspection Photos
Location Name: Lark 33-5 #21-4
API: 05-007-06323

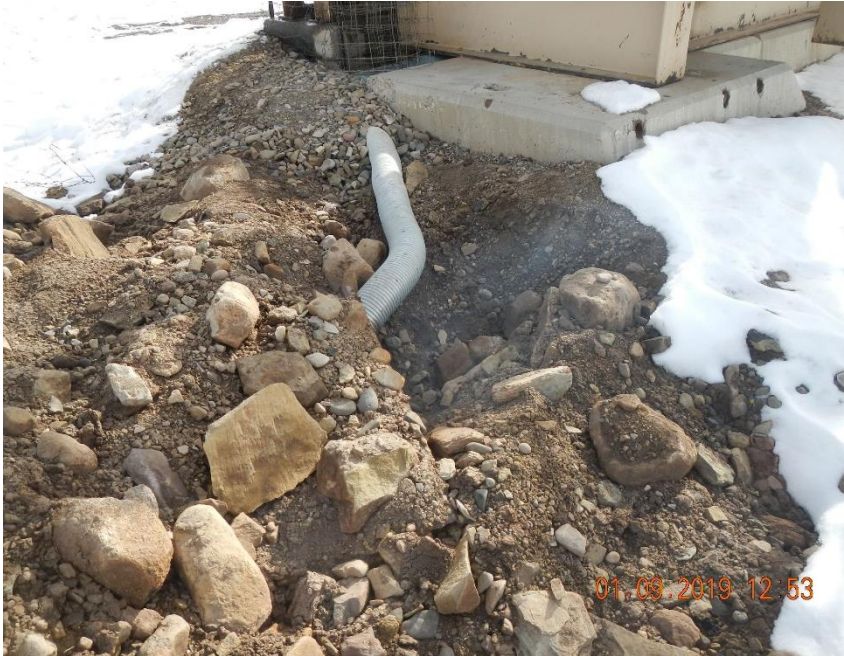
Prime mover exhaust routed underground.

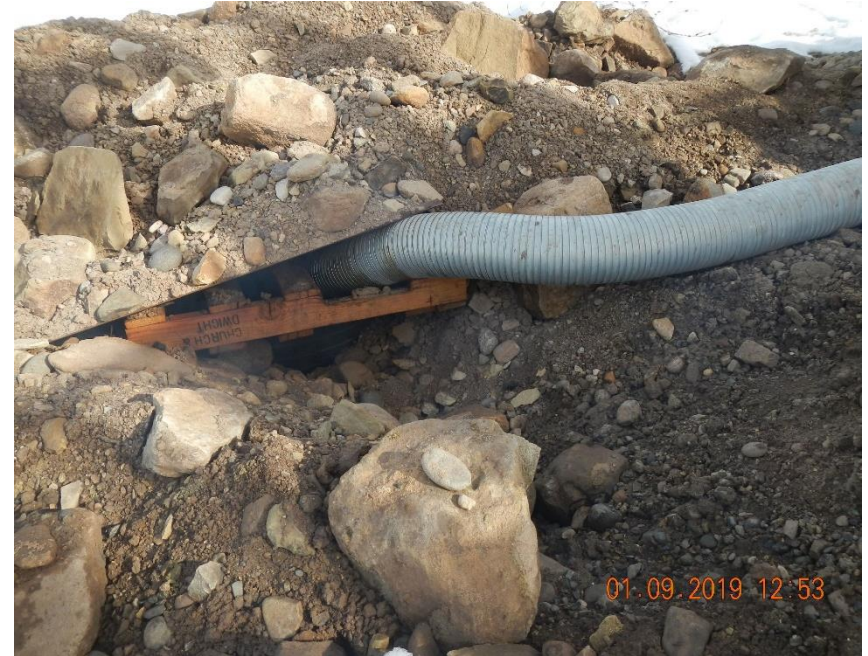
Prime mover exhaust pipe routed underground, reportedly for noise control.

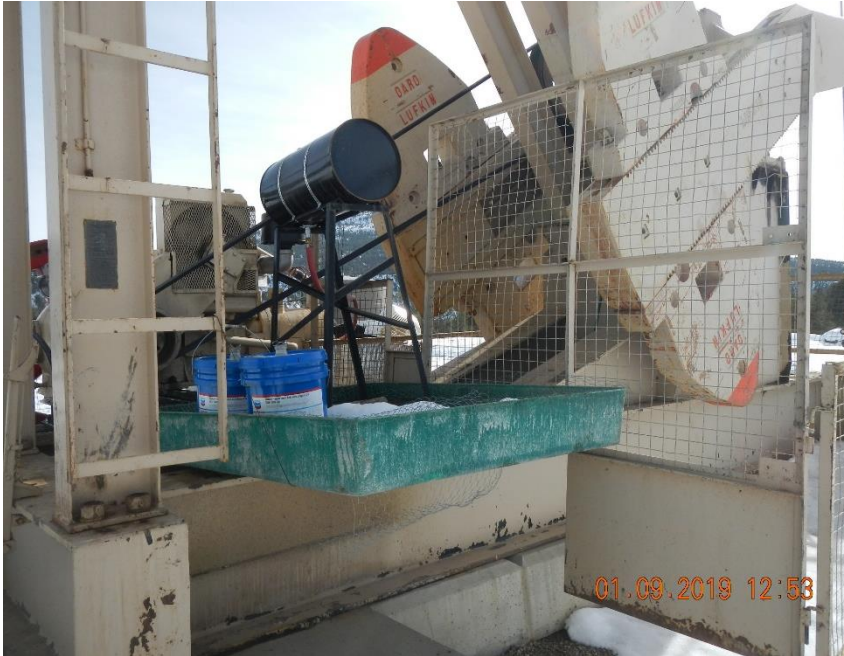
Two five gallon buckets of engine oil stored in secondary containment for lube oil container.

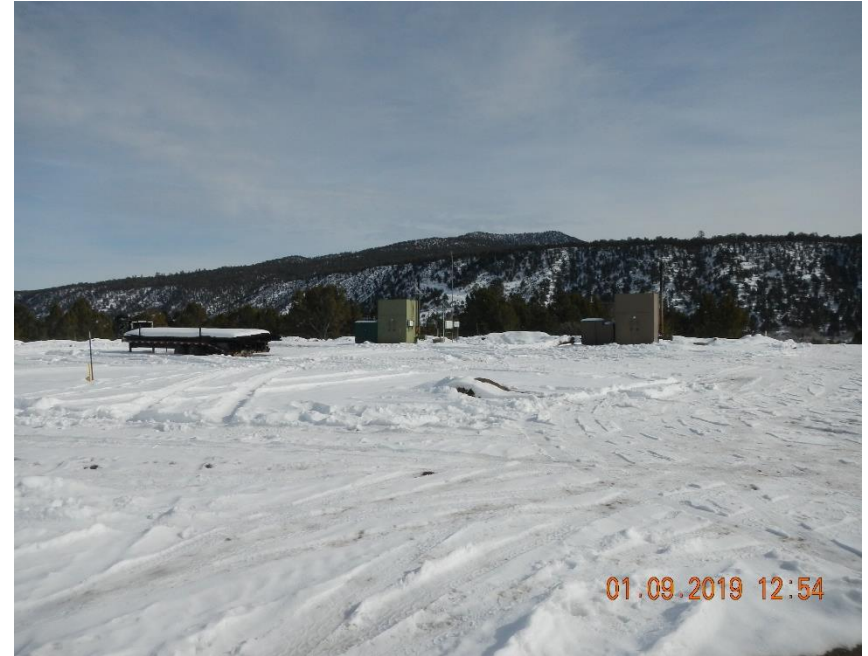
Tubing trailer stored on site during this inspection.

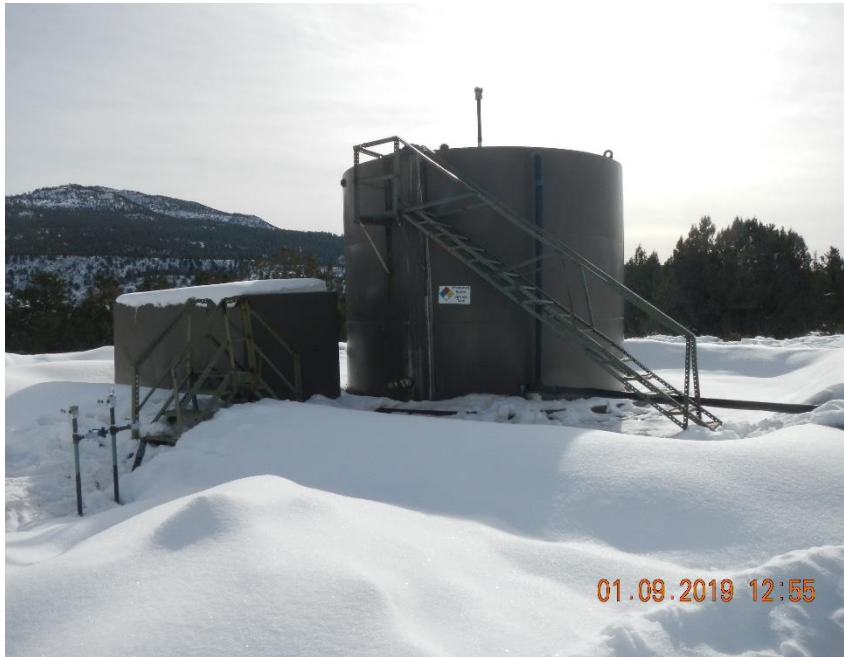
400 bbl. produced water AST installed since last inspection.

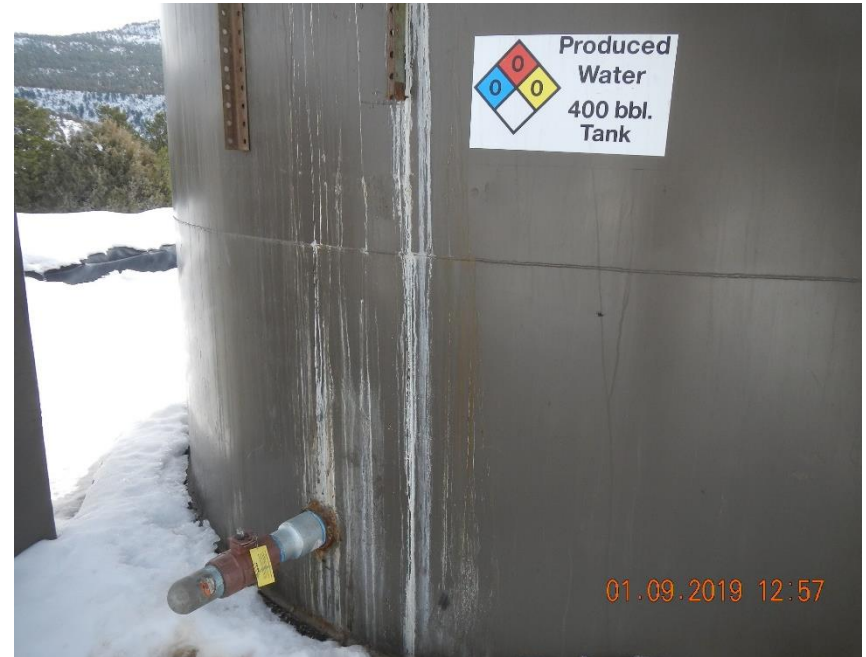
AST is stained and NFPA placard has zeros for all fields.

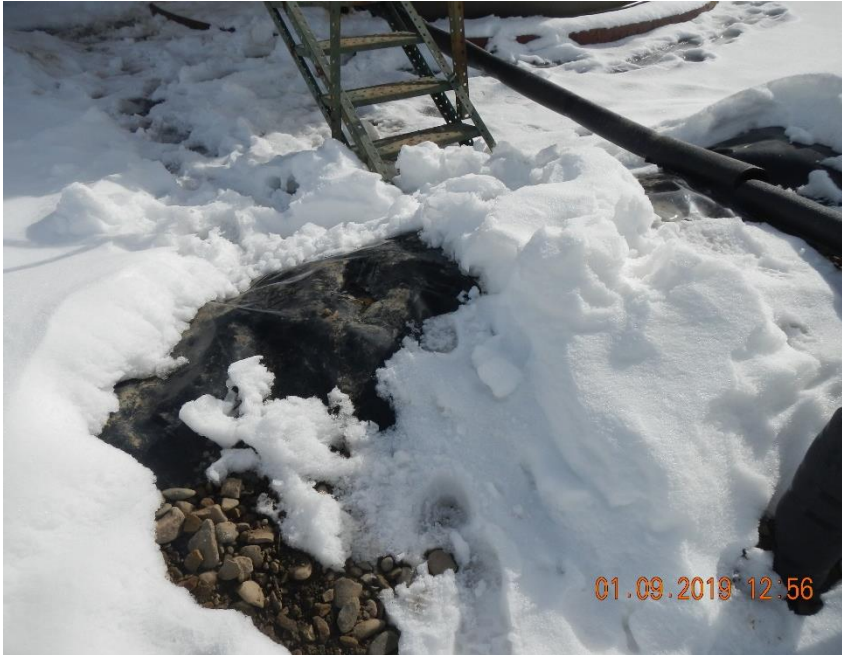
Liner in secondary containment berm for 400 bbl. AST.

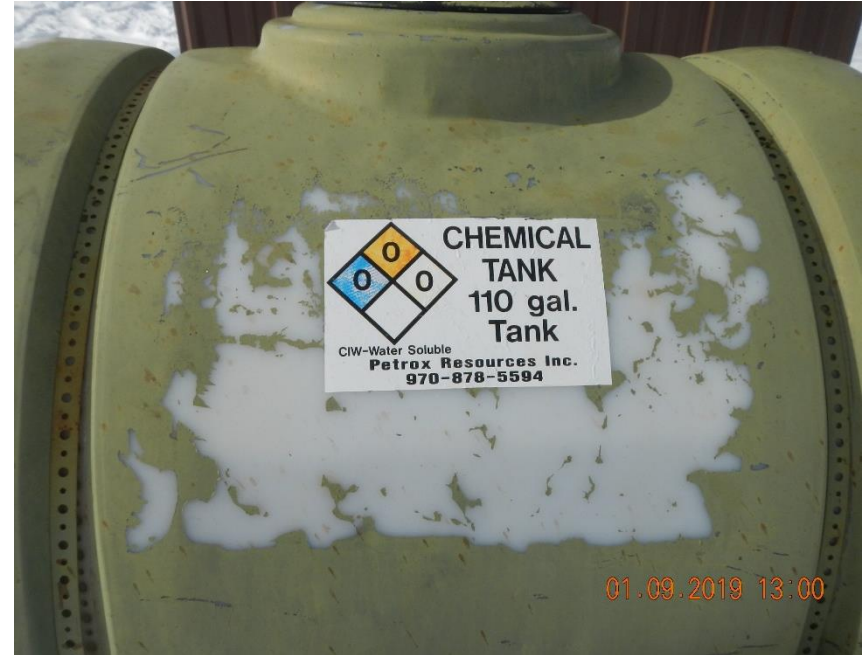
NFPA placard for corrosion inhibitor chemical container has zeros for all fields.
