Inspection Photos
Location Name: AC 13-16
Location ID: 308925

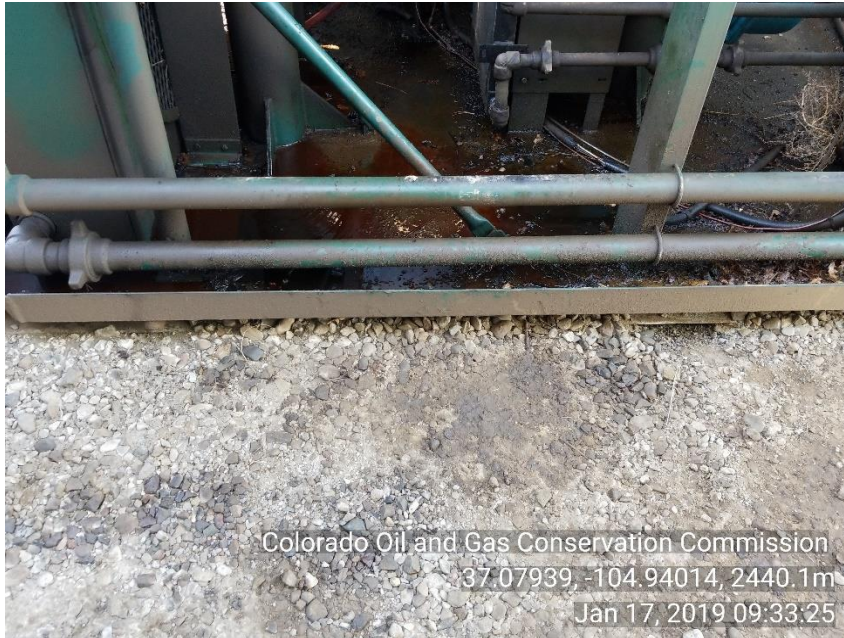
Photo 3 stained soil around liquid ring compressor
