Inspection Photos
Location Name: Basin Pipeline WC-4 Vault Release
Spill/Release ID: #460722
Inspection Date: January 15, 2019

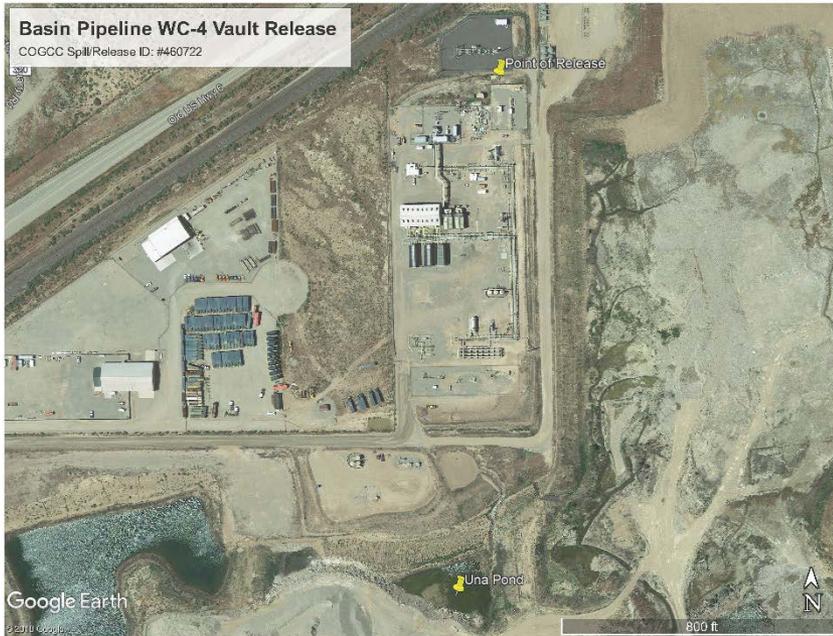
Photo #1 – Overview of spill location (2016 Google Earth aerial photo). North marker designates point of release (POR) and south marker designates impacted gravel pit location (Una pit).

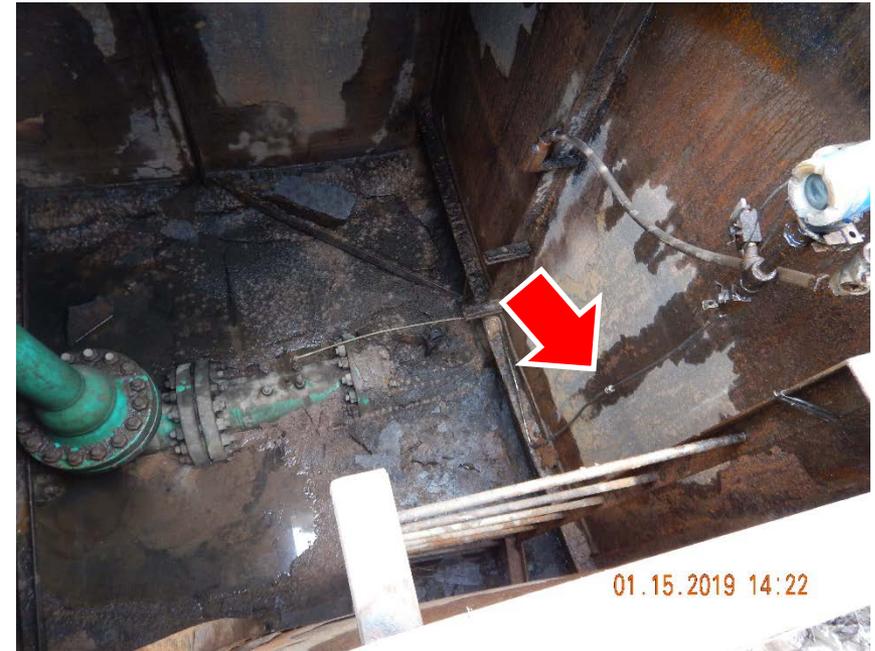
Photo #2 – Looking south into Basin Pipeline WC-4 Vault. Red arrow points to location of 3/8” stainless steel line that was the POR. Stainless steel line had been repaired prior to inspection date.

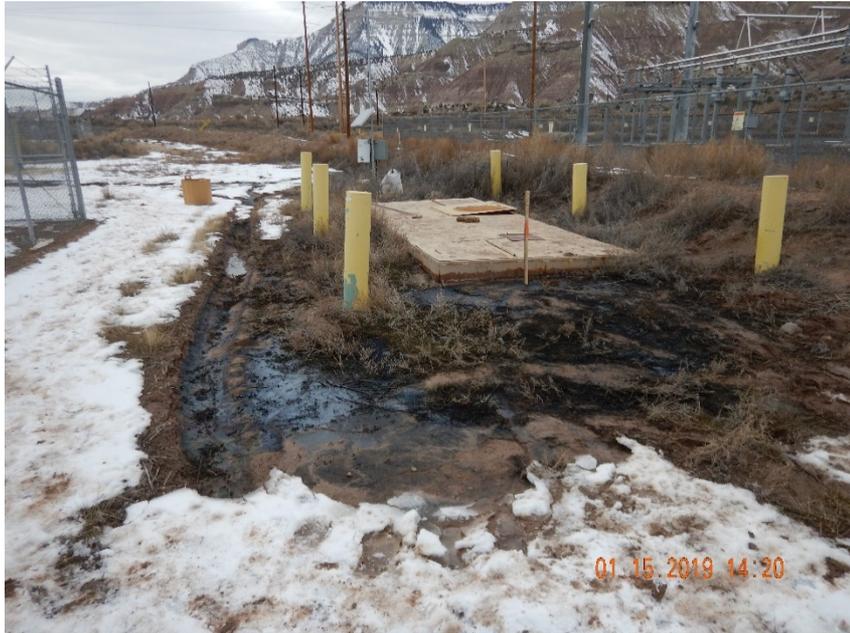
Photo #3 – Stained soil surrounding pipeline vault/POR, looking west.

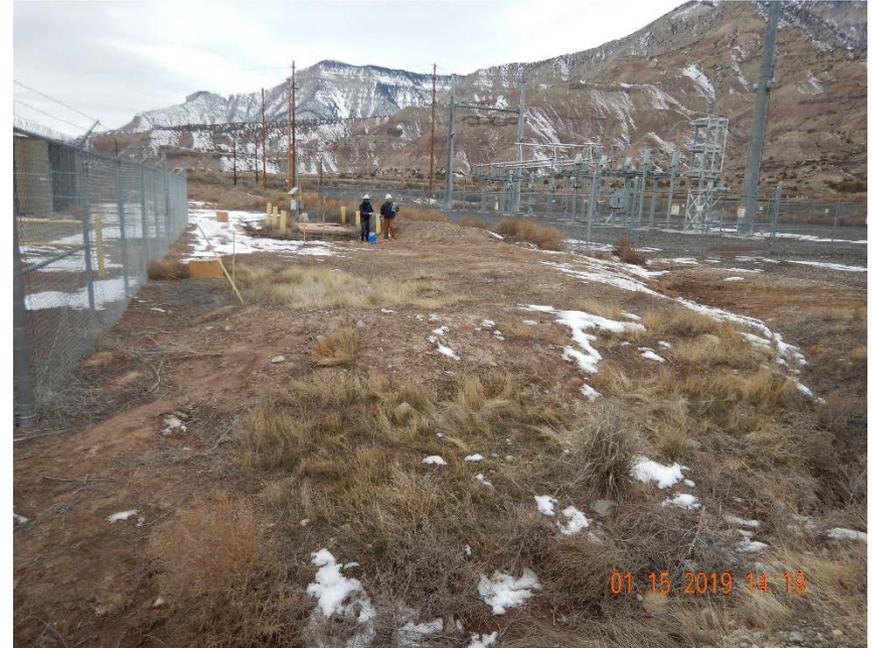
Photo #4 – LTE staff were collecting soil samples in response to spill on inspection date.

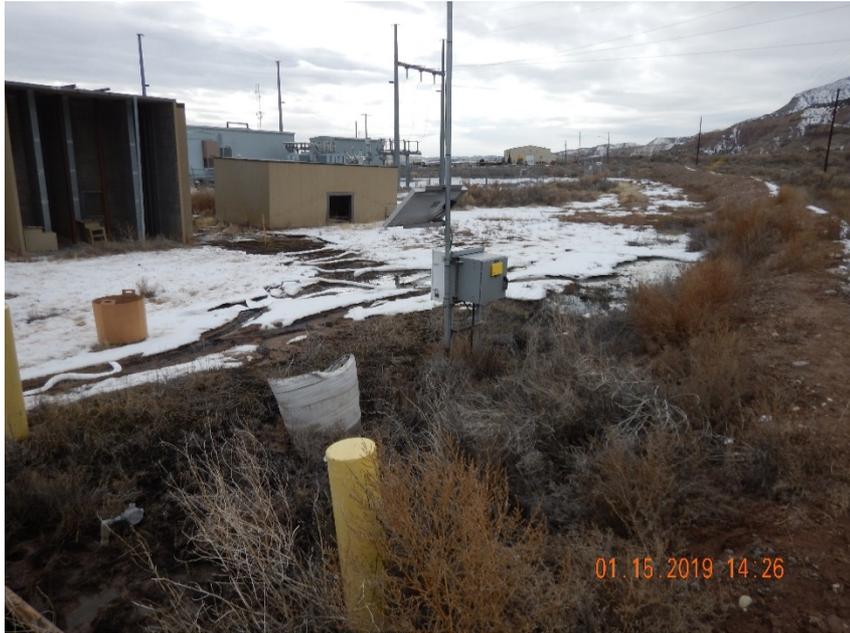
Photo #5 – Stained soil and free fluid located west of POR. Note absorbent booms had been placed along flow path by operator.

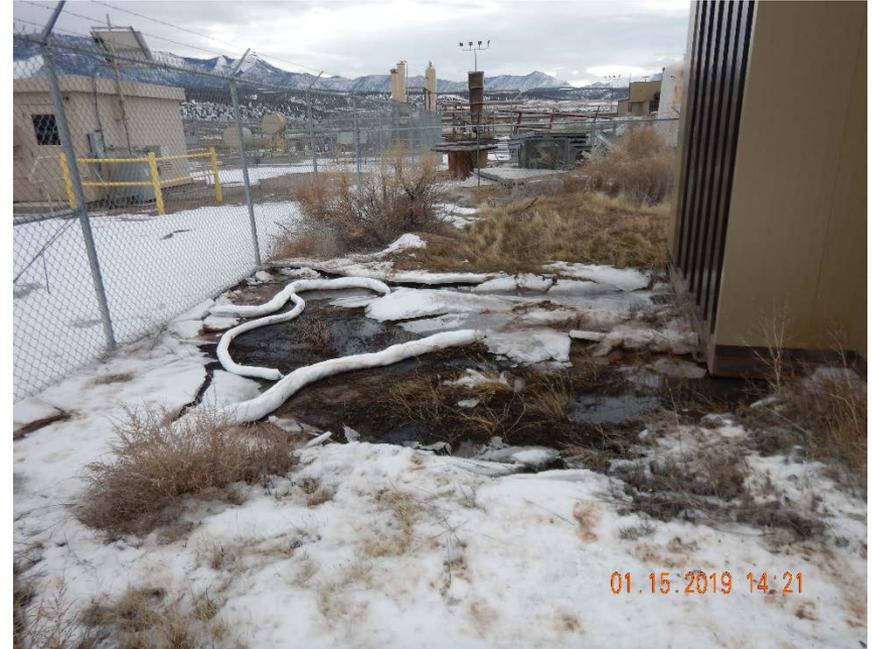
Photo #6 – Looking south along flow path and into Orchard Compressor Station.

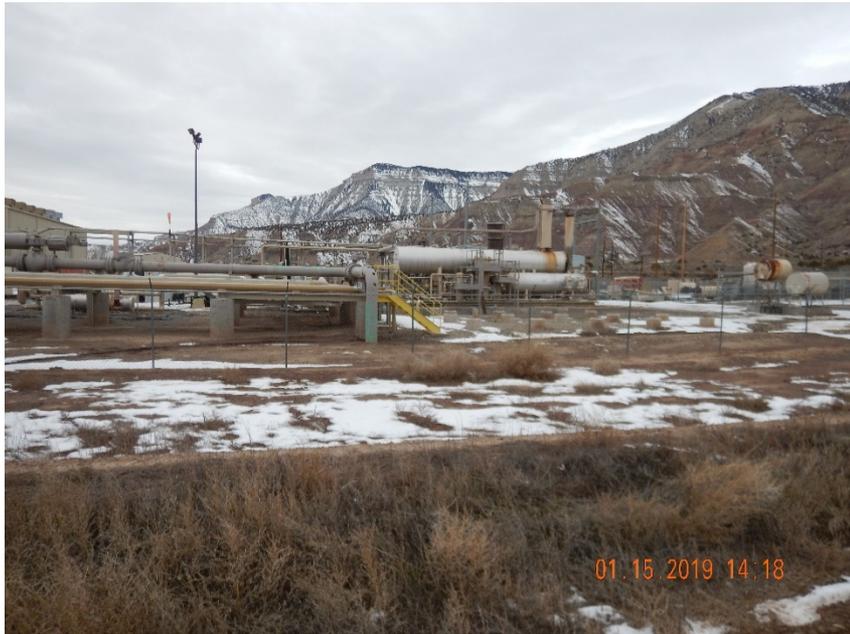
Photo #7 – Looking west into Orchard Compressor Station. Released fluids travelled along east fence line primarily through stormwater drainage ditch, though some fluid also flowed along ground surface inside of compressor station.

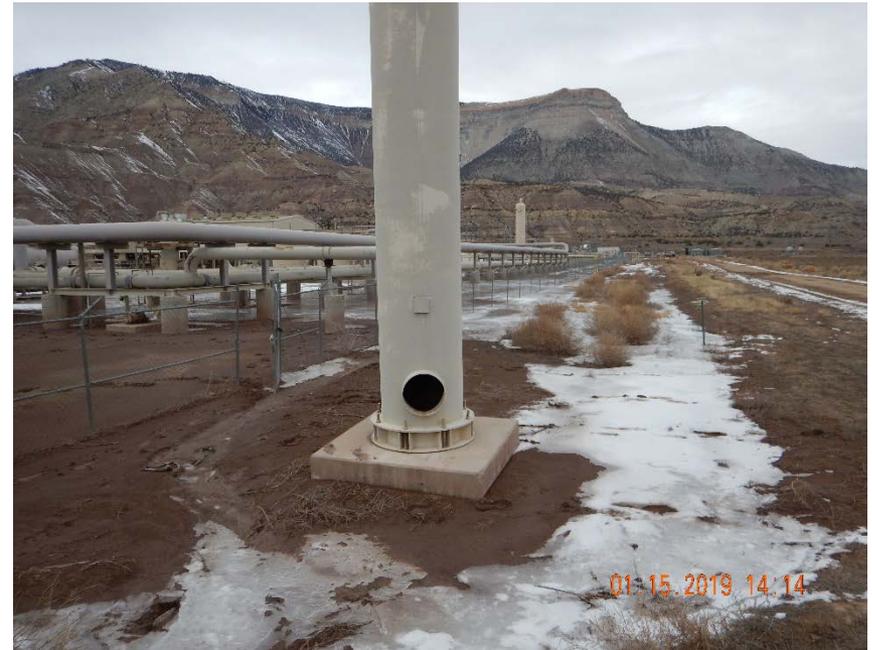
Photo #8 – View to the north along stormwater drainage ditch and flow path along east side of Orchard Compressor Station.

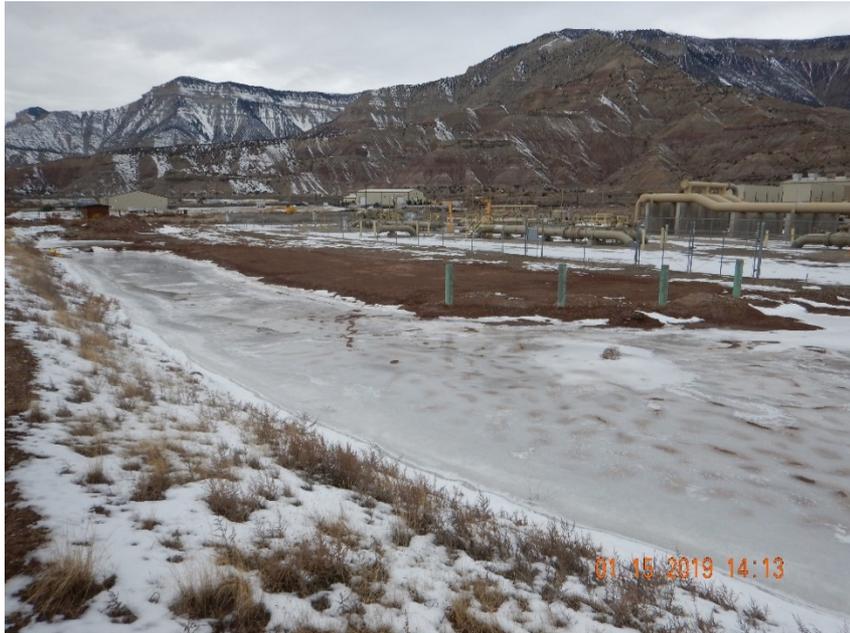
Photo #9 – Accumulation of released fluids and stormwater inside of sediment trap located south of Orchard Compressor Station.

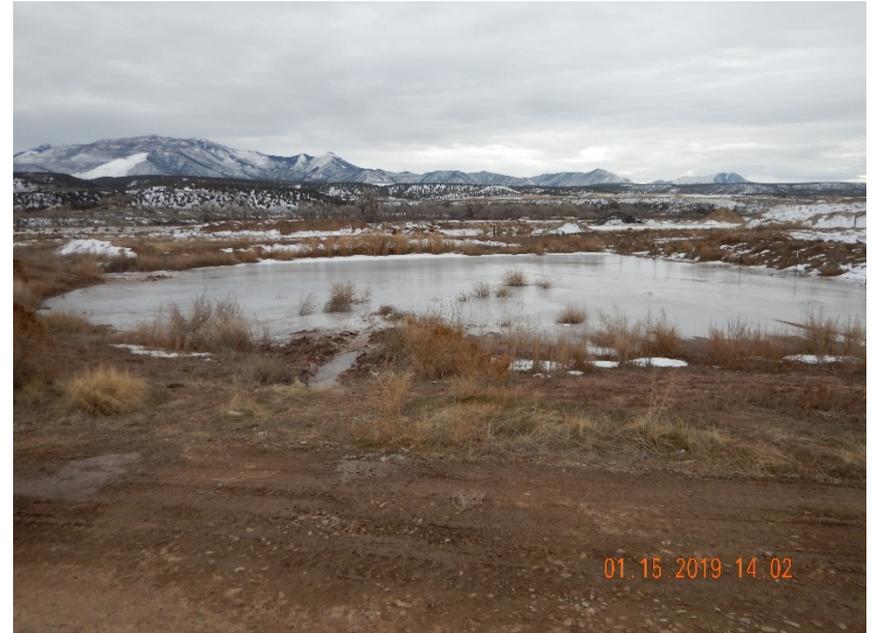
Photo #10 – View of stormwater pond located across access road (to the south) from Orchard Compressor Station. Released fluids flowed into sediment pond from sediment trap in previous photo via a culvert beneath access road.

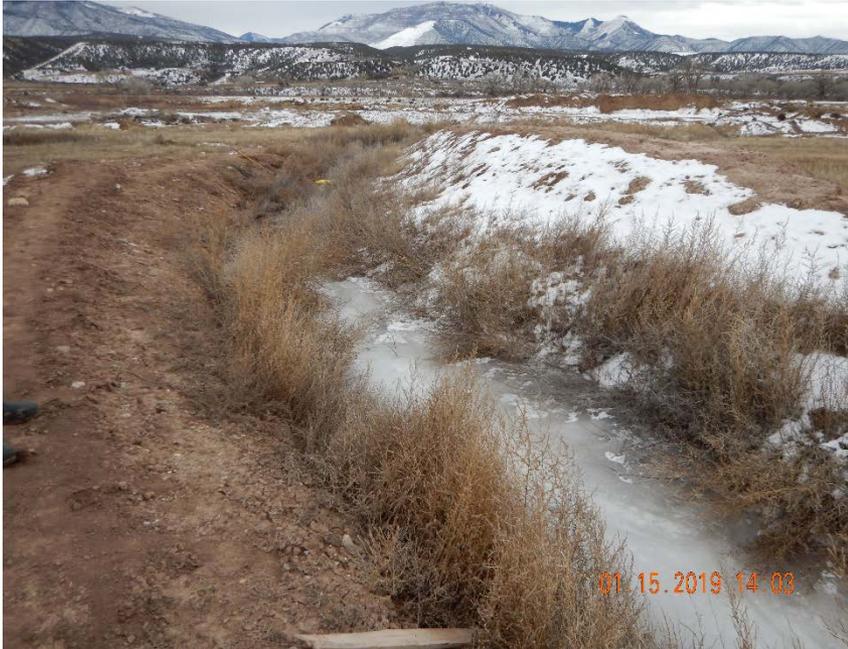
Photo #11 – Looking south along sediment pond overflow channel, located SE of sediment pond from previous photo. Released fluid flowed from pond through overflow channel and into gravel pit to the south.

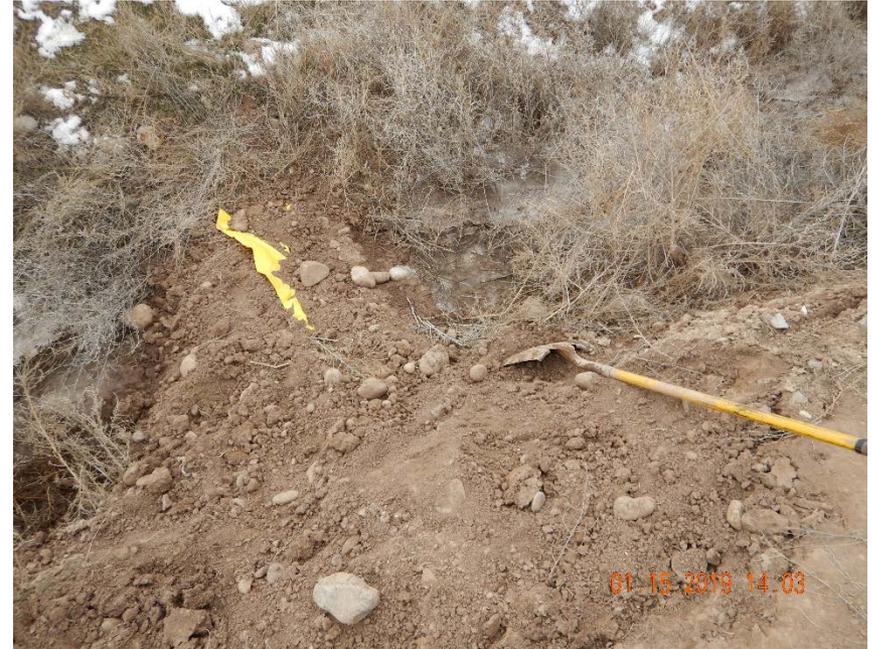
Photo #12 – Earthen dam inside of overflow channel was constructed by operator during initial spill response efforts.

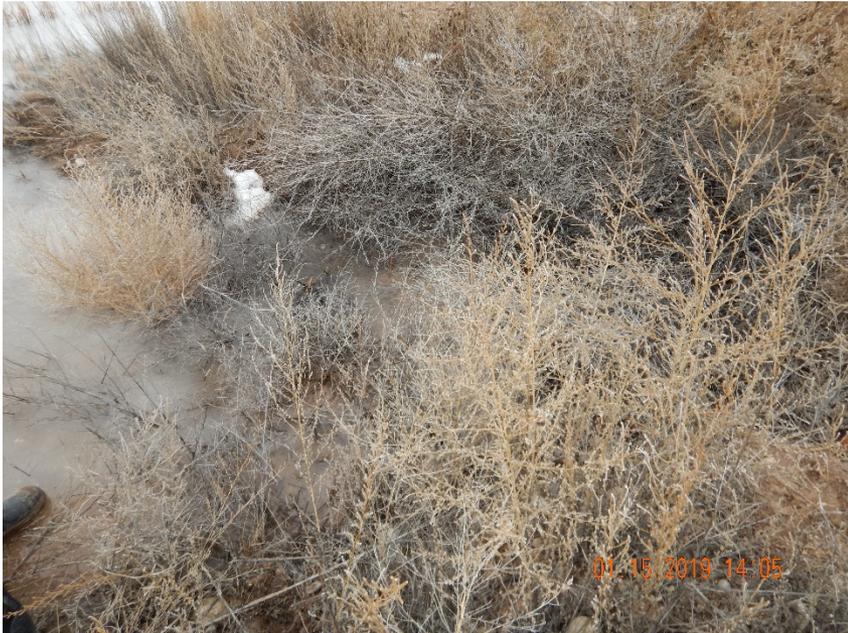
Photo #13 – Inlet to Una Pit complex from overflow channel in previous photos. Operator collected a water sample from this location prior to inspection date (pond inlet sample). Preliminary lab results for pond inlet sample confirm impacts to Una Pit (benzene exceedance of 144 ppb).

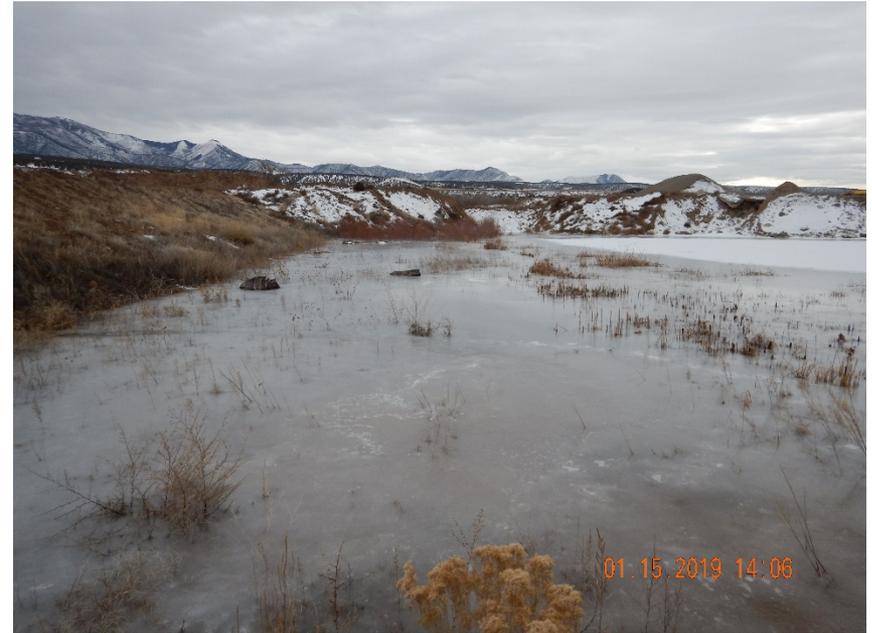
Photo #14 – View overlooking impacted Una Pit, looking south.

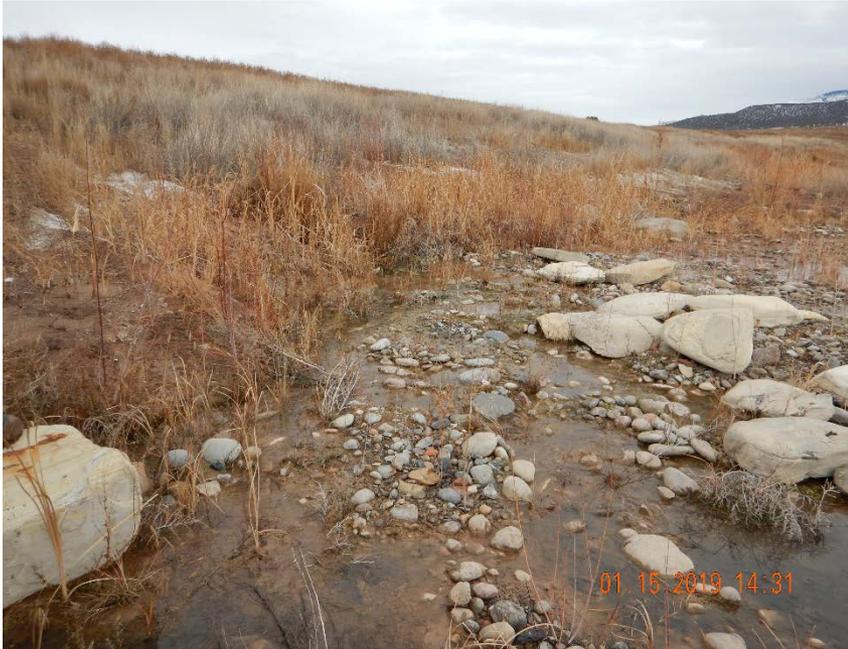
Photo #15 – View of groundwater seep located ~400' southeast of POR (~1140' NNE of Una Pit). Operator collected a water sample from this location on inspection date (results pending). Water from this seep was observed to flow south, parallel to flow path on inspection date.

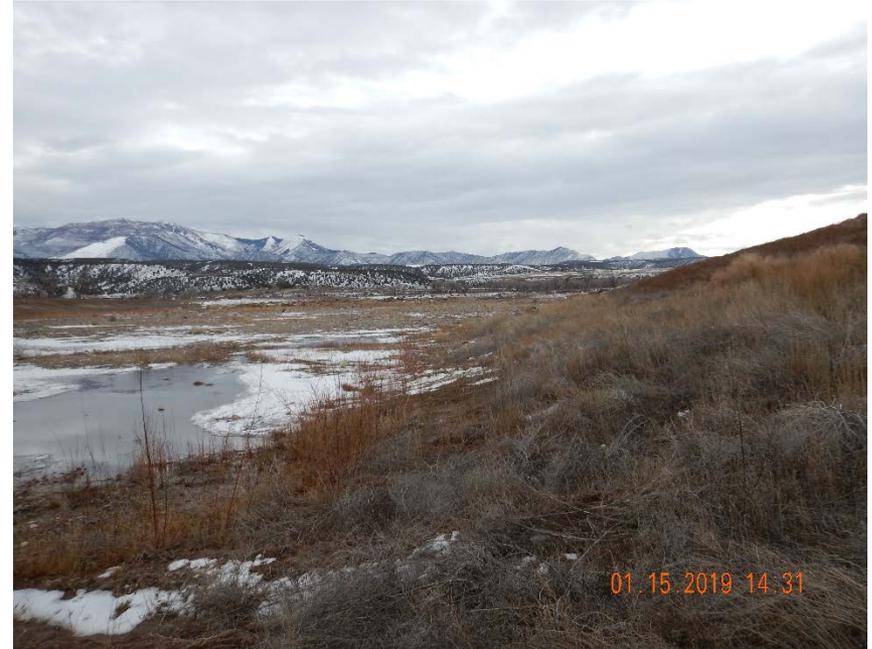
Photo #16 – View along flow path of water from groundwater seep in previous photo, looking southeast.
