Interim Reclamation and Stormwater Inspection

Operator: BONANZA CREEK ENERGY OPERATING COMPANY LLC - #8960

Location ID: 450201

Inspection Photos
Location Name: Longhorn /U-10 Pad
Location ID: 450201

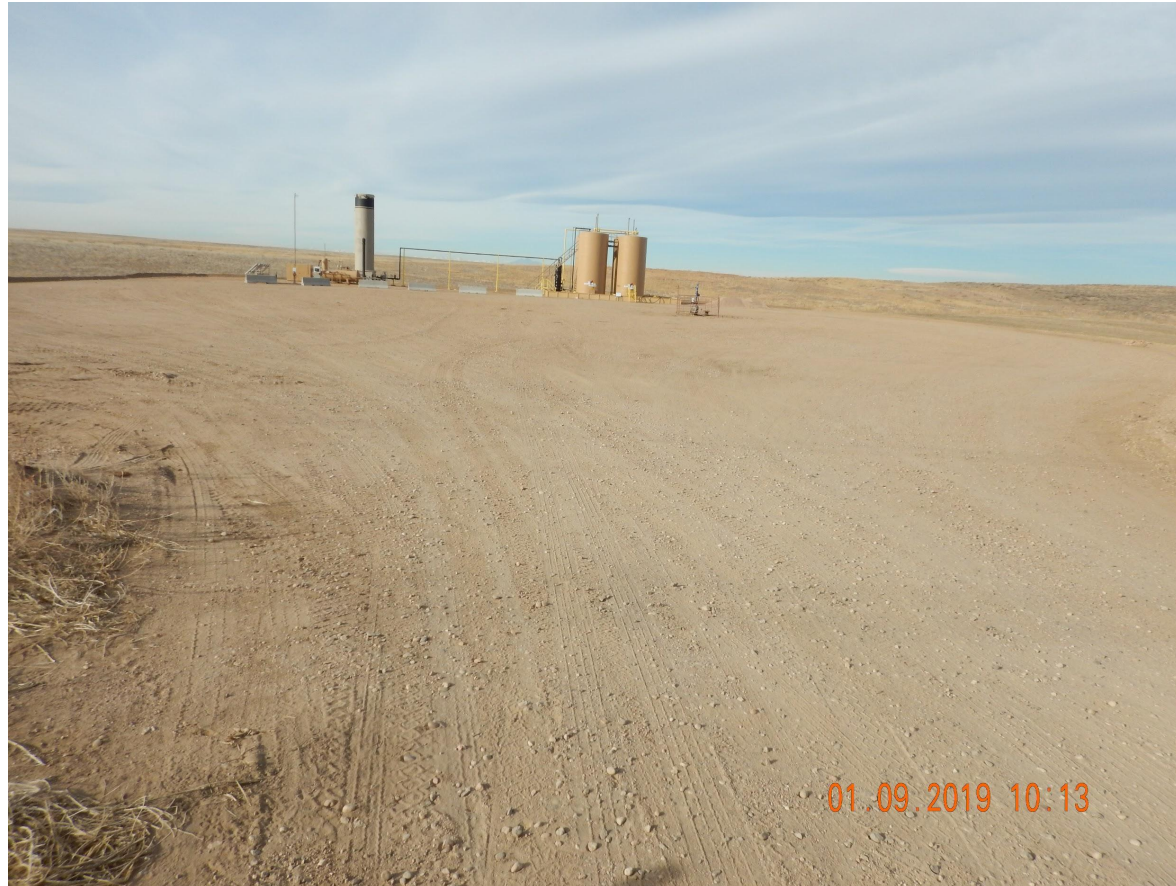
Photo 1. Photo taken from the entrance of the location, facing West. Operator has performed interim reclamation activities to reduce disturbance areas only needed for production operations; however, the southeastern well pad area does not appear to be needed for production operations. Operator shall comply with Rule 1003 standards to reduce disturbance areas only needed for production operations. In addition, it appears unconsolidated soil material from the well pad has not been adequately stabilized to control dust and wind erosion. Staff observed soil particle deposition as a result of wind erosion along the southwestern area off Location. Wind erosion was also observed along the southeastern area off Location.

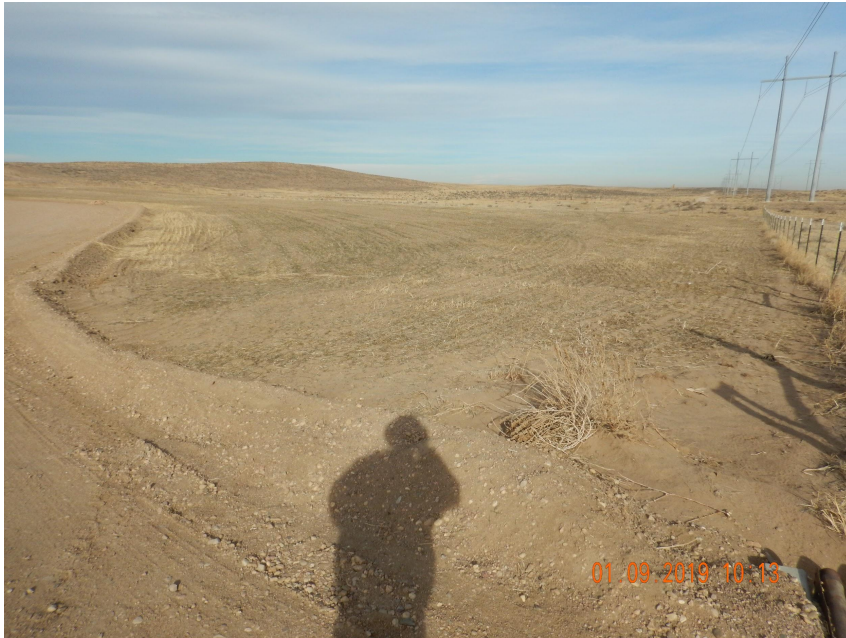
Photo 2. Photo taken from the entrance of the location, facing North. Operator has performed interim reclamation activities with the evidence of drilling rows, straw crimped mulch and germination. Interim areas appear to be properly contoured to the surrounding landscape.

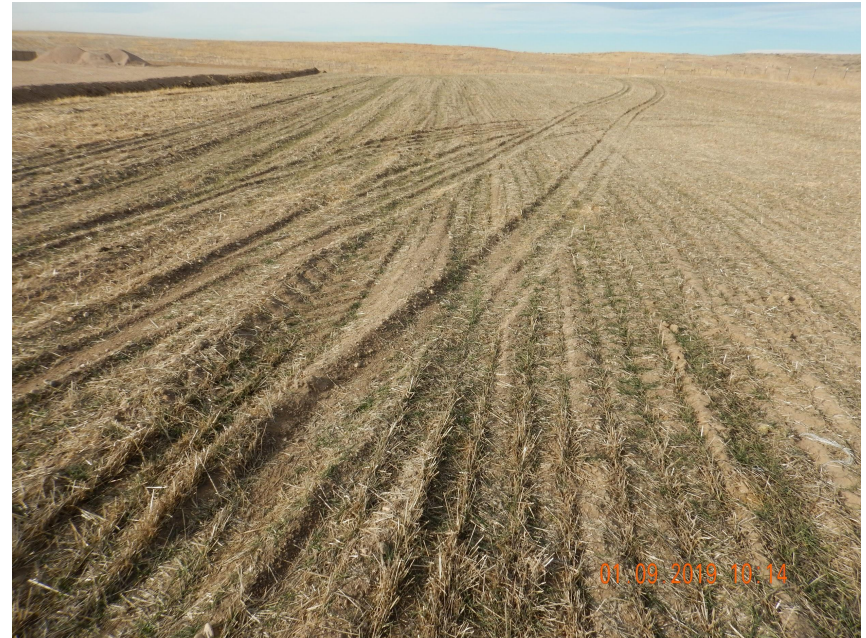
Photo 3. Photo taken from the northeastern interim area, facing West. Operator shall keep vehicle traffic off interim areas while in the revegetation process.

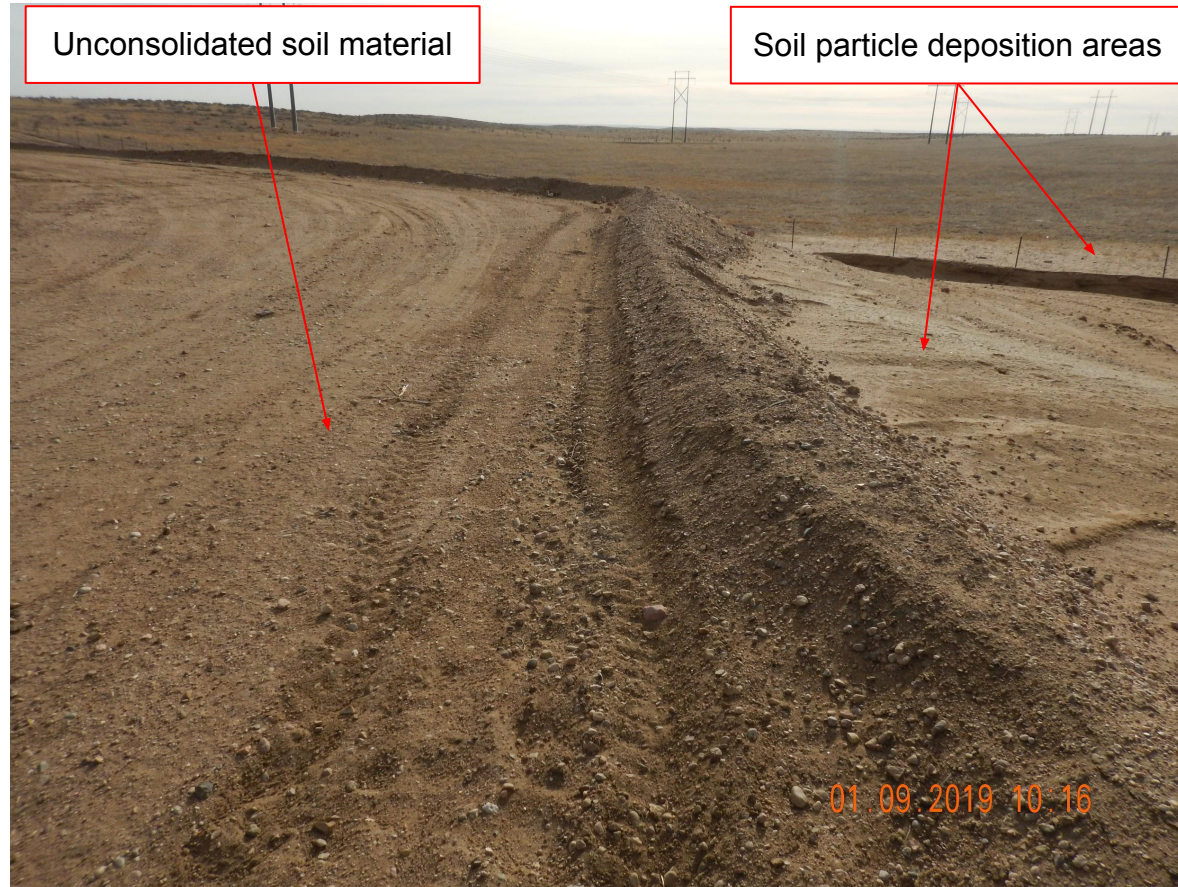
Photo 4. Photo taken from the southwestern well pad, facing South. It appears unconsolidated soil material from the well pad has not been adequately stabilized to control dust and wind erosion. Photo illustrates soil particle deposition as a result of wind erosion onto fill slopes and along the southwestern area off Location.

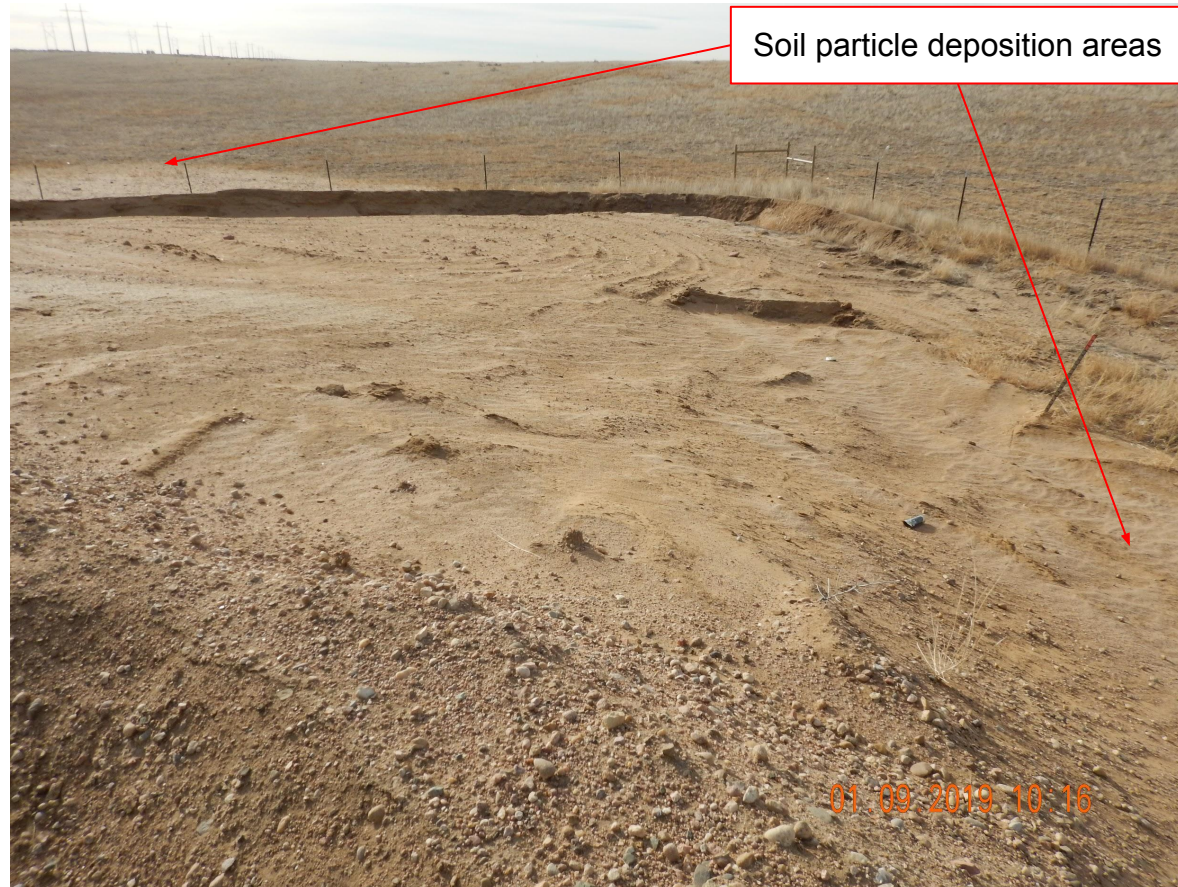
Photo 5. Photo taken from the southwestern well pad, facing Southwest. See comments under Photo 4.

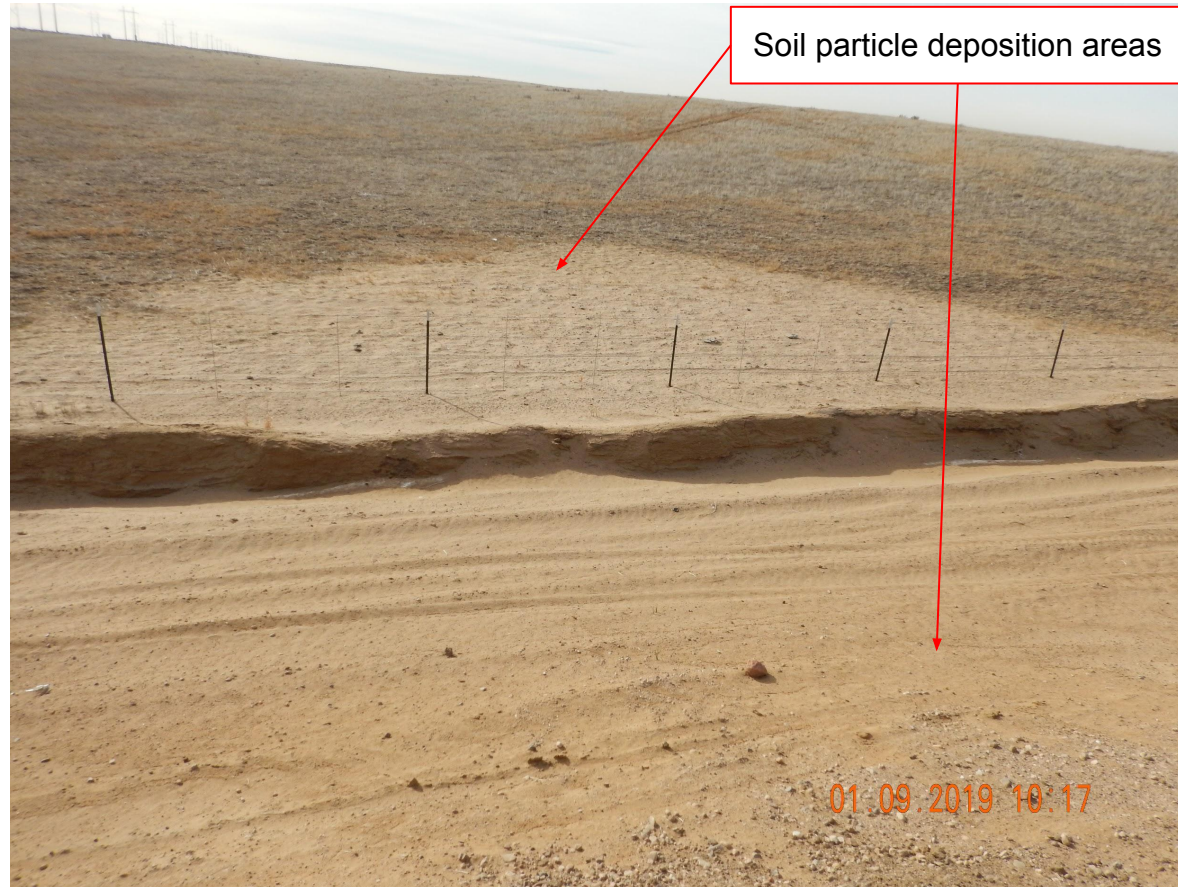
Photo 6. Photo taken from the southwestern well pad, facing Southwest. See comments under Photo 4.

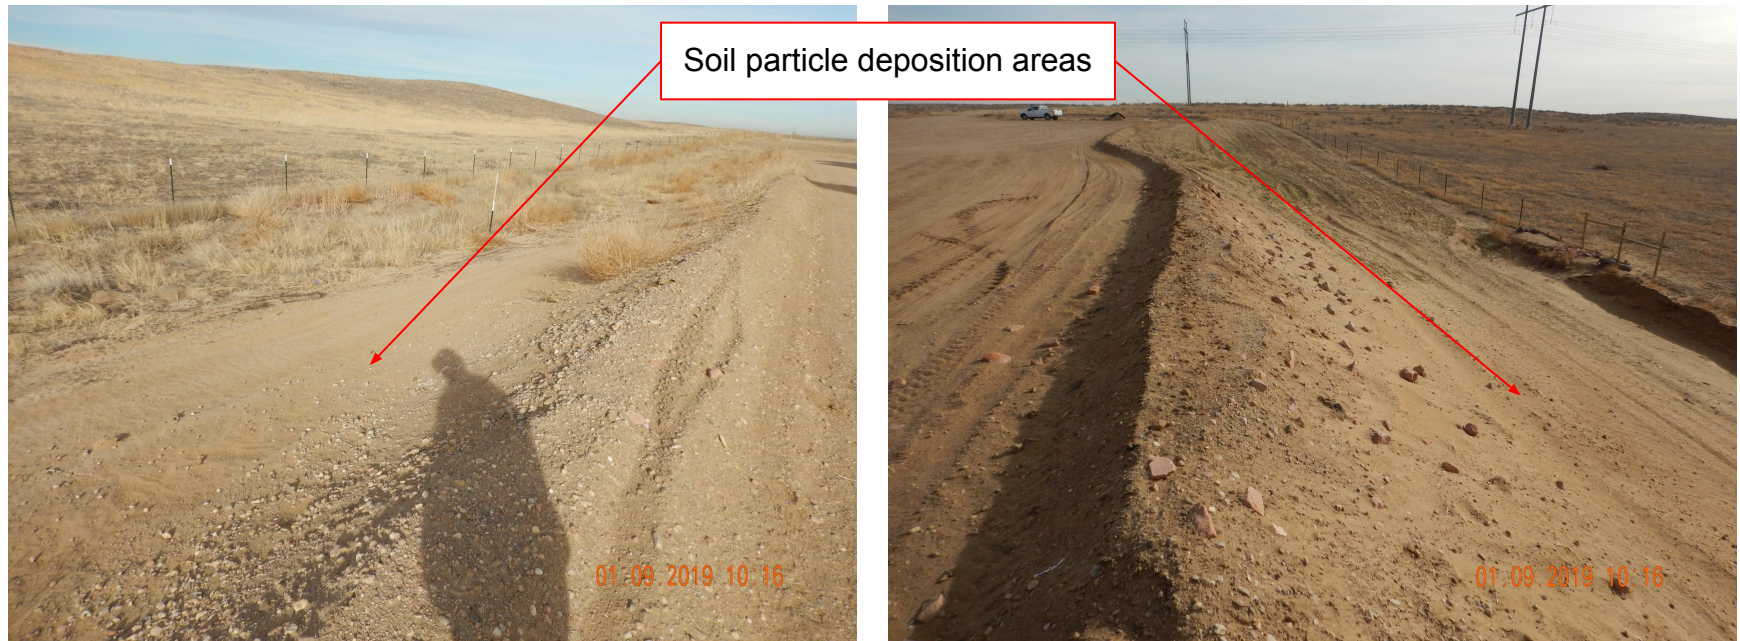
Photo 7. Photo taken from the southwestern well pad, facing Northwest. See comments under Photo 4.

Photo 8. Photo taken from the southwestern well pad, facing East. See comments under Photo 4.

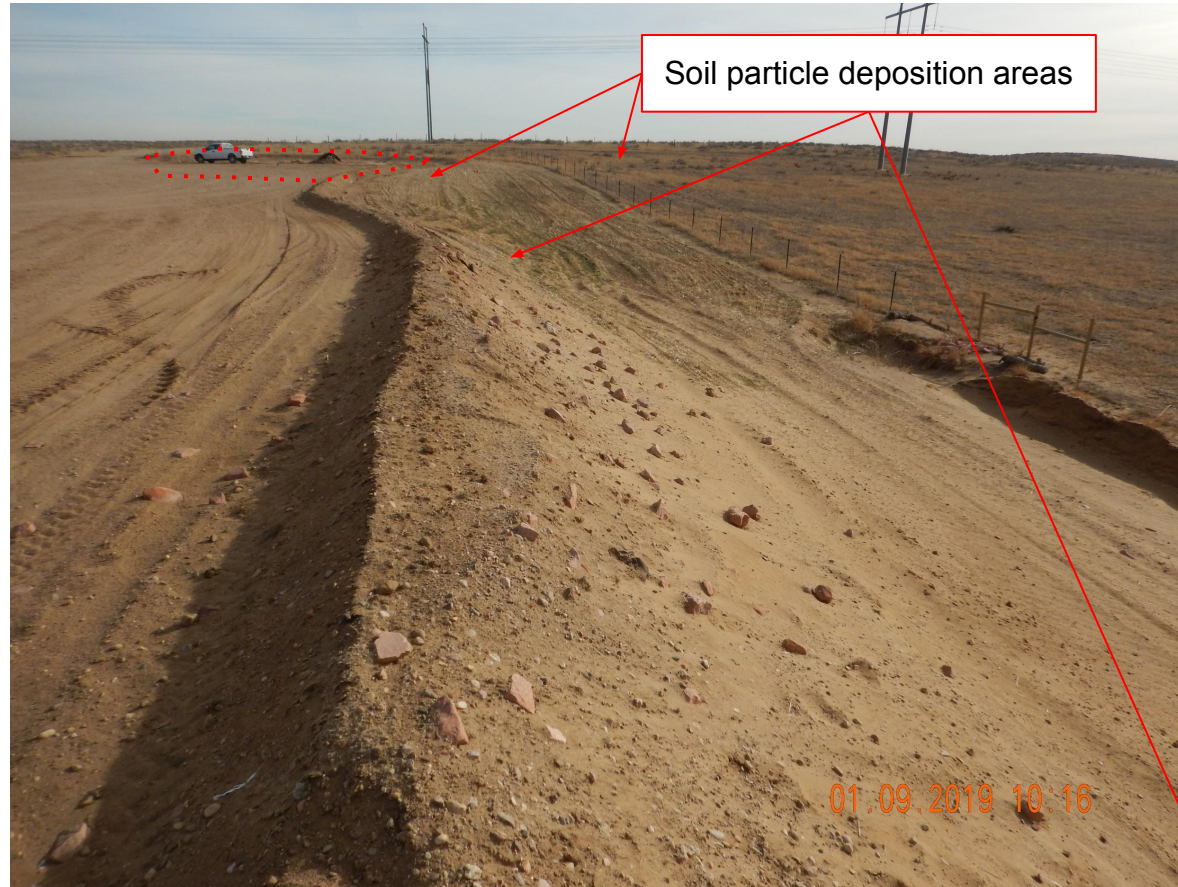
Photo 9. Photo taken from the southwestern well pad, facing East. The red-dotted circle indicates the area that does not appear to be needed for production operations and shall be reclaimed per Rule 1003. Also, appears this portion of the well pad and perimeter are not adequately stabilized, further support for reclaiming the area and implement long-term stabilization through revegetation. See Photos 11-13.

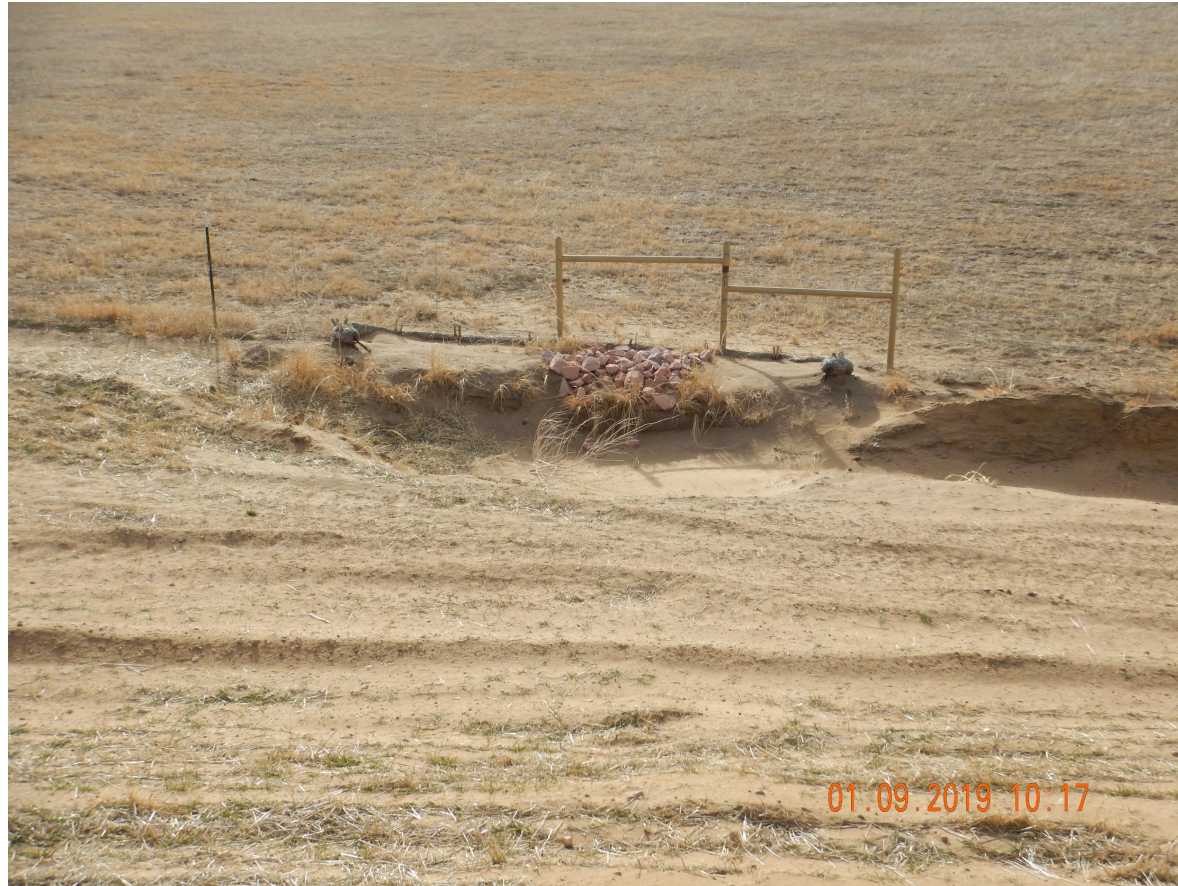
Photo 10. Photo taken from the southern well pad, facing South. Photo illustrates a sediment trap that has not been implemented in accordance with good engineering practices, has not been maintained to properly function, and does not appear to be adequately sized.

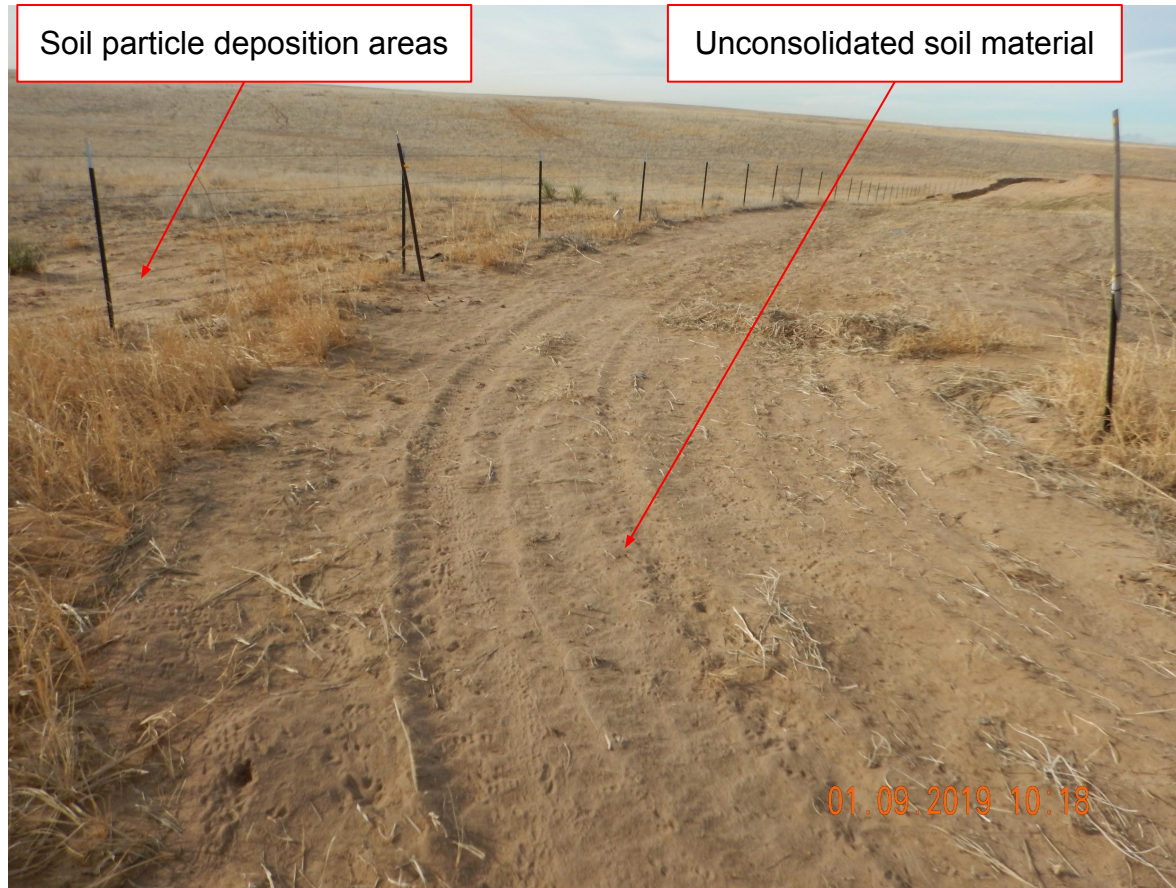
Photo 11. Photo taken from the southeastern perimeter of the location, facing West. Photo illustrates a portion of the perimeter that has not been properly stabilized and soil particle deposition as a result of wind erosion was observed off Location.

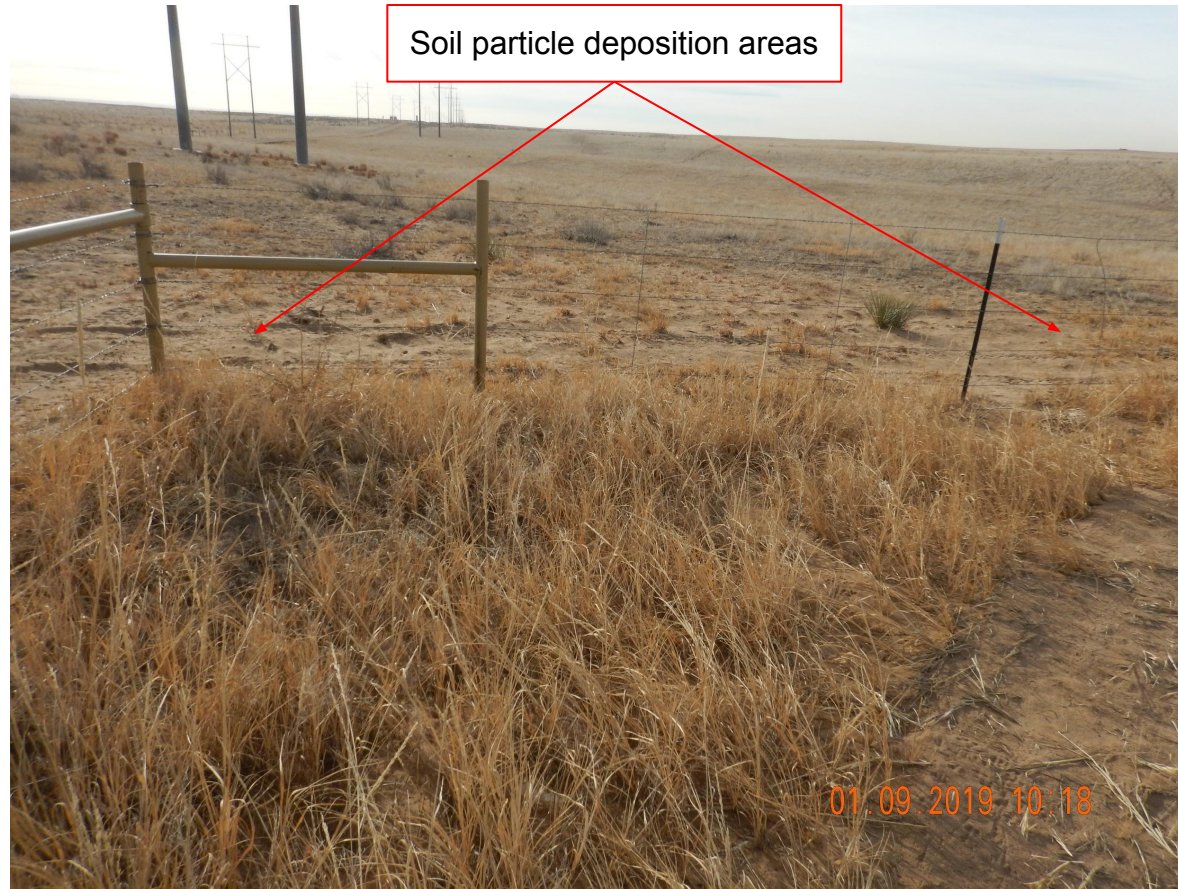
Photo 12. Photo taken from the southeastern perimeter of the location, facing South. See comments under Photo 10.

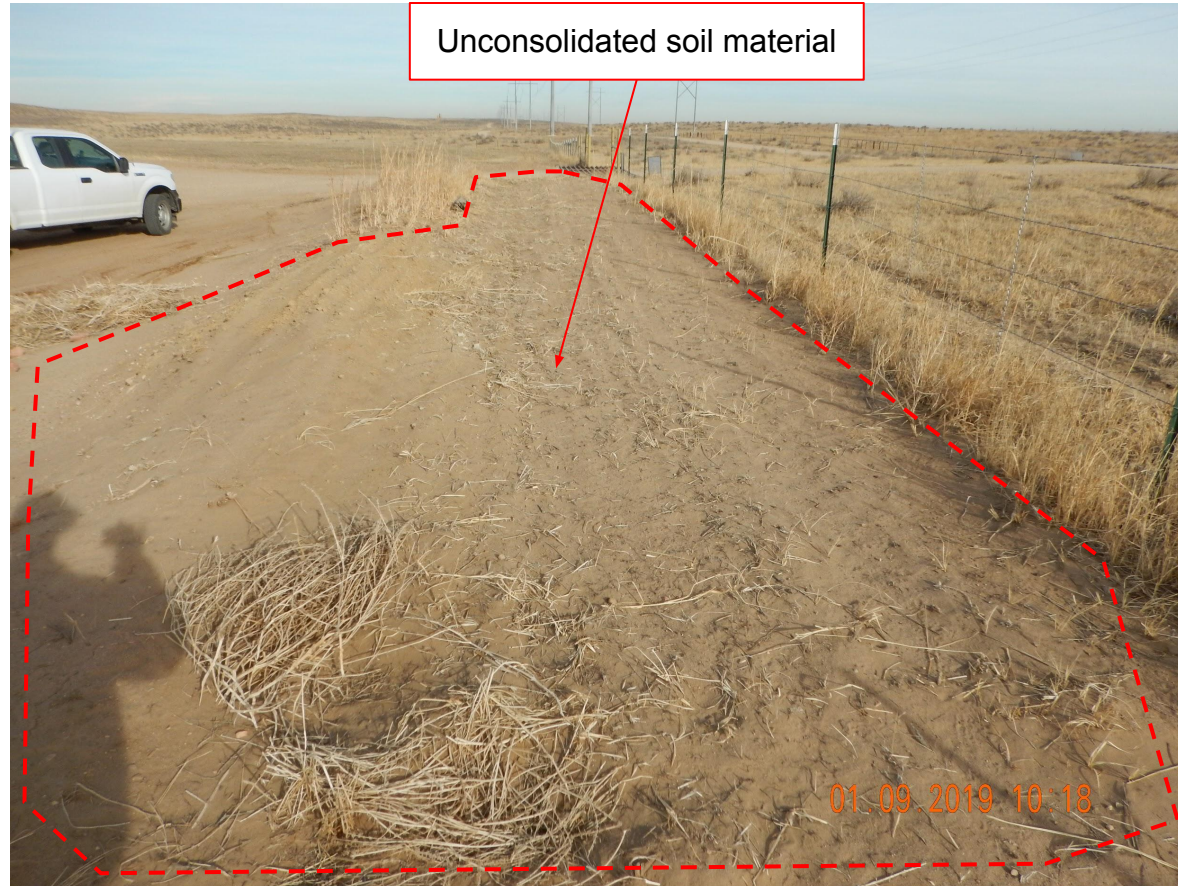
Photo 13. Photo taken from the southeastern perimeter of the location, facing South. See comments under Photo 10.
