**Inspection Photos**  
**Location Name: GE 34-03**  
**Location ID: 307294**

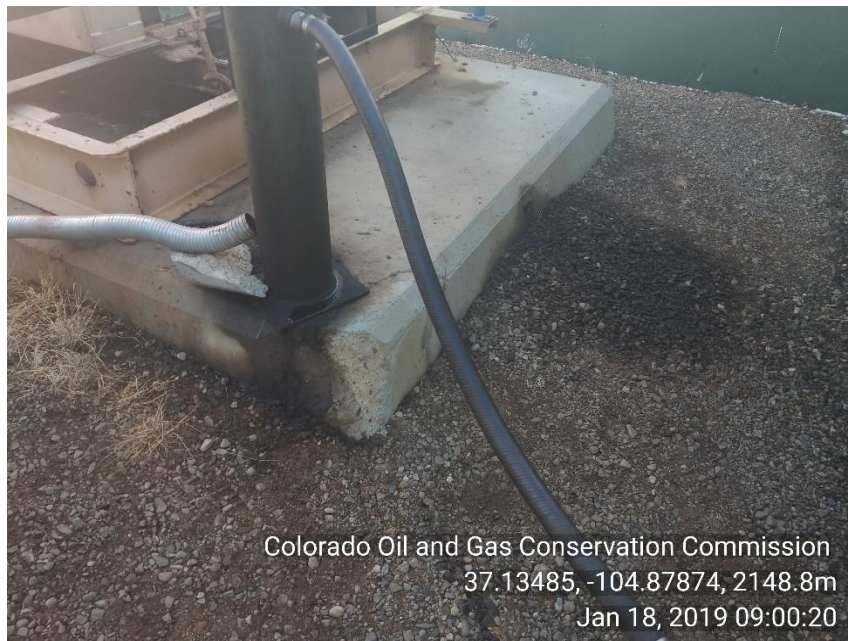
**Photo 3 Stained soil around cement base of PU**

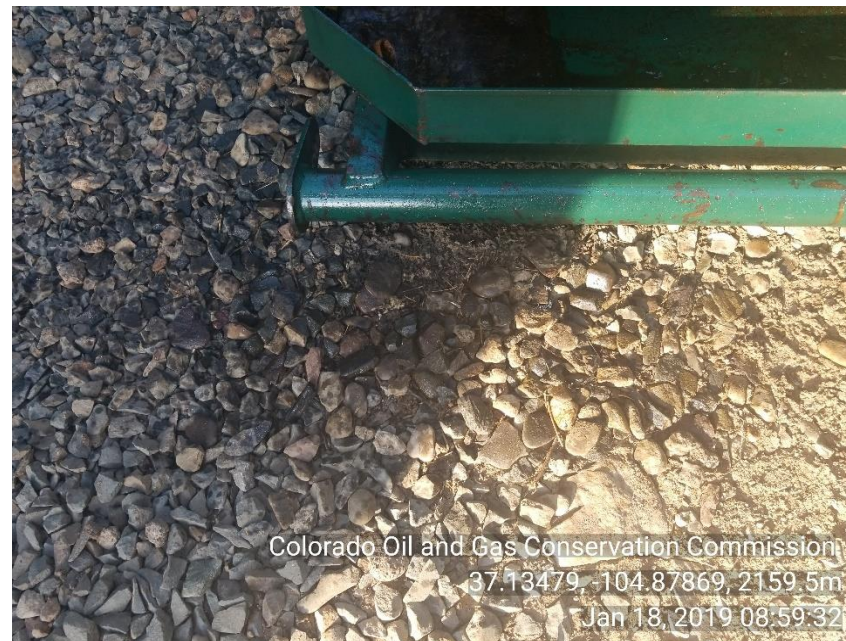
**Photo 4 Stained soil around liquid ring skid**

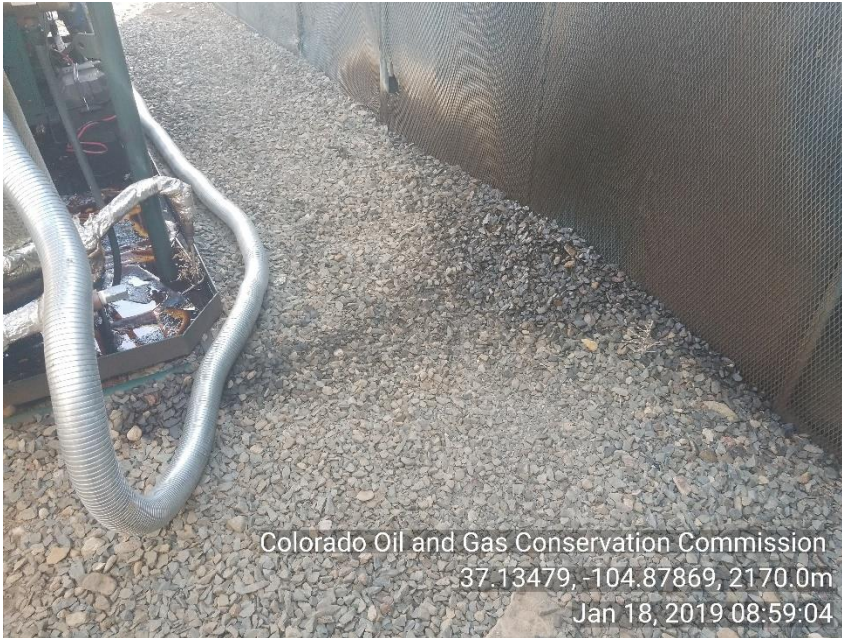
**Photo 5 Stained soil around base of liquid ring skid**
