Inspection Photos
Location Name: GE 28-16
Location ID: 308409

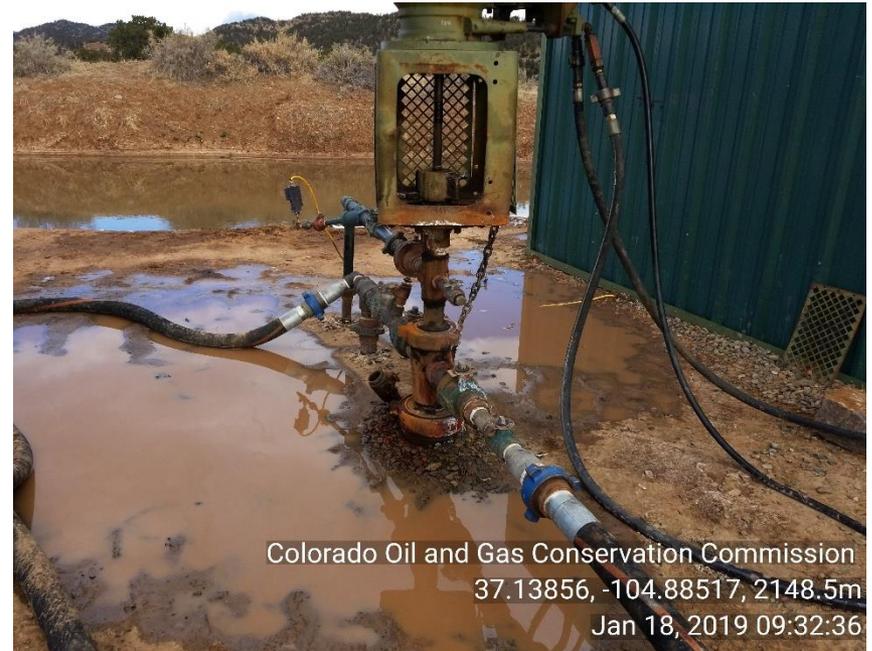
Photo 2 WH packing leaking at time of inspection

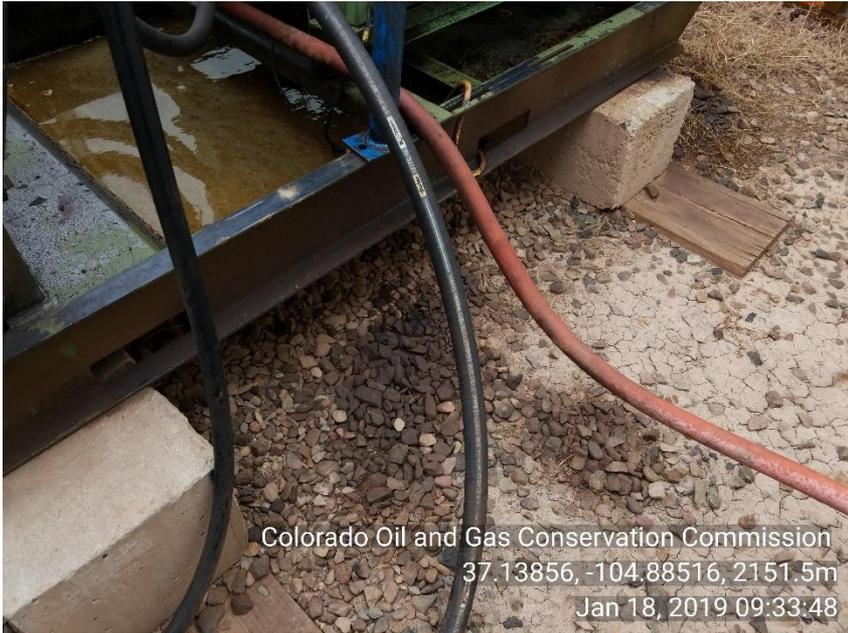
Photo 3 stained soil around HYD motor skid

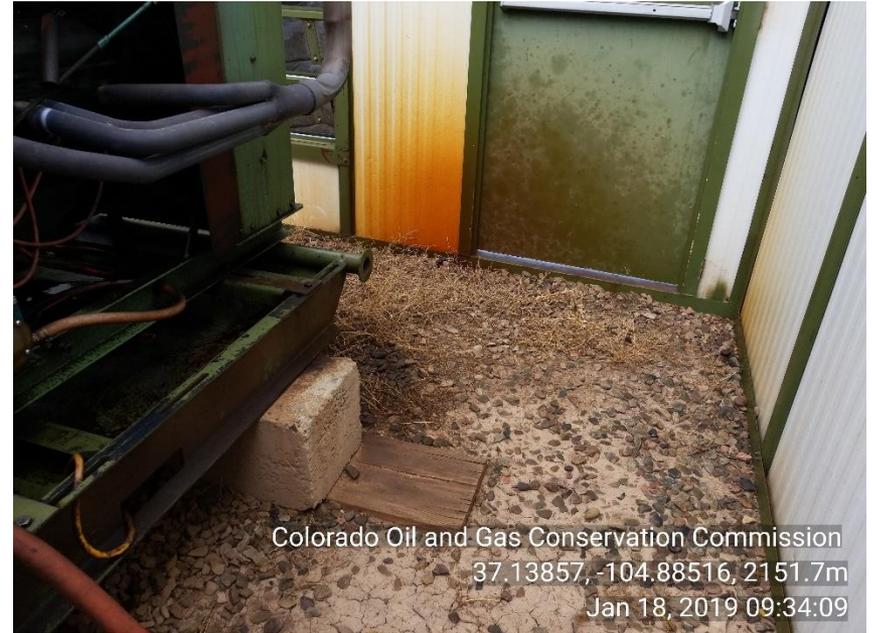
Photo 4 Stained soil around HYD motor skid

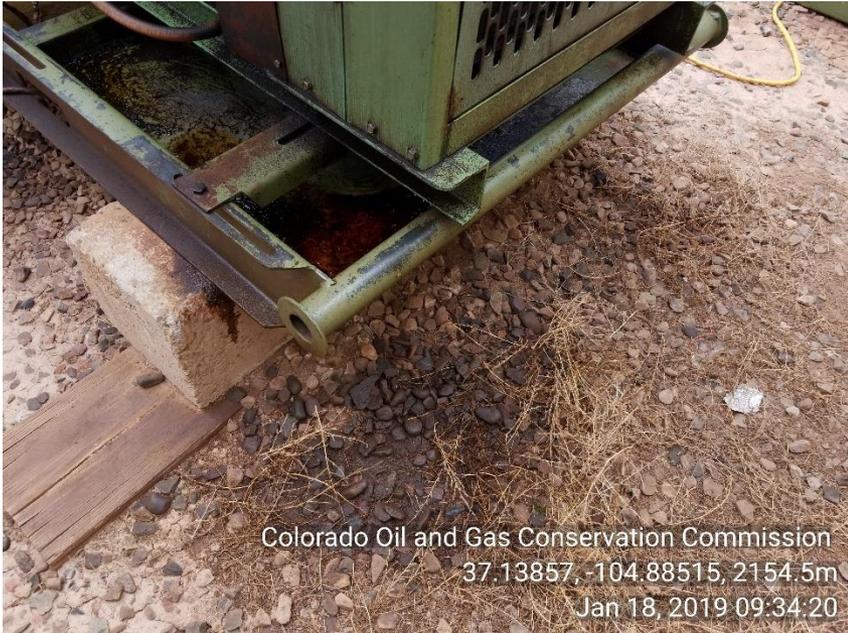
Photo 5 stained soil around HYD motor skid

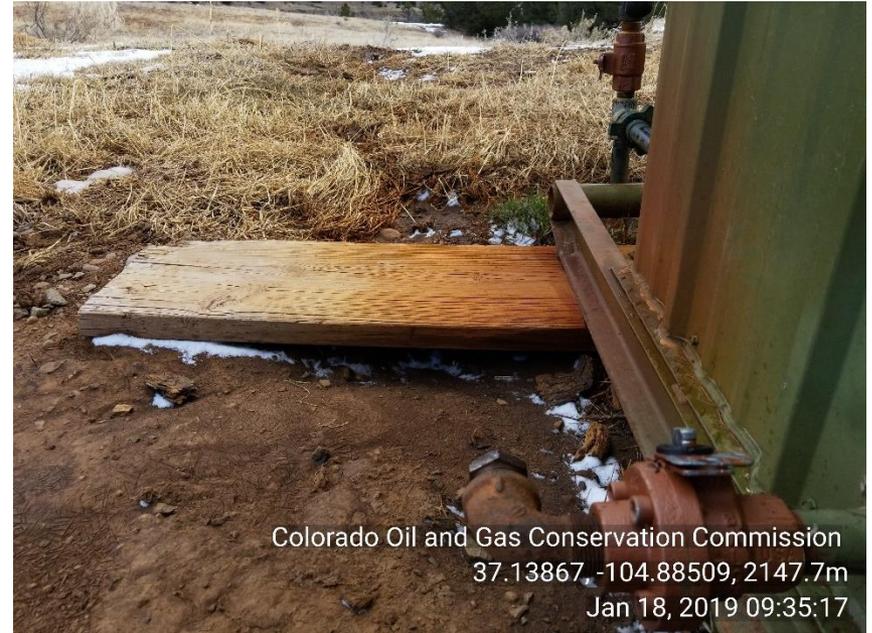
Photo 6 stained soil in back of separator house under 1" drain line for separator.
