**Inspection Photos**  
**Location Name: GE 28-14**  
**Location ID: 311967**

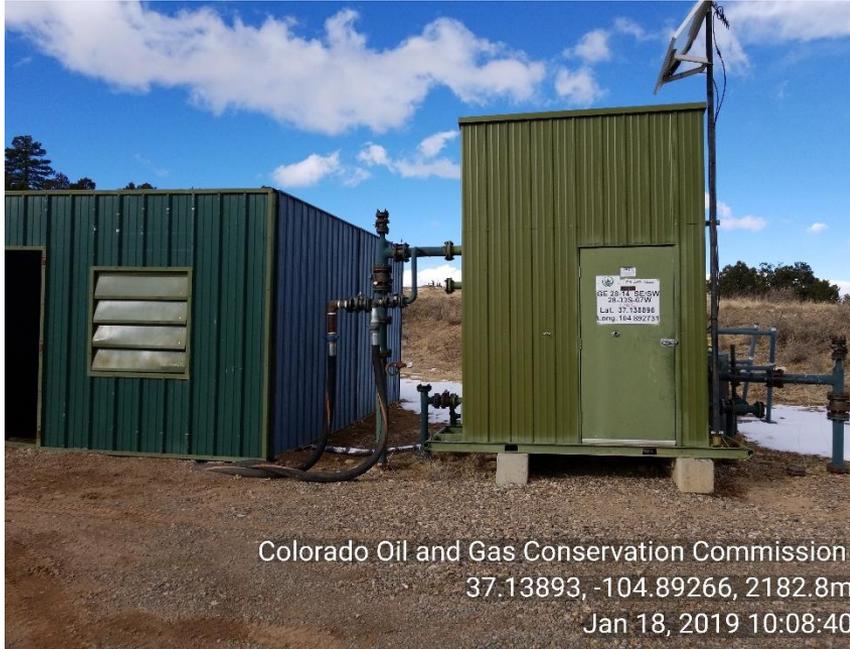
**Photo 1 Sep**

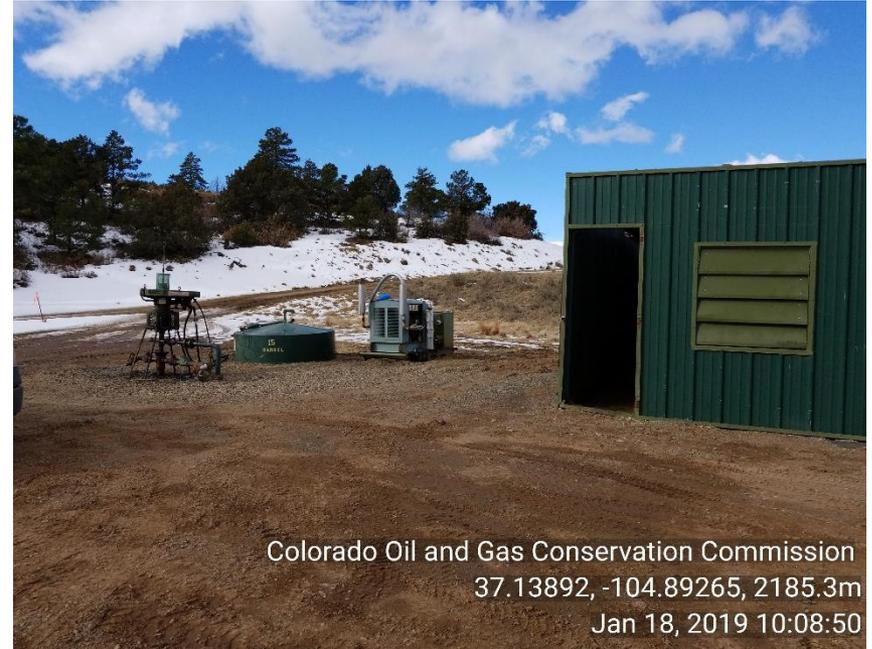
**Photo 2 loc pic and unused equipment 15 BBL tank**

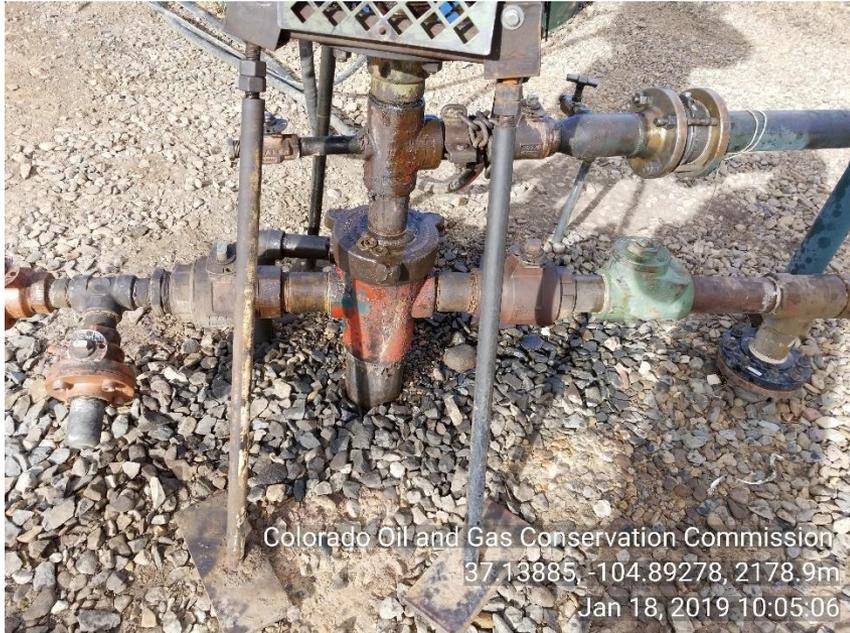
**Photo 3 stained soil around WH**

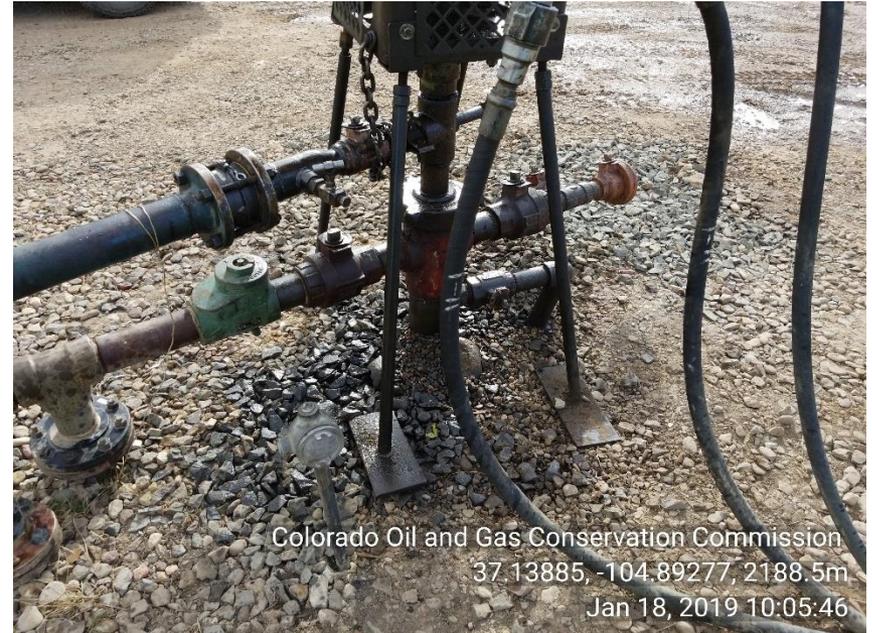
**Photo 4 stained soil around WH**

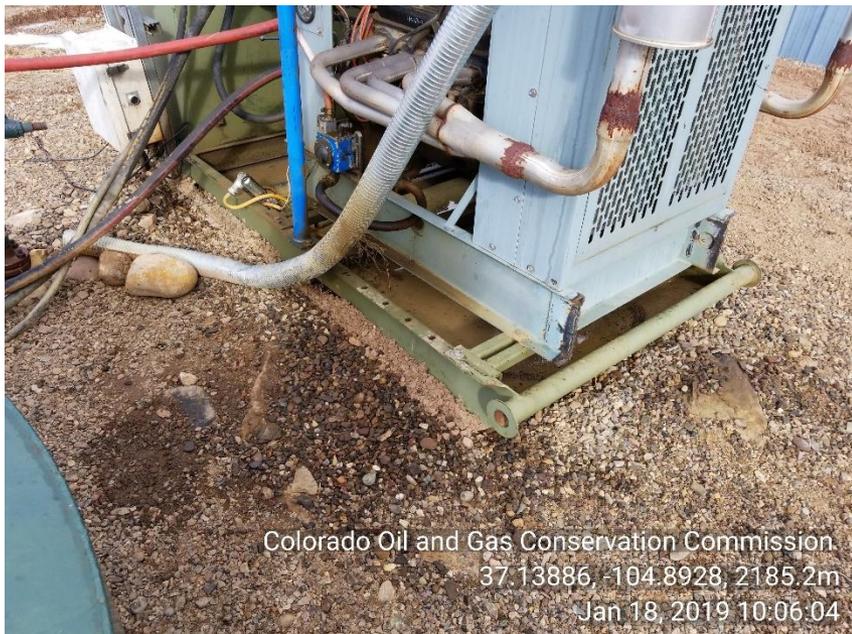
**Photo 5 stained soil around HYD motor skid**

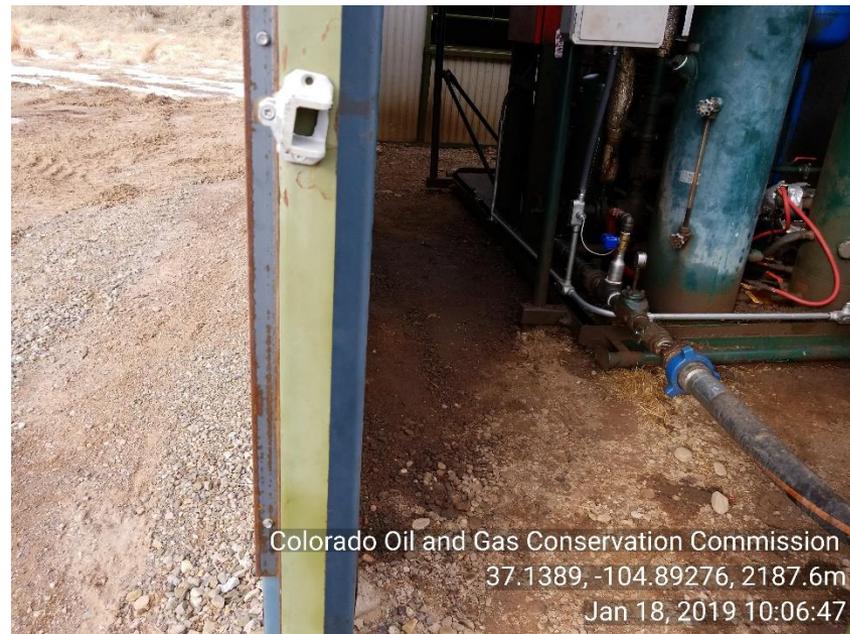
**Photo 6 Stained soil around liquid ring skid**

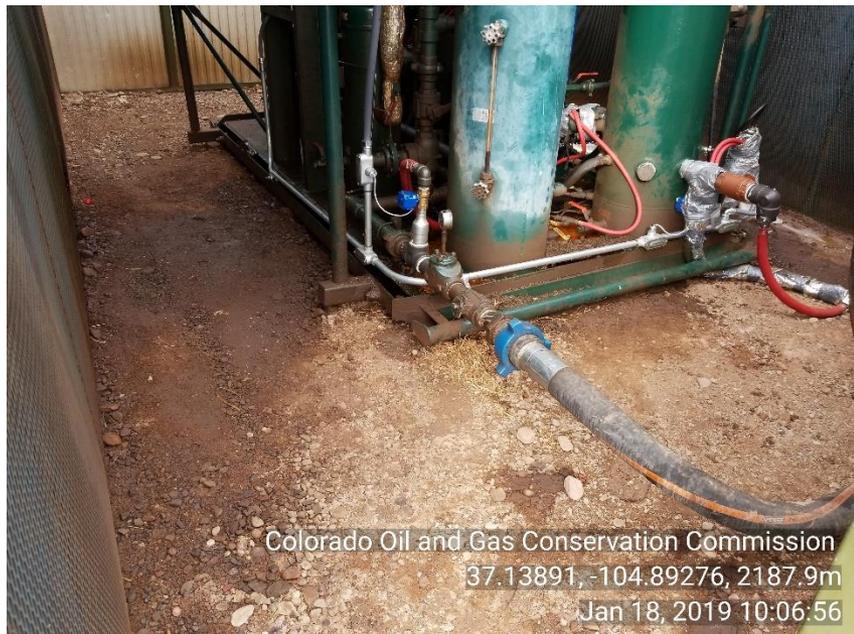
**Photo 7 stained soil around liquid ring skid**

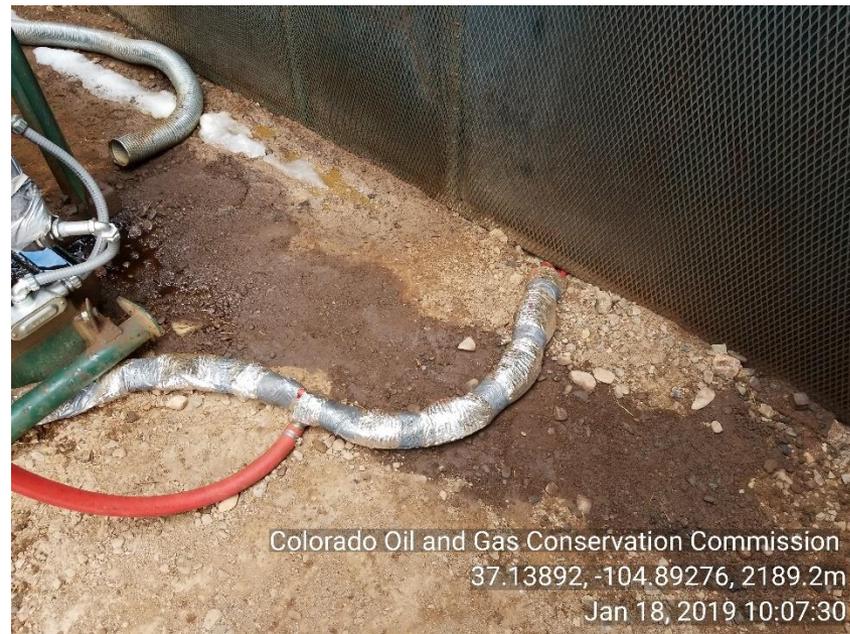
**Photo 8 Stained soil around liquid ring skid**

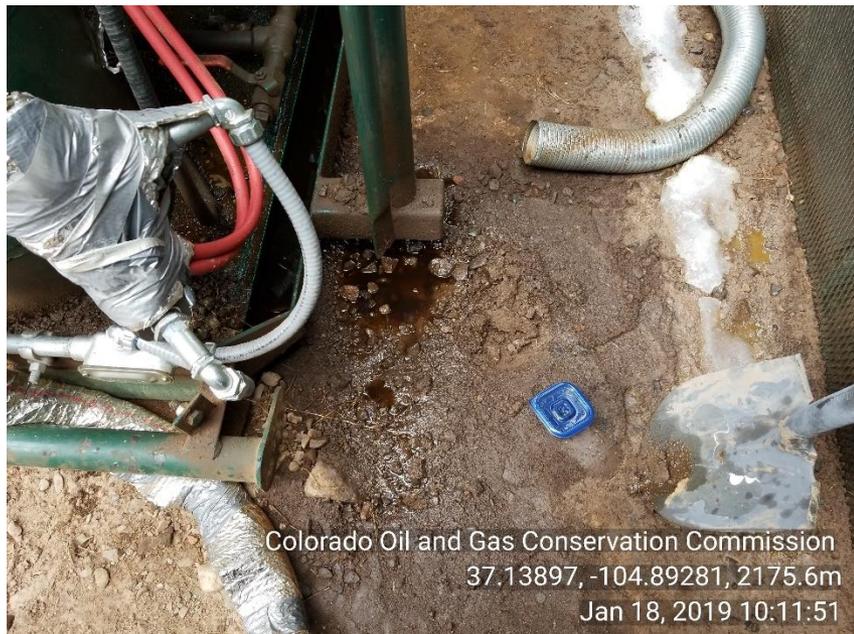
**Photo 9 stained soil around liquid ring skid took soil sample**

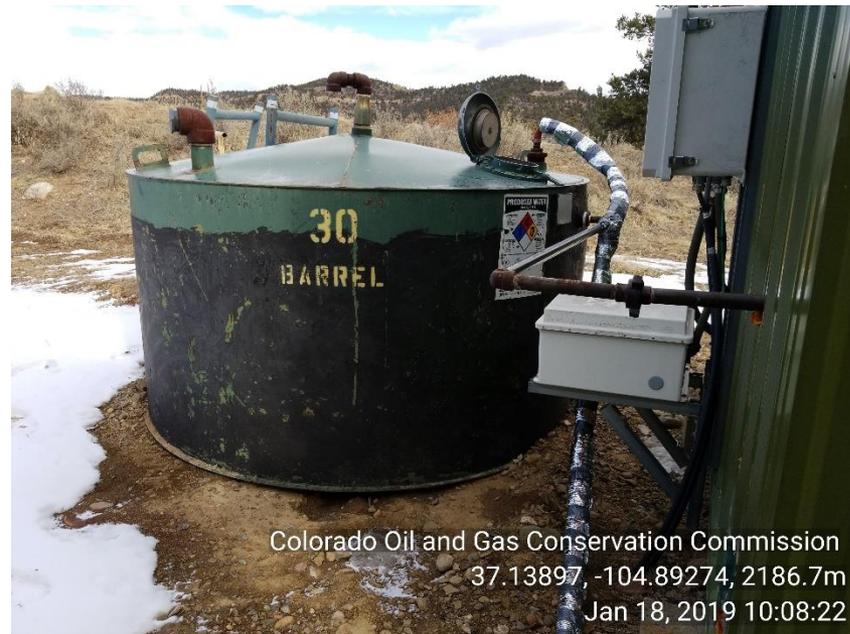
**Photo 10 30BBL produced water tank**
