**Inspection Photos**  
**Location Name: GE 33-04**  
**Location ID: 309416**

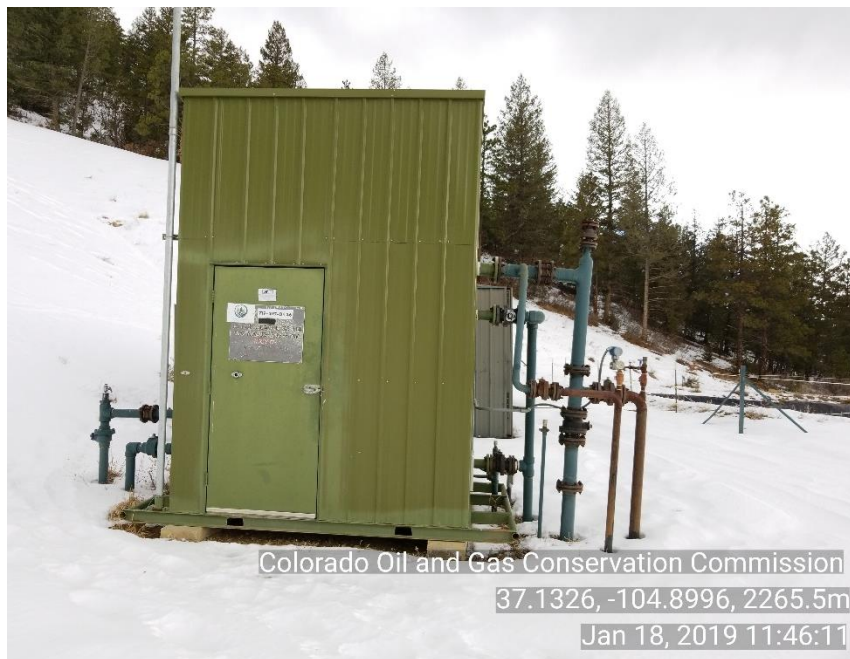
**Photo 1 sep. Location sign is faded needs to be replaced**

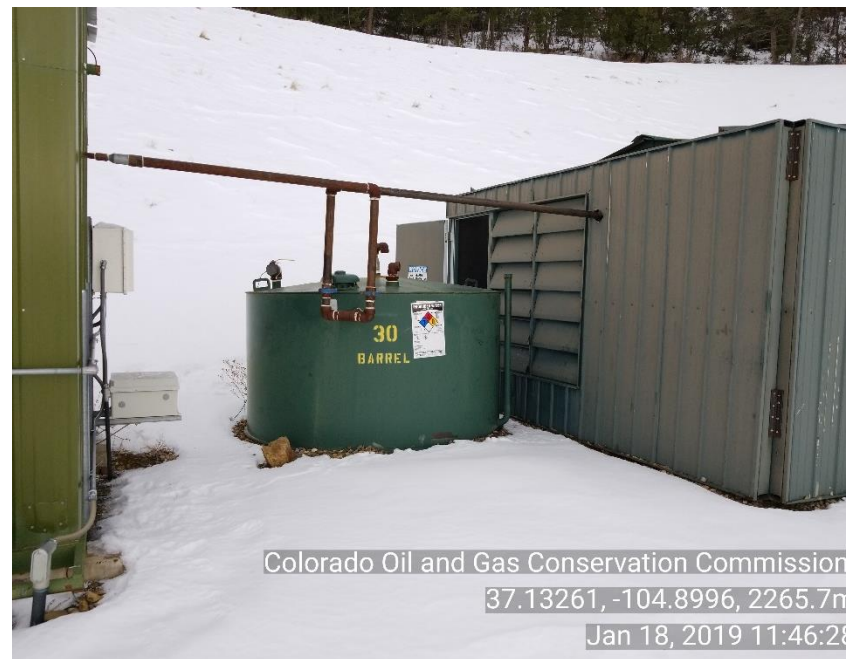
**Photo 2 sound walls for liquid ring compressor and 30 BBL production tank**

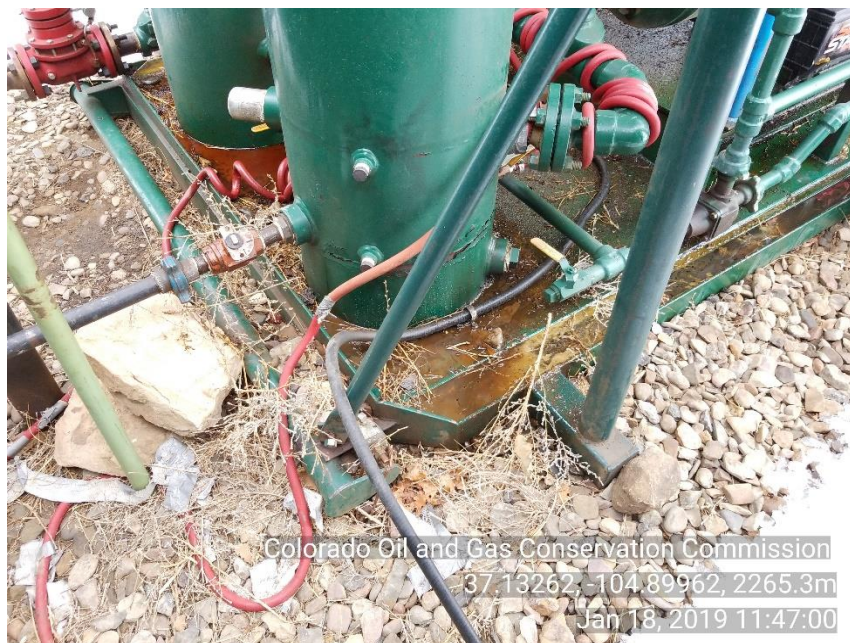
**Photo 3 Stained soil and fluid dripping out of liquid ring skid**

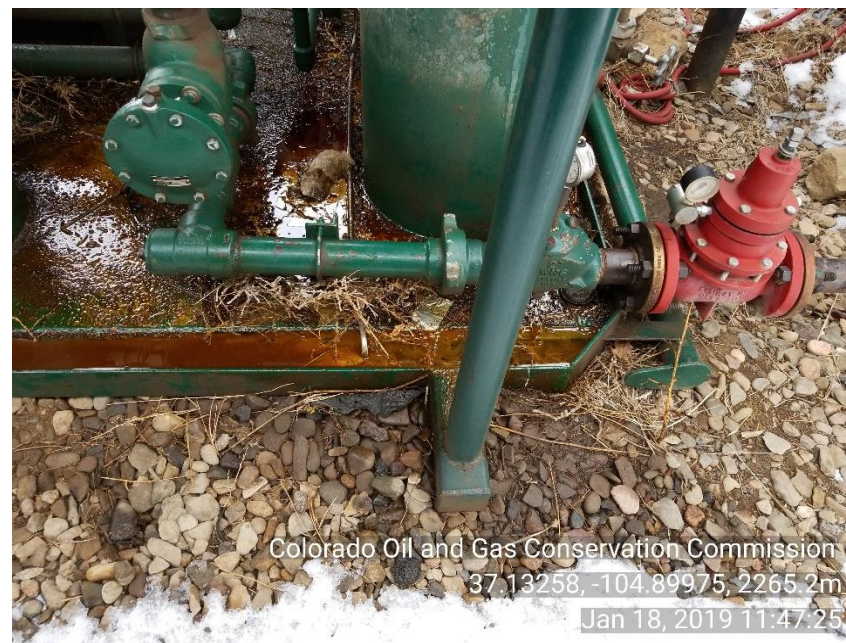
**Photo 4 Stained soil and fluid dripping out of liquid ring skid**

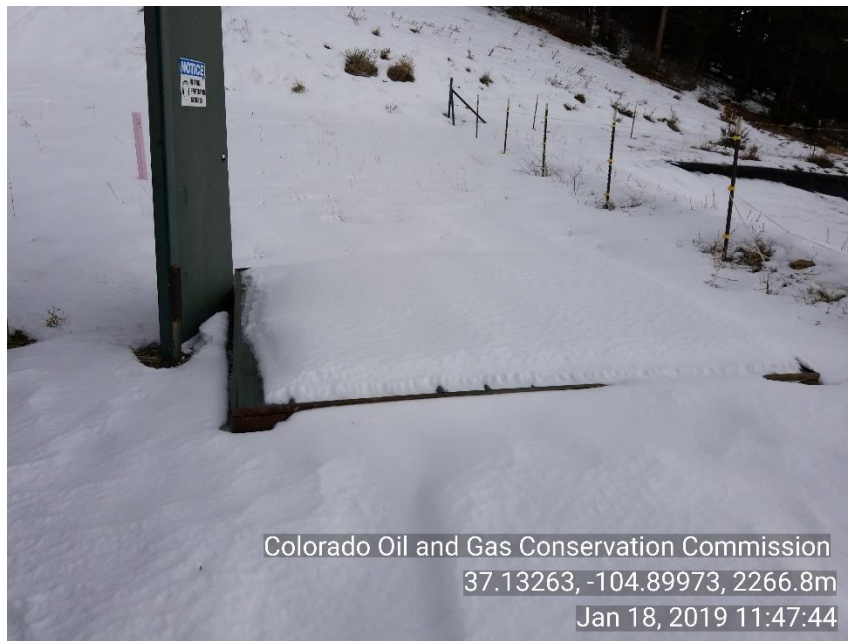
**Photo 5 sound wall panel laying on ground**

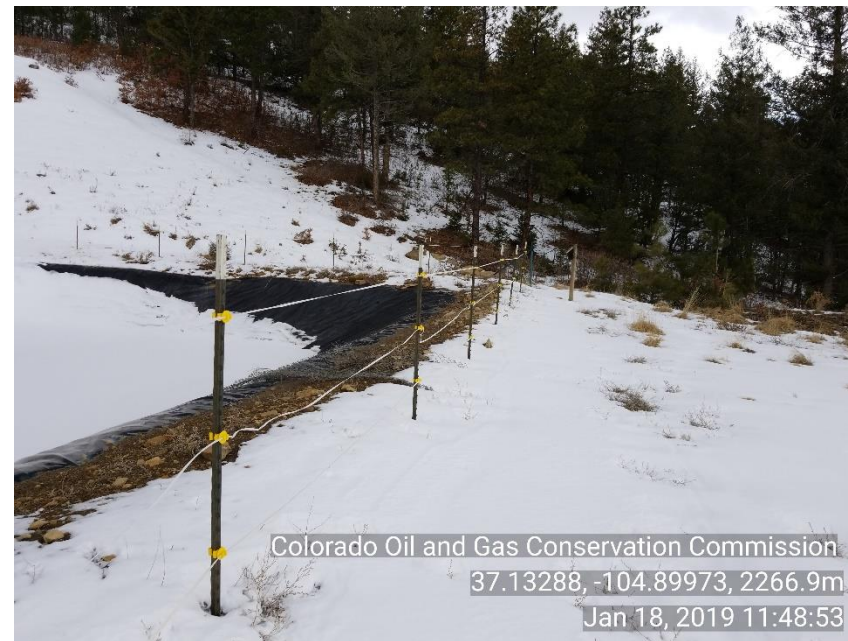
**Photo 6 electric fence around lined pit in disrepair**

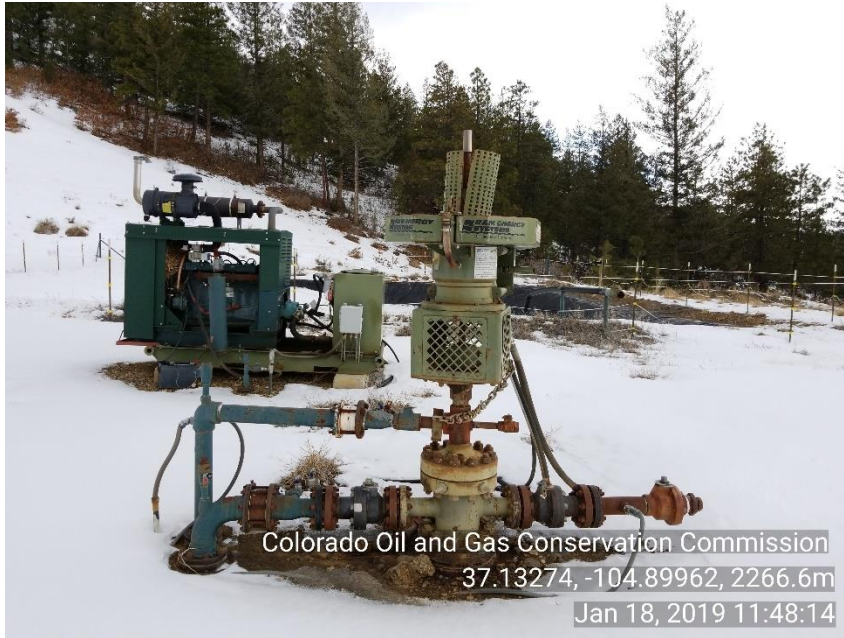
**Photo 7 WH and motor skid**
