Inspection Photos
Location Name: GE 29-09-02
Location ID:309302

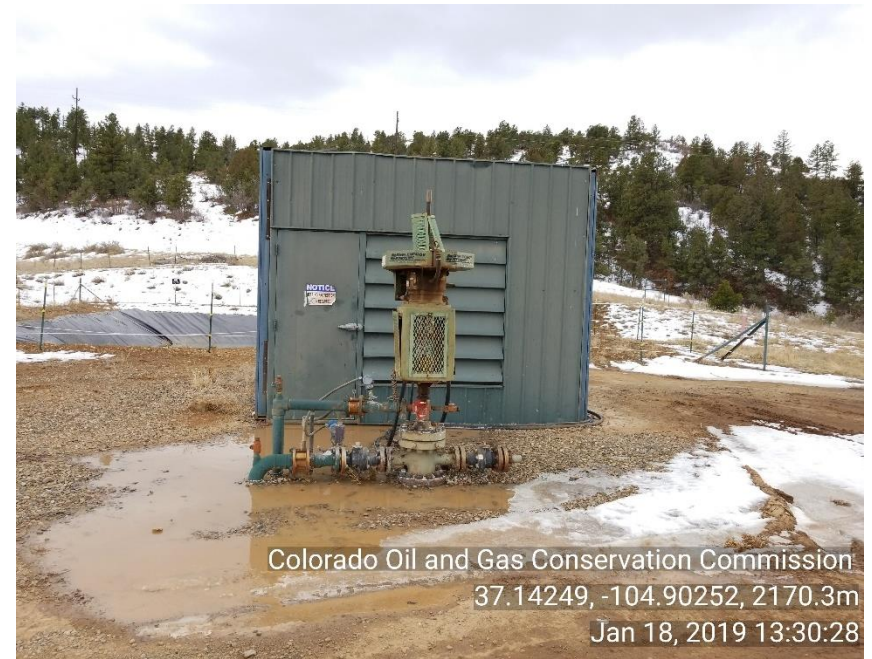
Photo 2 WH/ HYD motor sound walls

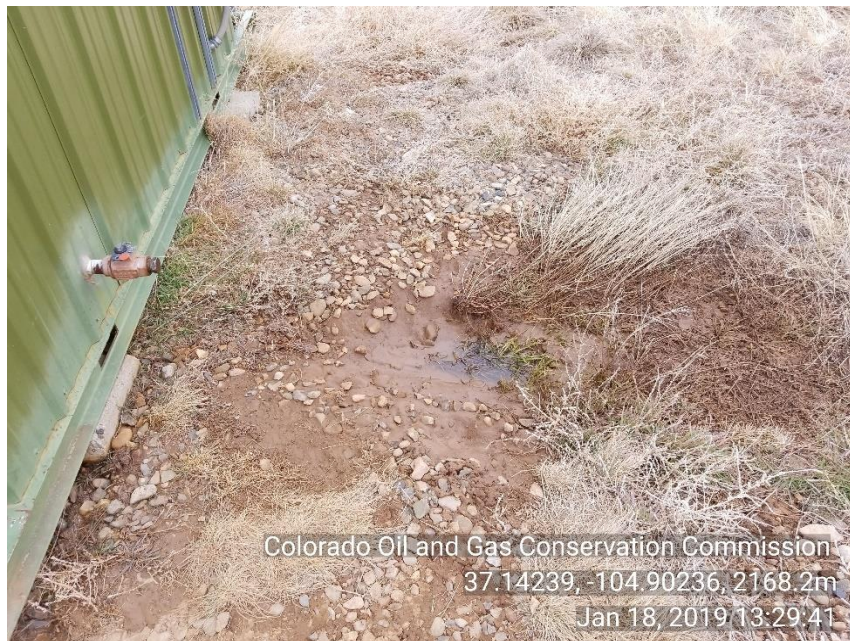
Photo 3 stained soil under 1" drain line for separator

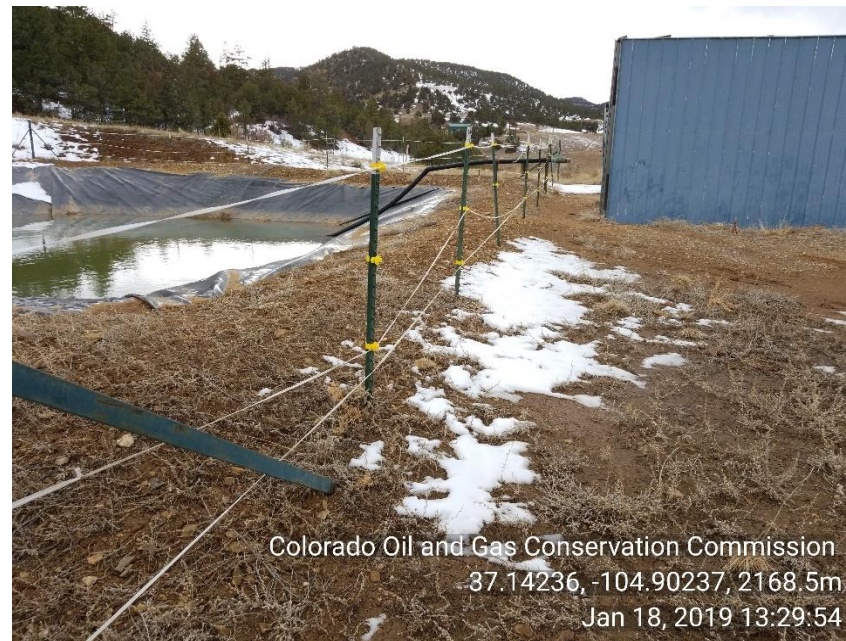
Photo 4 Electric fence around lined pit in disrepair

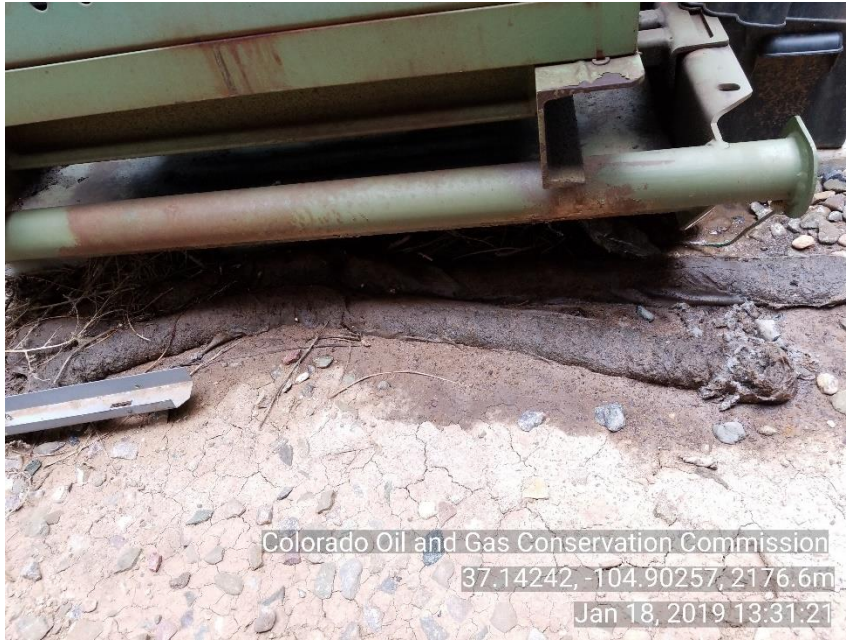
Photo 3 stained soil under HYD motor skid
