**Inspection Photos**  
**Location Name: APACHE CANYON 03-05**  
**Location ID: 307339**

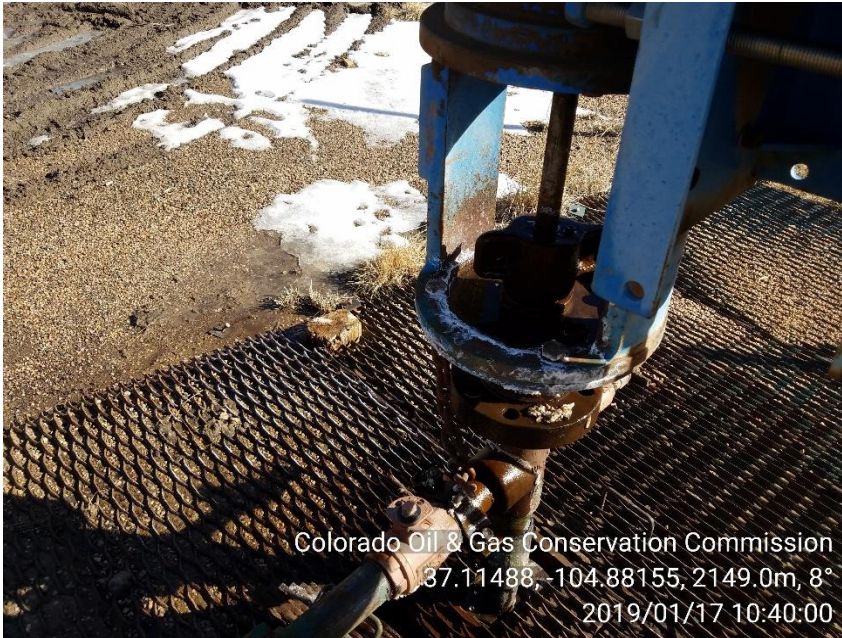
**PHOTO 3: PACKING ON TBG HEAD IS LEAKING**

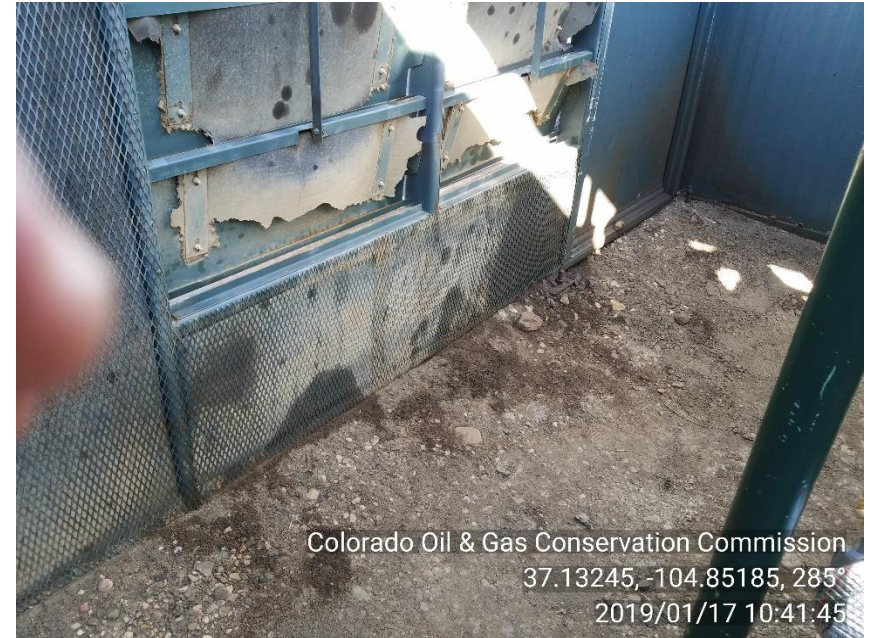
**PHOTO 4: STAINED SOIL INSIDE SOUND WALL AROUND COMPRESSOR**

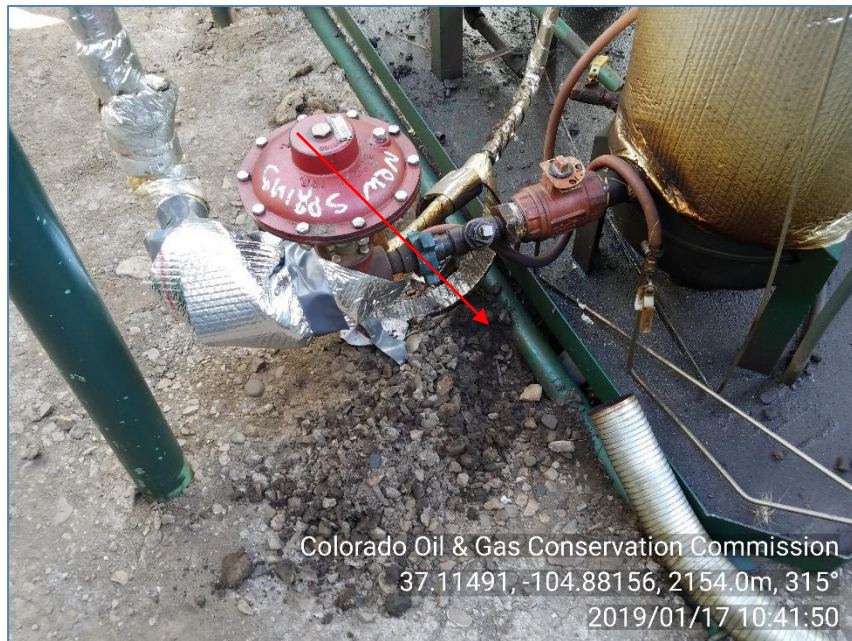
**PHOTO 5: STAINED SOIL ON WEST SIDE OF COMPRESSOR SKID UNDER COMPRESSOR SKID APPEARS TO BE STAINED AS FAR AS SOIL CAN BE SEEN.**

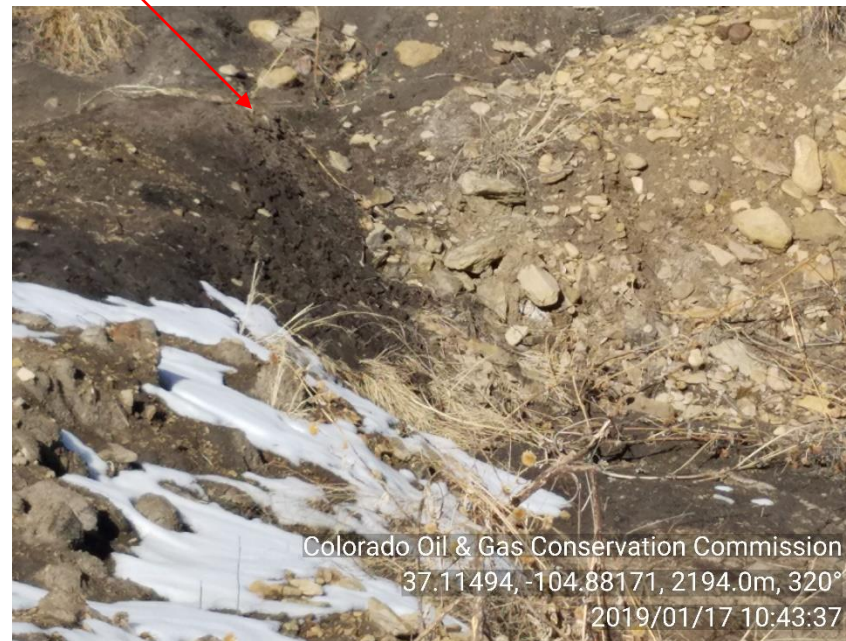
**PHOTO 6: BERM AROUND PIT ON SOUTH WEST CORNER HAS BEEN BREACHED AND STORM RUNOFF IS ABLE TO ENTER PRODUCTION PIT.**

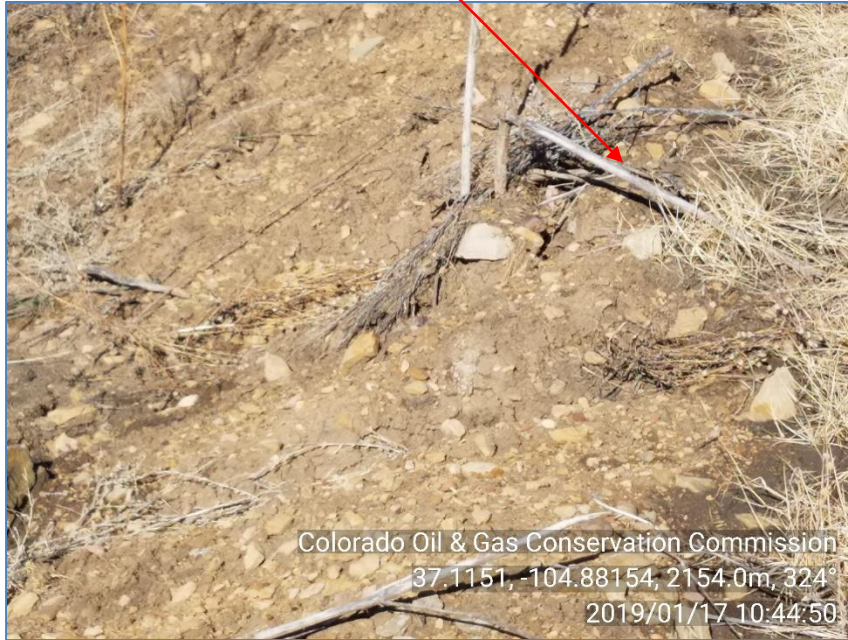
**PHOTO 7: BERM AROUND PIT ON NORTH SIDE OF PIT HAS BEEN BREACHED AND STORM RUNOFF IS ABLE TO ENTER PRODUCTION PIT.**
