Interim Reclamation and Stormwater Inspection

January 9, 2019

Operator: BONANZA CREEK ENERGY OPERATING COMPANY LLC - #8960

Inspection Photos
Location Name: Longhorn /14-11
Location ID: 451353

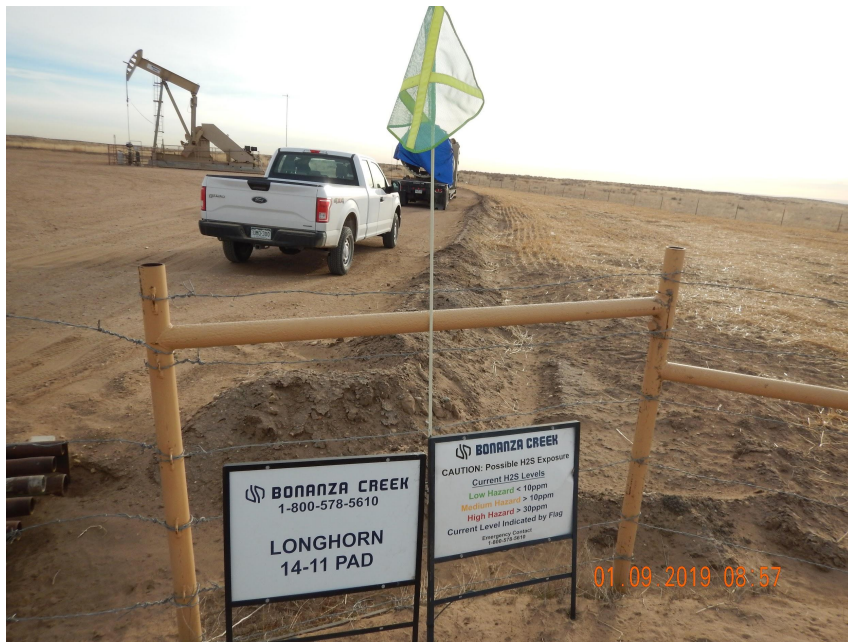
Photo 1. Photo taken from the entrance of the location, facing East. Photo illustrates Operator signs.

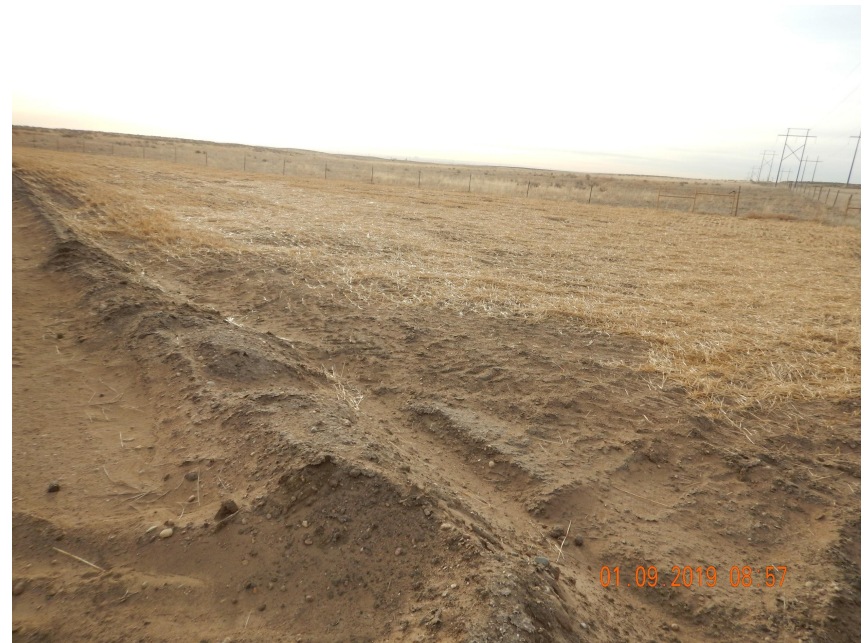
Photo 2. Photo taken from the southwest location, facing Southeast. Operator has performed interim reclamation activities with the evidence of drilling rows and straw crimped mulch. Interim areas appear to be properly contoured to the surrounding landscape.

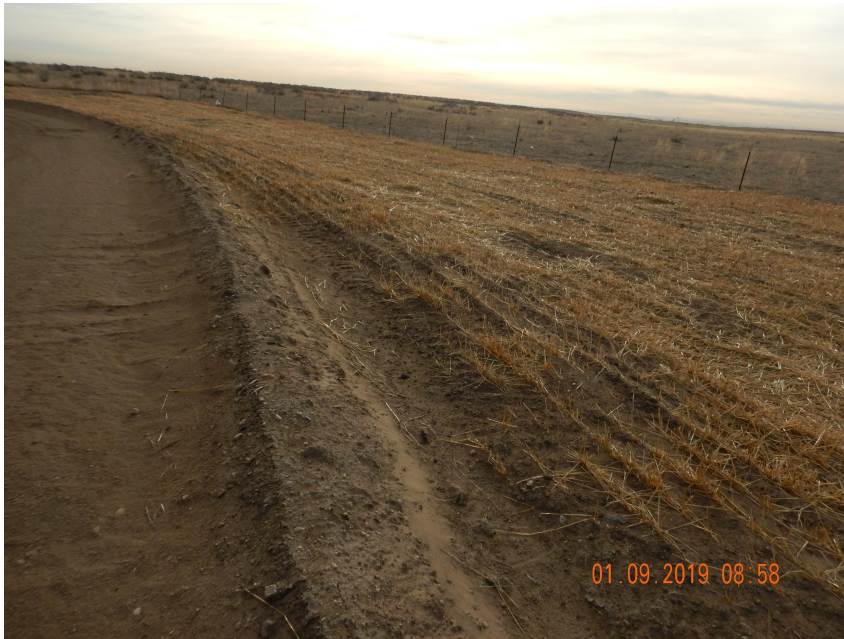
Photo 3. Photo taken from the southern location, facing East. See comments under Photo 2.

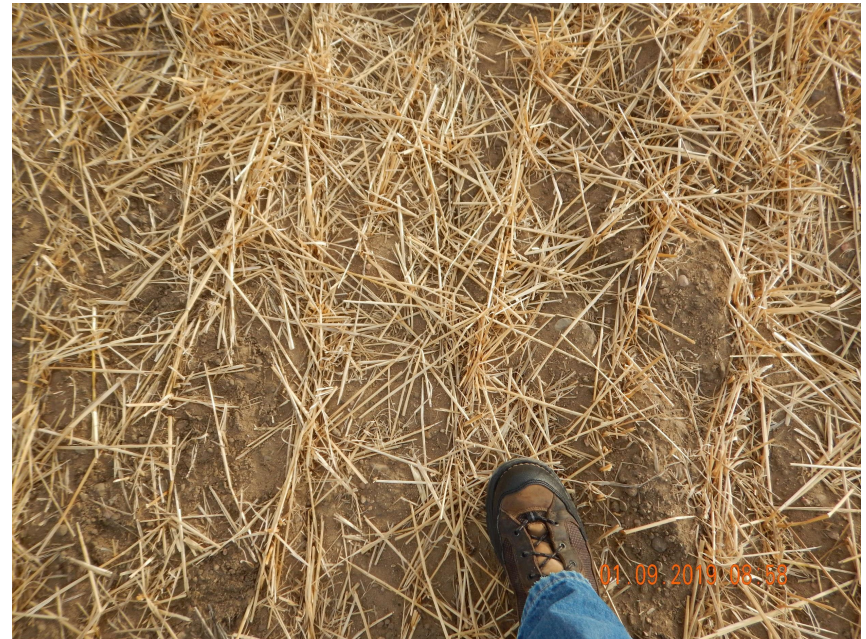
Photo 4. Photo taken from the interim reclamation area. See comments under Photo 2.

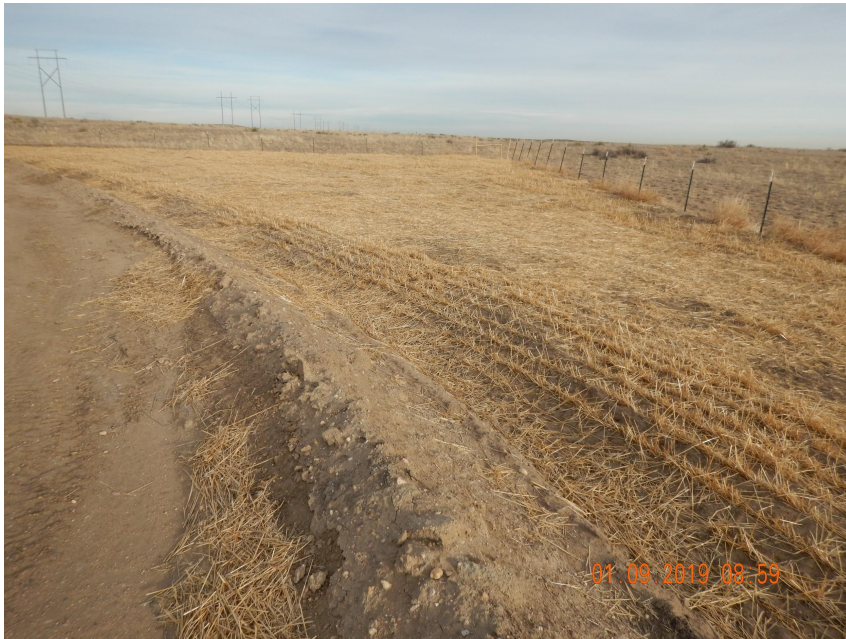
Photo 5. Photo taken from the eastern location, facing North. See comments under Photo 2.

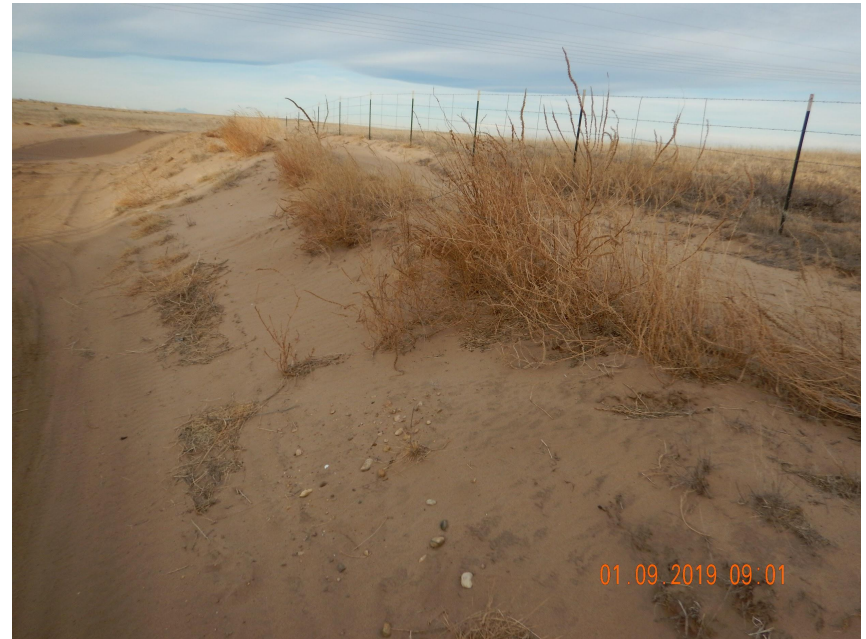
Photo 6. Photo taken from the northern location, facing West. Cut slope is not stabilized.

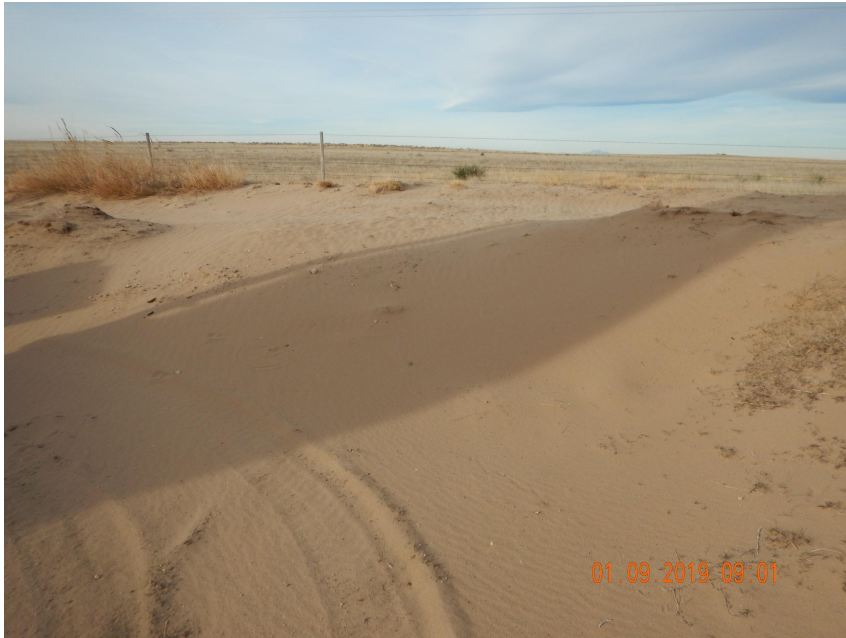
Photo 7. Photo taken from the northwestern location, facing West. Site degradation is occurring due to the lack of stabilization along the cut slope.

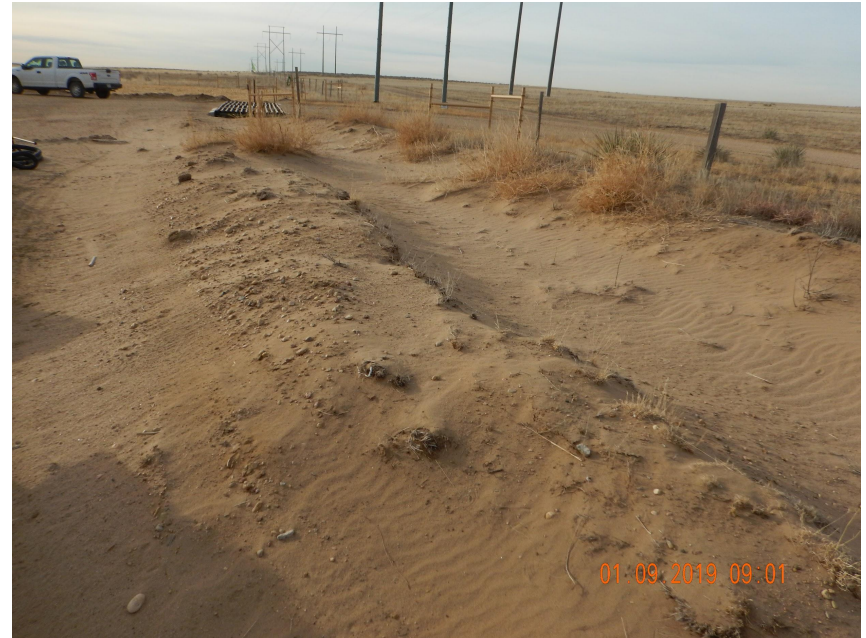
Photo 8. Photo taken from the western location, facing South. See comments under Photos 6 & 7.

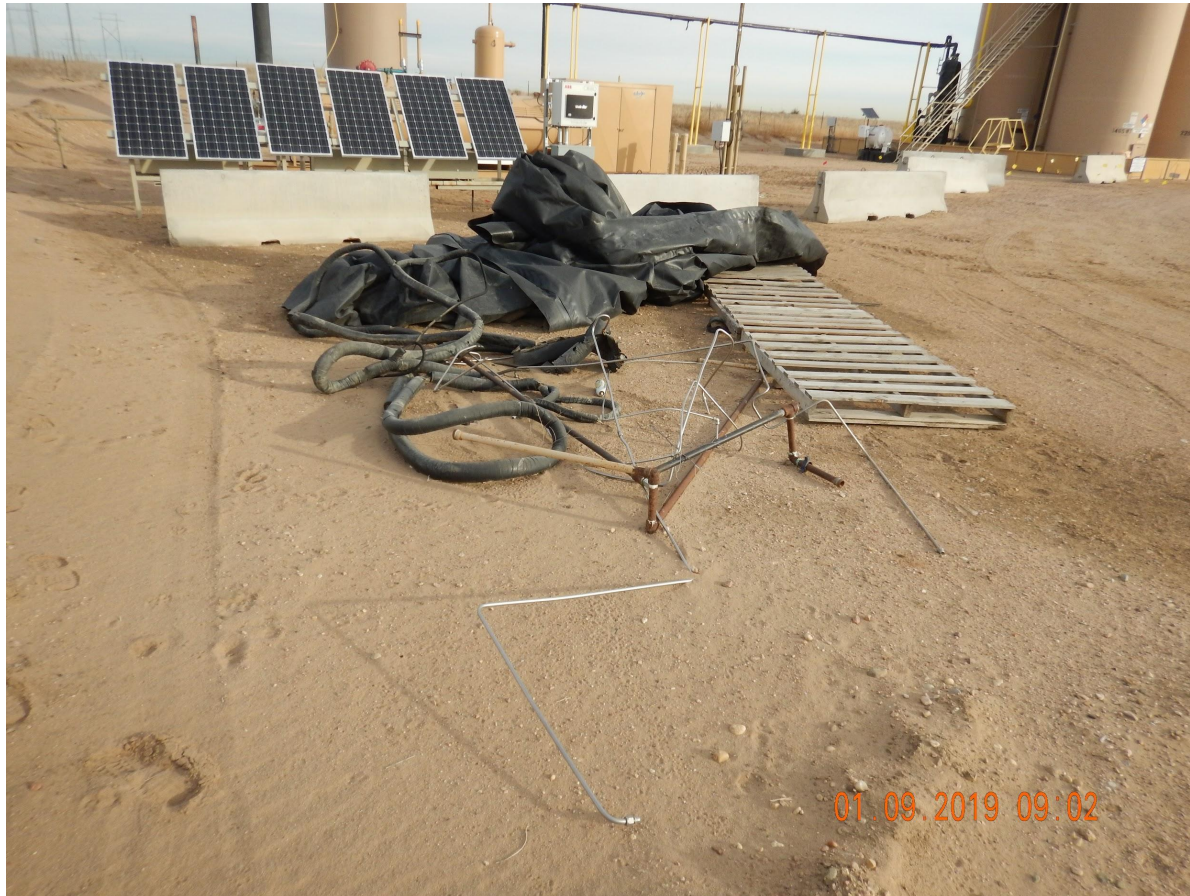
Photo 9. Photo taken from the northwestern production area, facing North. Appears unused equipment needs to be removed.
