Interim Reclamation and Stormwater Inspection

Operator: BONANZA CREEK ENERGY OPERATING COMPANY LLC - #8960

Location ID: 450210

Inspection Photos
Location Name: Mustang /14-26
Location ID: 450210

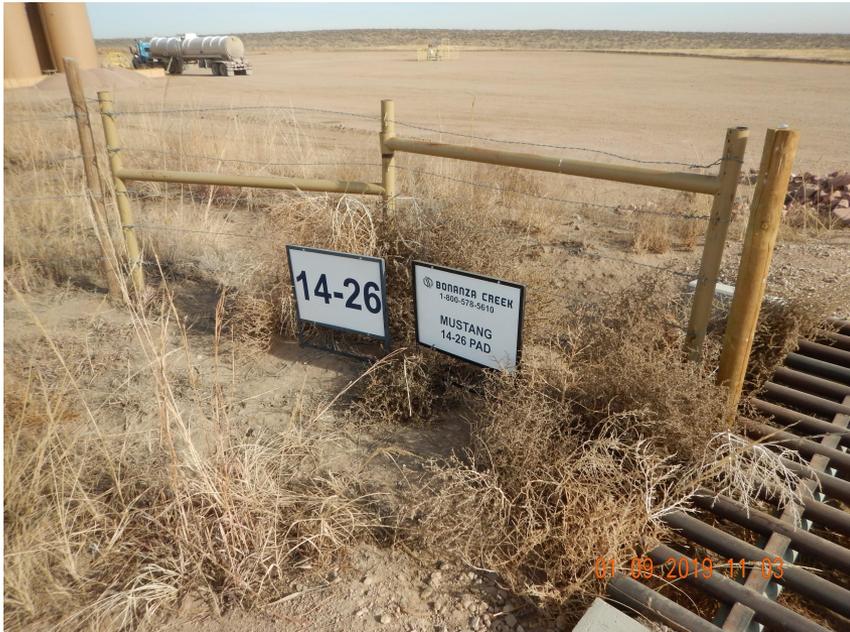
Photo 1. Photo taken from the entrance of the location, facing East. Photo illustrates Operator signs.

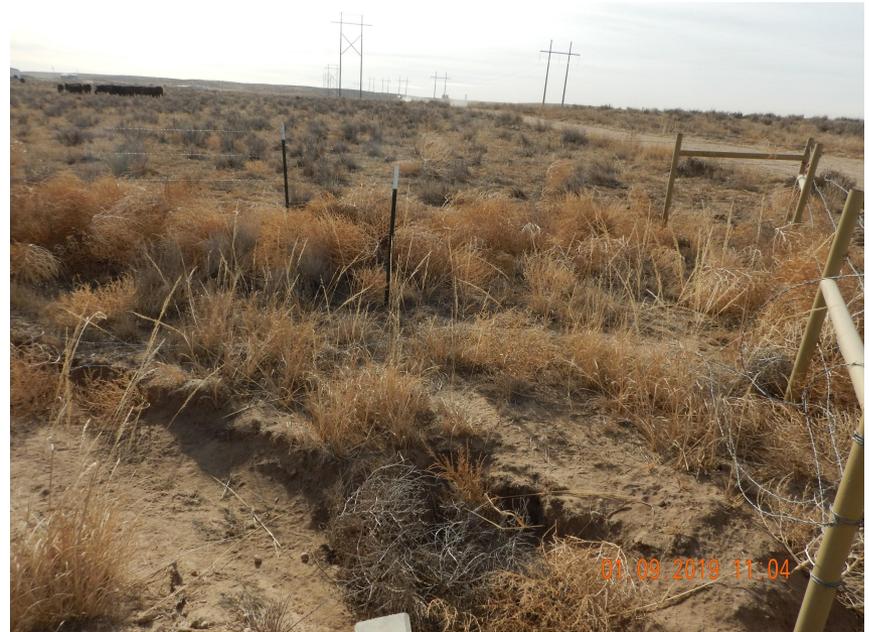
Photo 2. Photo taken from the southwest location, facing South. Photo illustrates Russian thistle weed debris. More weed debris was observed along the southern and northern perimeter of the location.

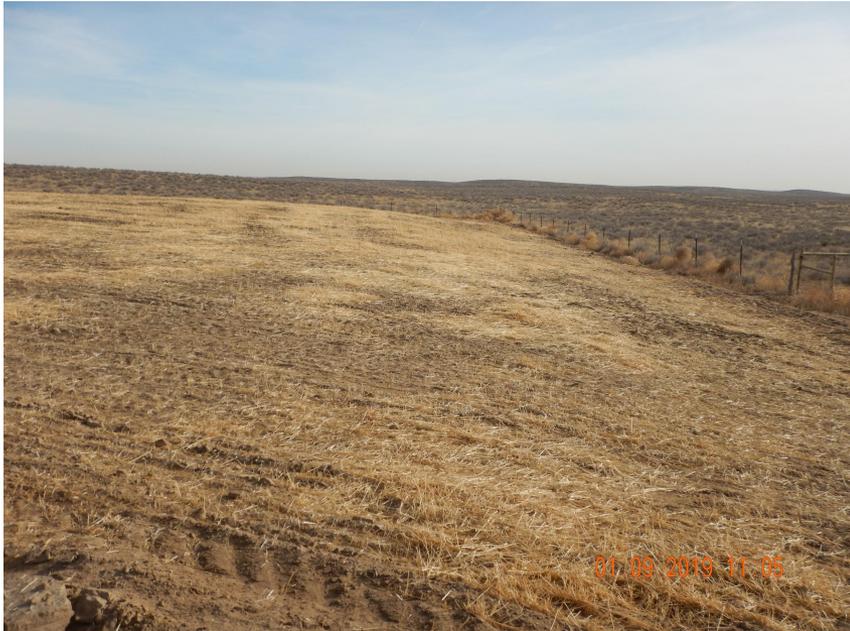
Photo 3. Photo taken from the southeast location, facing East. Operator has performed interim reclamation activities with the evidence of drilling rows and straw crimped mulch. However, interim areas do not appear to be properly contoured to the surrounding landscape- see Photos 5 & 6.

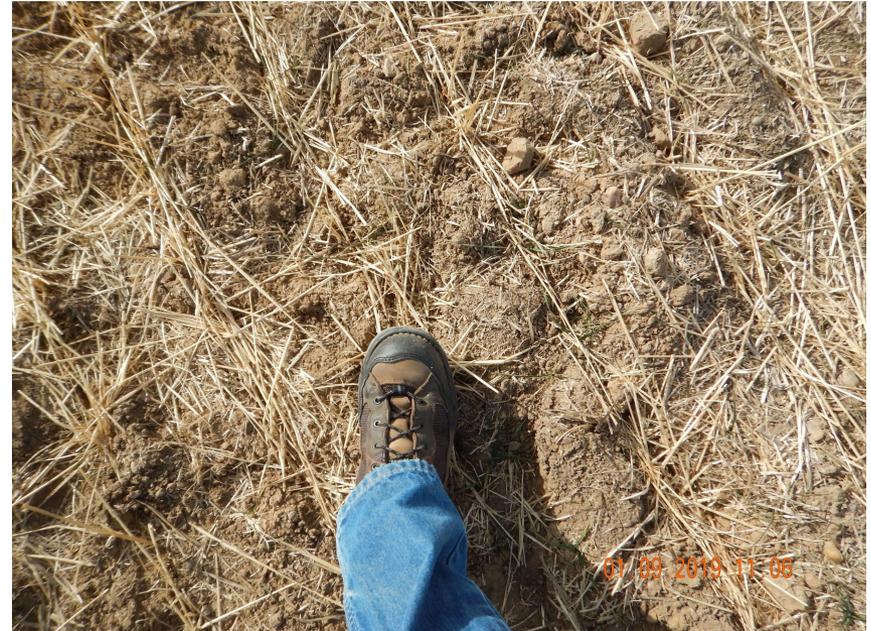
Photo 4. Photo taken from the interim reclamation area. See comments under Photo 3.

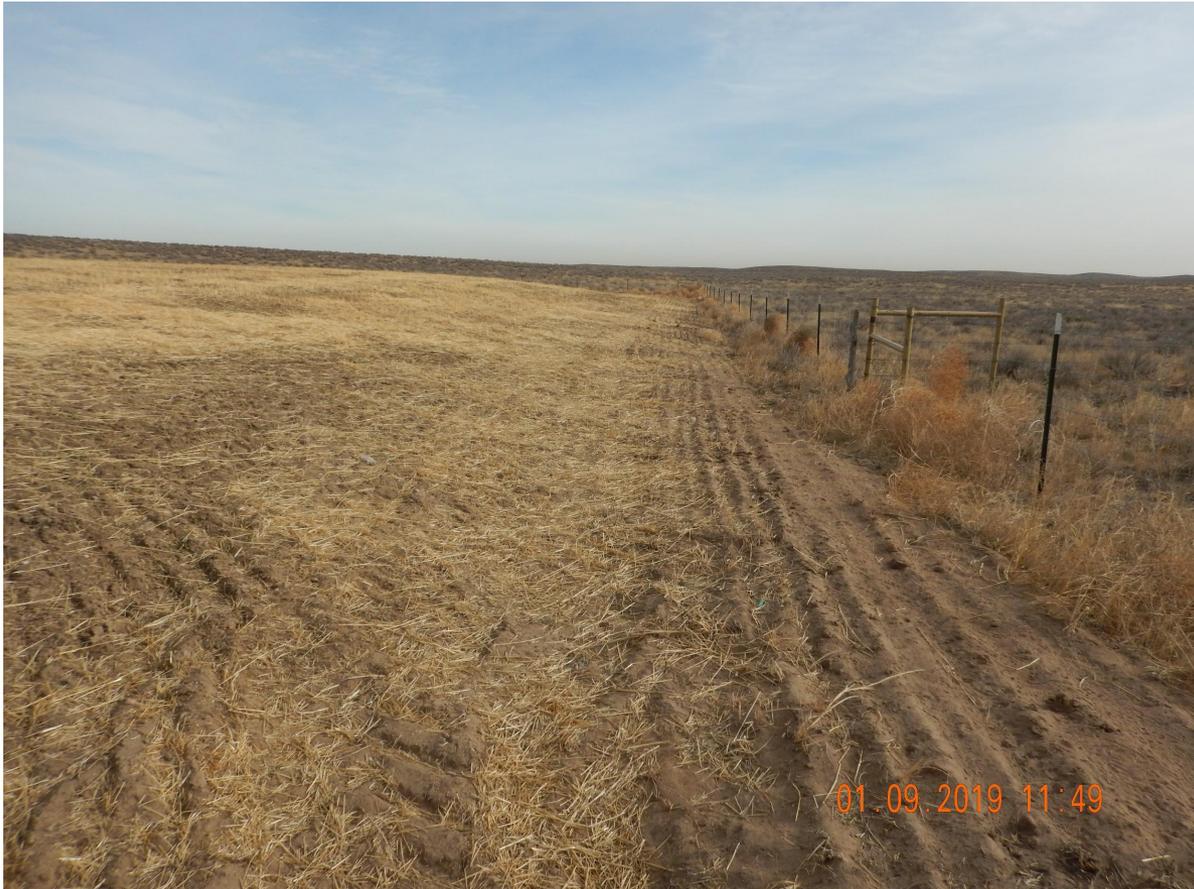
Photo 5. Photo taken from the southern perimeter of the location, facing East. Photo illustrates interim areas do not appear to be properly contoured to the surrounding landscape. Further review is required but Operator may need to perform additional contouring to comply with Rule 1003 standards.

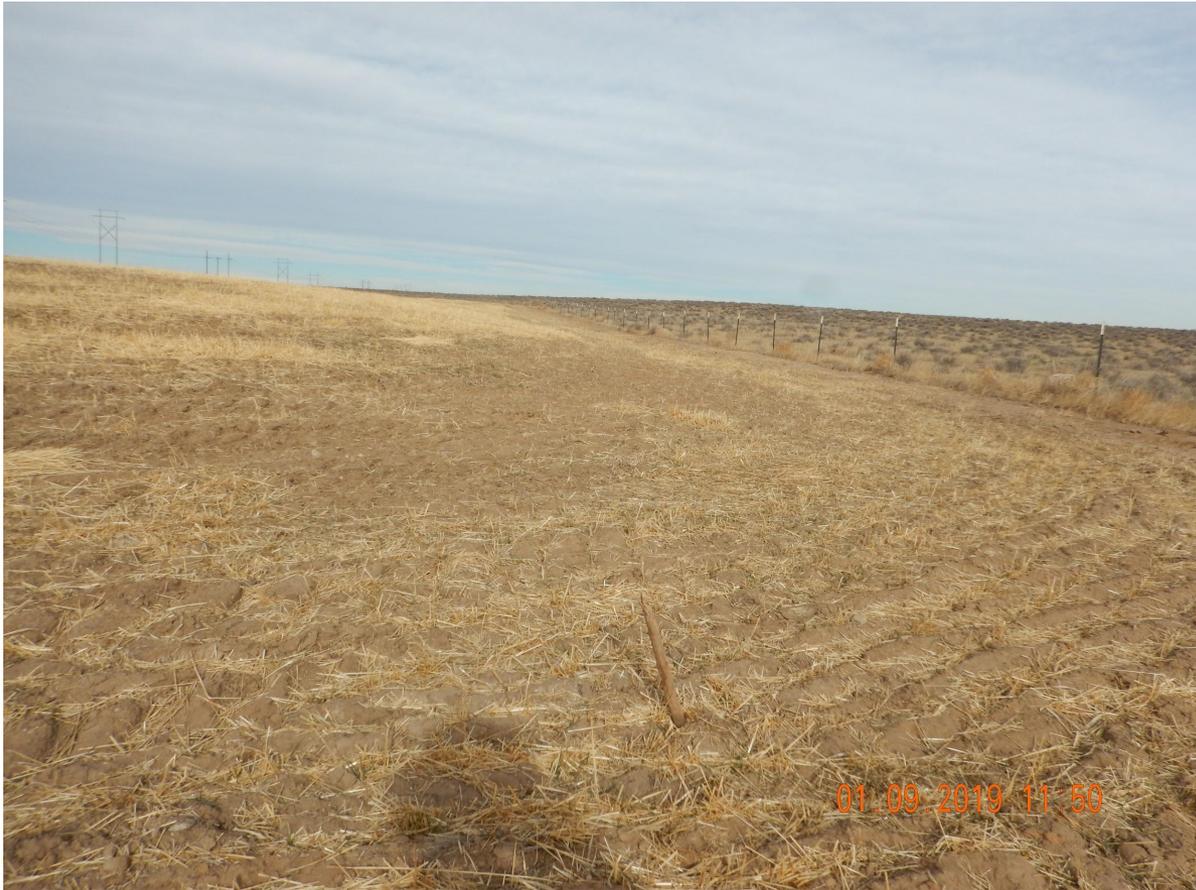
Photo 6. Photo taken from the southeastern perimeter of the location, facing North. See comments under Photo 5.

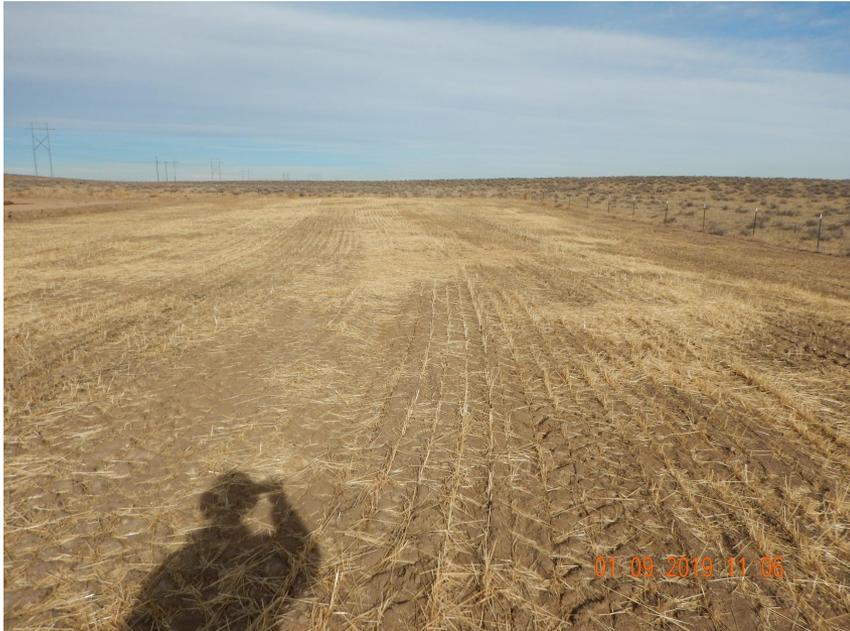
Photo 7. Photo taken from the eastern interim area, facing North. See comments under Photo 3.

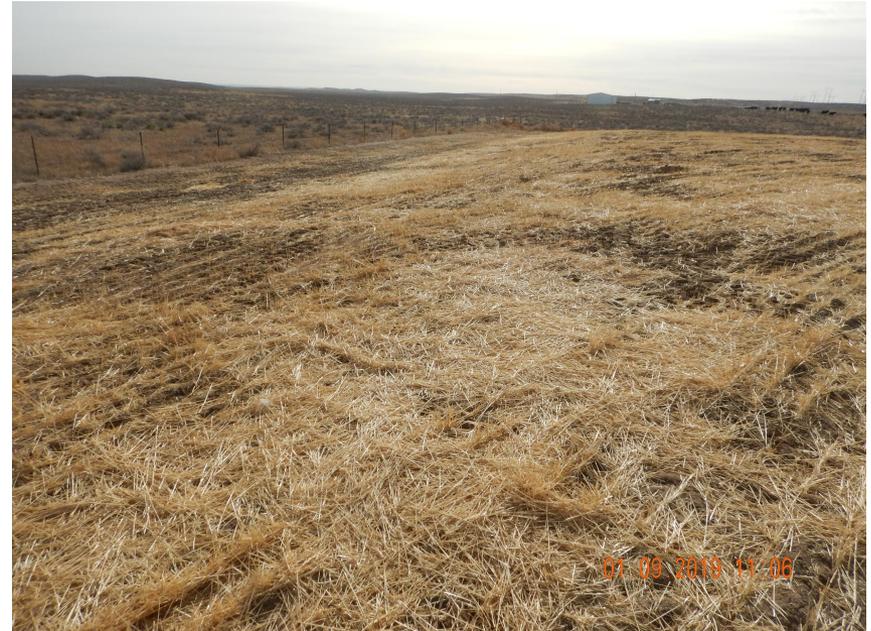
Photo 8. Photo taken from the eastern interim area, facing South. See comments under Photo 3.

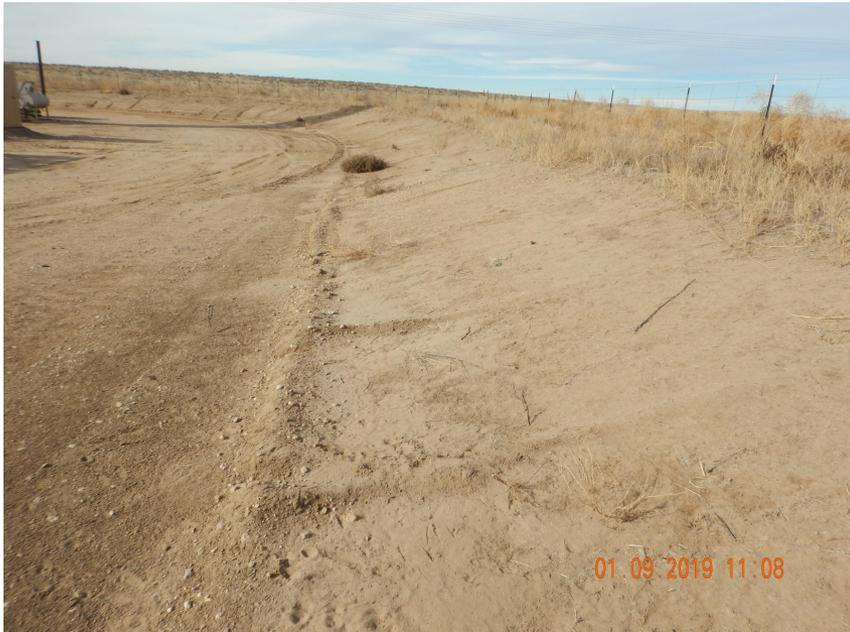
Photo 9. Photo taken from the northern location, facing West. Tackifier was observed on the cut slope but appears to be in need of maintenance.

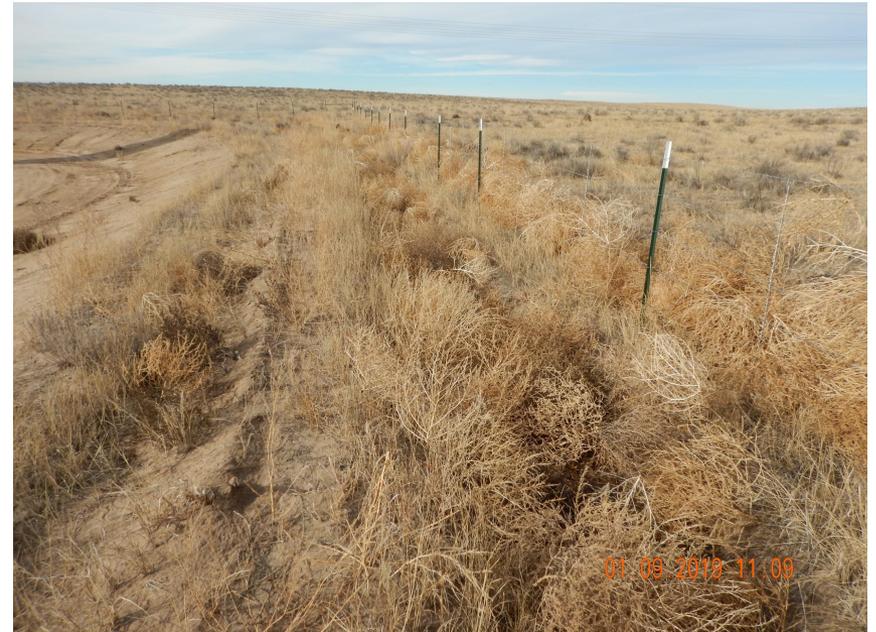
Photo 10. Photo taken from the northern location, facing West. See comments under Photo 2.
