Construction and Stormwater Inspection

Operator: CRESTONE PEAK RESOURCES OPERATING LLC - #10633

Location ID: 451044

Location Name: Regnier Farms /19H-B268 Wells

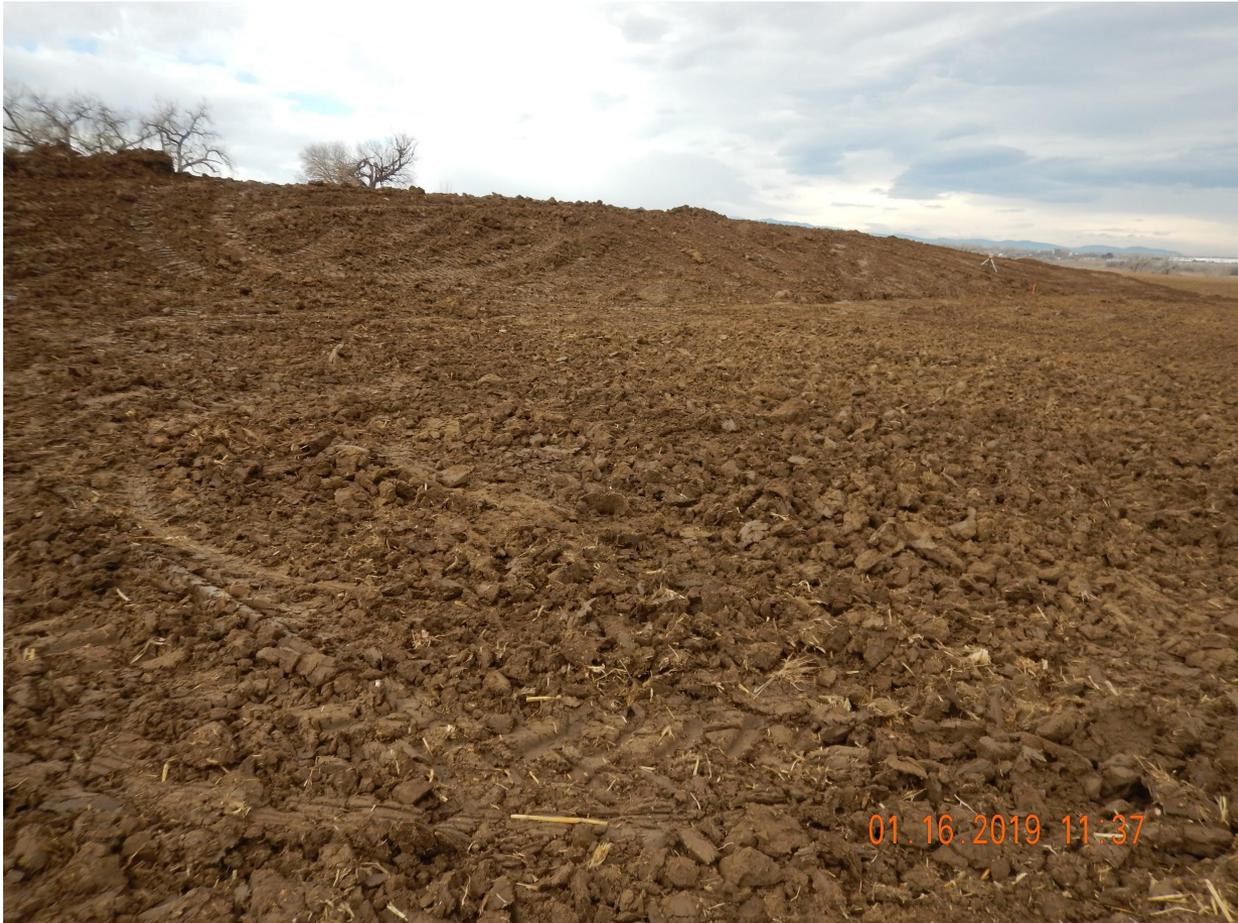
Photo 1. Photo taken from the western location, facing Northwest. Photo illustrates the western topsoil stockpile. Operator was still salvaging topsoil from the northern location. Based on field observations, it appears the Operator is salvaging all topsoil from disturbance areas.

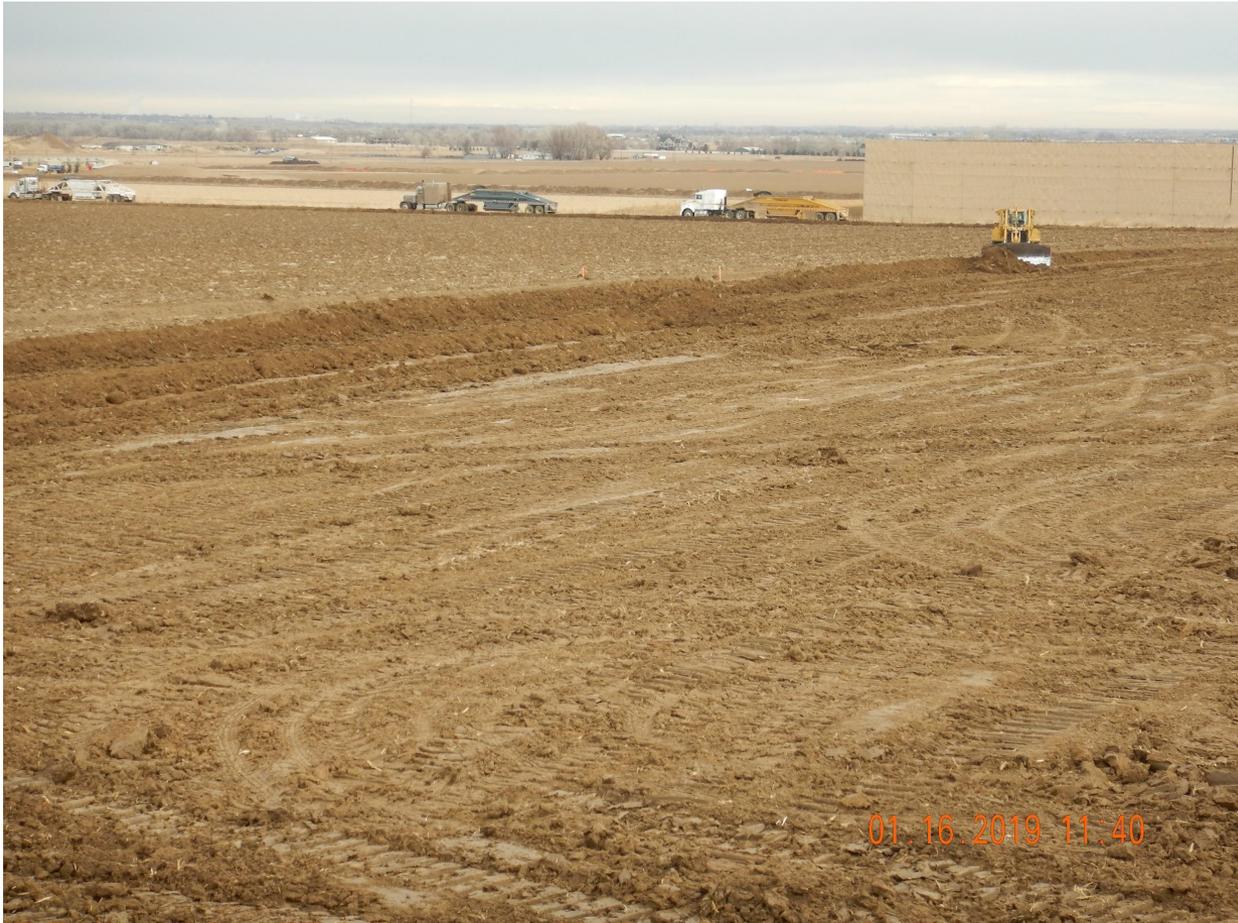
Photo 2. Photo taken from the western topsoil stockpile, facing East. Photo illustrates salvage operations underway along the northern location.

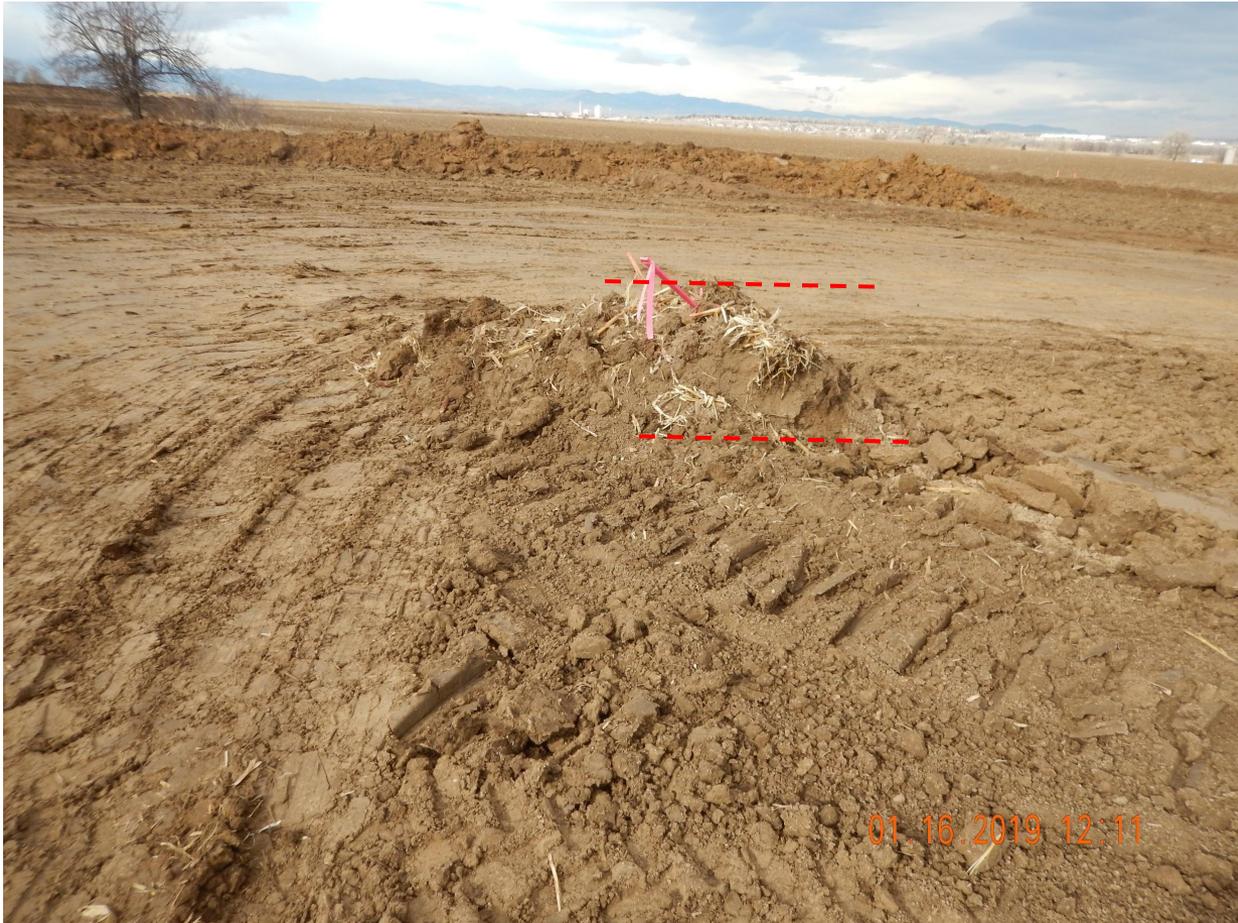
Photo 3. Photo taken from the central location, facing Northwest. Photo illustrates the original surface height compared to how much topsoil is being salvaged. Appears about 15” of topsoil has been salvaged from the location.

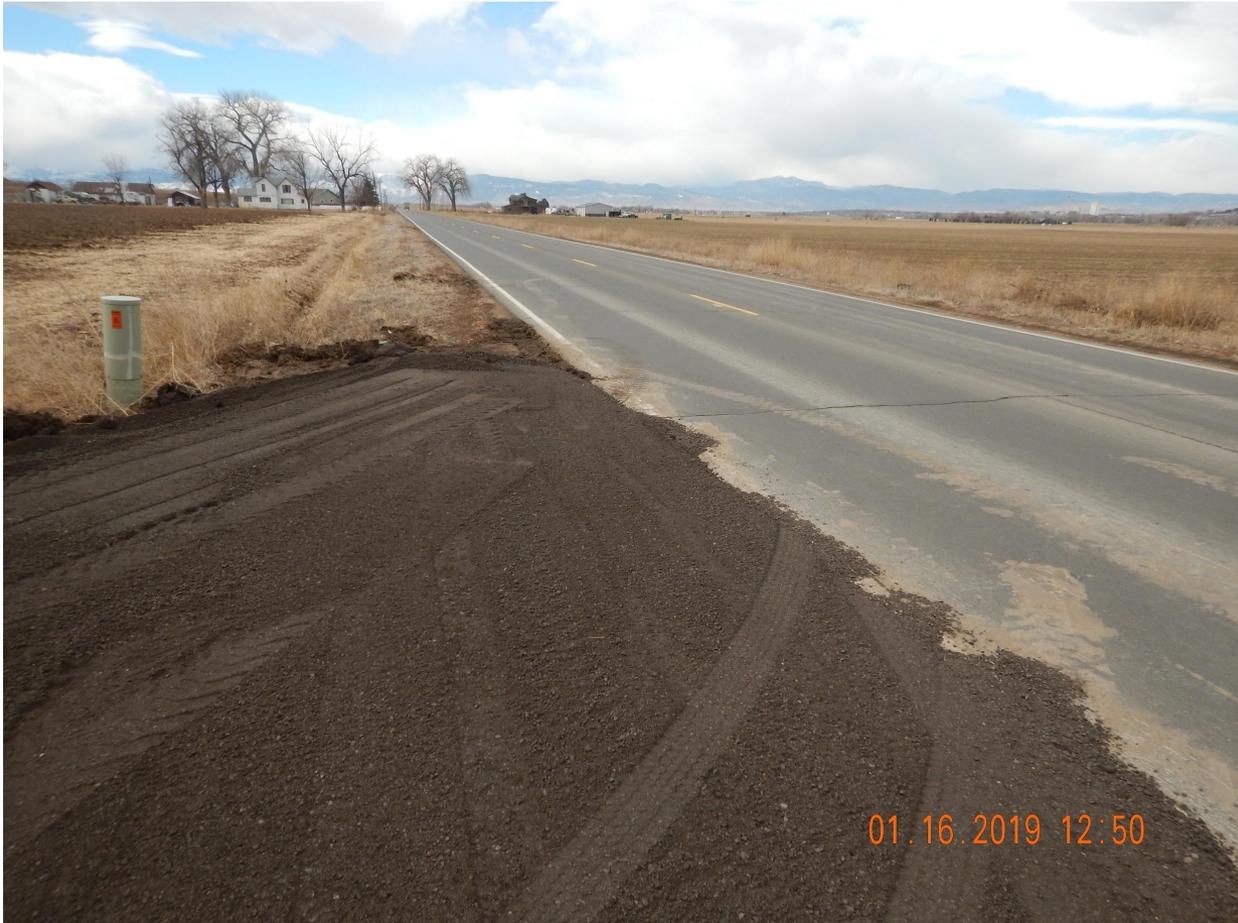
Photo 4. Photo taken from the entrance of location, facing West. Photo illustrates there is no vehicle track out issues. Operator is still constructing the access road and has additional vehicle tracking device BMPs planned.

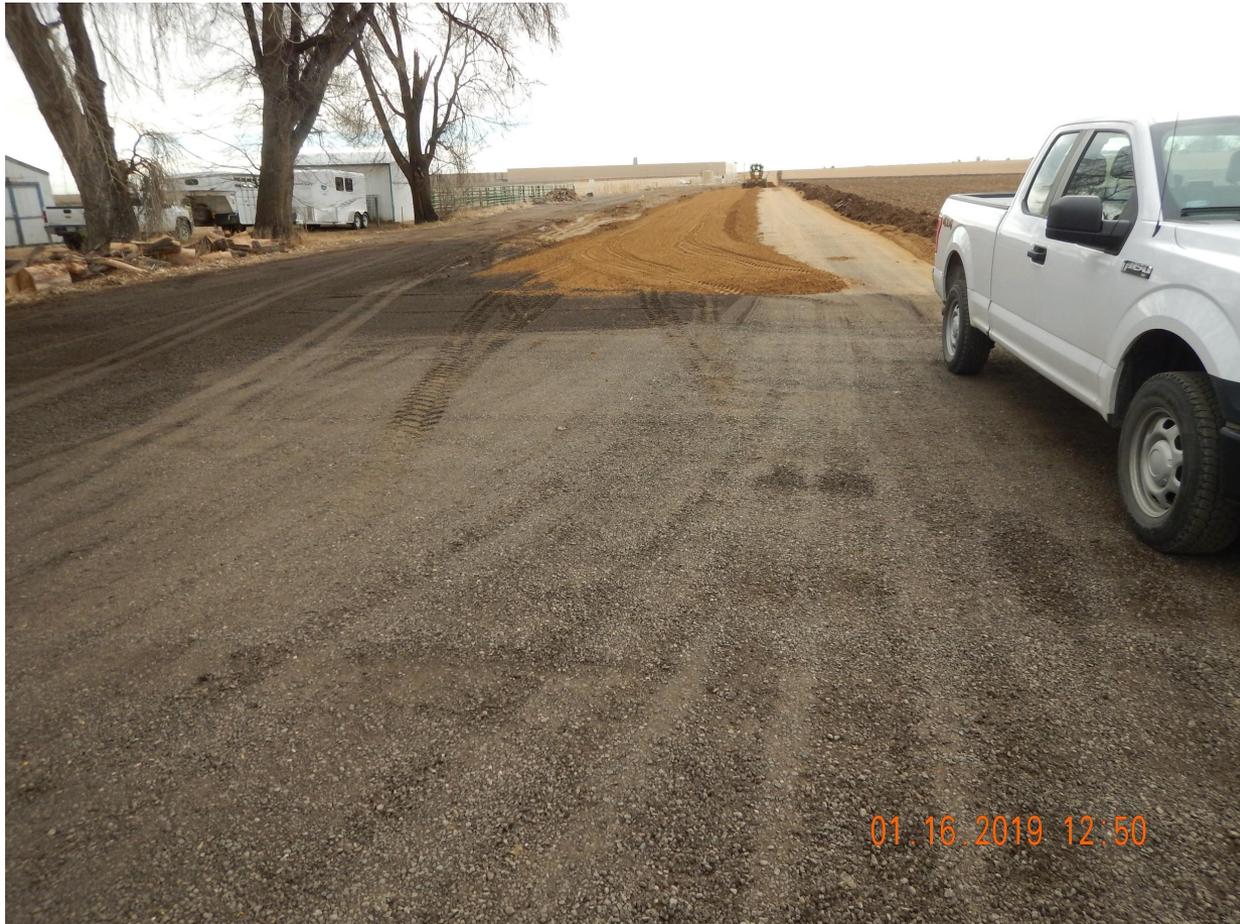
Photo 5. Photo taken from the entrance of location, facing South. See comments under Photo 4.
