Inspection Photos

API: 05-009-06661

Operator: BAYHORSE PETROLEUM LLC

Inspection Date: 1/18/2019

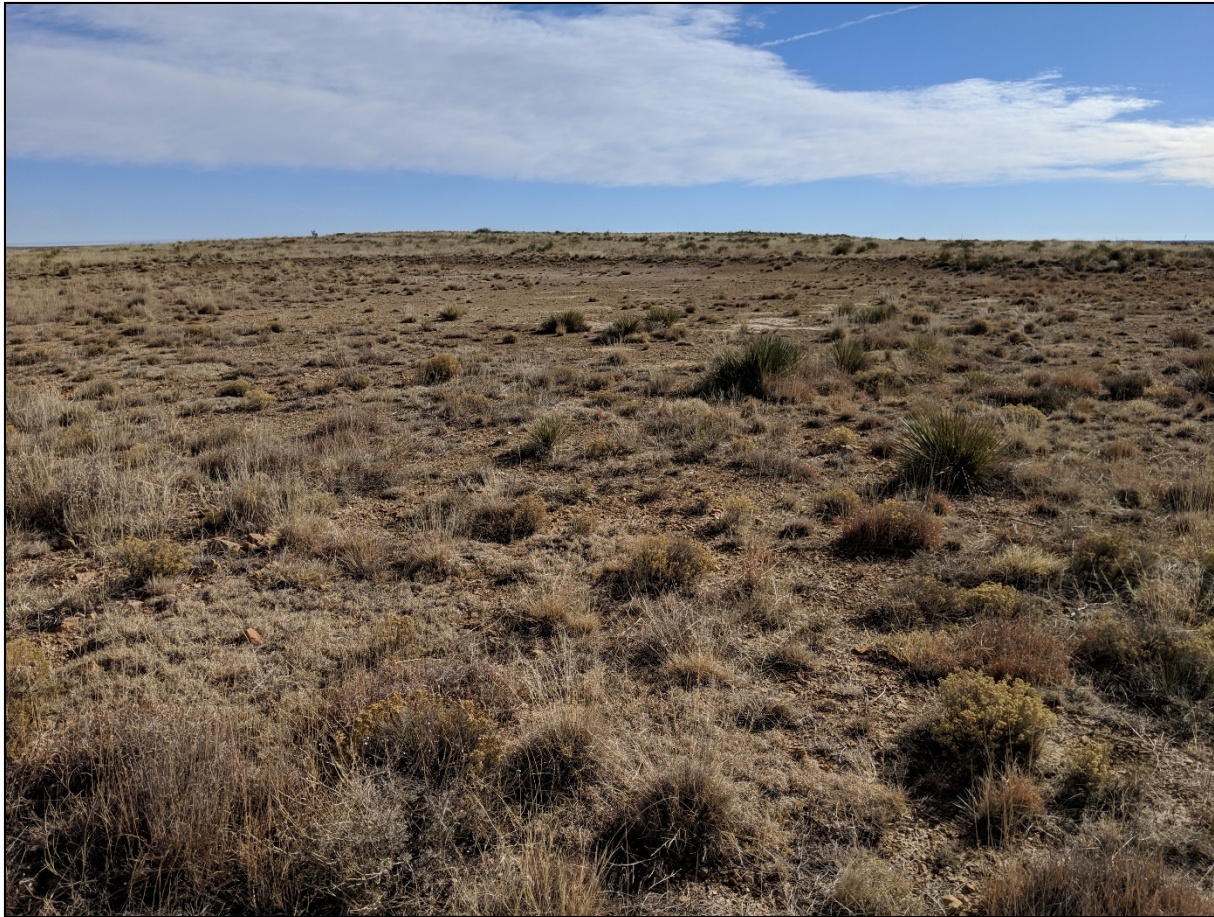
Photo 1. West side of the location facing east.

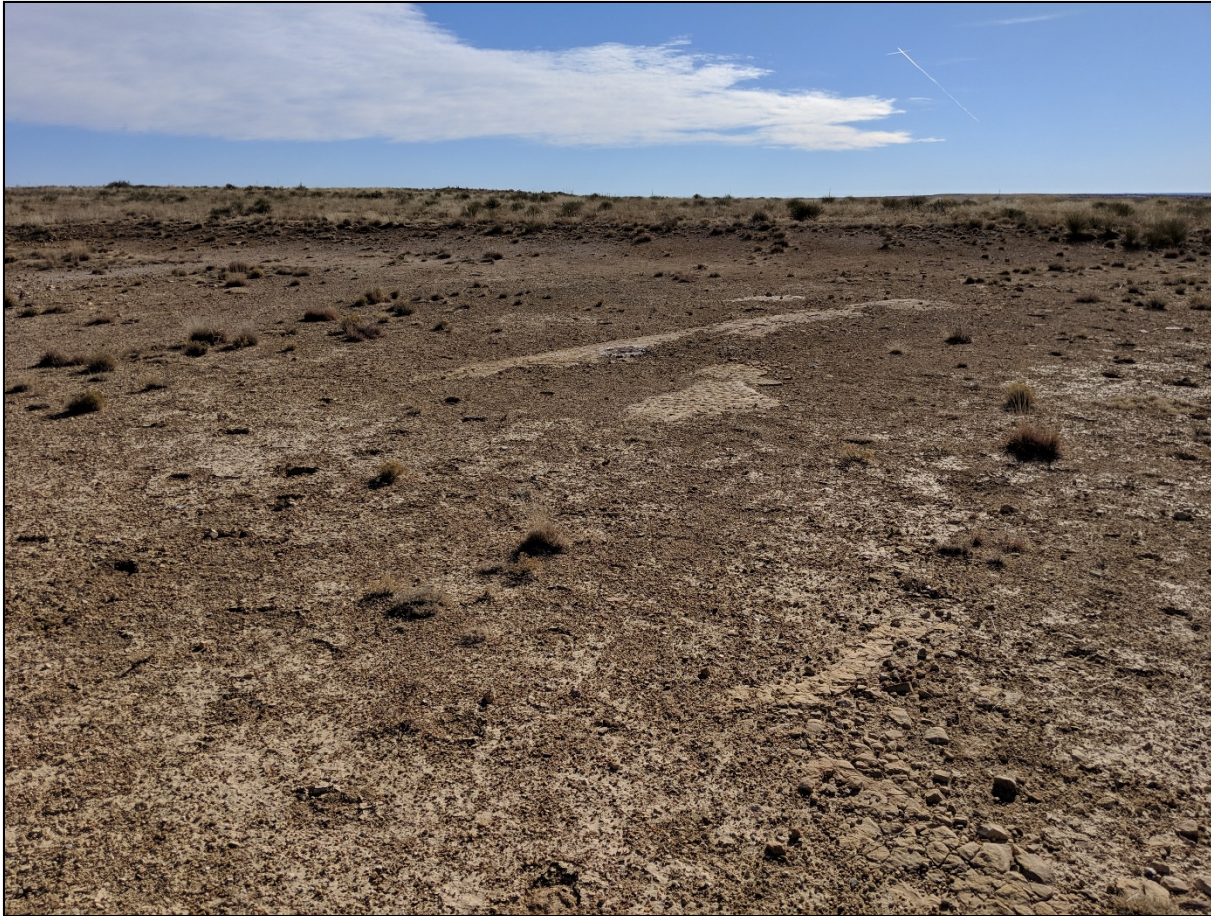
Photo 2. Facing east at the east side of the location. Vegetation has not established in this area approximately 100'x150'.

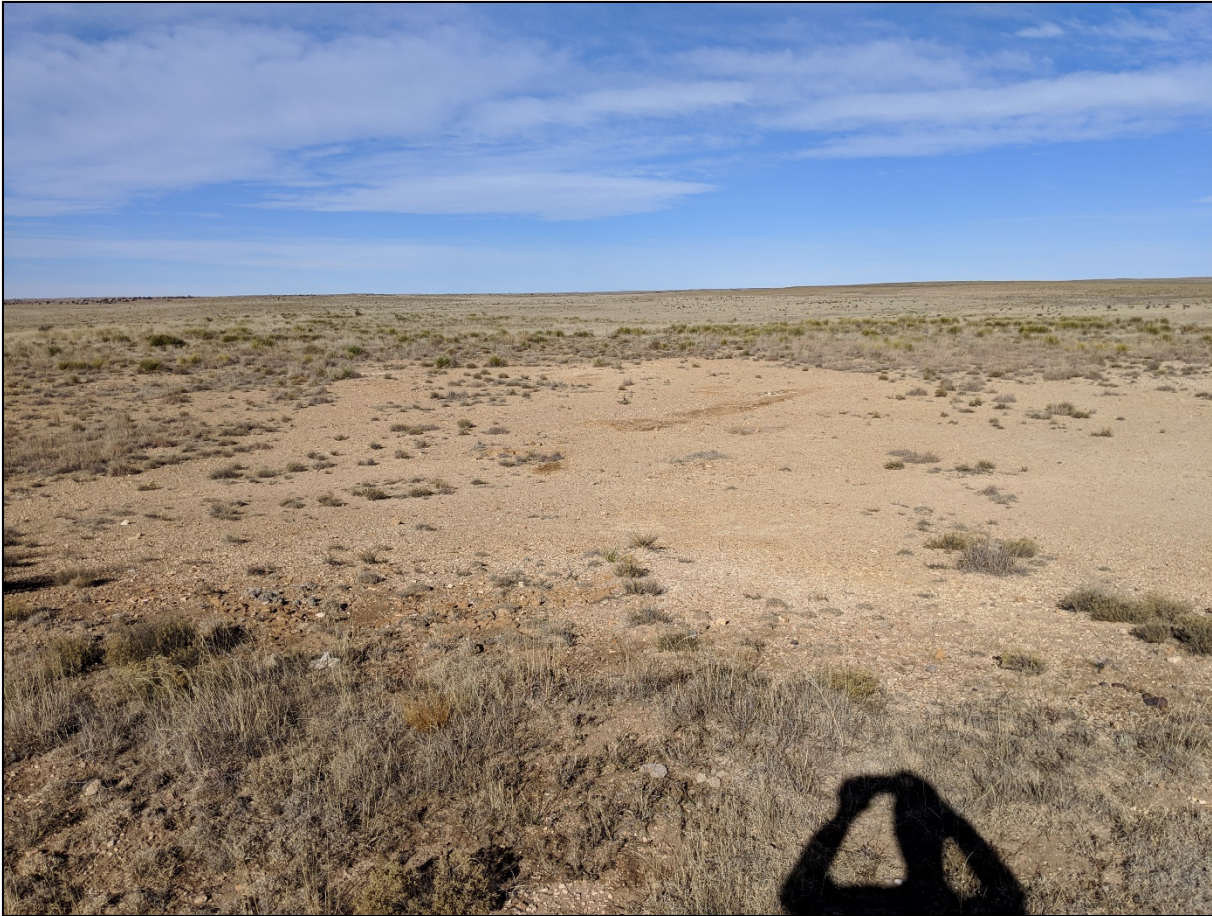
Photo 3. East side of the location facing west.

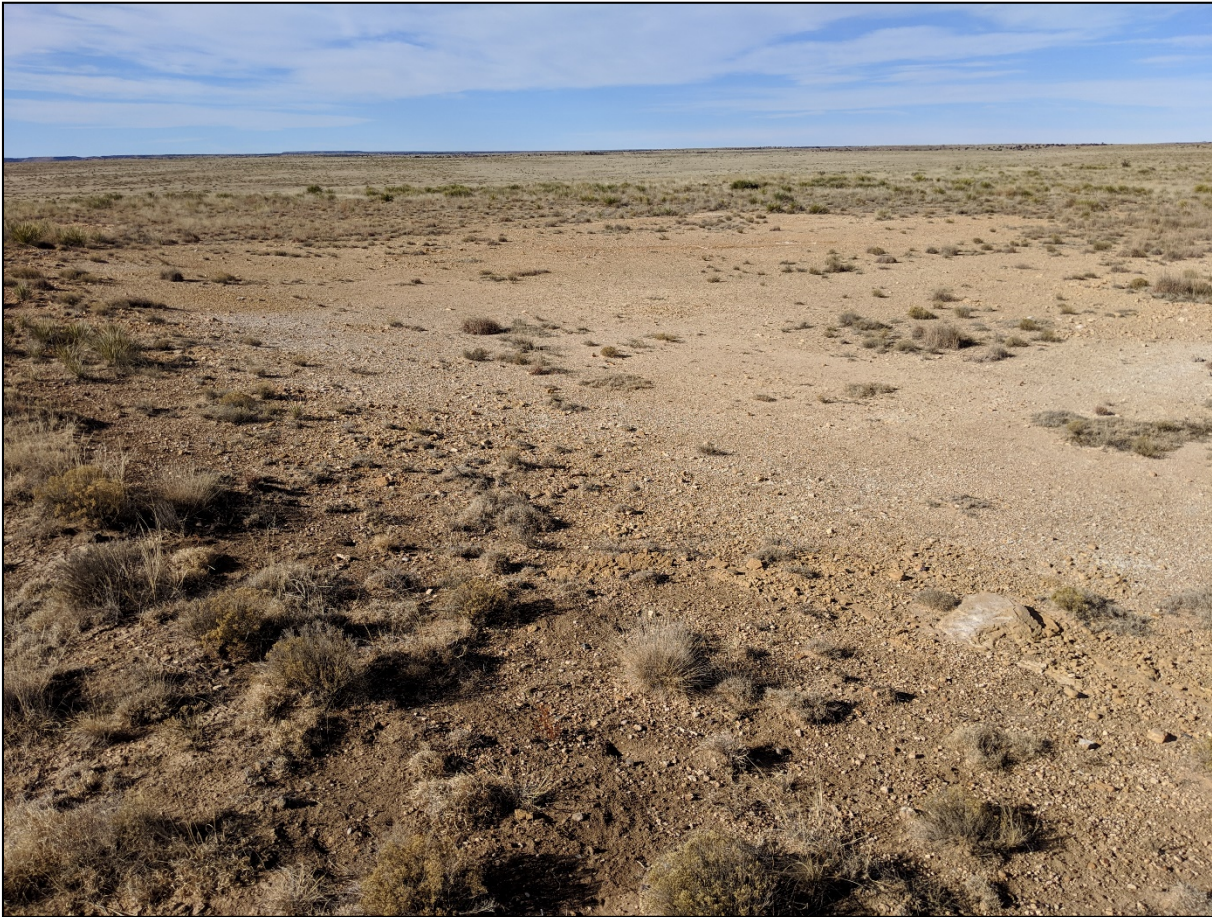
Photo 4. Northeast side of the location facing southwest.

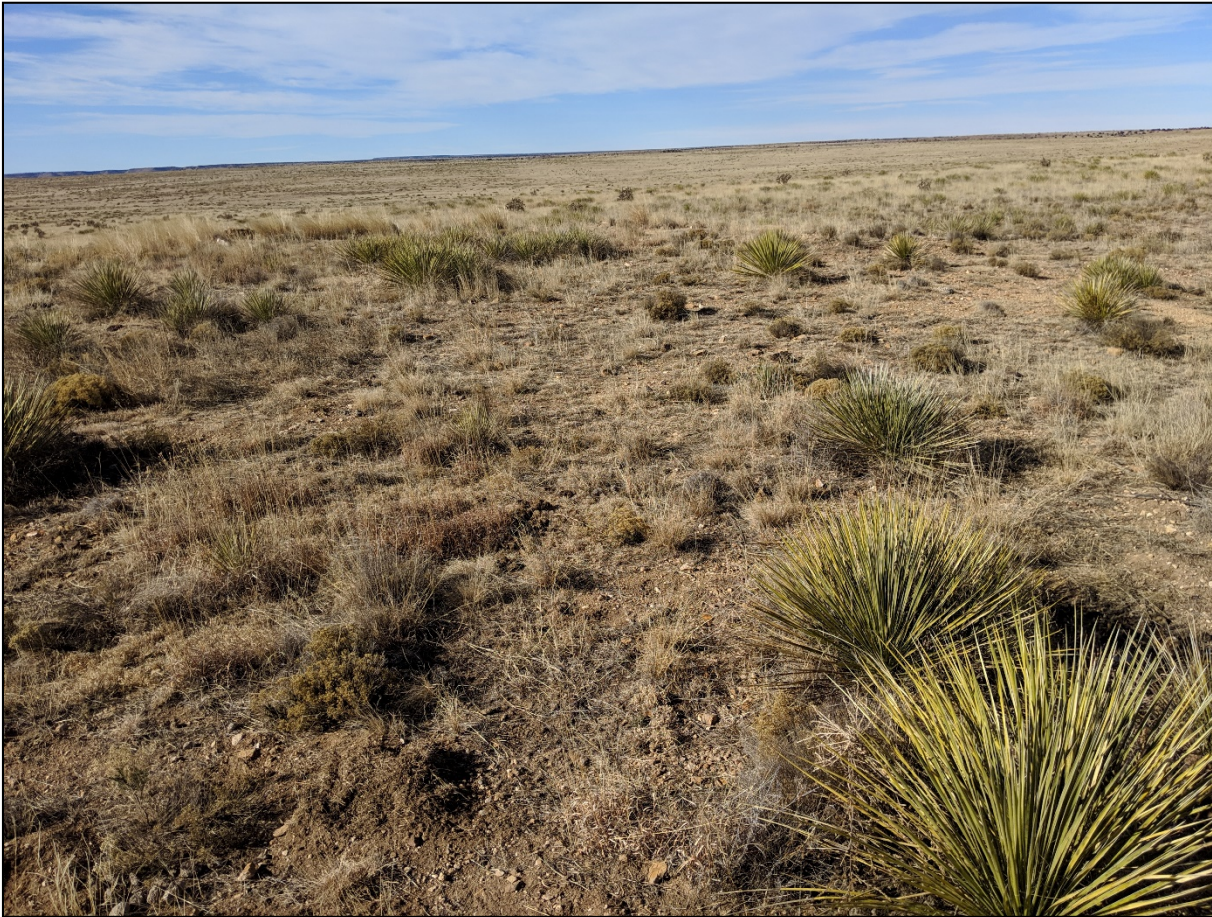
Photo 5. Facing south toward the undisturbed vegetation.
