Inspection Photos

1/25/2019

Operator: MALLARD EXPLORATION LLC # 10670

Location ID: 453517

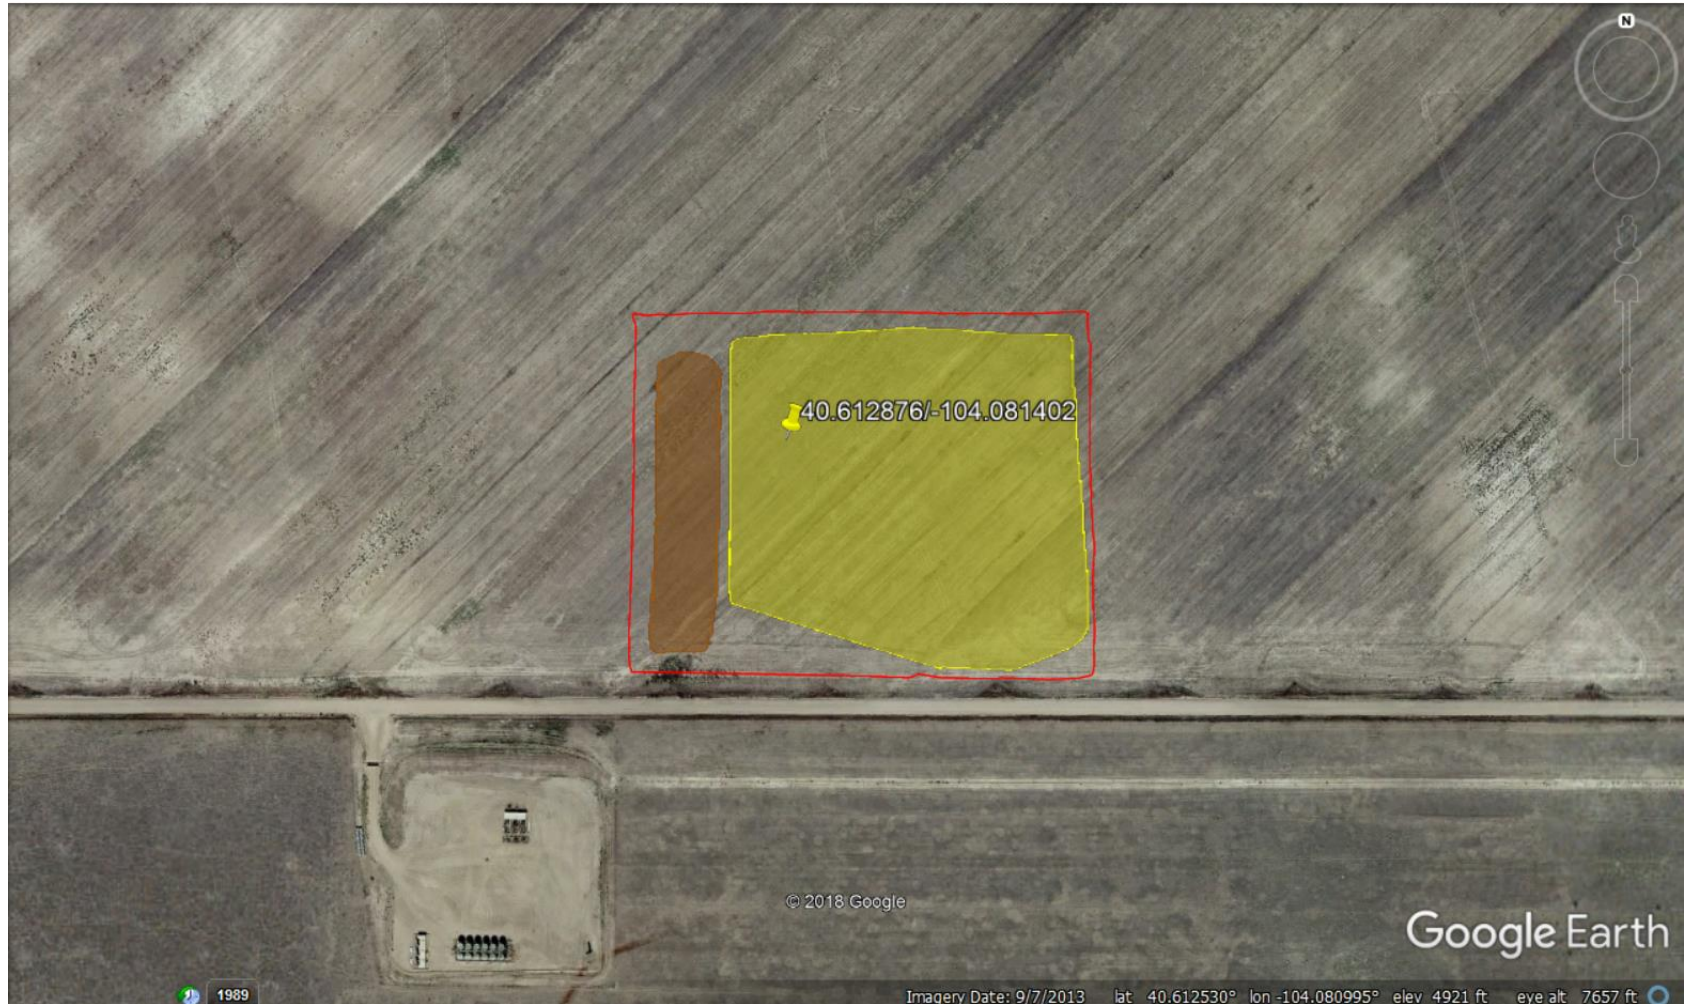
Photo 1: 2013 Google Earth aerial imagery. Photo shows areas of disturbance for the location mapped using a Trimble Juno 3B handheld device. Red polygon shows area of total disturbance (13.5 acres), brown indicates area of the topsoil stockpile (1.5 acres), and yellow indicates the area of the constructed pad (8.95 acres). Total disturbance appears to be in compliance with the approved Form 2A for the permitted disturbance area.

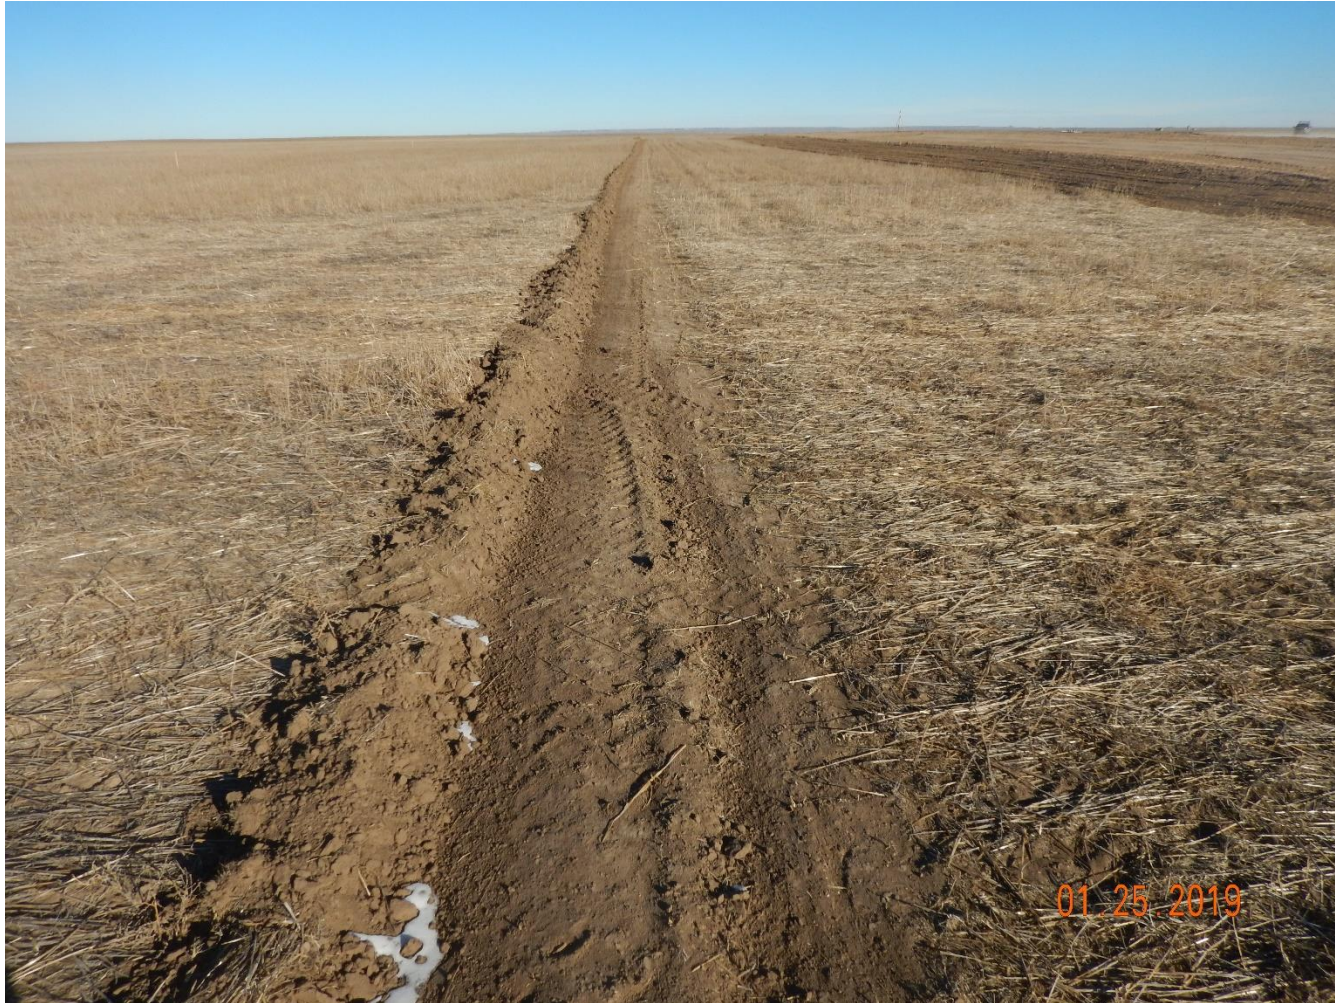
Photo 2: Photo taken from the southwest corner of the disturbance area, facing north. Operator appears to have installed a stormwater ditch and berm BMP along the perimeter of the disturbance area. Ditch/Berm BMP is shallow with unconsolidated material. Ditch/Berm BMP does not appear to have been constructed in accordance with good engineering practices, is improper and insufficient.

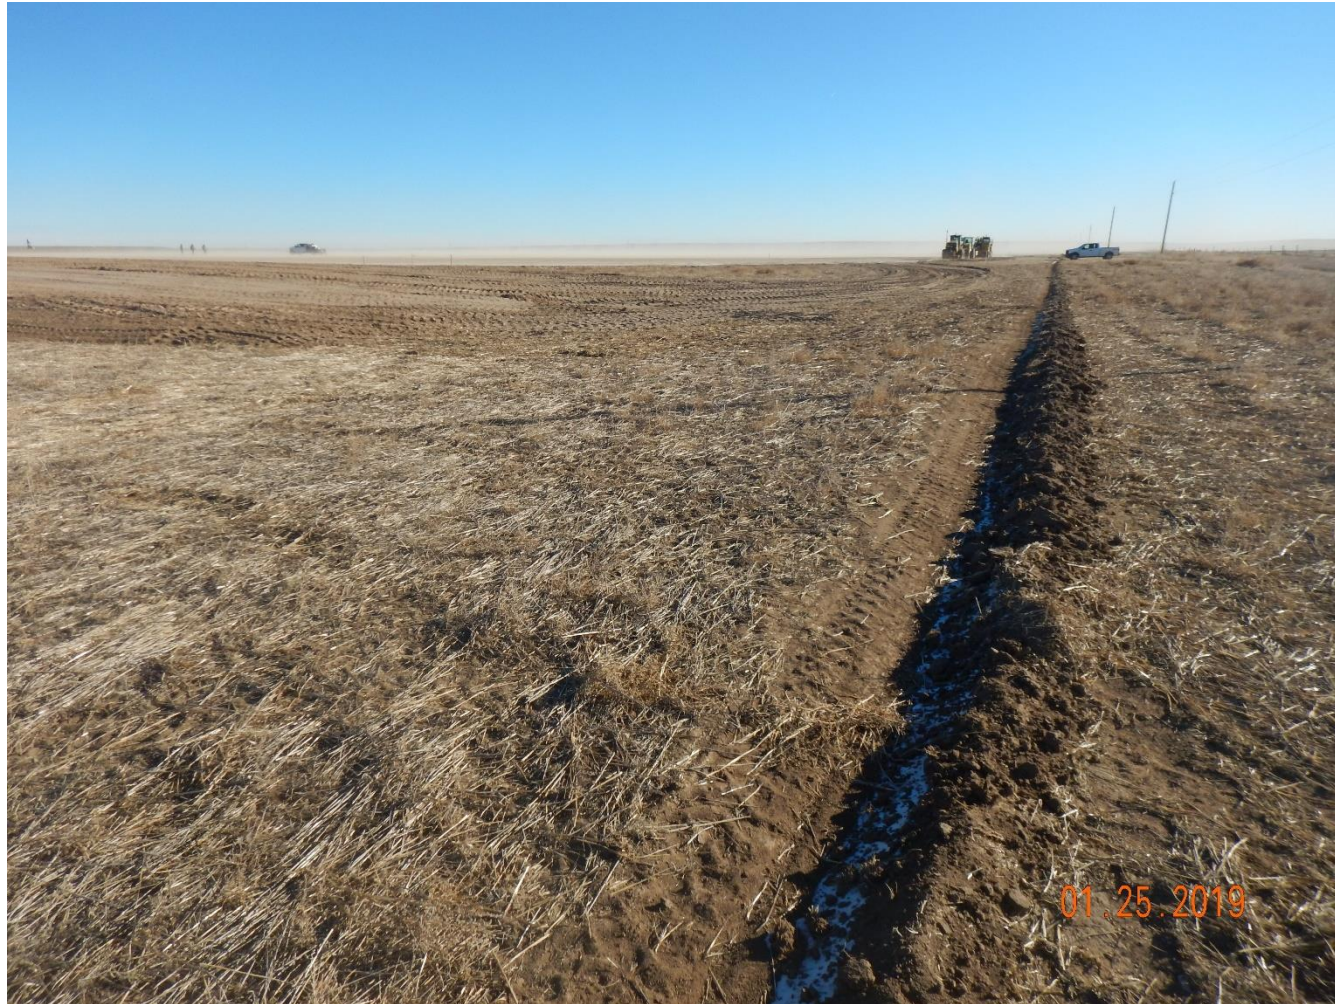
Photo 3: Photo taken from the southwest corner of the disturbance area, facing east. Photo shows ditch/berm BMP along perimeter of the location. See comments under photo 2.

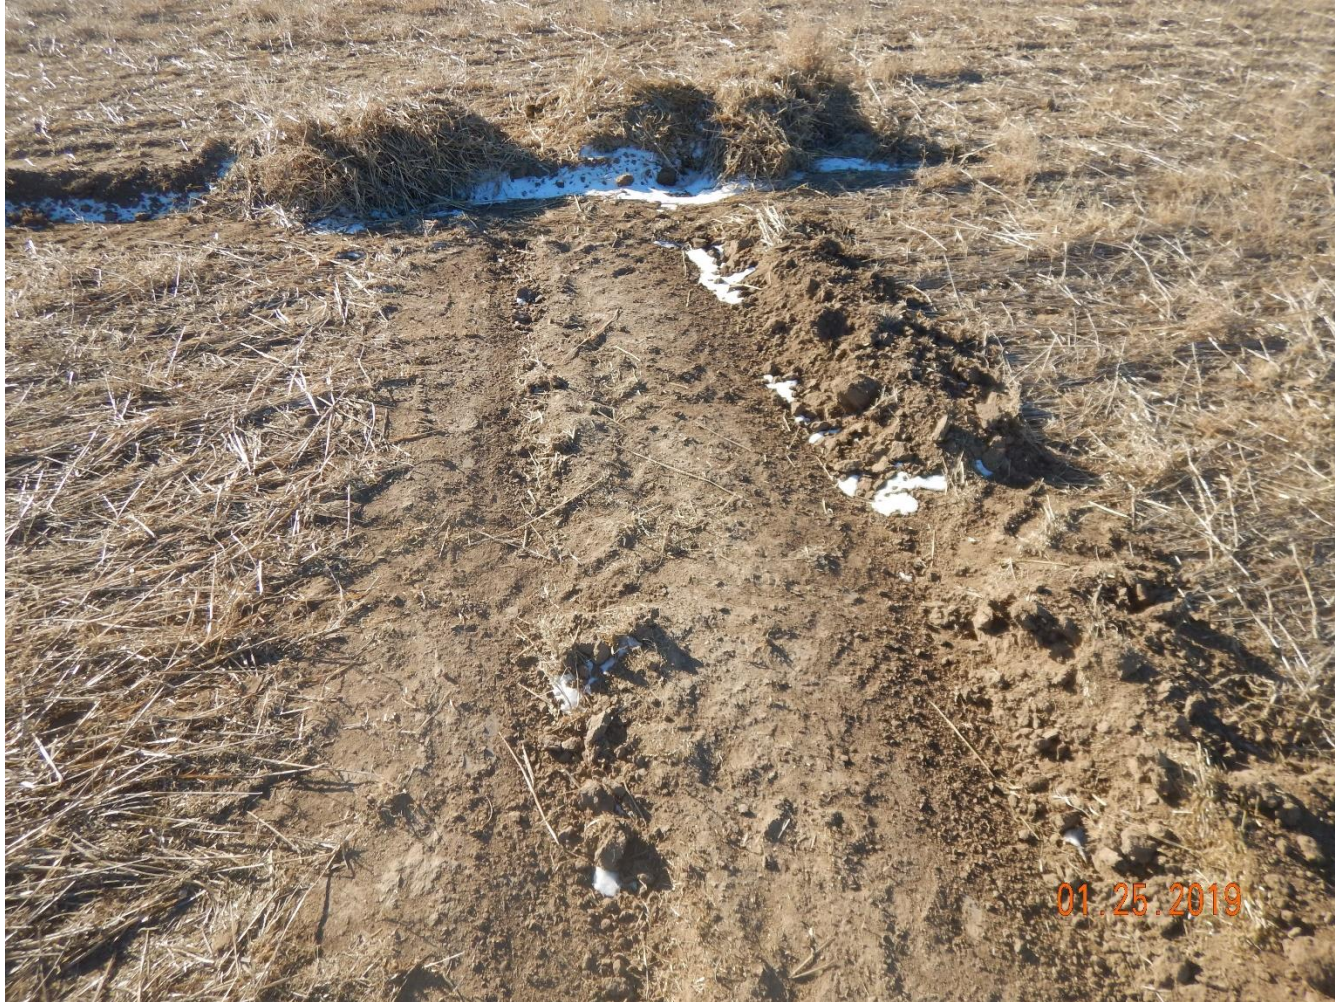
Photo 4: Photo taken from the southwest corner of the location. Photo shows ditch/berm BMP along perimeter of the location. See comments under photo 2.

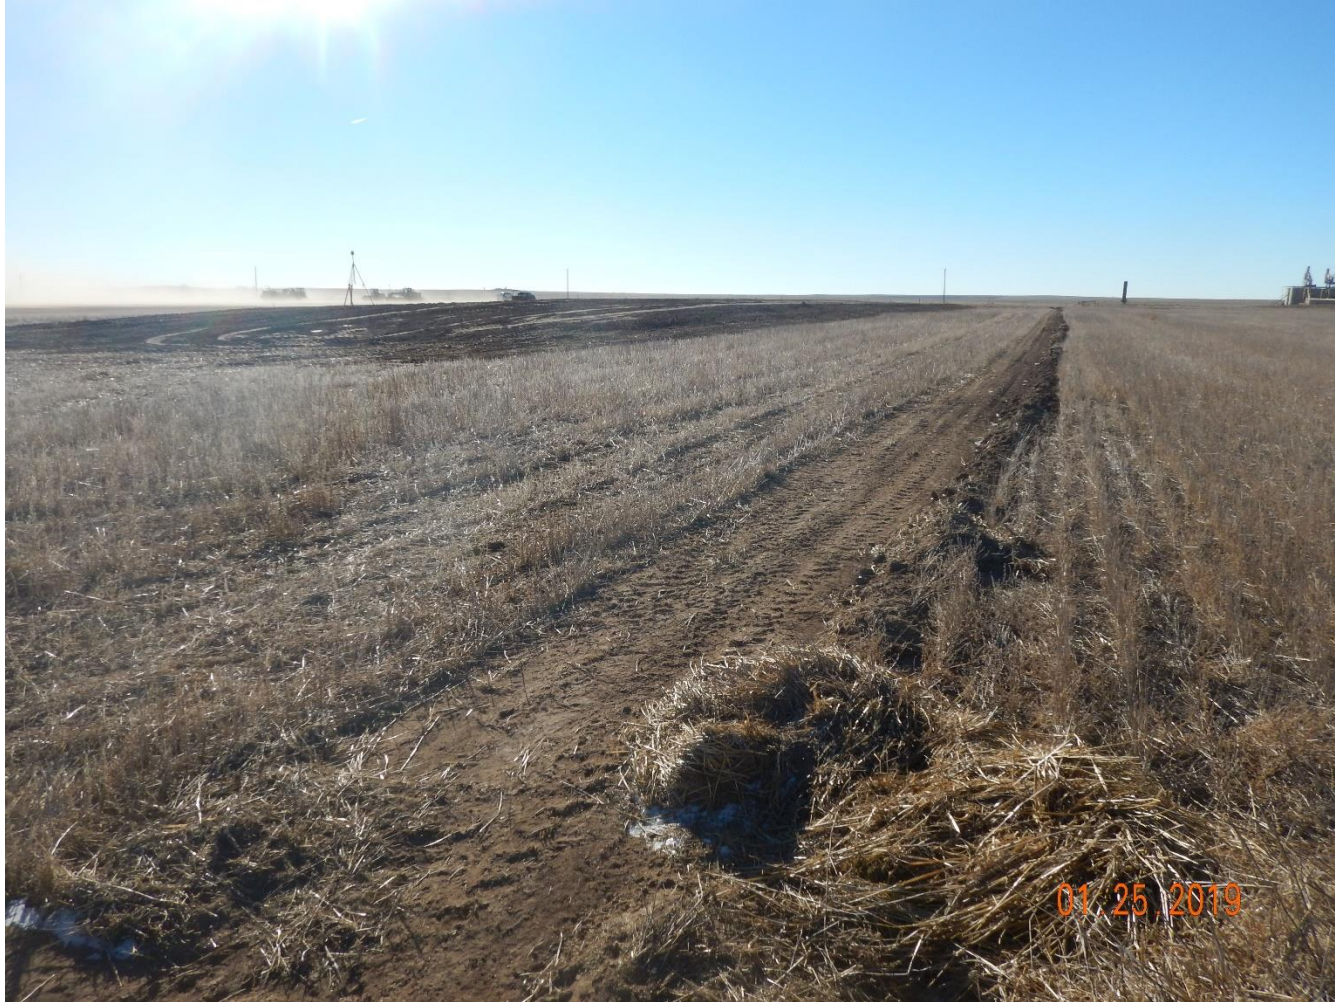
Photo 5: Photo taken from the northwest corner of the location, facing south. Photo shows ditch/berm BMP along perimeter of the location. See comments under photo 2.

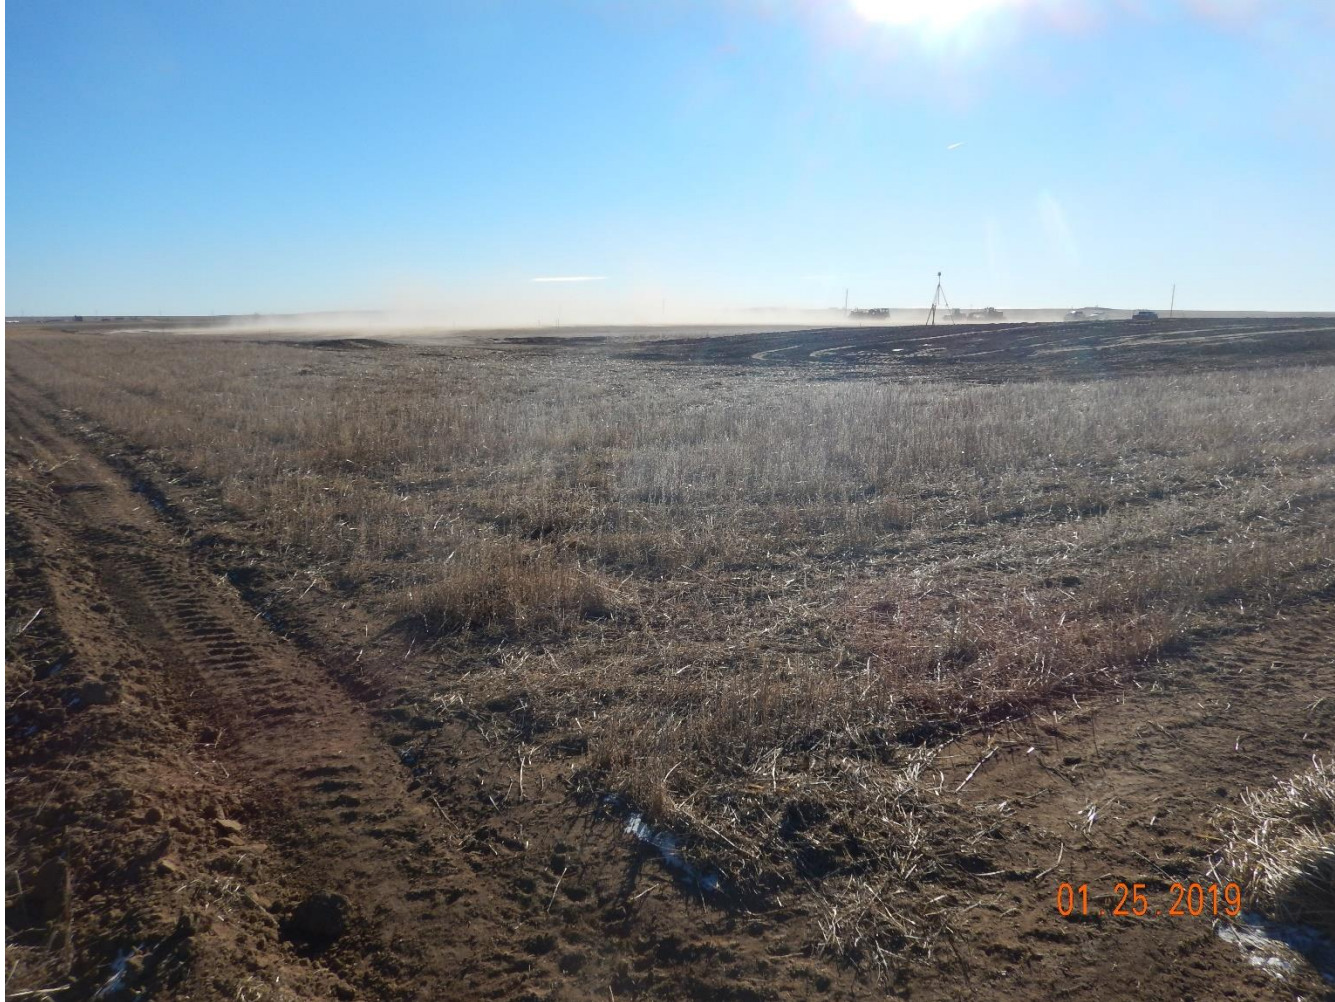
Photo 6: Photo taken from the northwest corner of the location, facing south. Photo shows ditch/berm BMP along perimeter of the location. See comments under photo 2. Photo also shows ongoing wind erosion and sediment transport off the location.

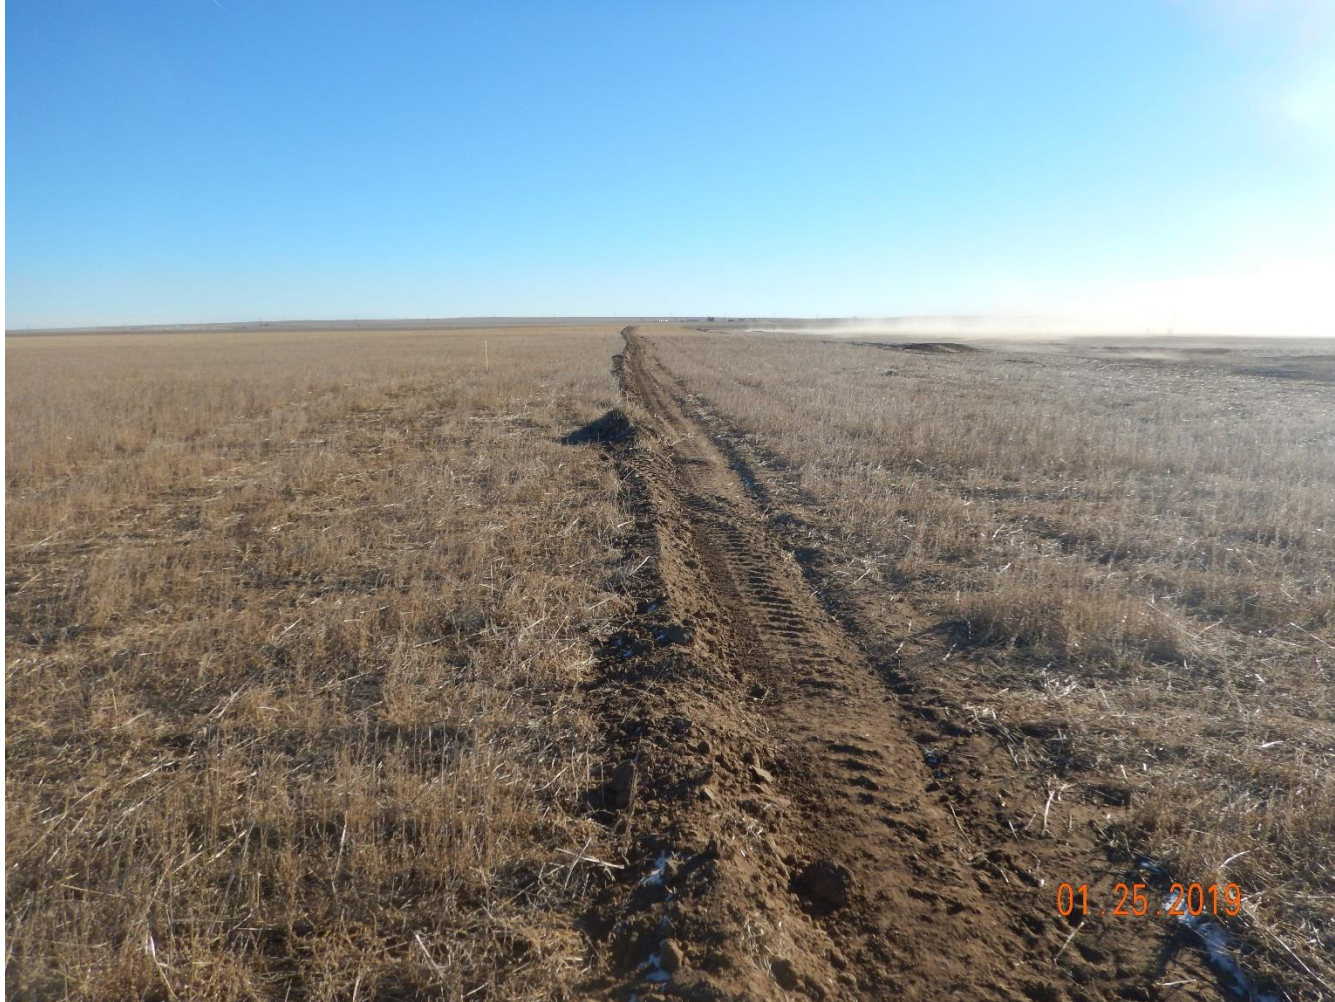
Photo 7: Photo taken from the northwest corner of the location, facing east. Photo shows ditch/berm BMP along perimeter of the location. See comments under photo 2.

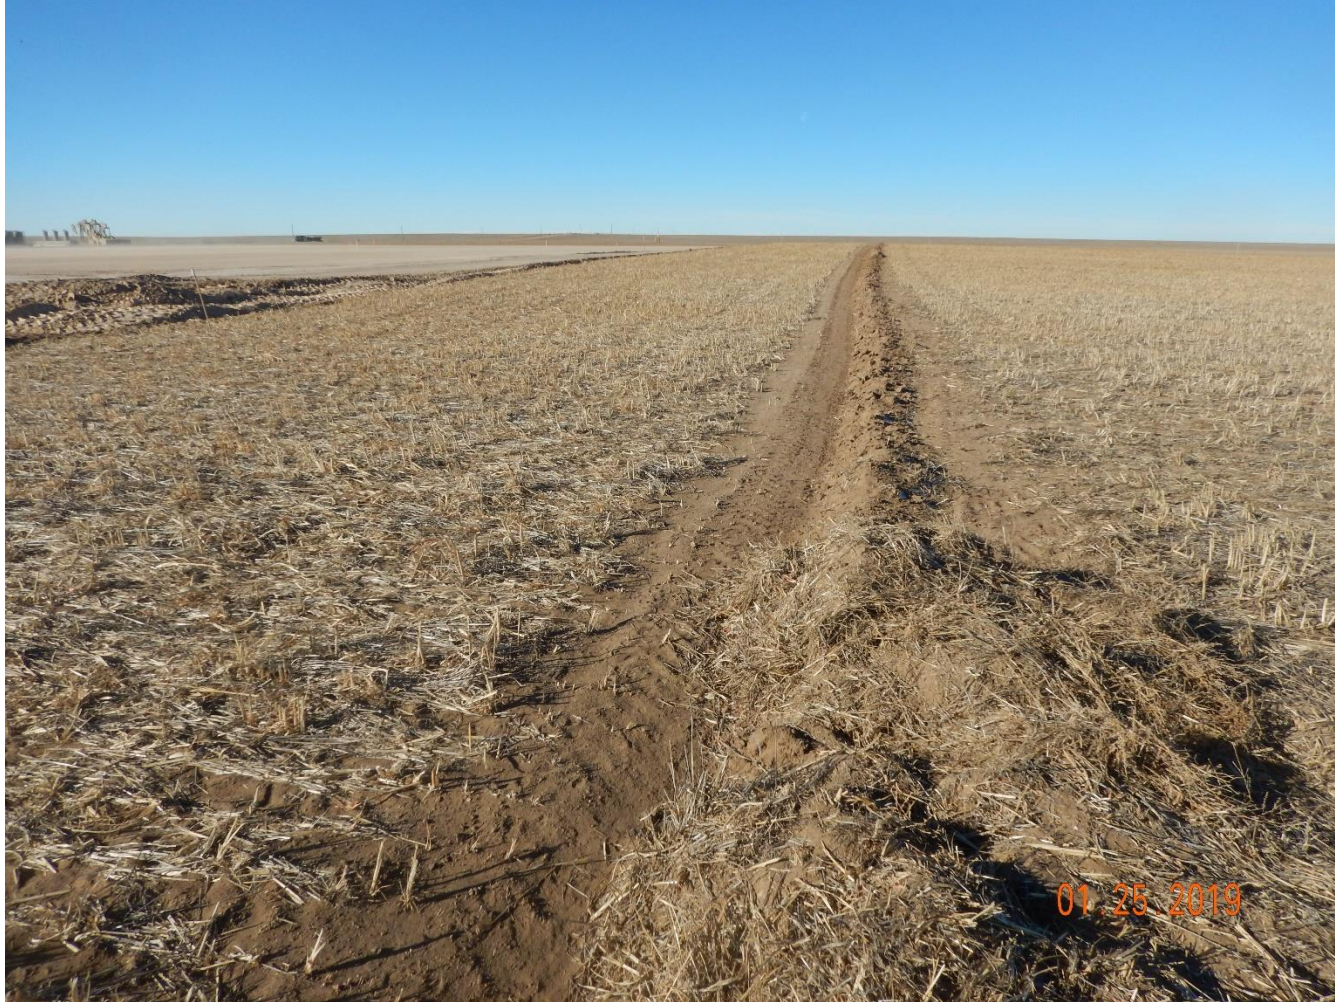
Photo 8: Photo taken from the northeast corner of the location, facing west. Photo shows ditch/berm BMP along perimeter of the location. See comments under photo 2.

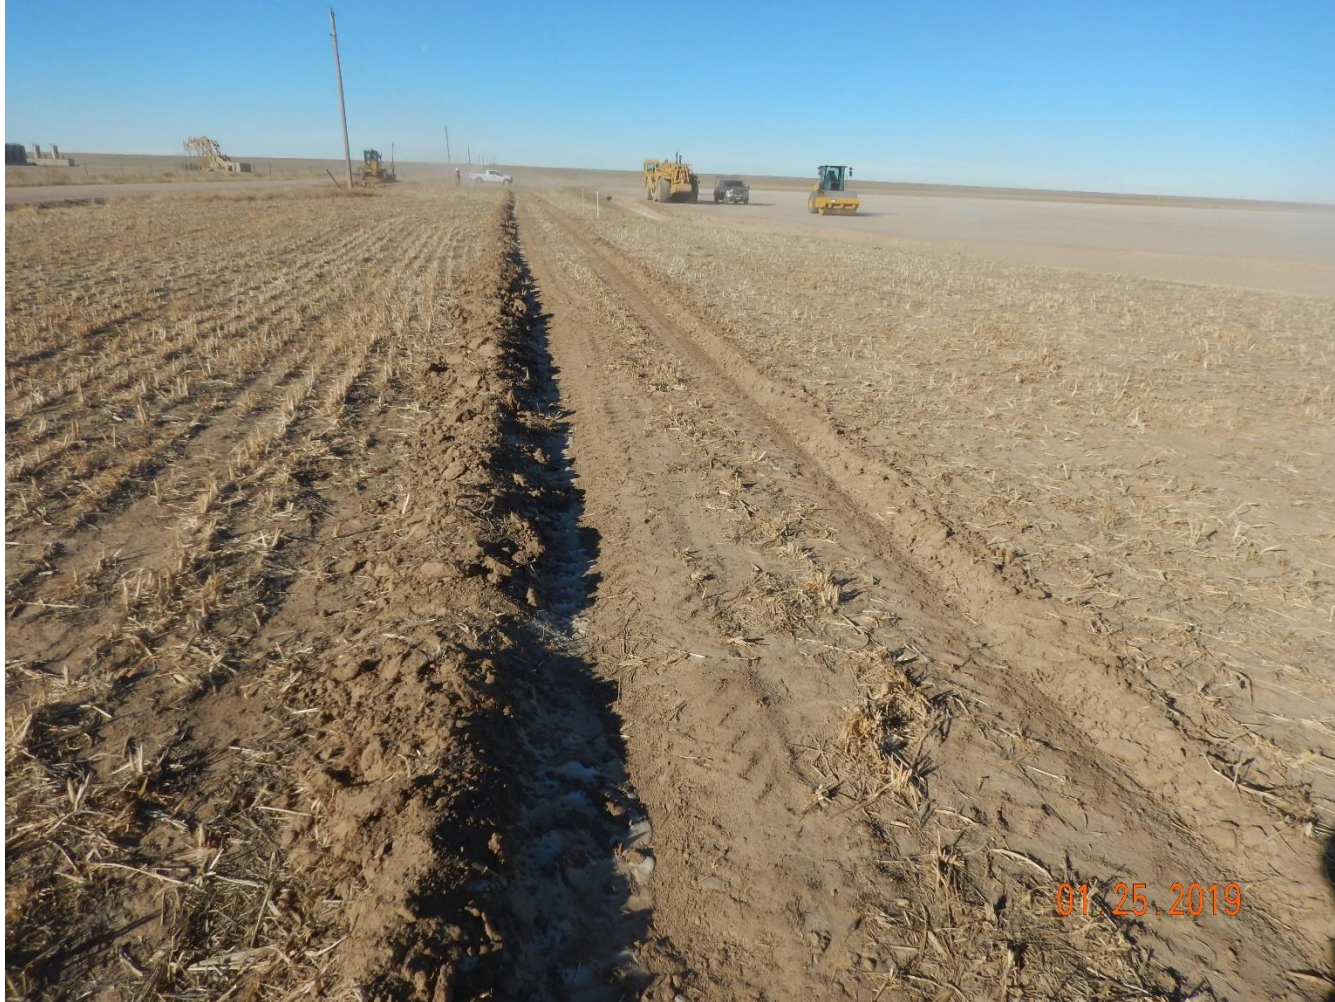
Photo 9: Photo taken from the southeast corner of the location, facing west. Photo shows ditch/berm BMP along perimeter of the location. See comments under photo 2.

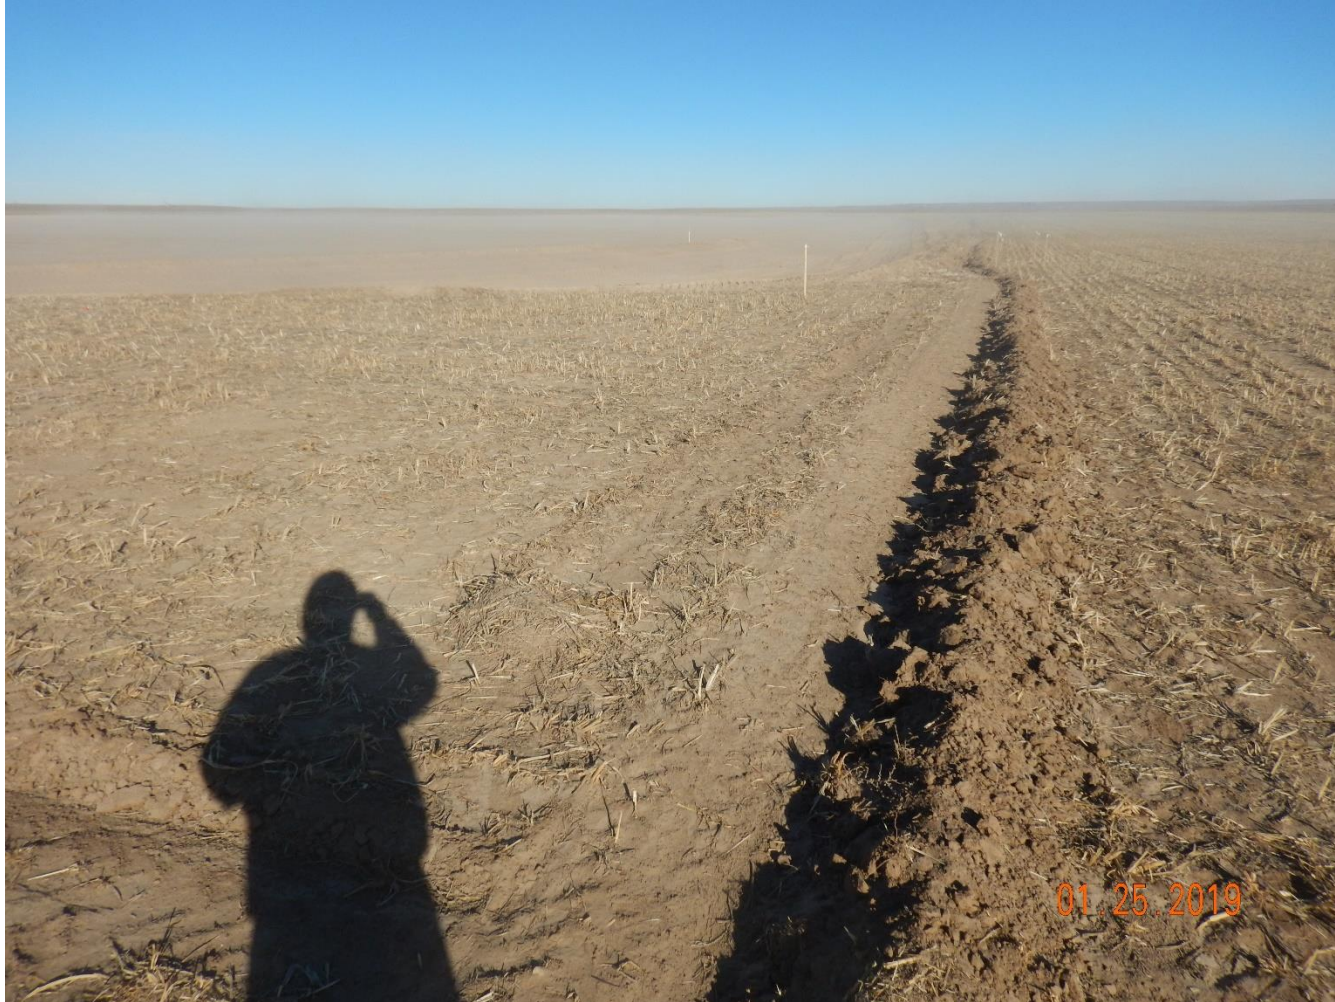
Photo 10: Photo taken from the southeast corner of the location, facing north. Photo shows ditch/berm BMP along perimeter of the location. See comments under photo 2

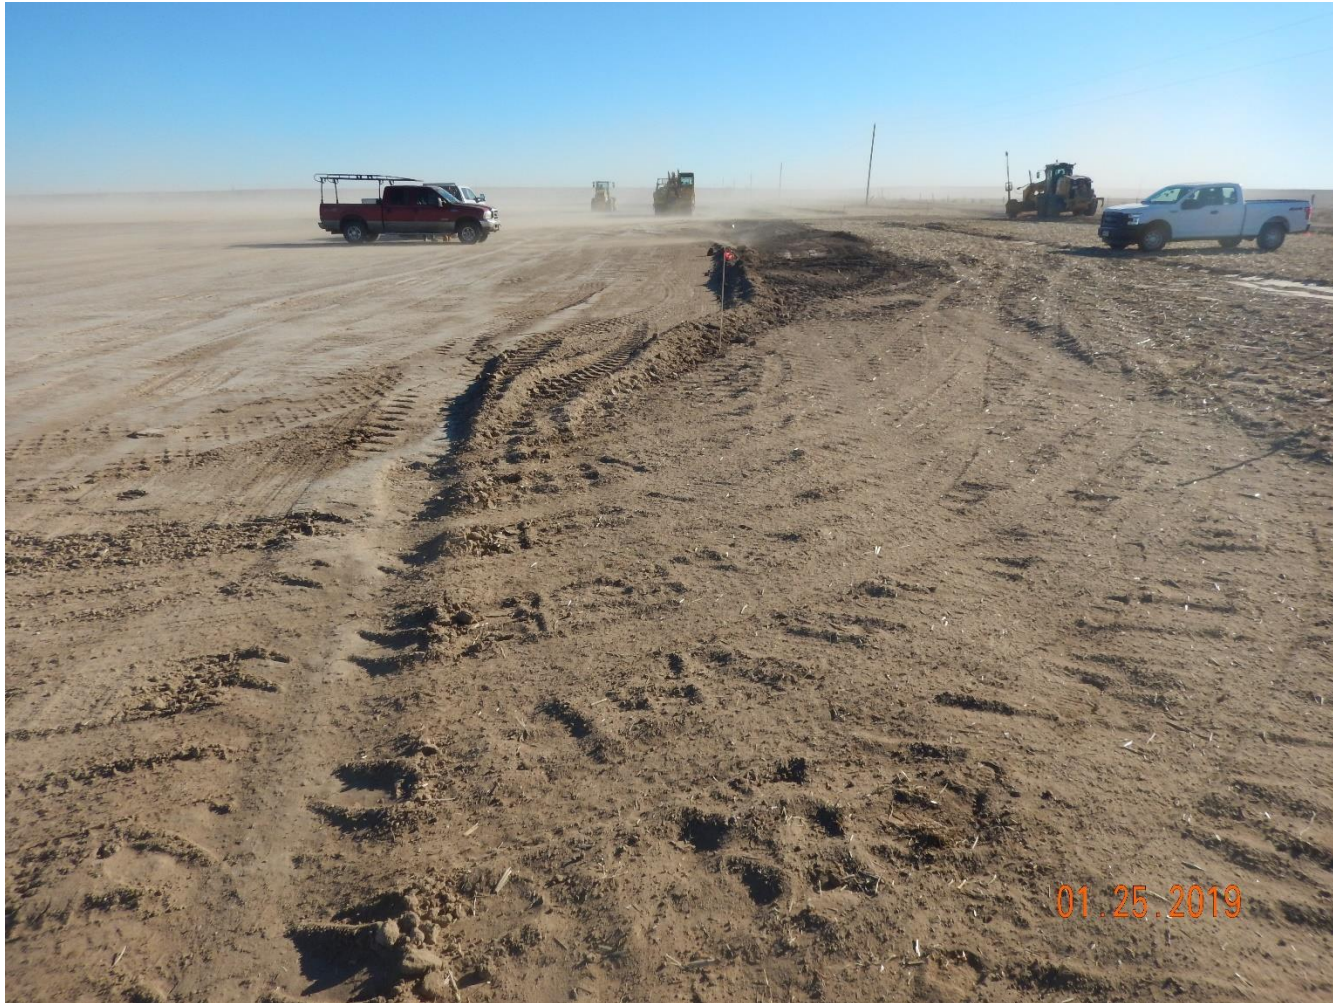
Photo 11: Photo taken from the southwest corner of the pad. Operator appears to have constructed a ditch along the northern end (with exception to the northeast corner), the eastern and southeastern areas of the constructed pad. Photo shows area of the pad on the southwest where the ditch ends. Required stormwater and erosion control BMPs do not appear to have been installed (or constructed in accordance with good engineering practices) along the western, northwest and northeastern areas of the constructed pad. See photos 12

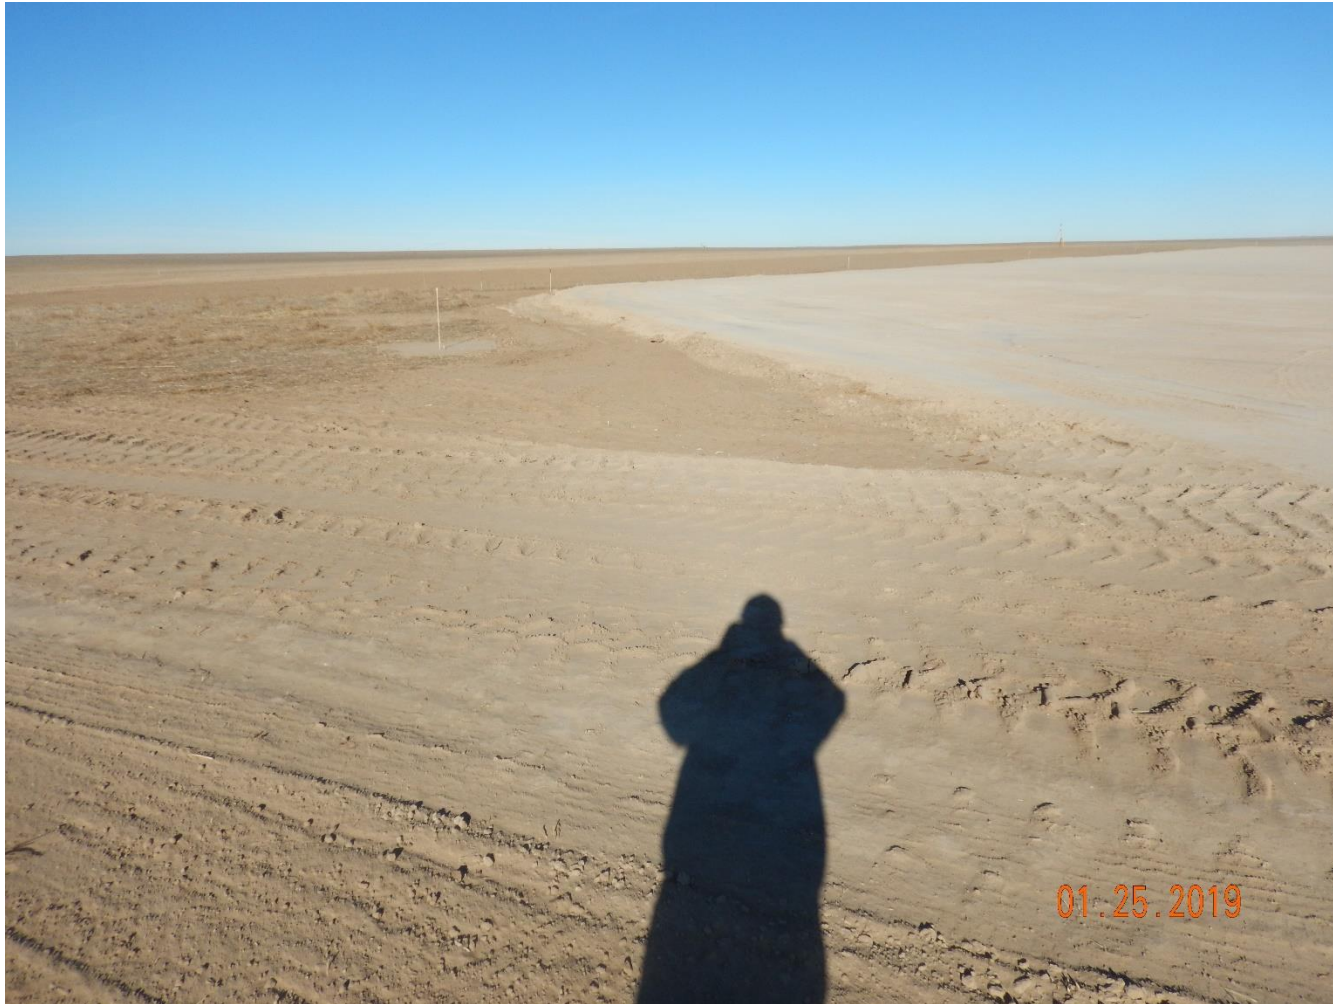
Photo 12: Photo taken from the southwest corner of the pad, facing northwest. See comments under photo 11.

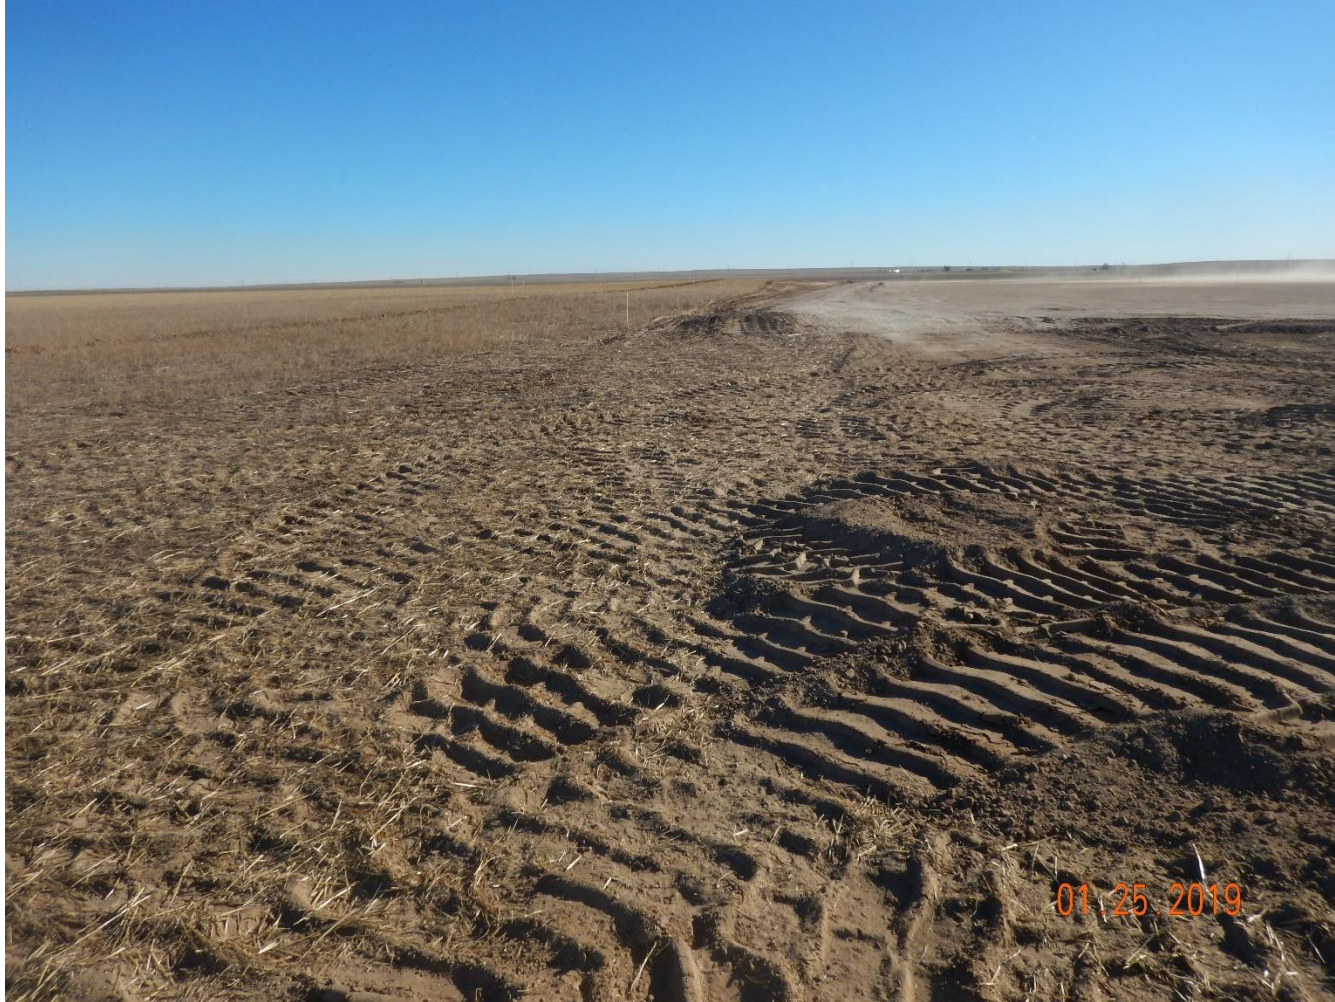
Photo 13: Photo taken from the northwest corner of the pad, facing east. Sufficient stormwater and erosion control BMPs do not appear to have been installed on the northeast corner of the pad. See comments under photo 11.

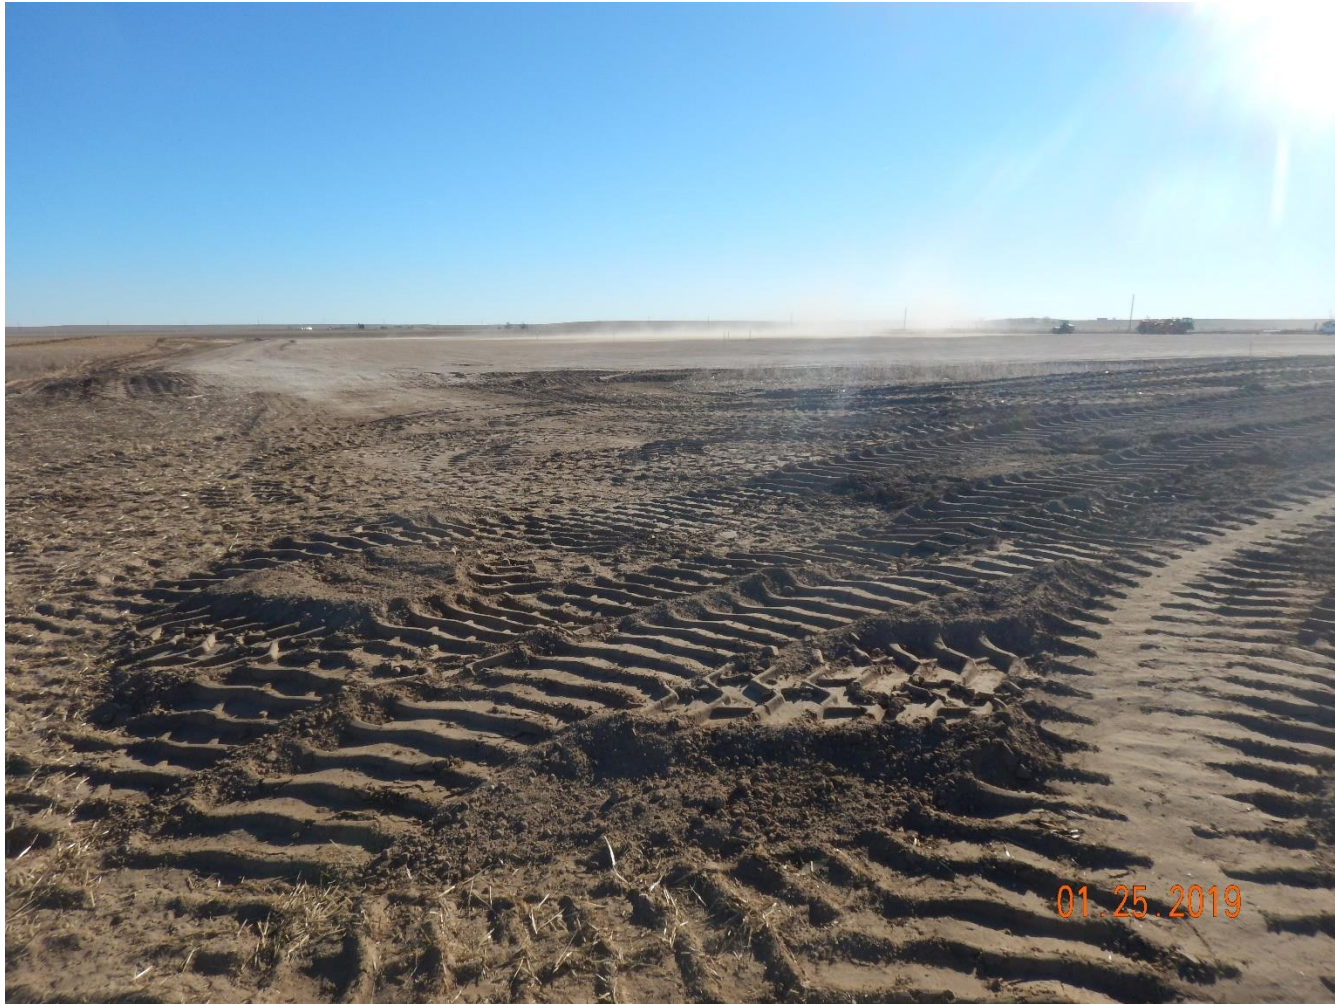
Photo 14: Photo taken from the northwest corner of the pad, facing southeast. Sufficient stormwater and erosion control BMPs do not appear to have been installed on the northeast corner of the pad. See comments under photo 11.

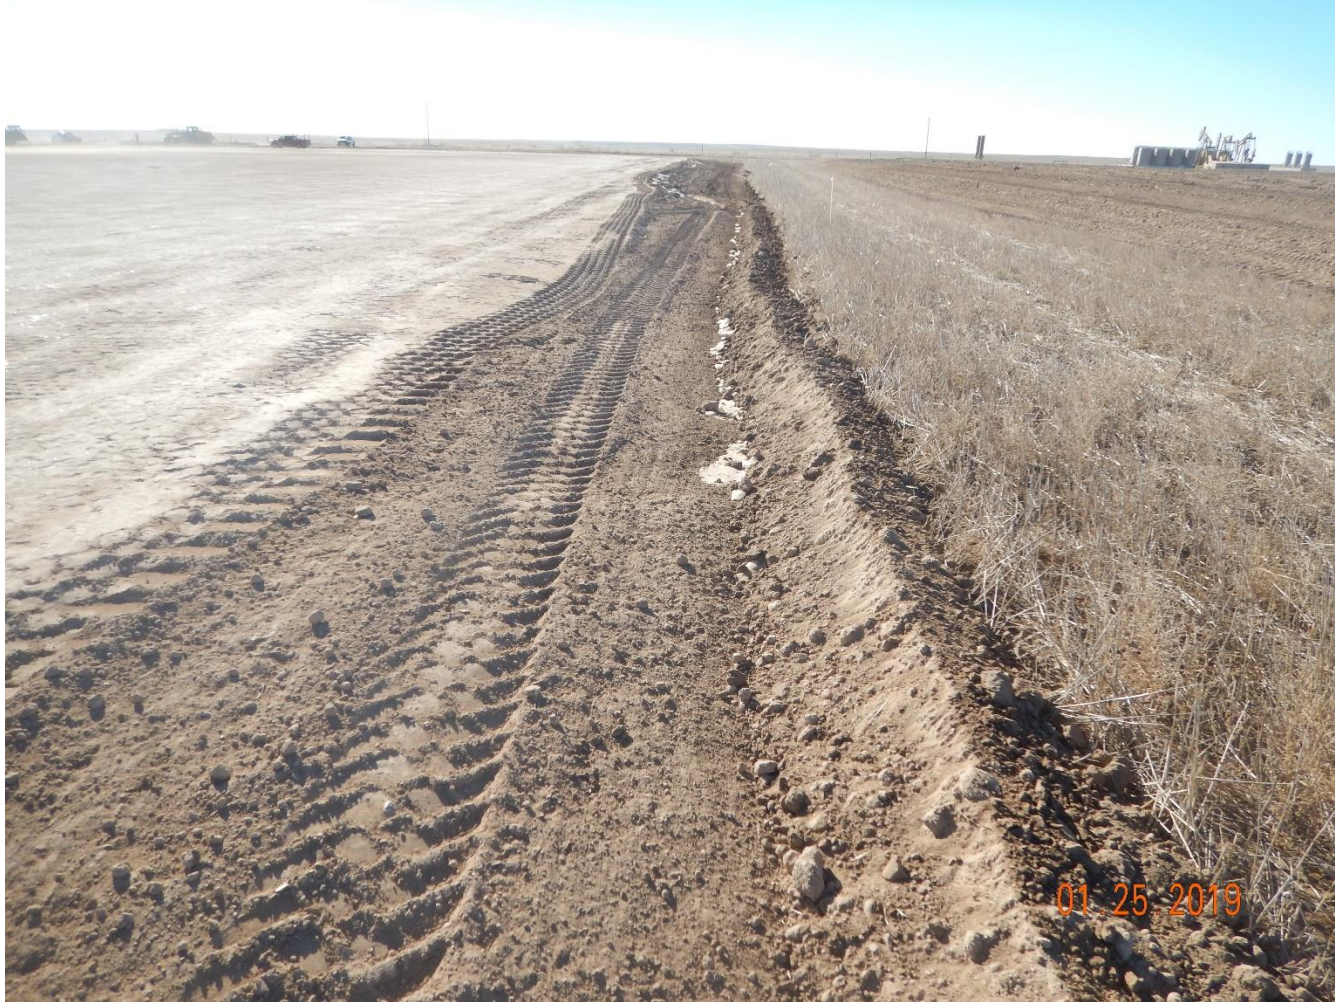
Photo 15: Photo taken from the west end of the pad, facing south. Photo shows stormwater and erosion control BMPs do not appear to have been installed in accordance with good engineering practices, and is insufficient. See comments under photo 11.

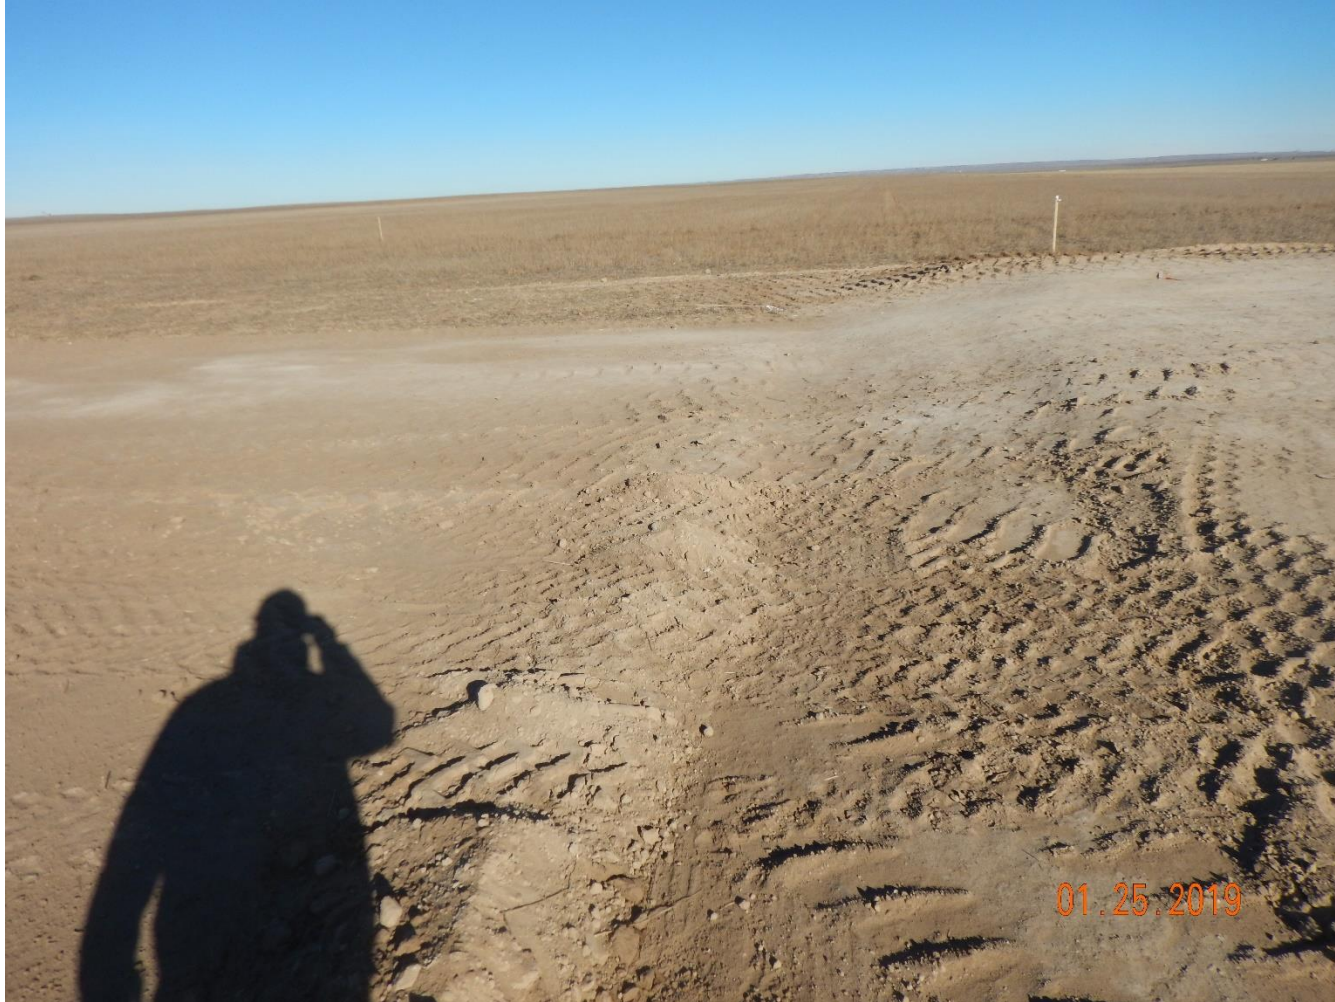
Photo 16: Photo taken from the northwest corner of the pad, facing north. Sufficient stormwater and erosion control BMPs do not appear to have been installed on the northwest corner of the pad. See comments under photo 11.
