Inspection Photos

1/25/2019

Operator: MALLARD EXPLORATION LLC # 10670

Location ID: 453517

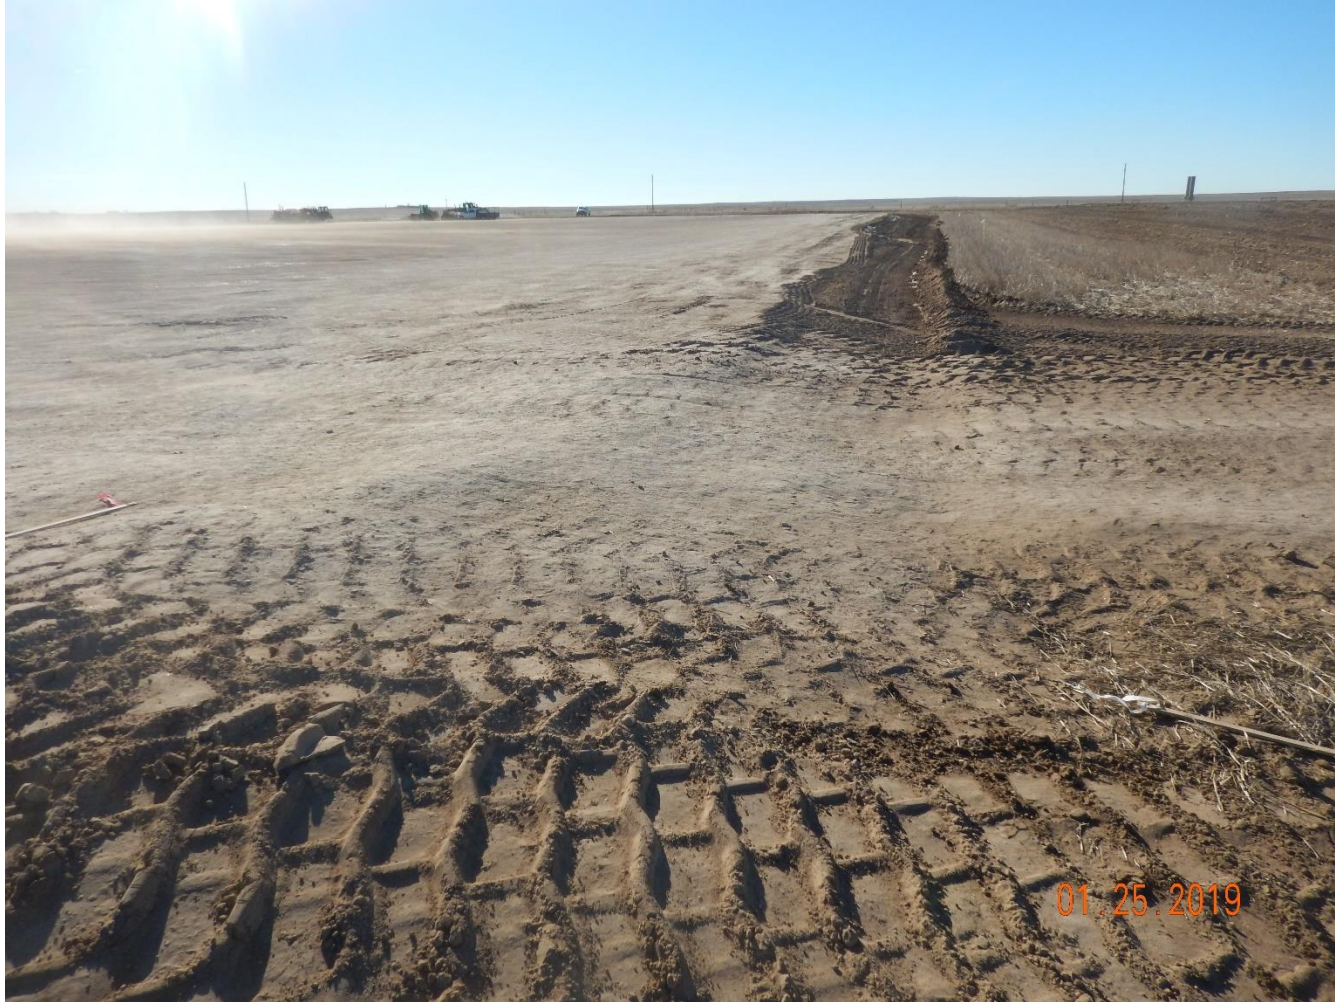
Photo 11: Photo taken from the southwest corner of the pad. Operator appears to have constructed a ditch along the northern end (with exception to the northeast corner), the eastern and southeastern areas of the constructed pad. Photo shows area of the pad on the southwest where the ditch ends. Required stormwater and erosion control BMPs do not appear to have been installed (or constructed in accordance with good engineering practices) along the western, northwest and northeastern areas of the constructed pad. See photos 12

Photo 17: Photo taken from the northwest corner of the pad, facing south. Sufficient stormwater and erosion control BMPs do not appear to have been installed on the northwest corner of the pad. See comments under photo 11.

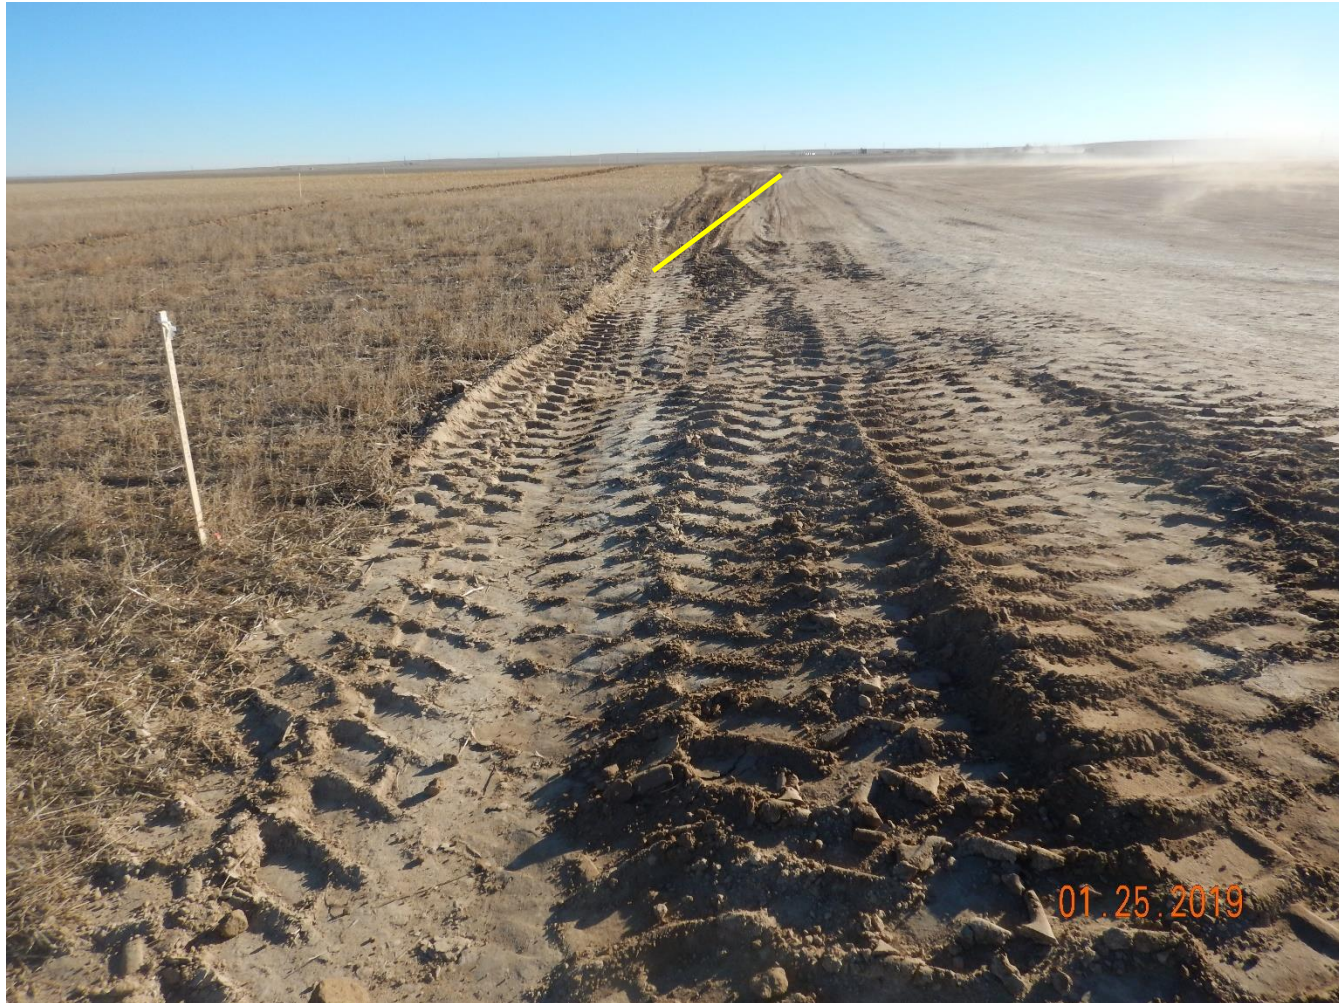
Photo 18: Photo taken from the northwest corner of the pad, facing east. Sufficient stormwater and erosion control BMPs do not appear to have been installed on the northwest corner of the pad. See comments under photo 11. Photo also shows areas where a ditch appears to have been constructed on the north end of the pad.

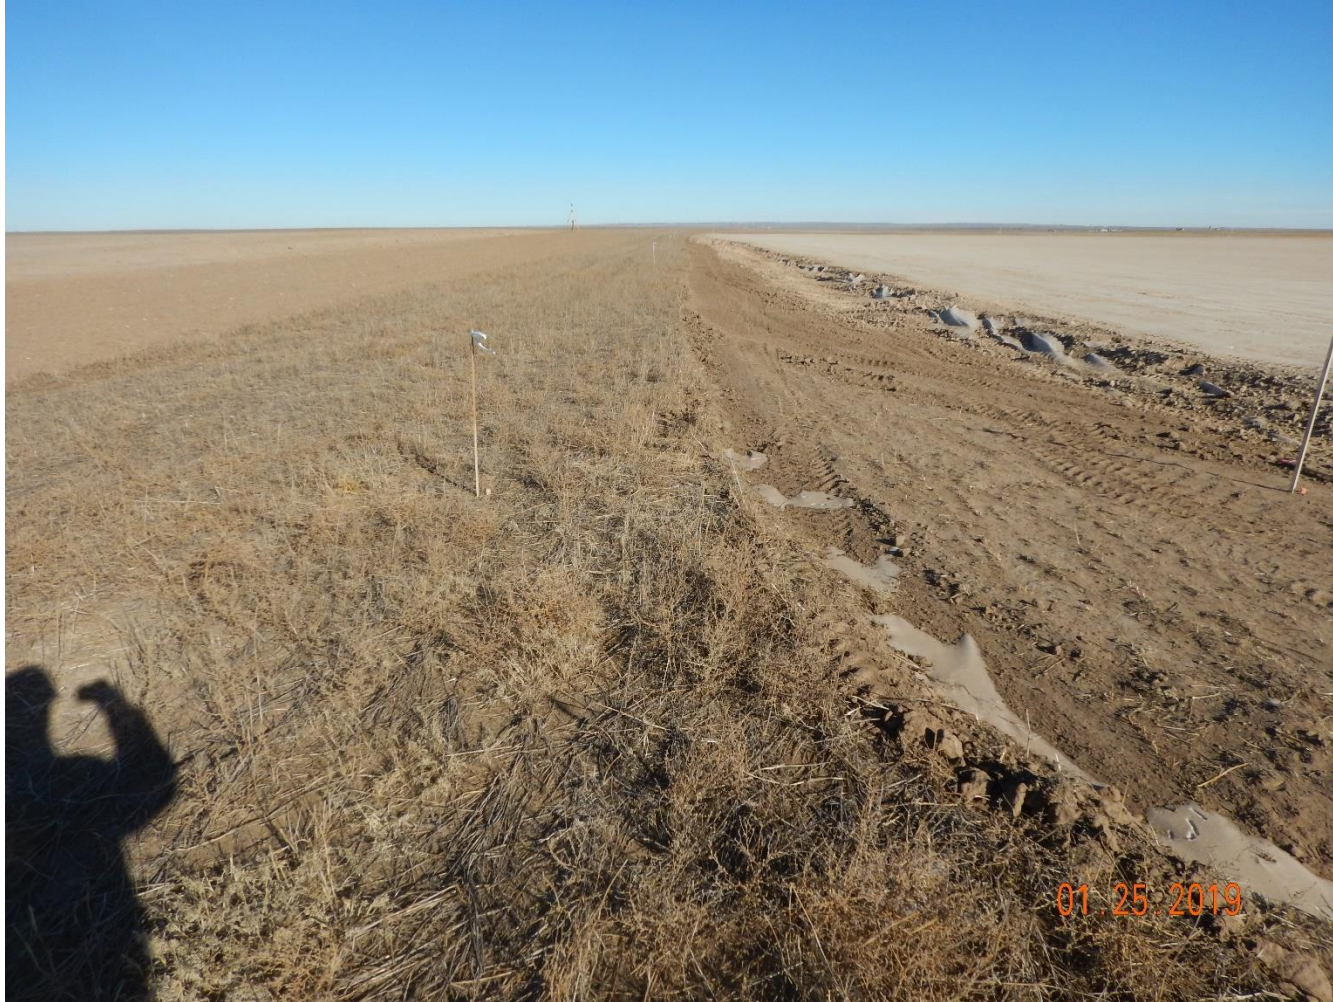
Photo 19: Photo taken from the southwest end of the pad, facing north. Photo shows stormwater and erosion control BMPs do not appear to have been installed in accordance with good engineering practices, and is insufficient. See comments under photo 11.

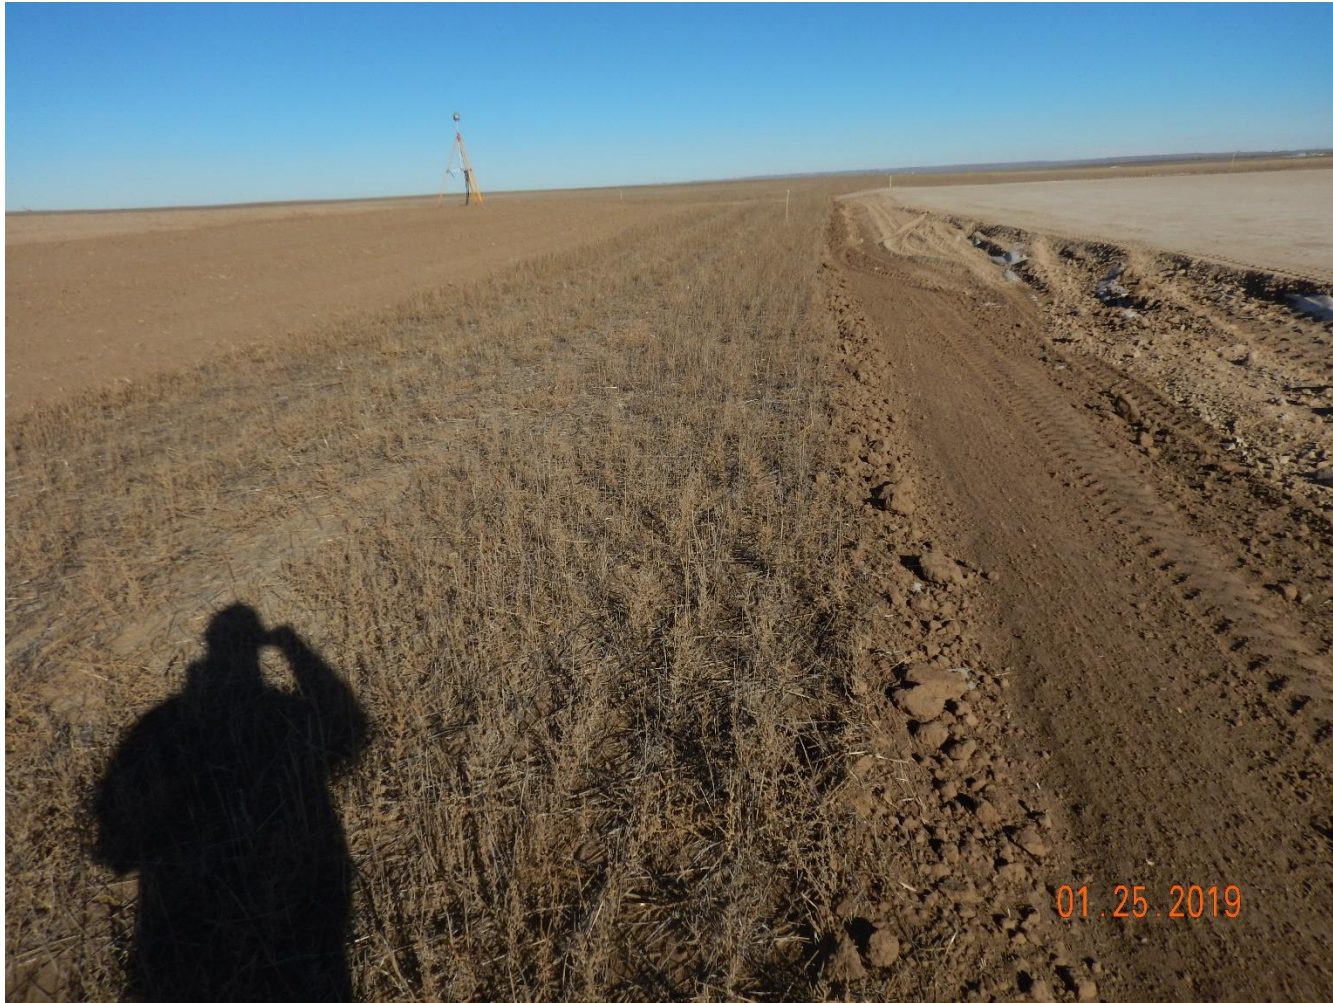
Photo 20: Photo taken from the southwest end of the pad, facing north. Photo shows stormwater and erosion control BMPs do not appear to have been installed in accordance with good engineering practices, and is insufficient. See comments under photo 11.

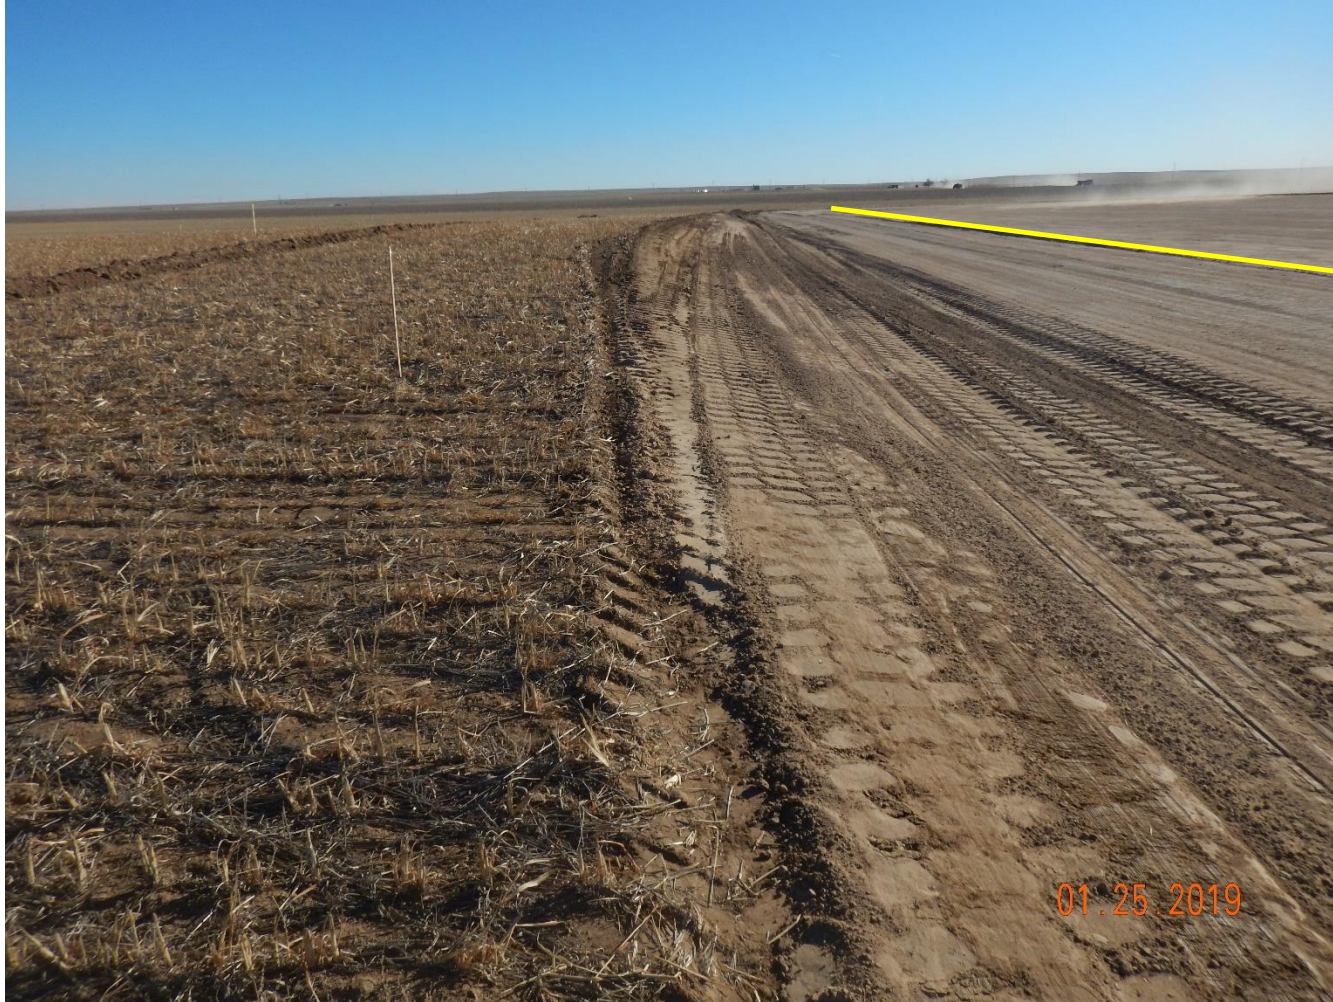
Photo 21: Photo taken from the north end of the location, facing east. Photo shows areas of the cutslope, where a large ditch appears to have been constructed. Yellow line indicates top of pad. Photos 21-25 also provide an overview of the constructed pad from east, southeast, southwest to west.

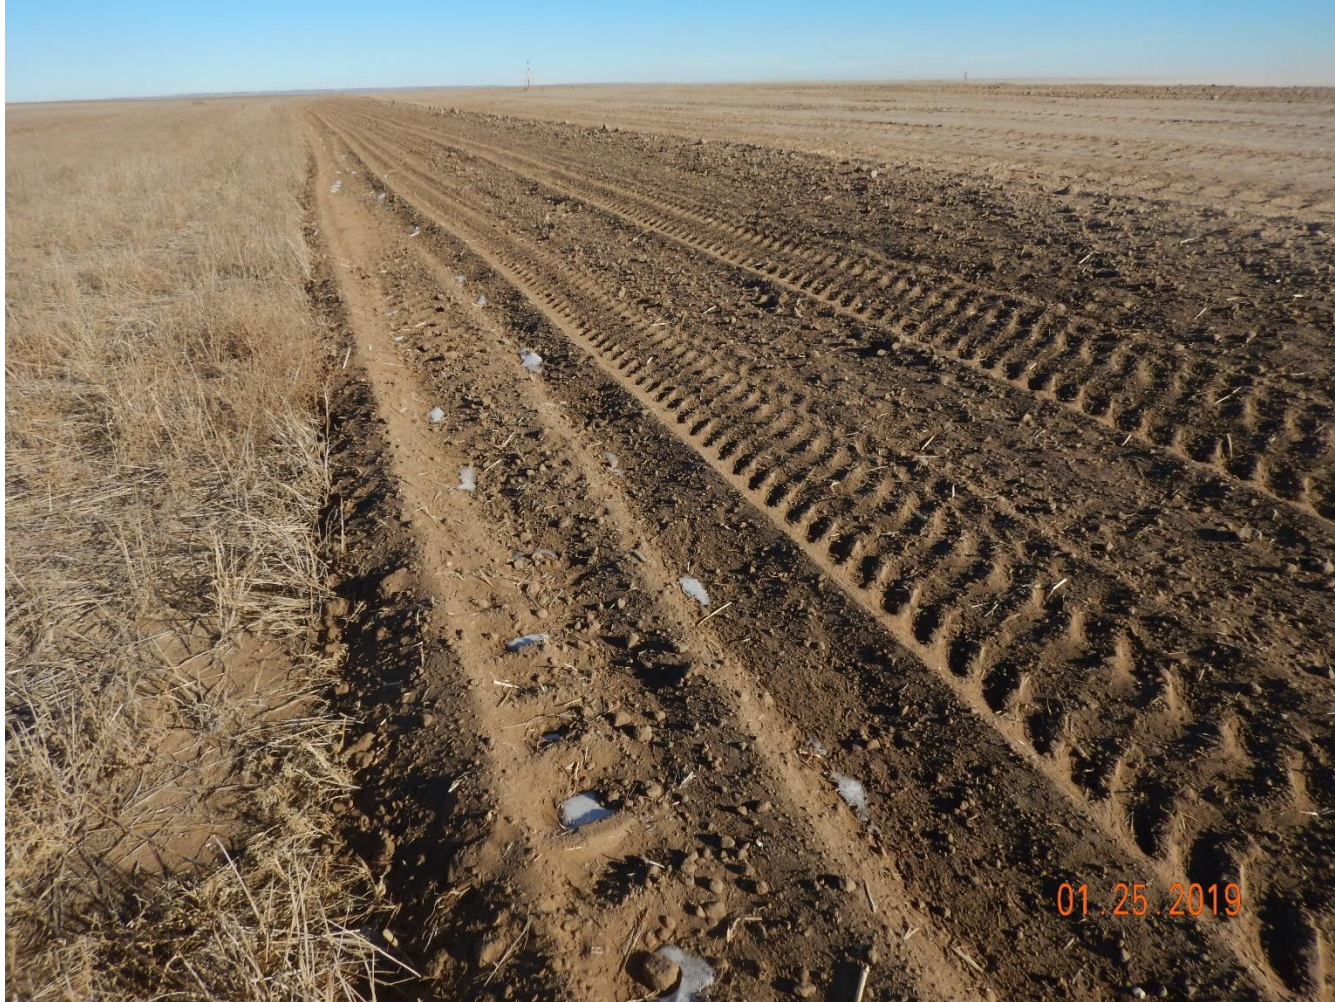
Photo 27: Photo taken from the west end of the topsoil stockpile, facing northeast. Photos shows topsoil stockpile has not been stabilized and remains loose material, and sufficient stormwater and erosion control BMPs do not appear to have been installed.

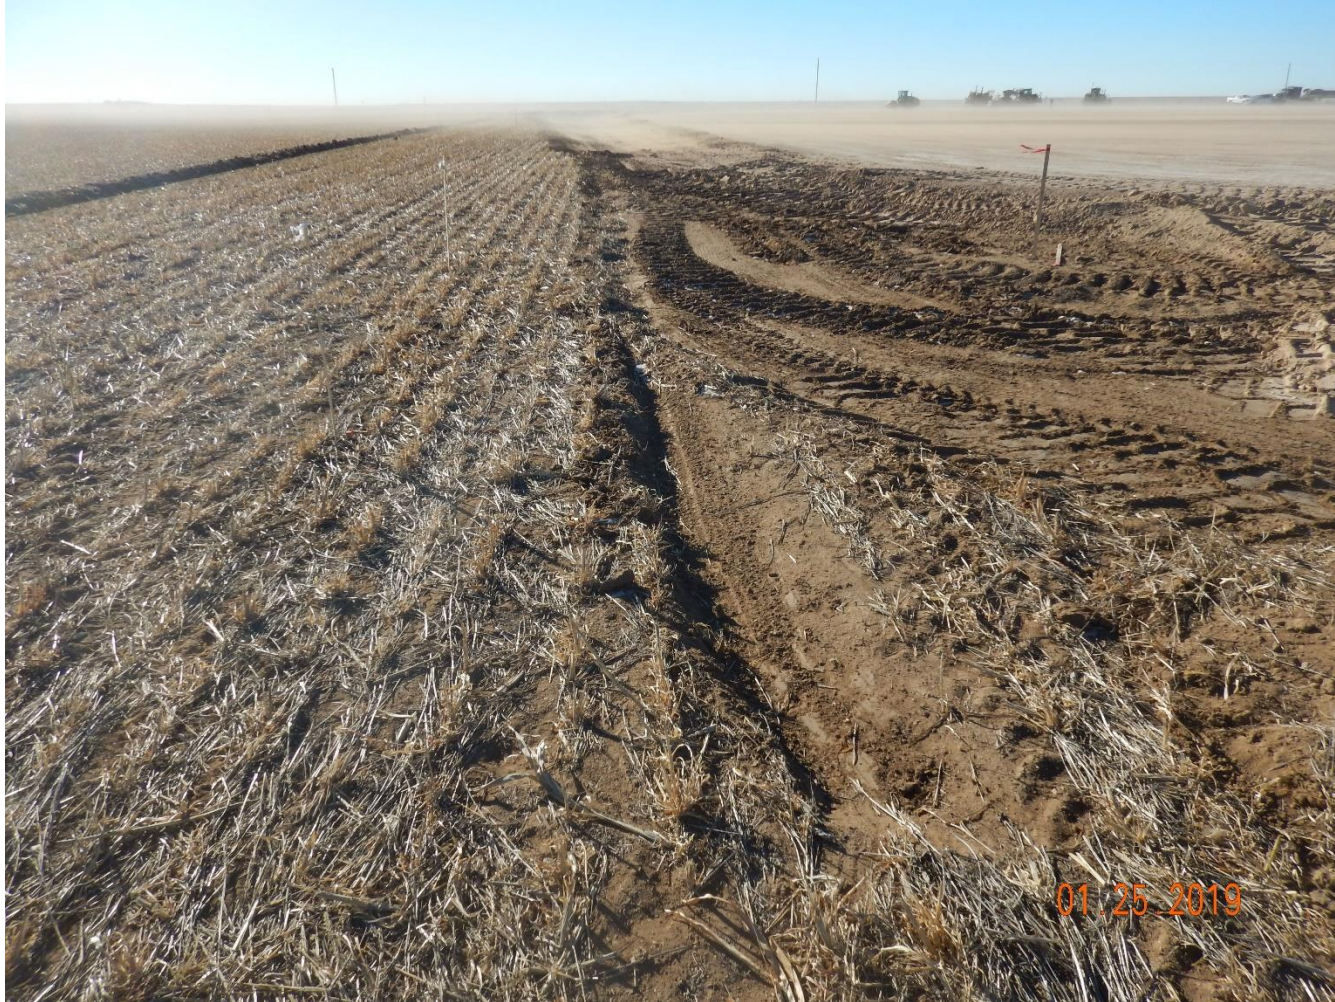
Photo 28: Photo taken from the northeast corner of the pad, facing south. Sufficient stormwater and erosion control BMPs do not appear to have been installed on the northeast corner of the pad. See comments under photo 11.

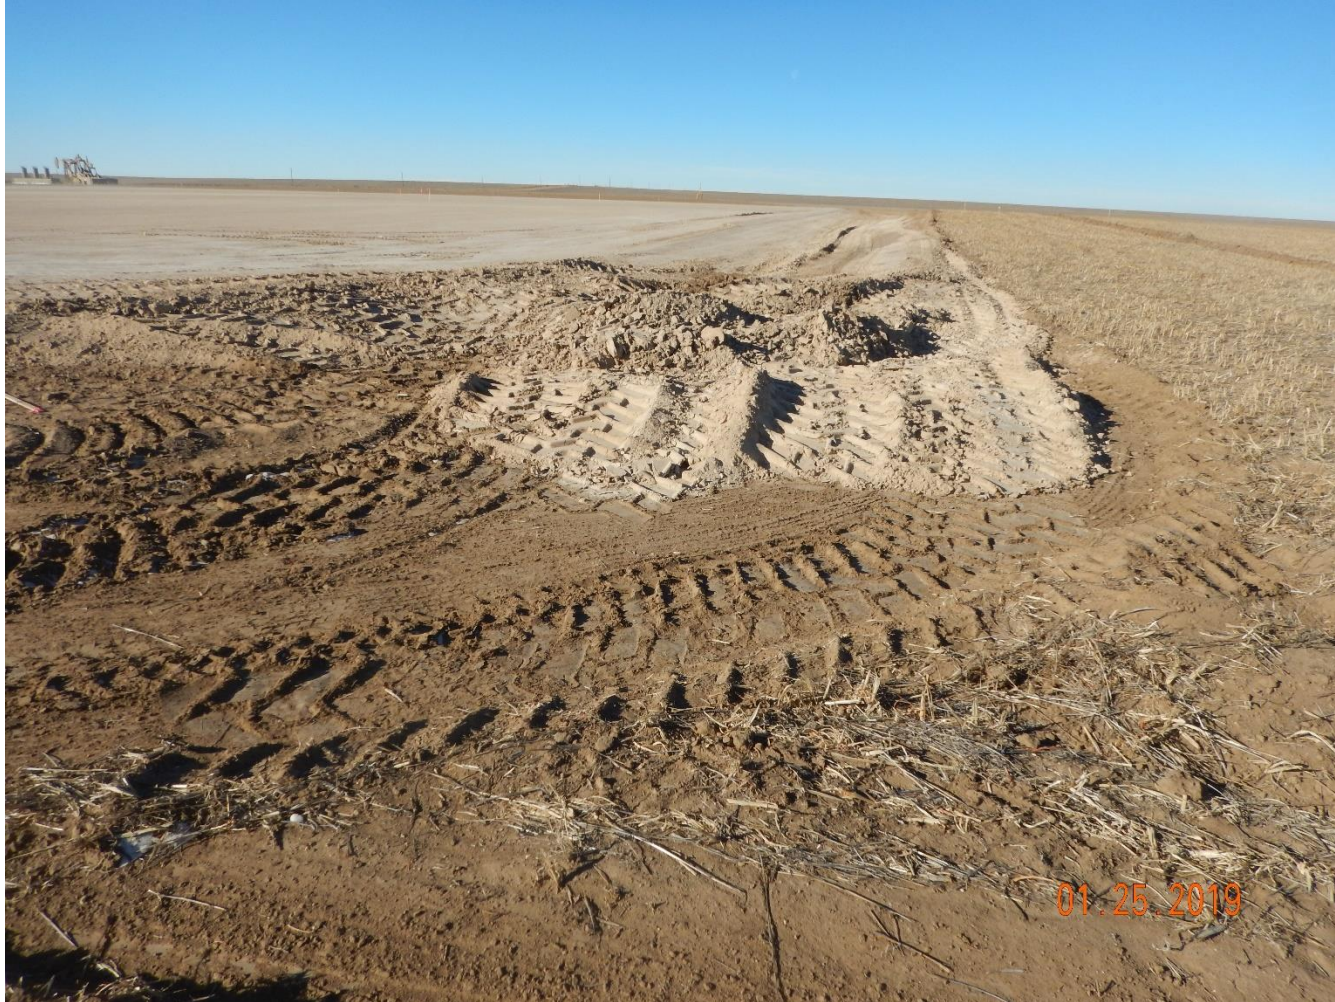
Photo 29: Photo taken from the northeast corner of the pad, facing east. Sufficient stormwater and erosion control BMPs do not appear to have been installed on the northeast corner of the pad. See comments under photo 11.

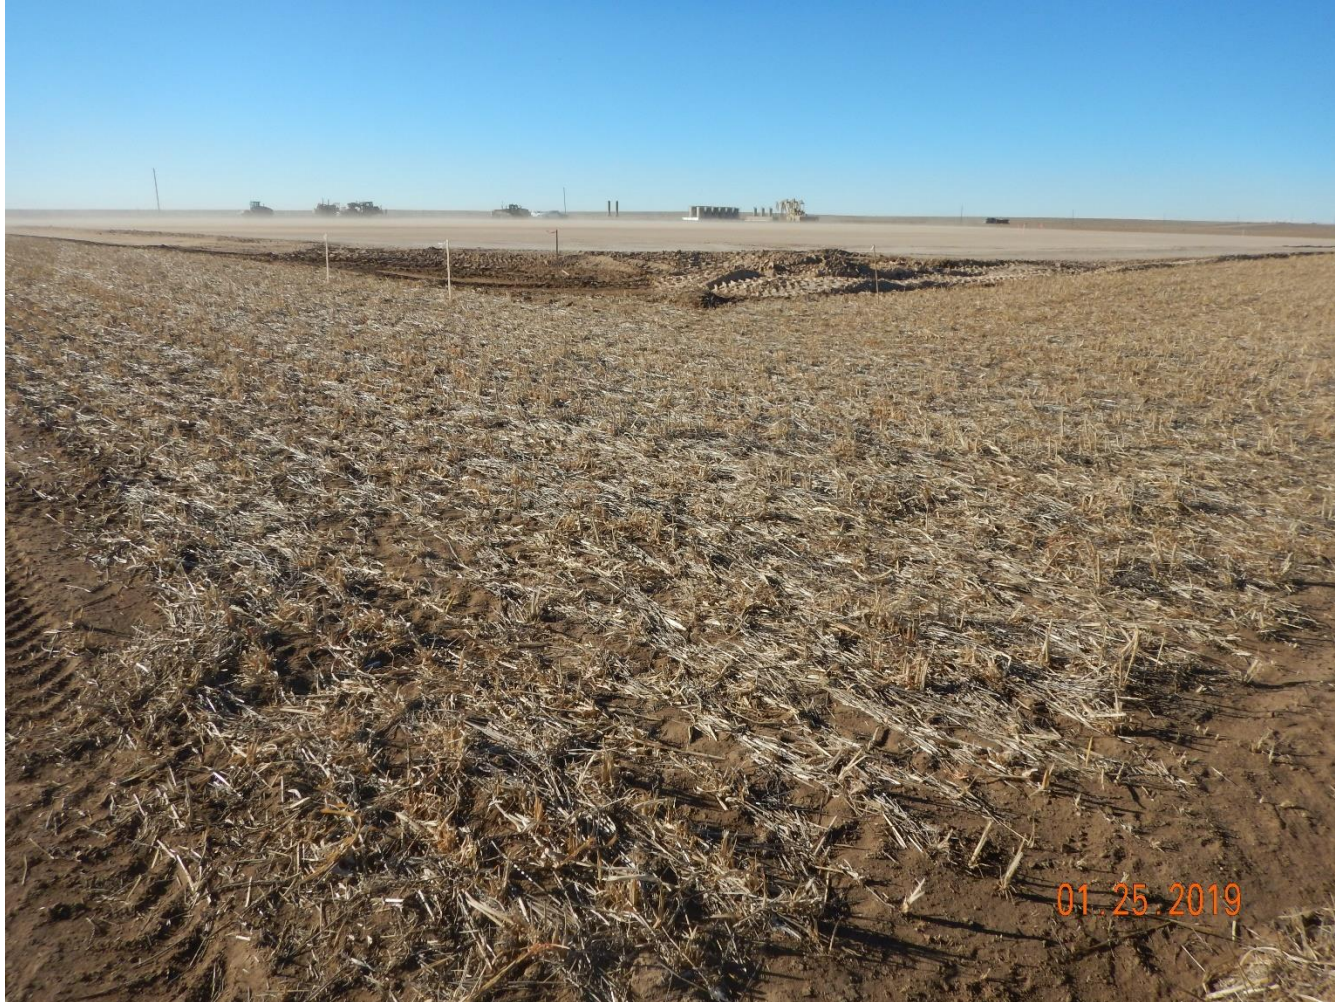
Photo 30: Photo taken from the northeast corner of the location, facing southwest. Sufficient stormwater and erosion control BMPs do not appear to have been installed on the northeast corner of the pad. See comments under photo 11.

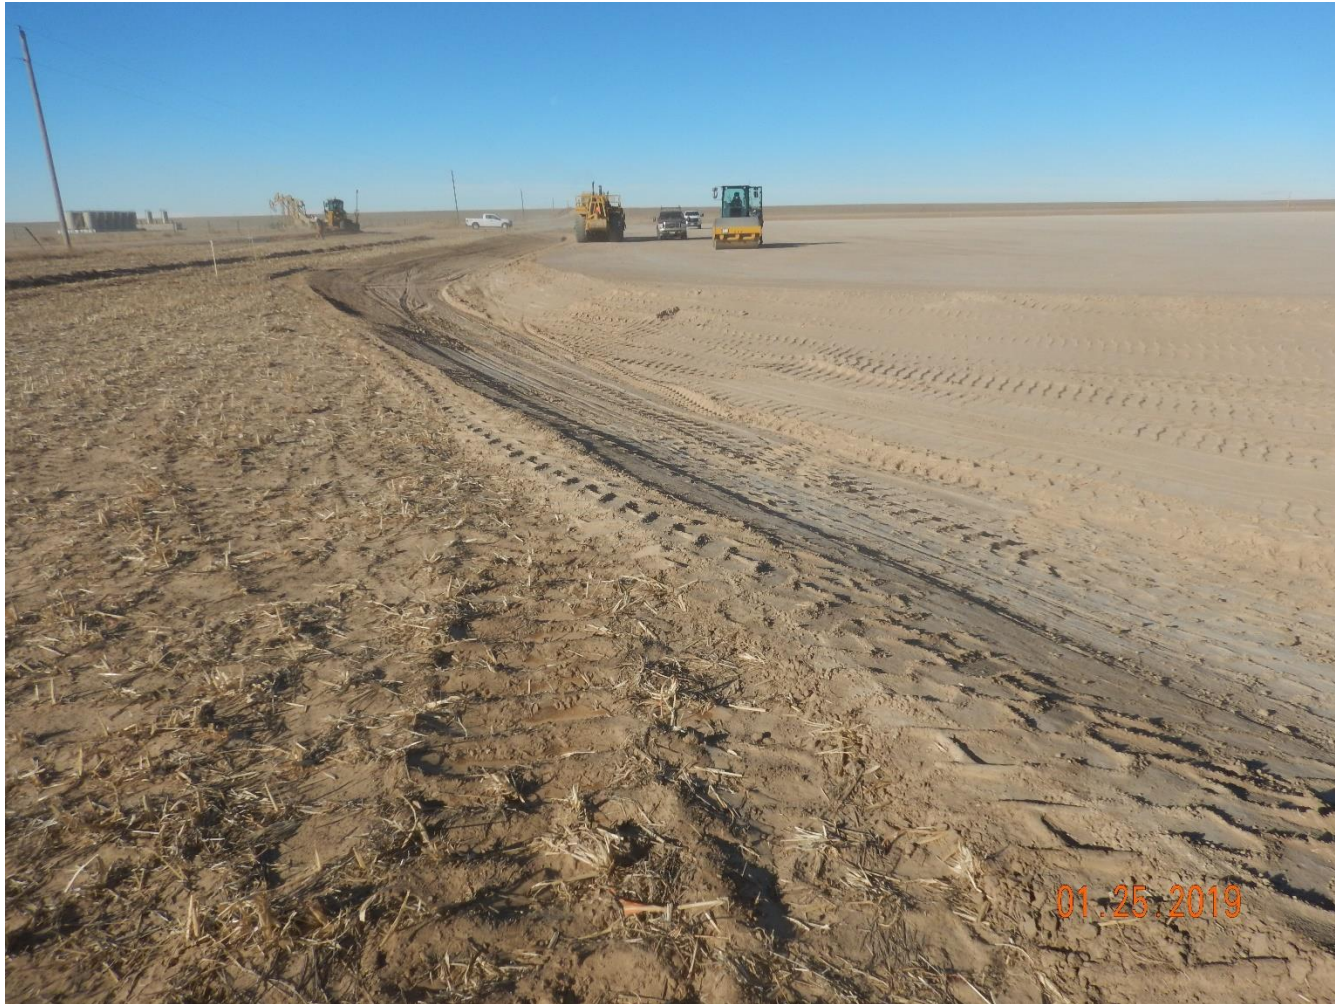
Photo 31: Photo taken from the southeast corner of the pad, facing west. Photo shows operator appears to have installed a ditch and sediment pond on the southeast end of the pad.

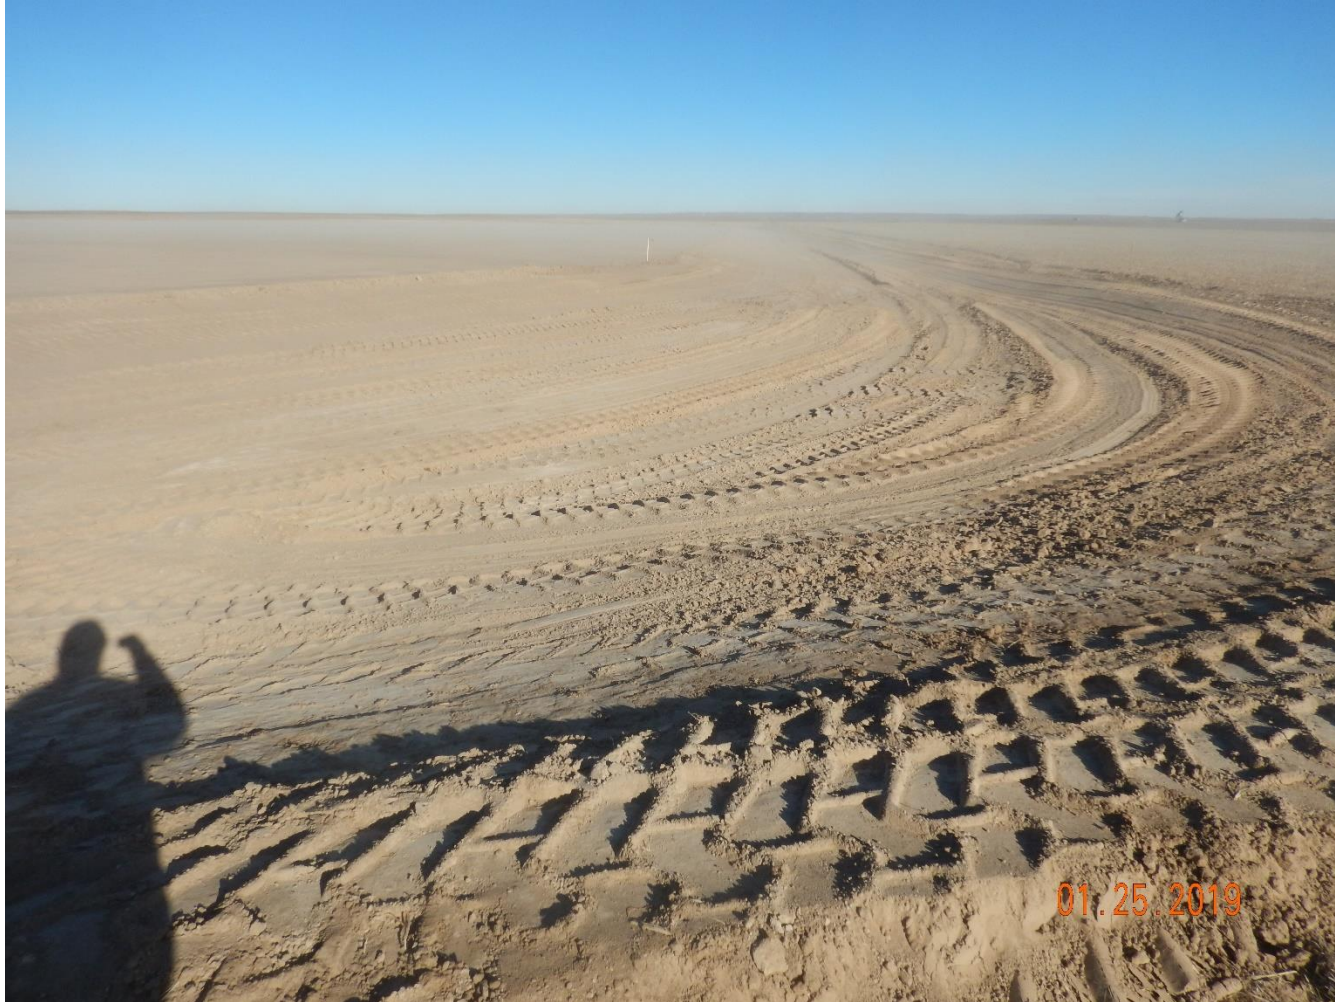
Photo 32: Photo taken from the southeast corner of the pad, facing north. Photo shows operator appears to have installed a ditch and sediment pond on the southeast end of the pad.

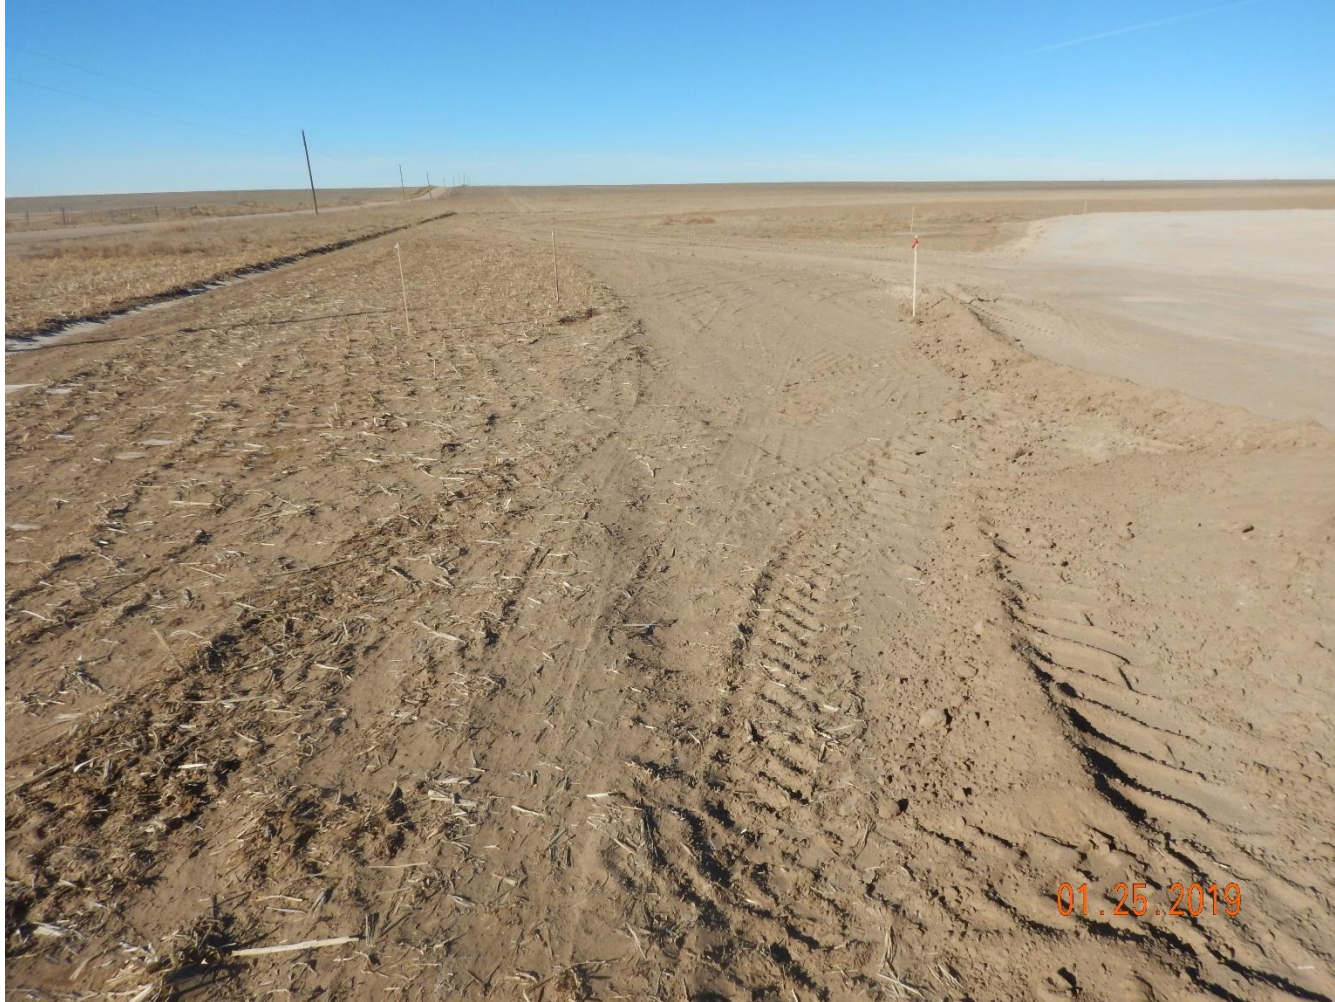
Photo 33: Photo taken from the south end of the location, facing west. See comments under photo 11.

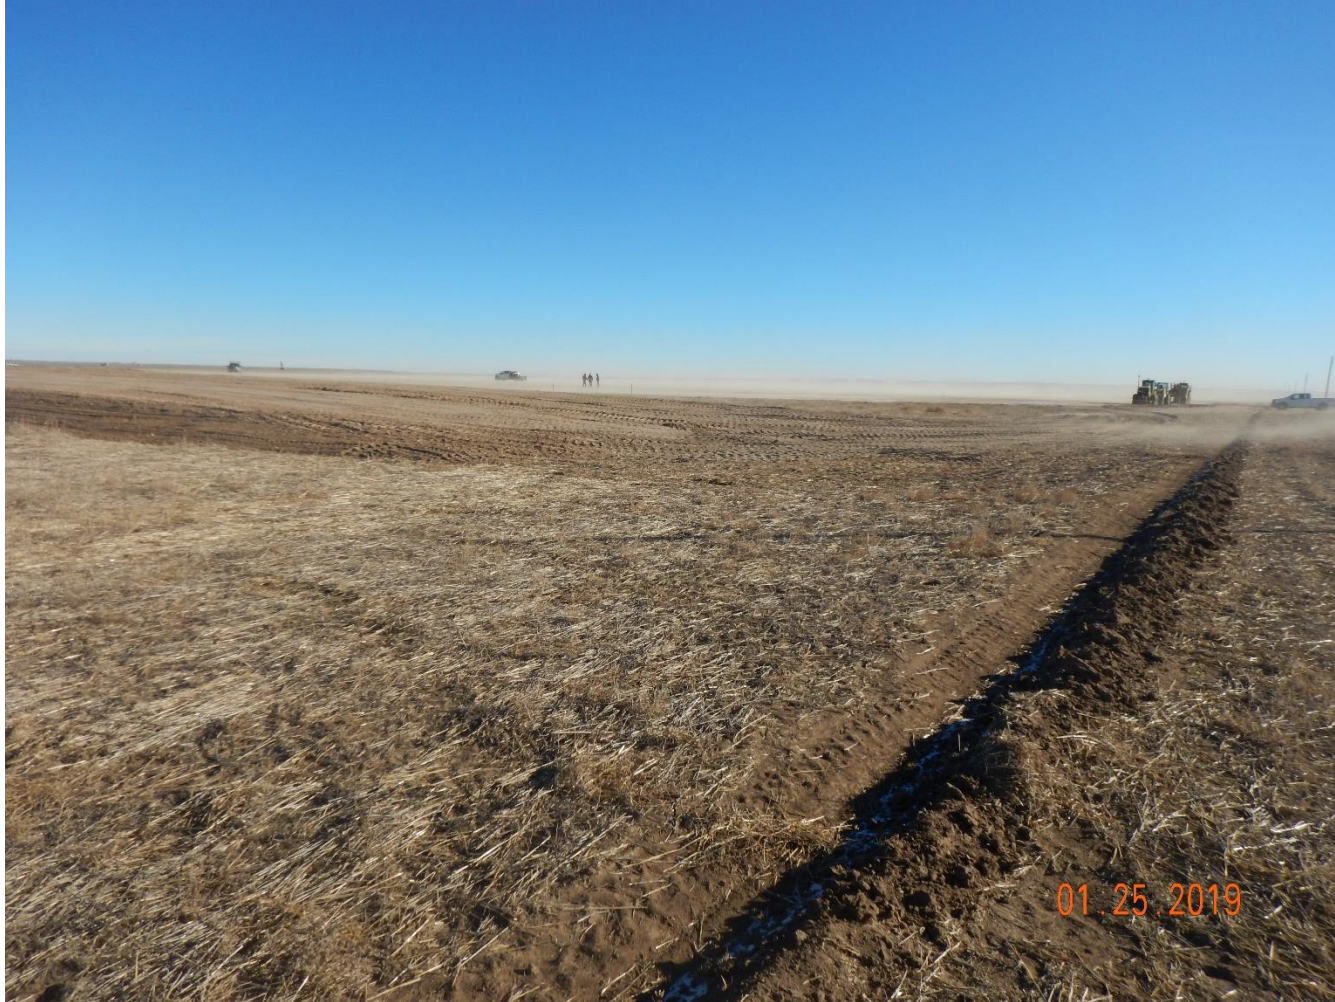
Photo 34: Photo taken from the southwest end of the location, facing east. Photo shows wind erosion transporting sediment offsite. This does not comport with rule 1002.e and 1002.f

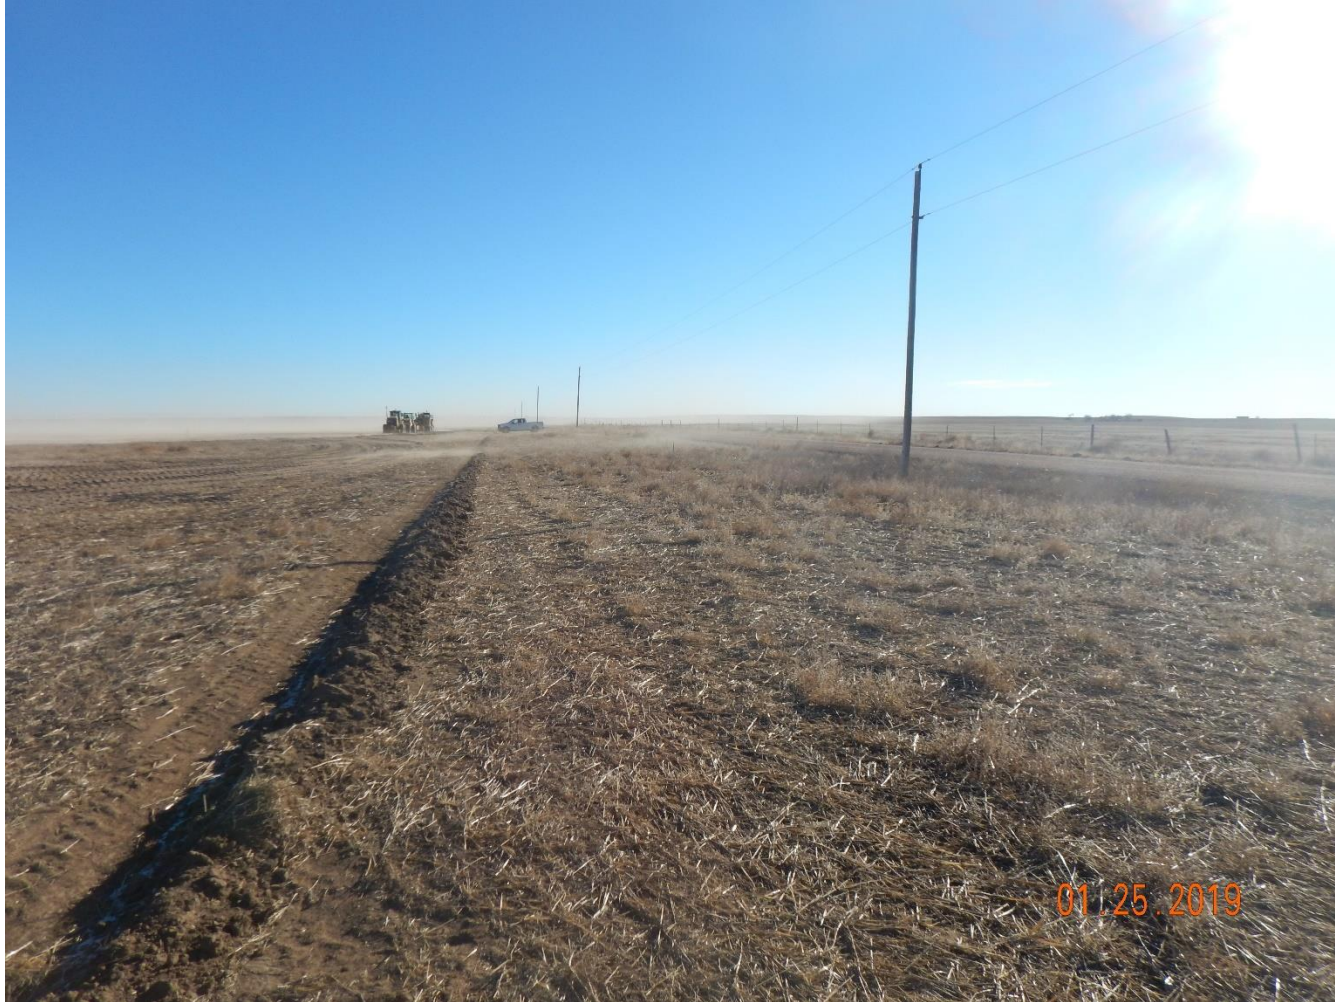
Photo 35: Photo taken from the southwest end of the location, facing southeast away from the location. Photo shows wind erosion transporting sediment offsite. This does not comport with rule 1002.e and 1002.f

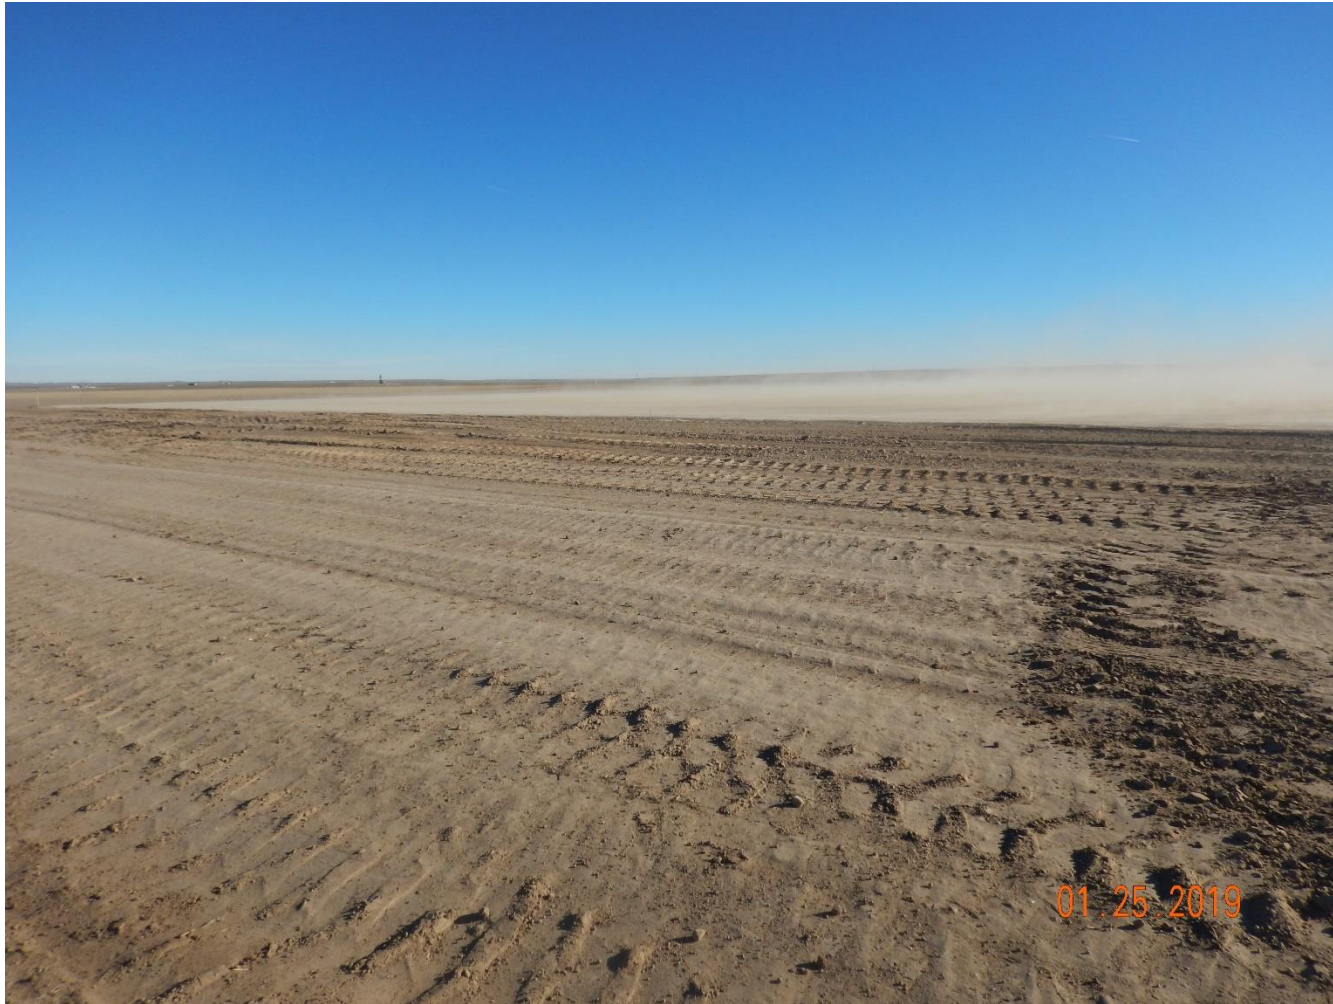
Photo 36: Photo taken from the west end of the location, facing northeast. Photo shows wind erosion transporting sediment offsite. This does not comport with rule 1002.e and 1002.f

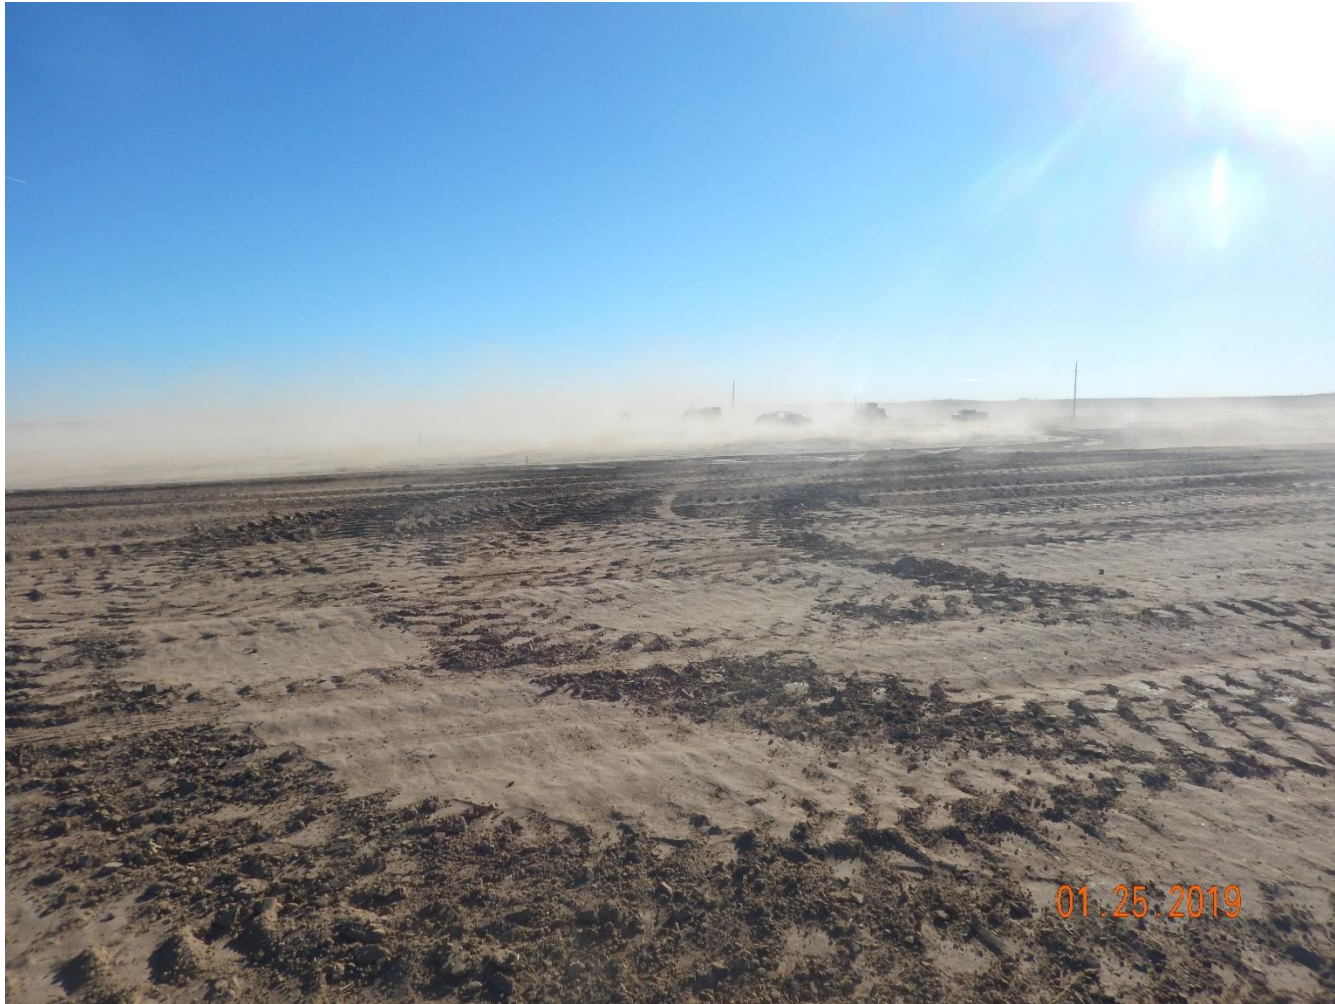
Photo 37: Photo taken from the west end of the location, facing southeast. Photo shows wind erosion transporting sediment offsite. This does not comport with rule 1002.e and 1002.f
