Inspection Photos

1/25/2019

Operator: MALLARD EXPLORATION LLC # 10670

Location ID: 453517

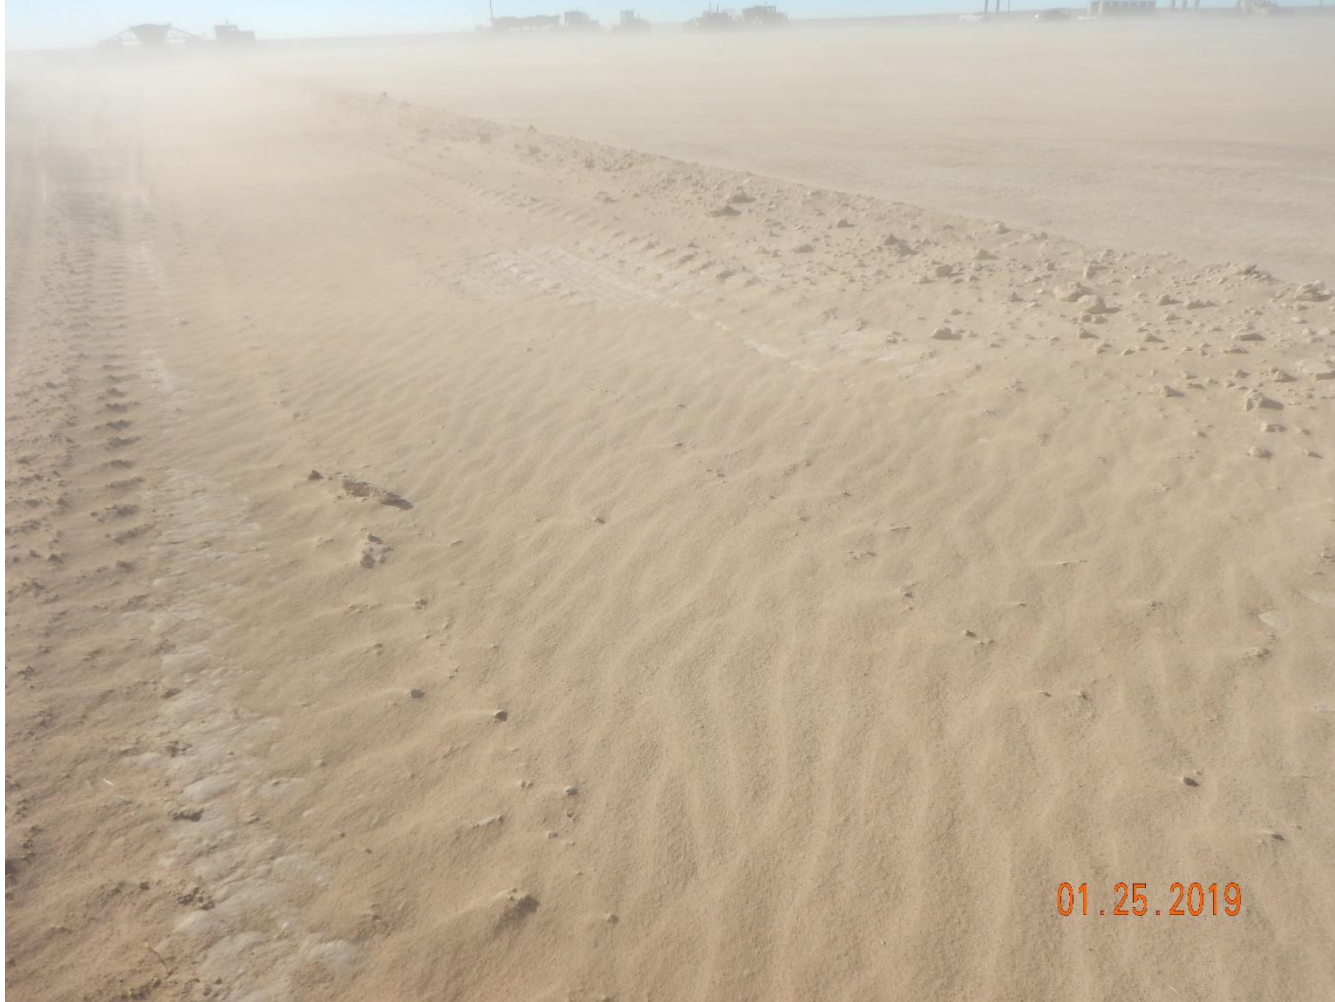
Photo 38: Photo taken from the stormwater ditch on the east end of the location. Photo shows sediment deposition due to wind erosion within the ditch.

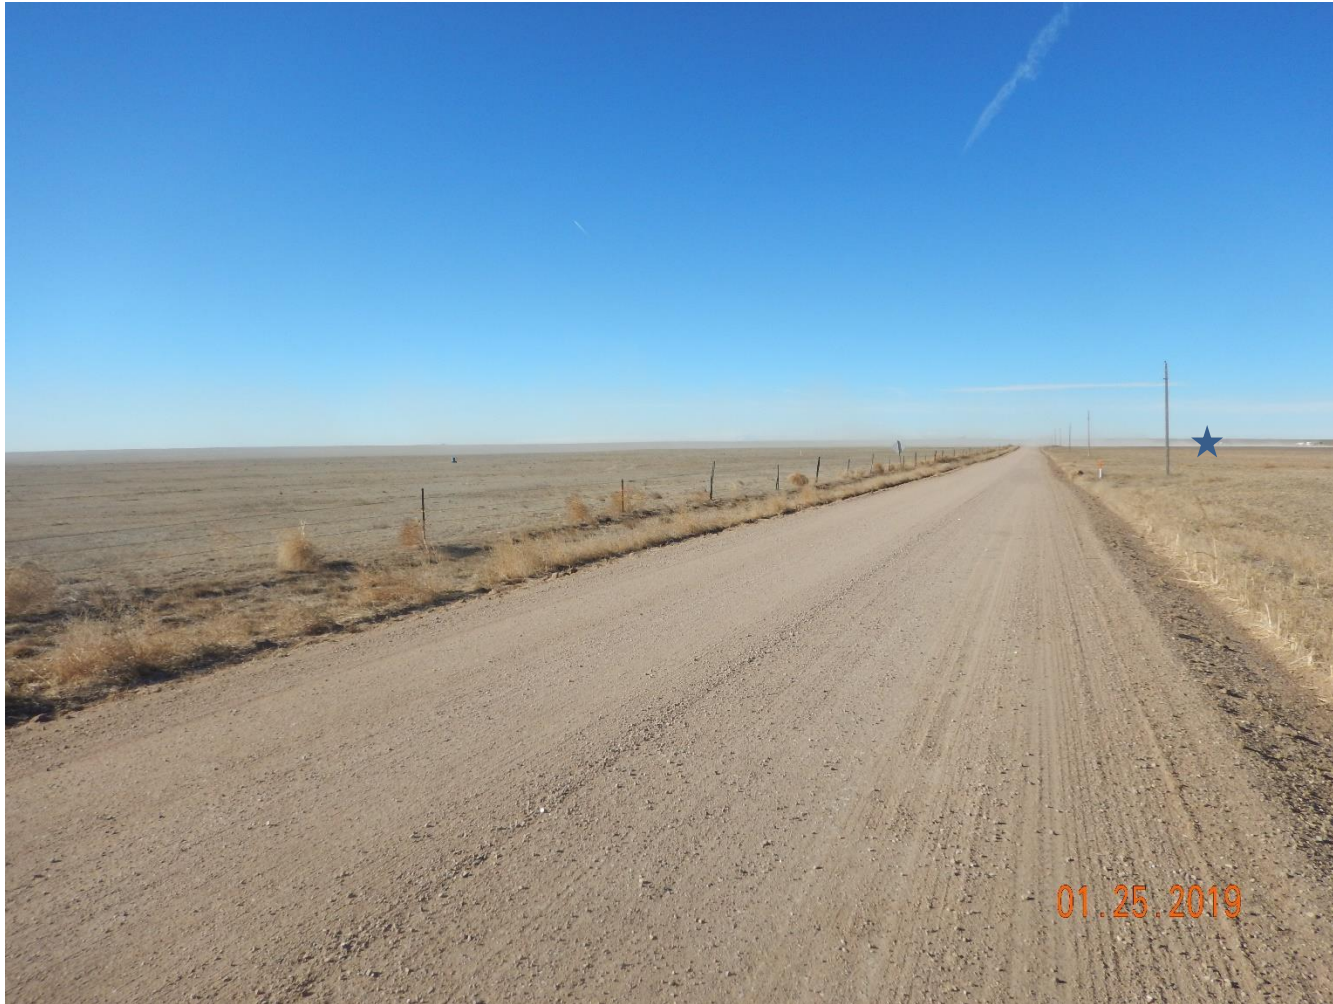
Photo 39: Photo taken from CR 86 ~1/2 mile east of the location (star), facing west towards the location. Photo shows wind erosion transporting sediment from the location offsite to the southeast.

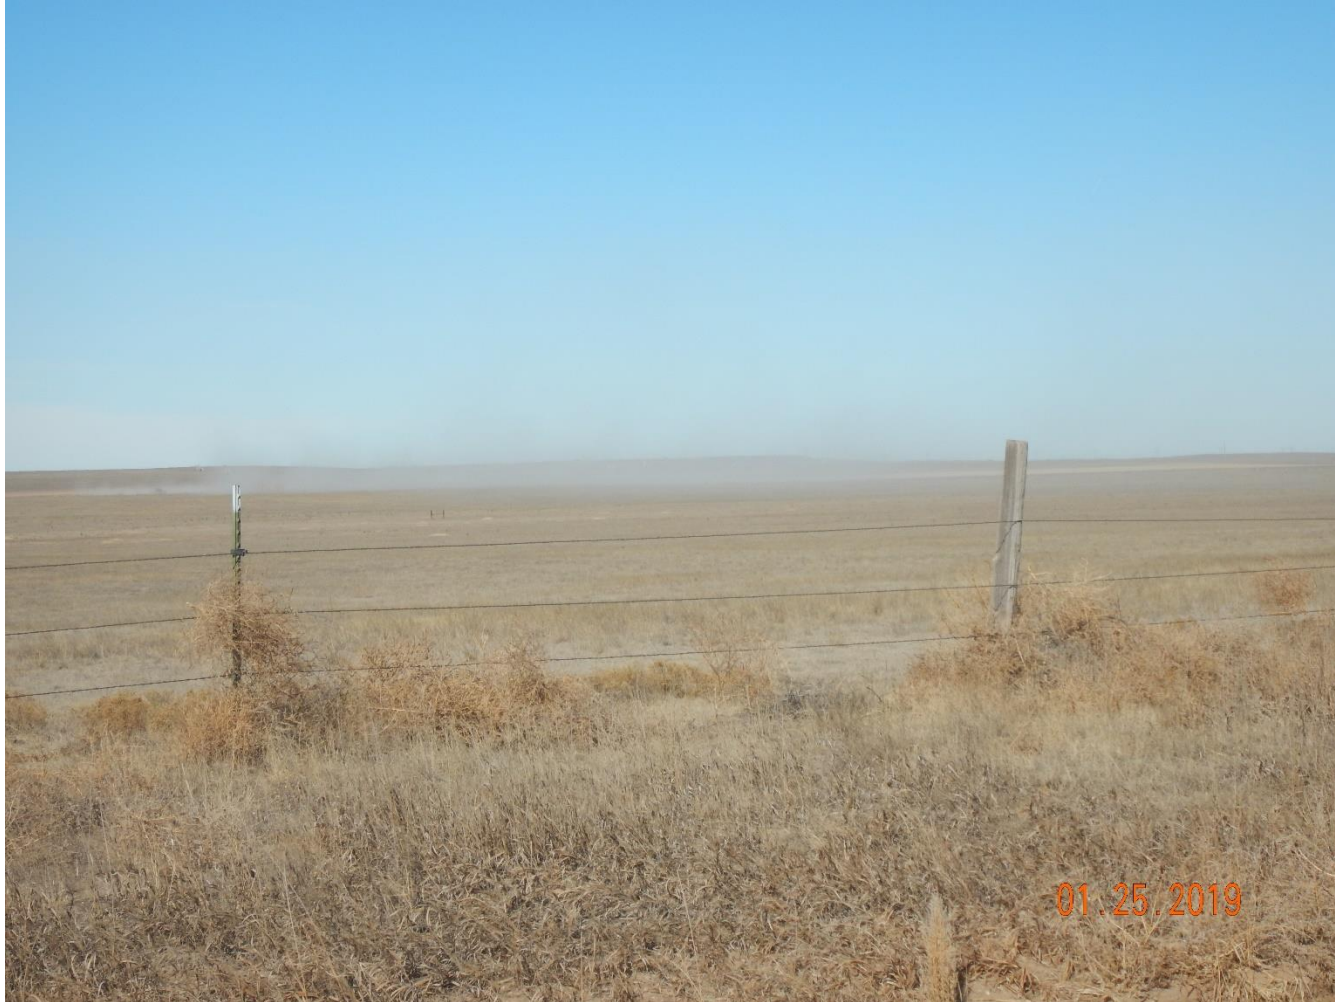
Photo 40: Photo taken from CR 105, ~1 mile southeast of the location, facing northwest towards the location. Photo shows wind erosion transporting sediment from the location offsite to the southeast.
