Construction and Stormwater Inspection

January 28, 2019

Operator: NICKEL ROAD OPERATING LLC #10669

Inspection Photos
Location Name: DRAKE PAD
Location ID: 454899

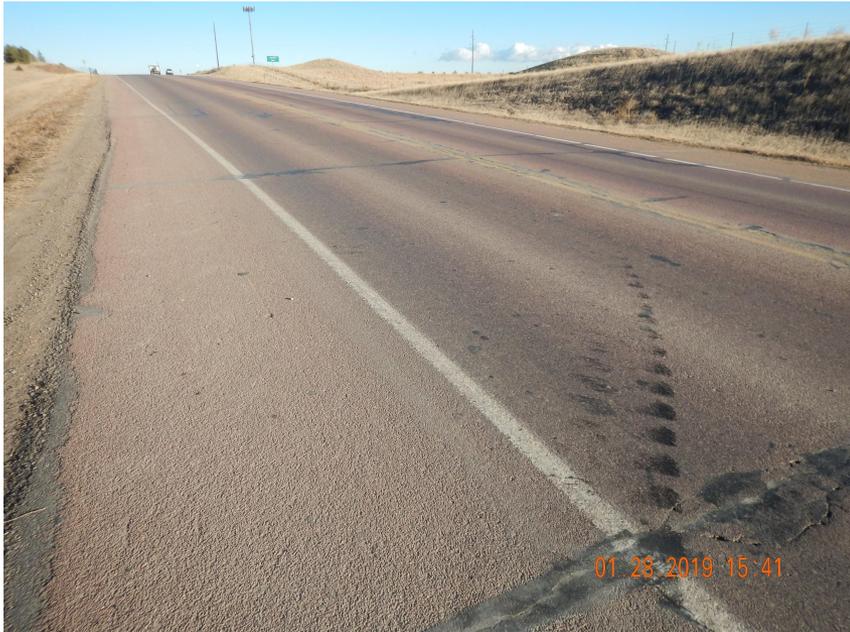
Photo 1. Photo taken from the entrance of the location off HWY 14, facing East. Photo illustrates no vehicle track out issues. Operator has not yet installed the planned vehicle tracking device BMPs.

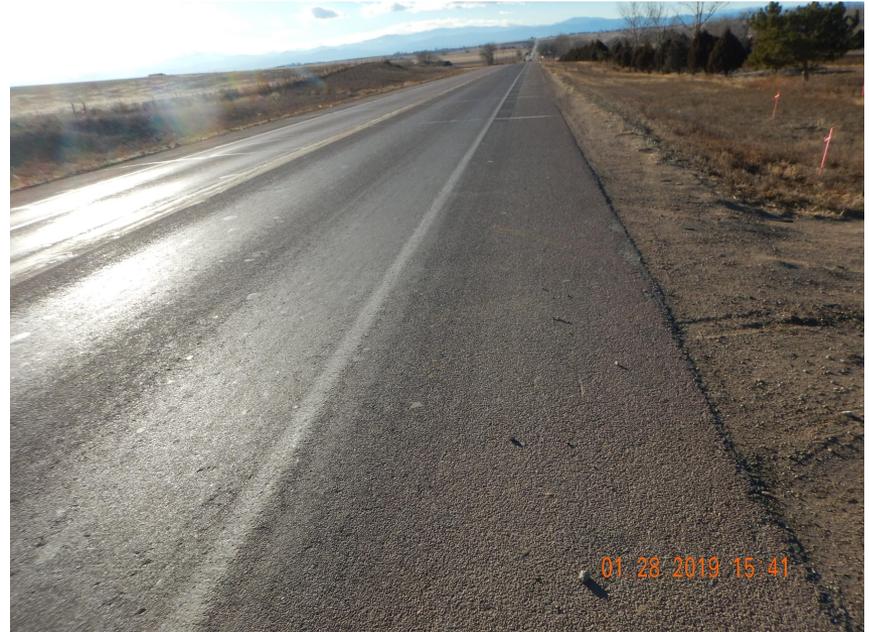
Photo 2. Photo taken from the entrance of the location off HWY 14, facing West. See comments under Photo 1.

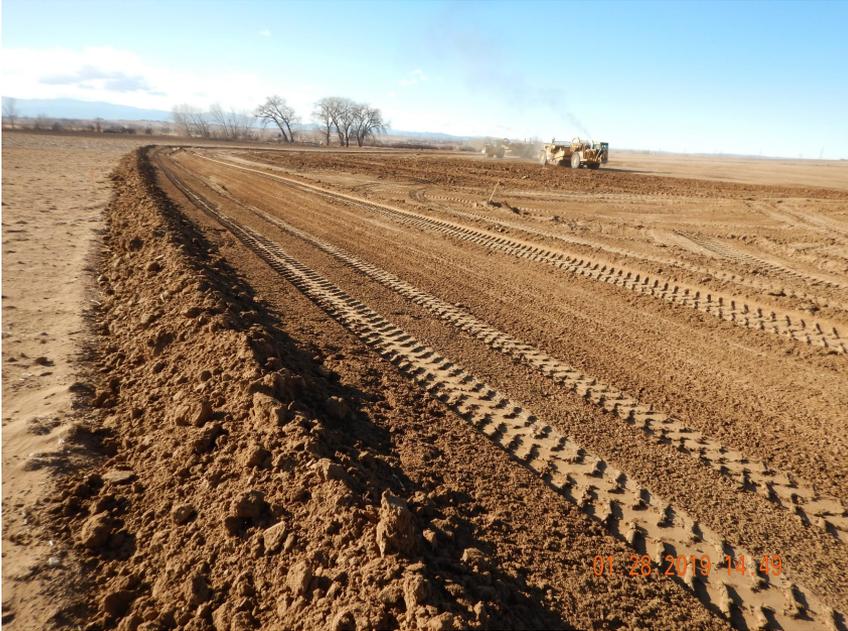
Photo 3. Photo taken from the southern perimeter of the location, facing West. Photo illustrates a temporary BMP (ditch). BMP has not been properly stabilized as unconsolidated soil material is not a properly functioning BMP. Unconsolidated soil material becomes a potential pollutant itself and is susceptible to wind and water erosion. Note: Per Rule 805.c., Operator shall control fugitive dust caused by their operations.

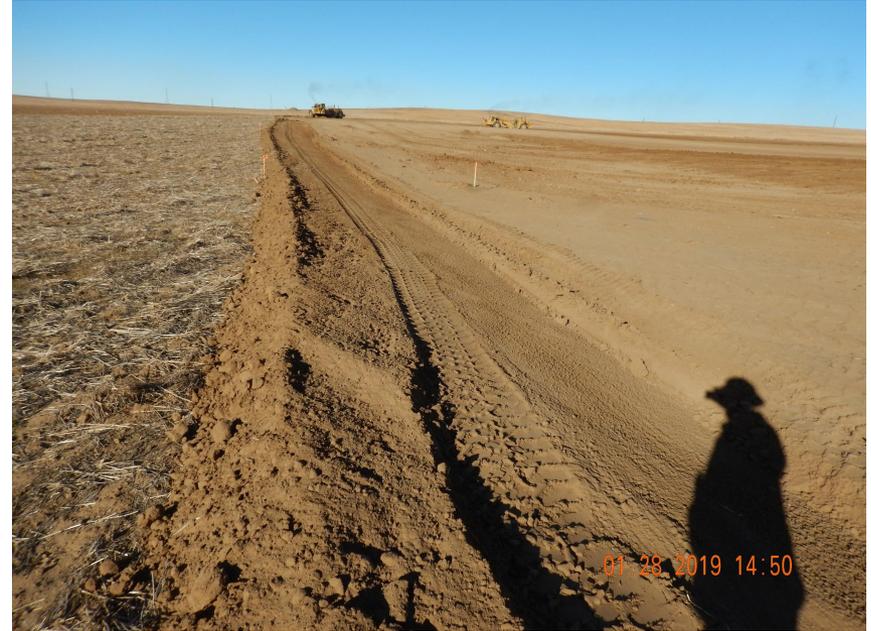
Photo 4. Photo taken from the southwestern perimeter of the location, facing North. See comments under Photo 3.

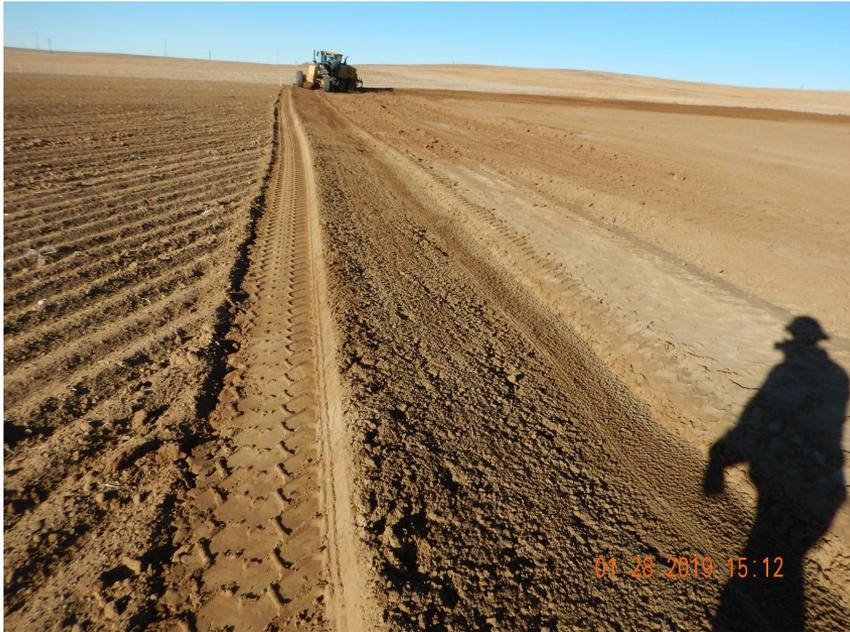
Photo 5. Photo taken from the northwestern perimeter of the location, facing North. See comments under Photo 3.

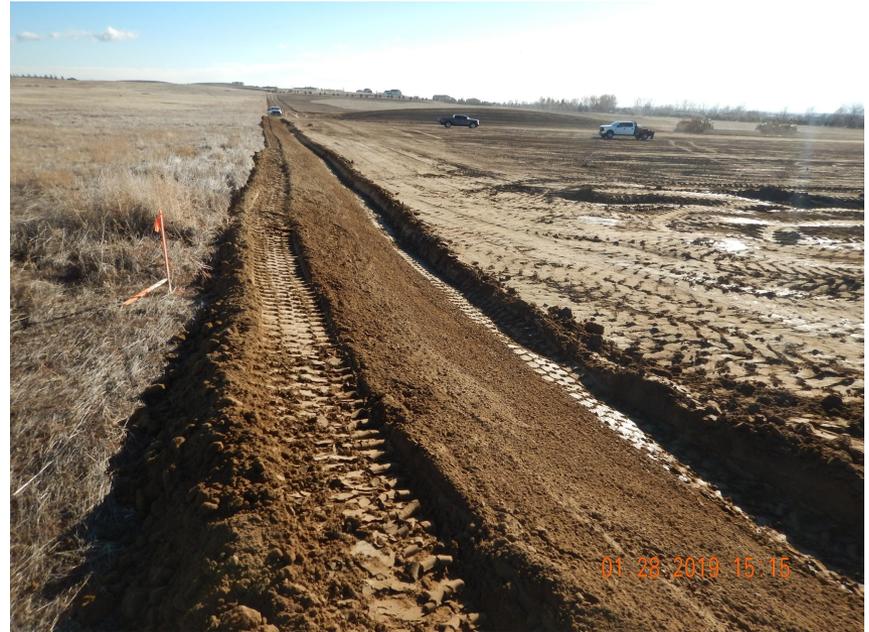
Photo 6. Photo taken from the northeastern perimeter of the location, facing South. See comments under Photo 3.

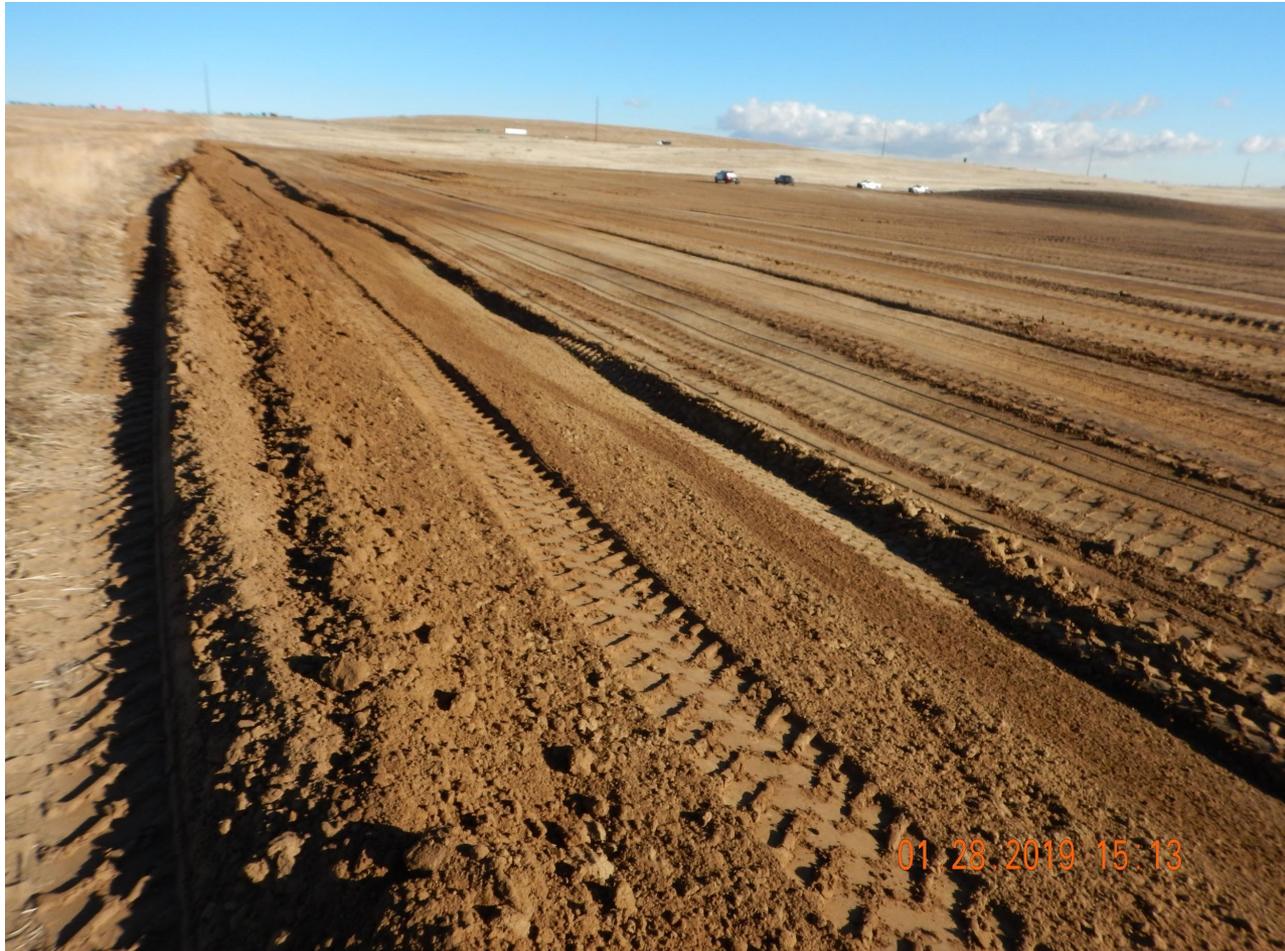
Photo 7. Photo taken from the northern perimeter of the location, facing East. See comments under Photo 3. Note: Photo also illustrates the subsoil layer coloration indicating that topsoil has been salvaged to the appropriate depth.

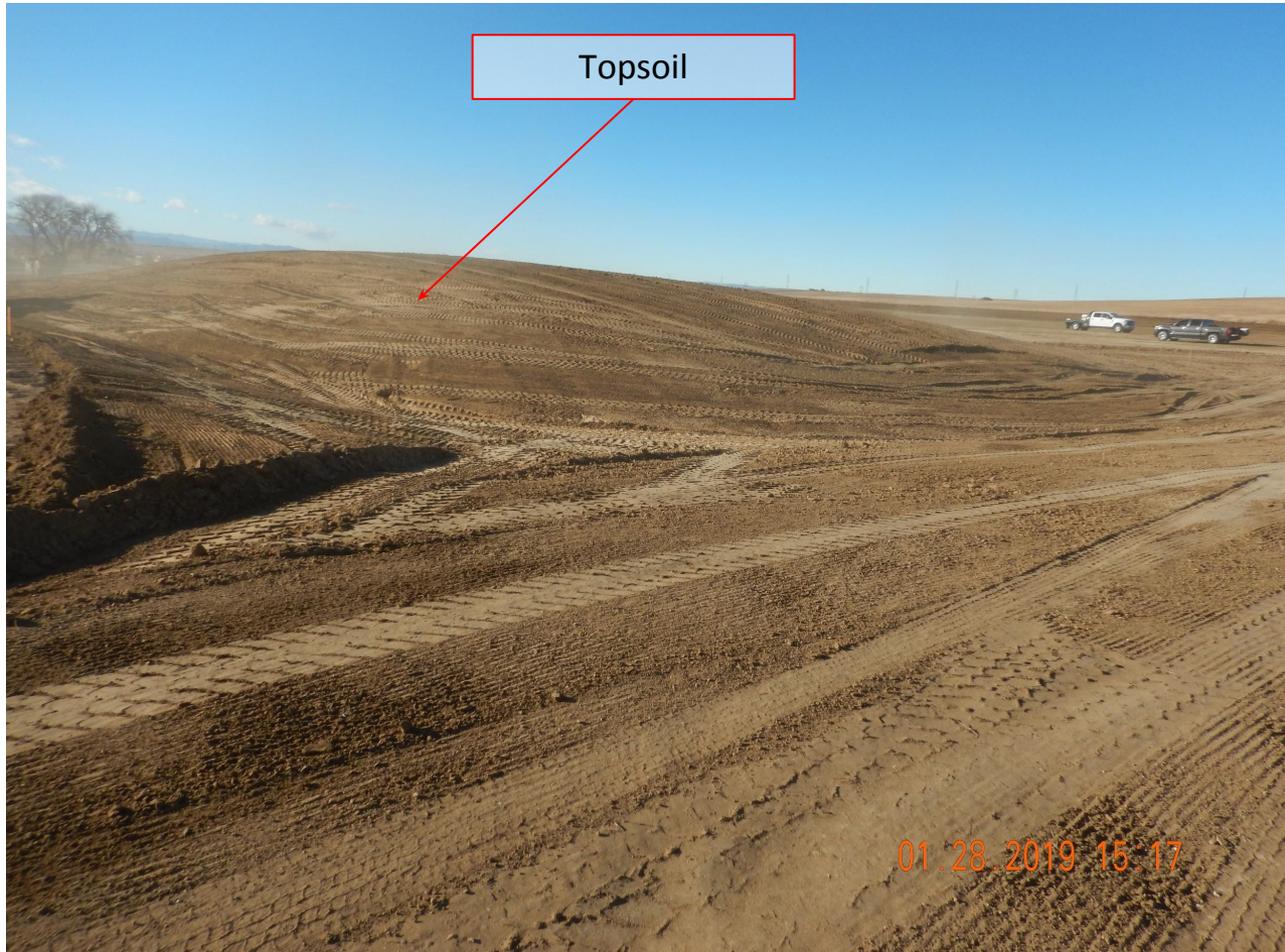
Photo 8. Photo taken from the southeastern perimeter of the location, facing West. Photo illustrates the topsoil stockpile and fugitive dust.

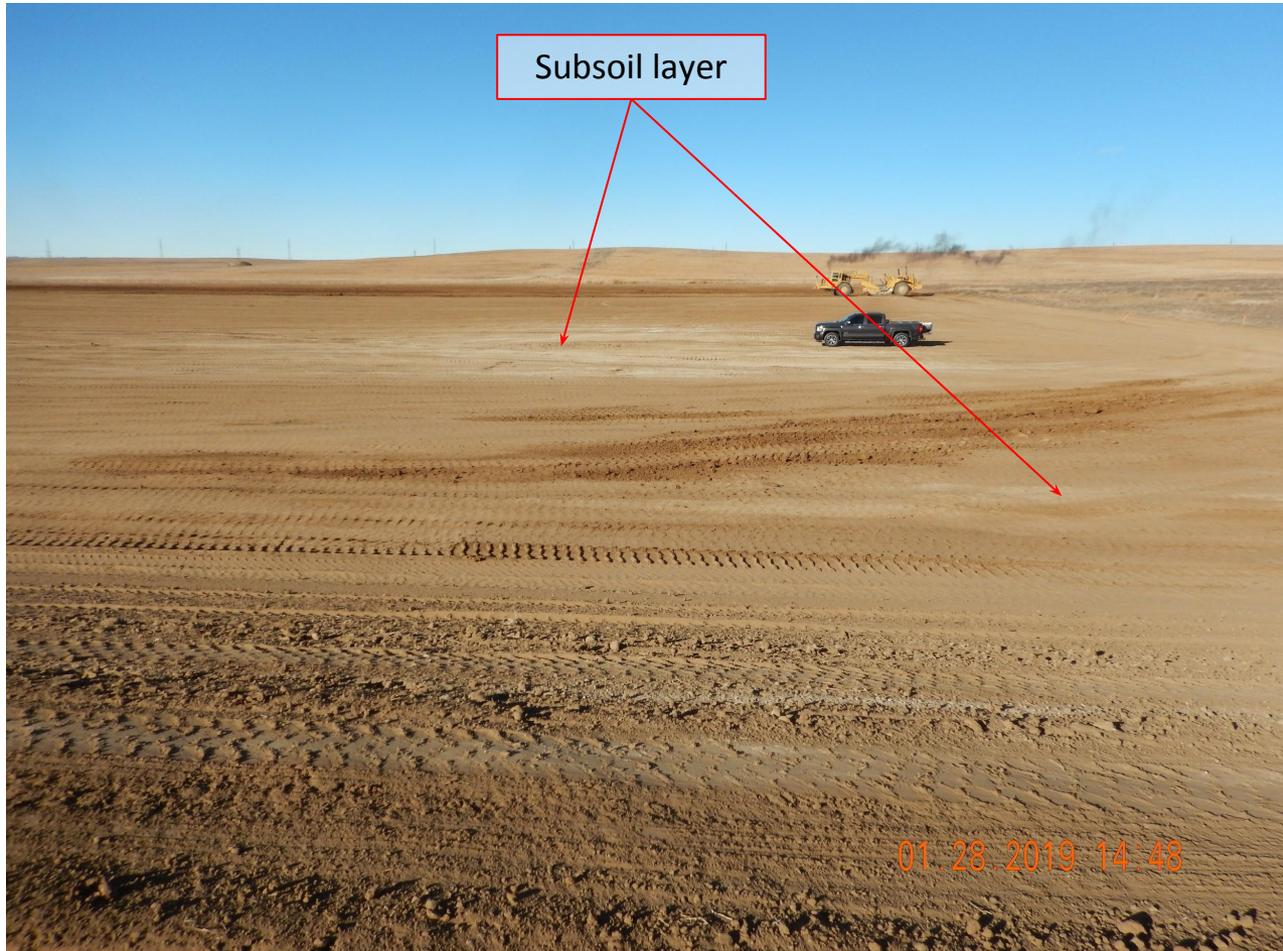
Photo 9. Photo taken from the topsoil stockpile, facing North. Photo illustrates the subsoil layer coloration indicating that topsoil has been salvaged to the appropriate depth.
