# Inspection Photos

API: 05-041-06072

Operator: HILCORP ENERGY COMPANY

Inspection and Photo Date: 12/7/2018

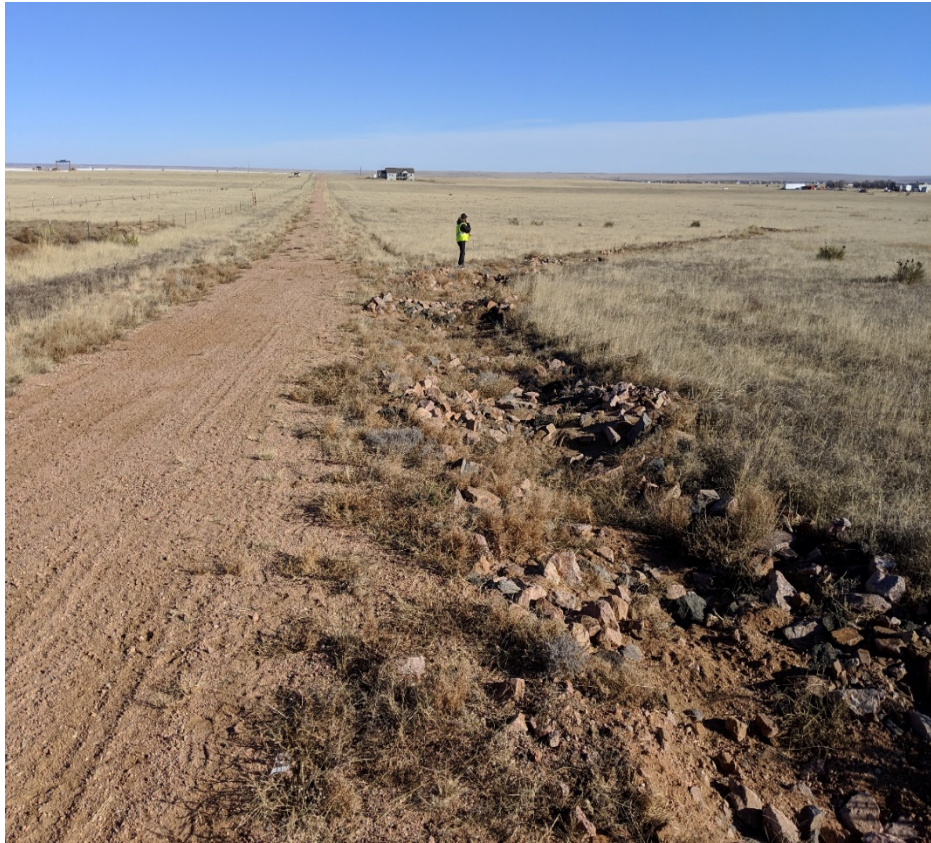
**COGCC Photo 1.** Facing east on the access road. Rock rip/rap can be seen in the drainage channel. Rock check dams have been lowered to allow water flow per previous inspection. See further information on photo 2.

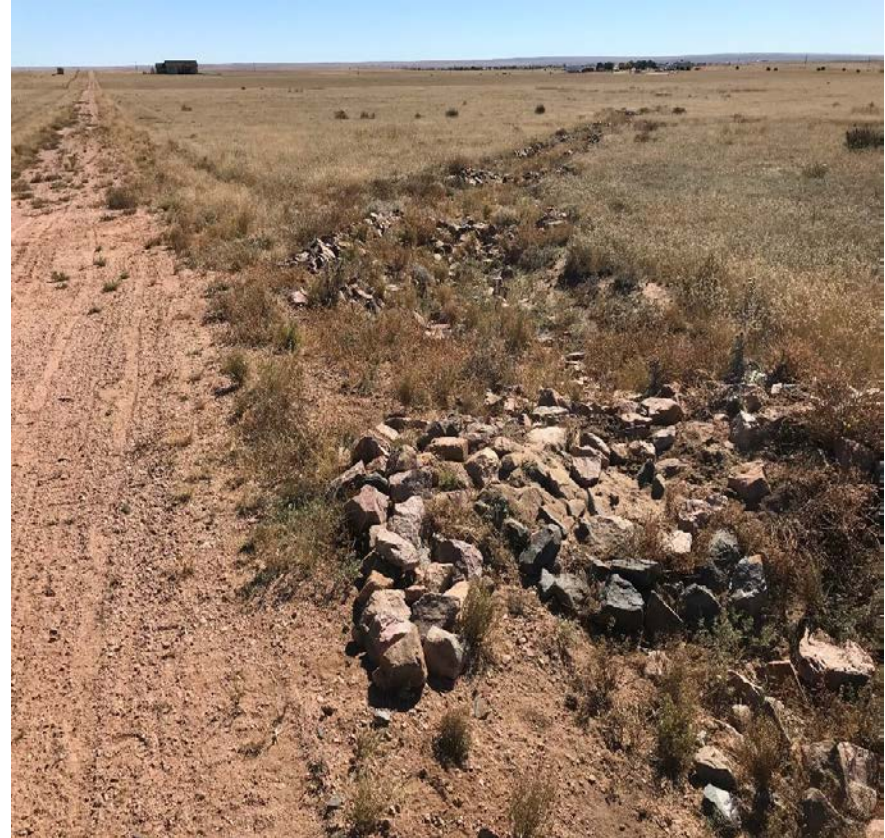
**10/3/18 - LTE/Hilcorp Photograph 1:** View east on access road towards Reilly residence.

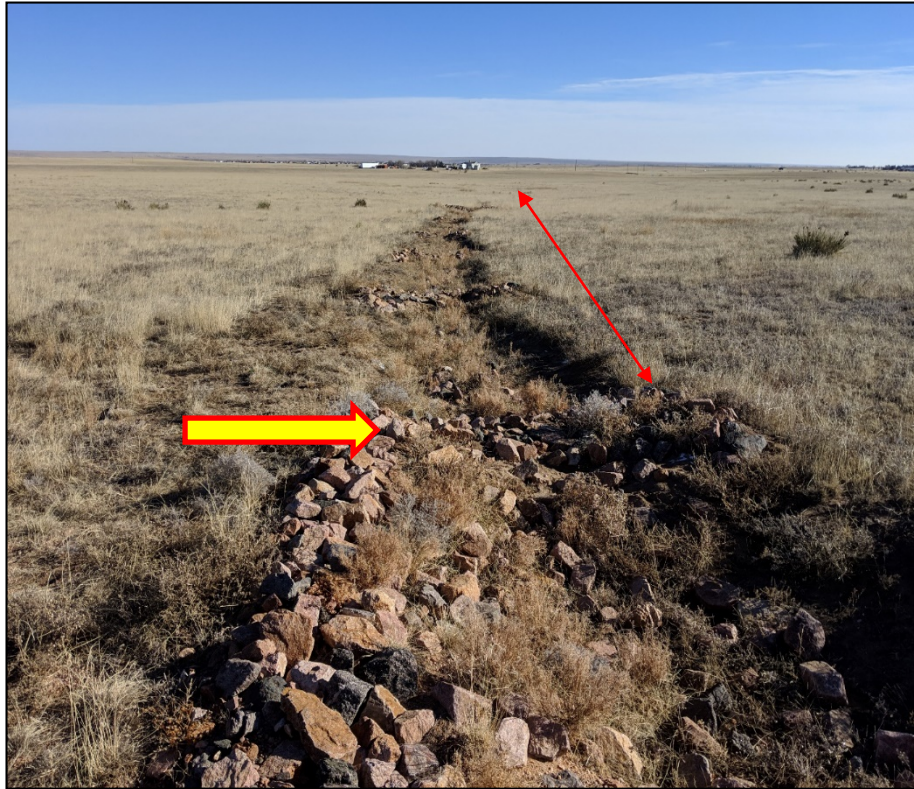
**COGCC Photo 2.** The drainage channel extends far out into the pasture. This is additional disturbance caused by erosion. The channel needs to be recontoured to grade and reclaimed/reseeded along the red arrow to the yellow arrow. A proper sediment trap should be constructed at the yellow arrow.

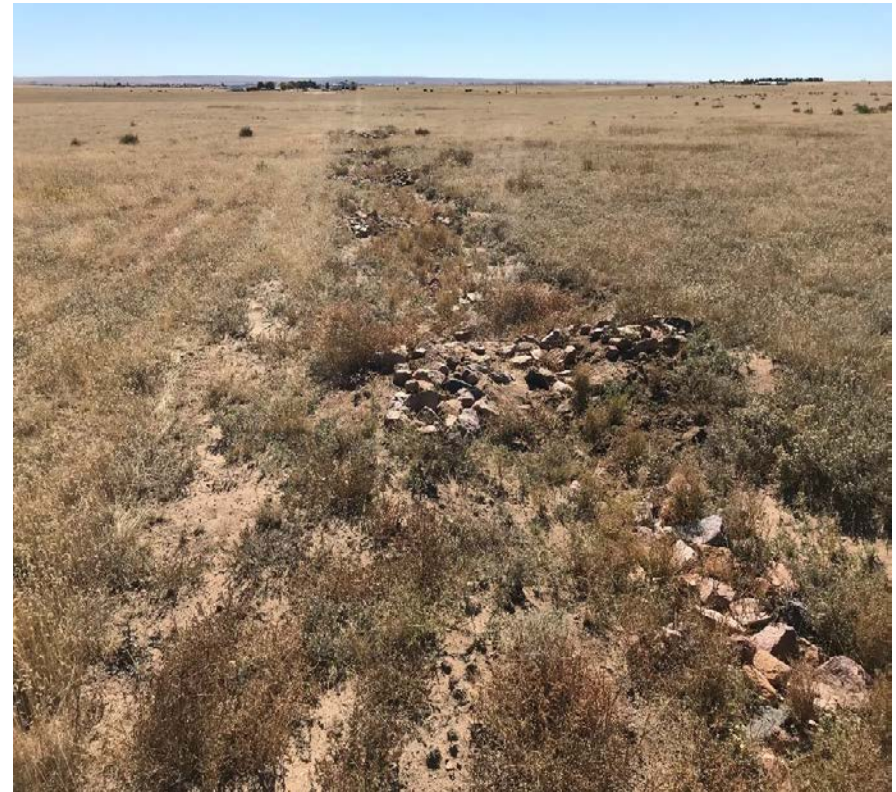
**10/3/18 - LTE/ Hilcorp Photograph 3:** Corresponds to COGCC inspection photo 7. Check dams have been repaired. Old sandbags have been removed and vegetation is filling in.

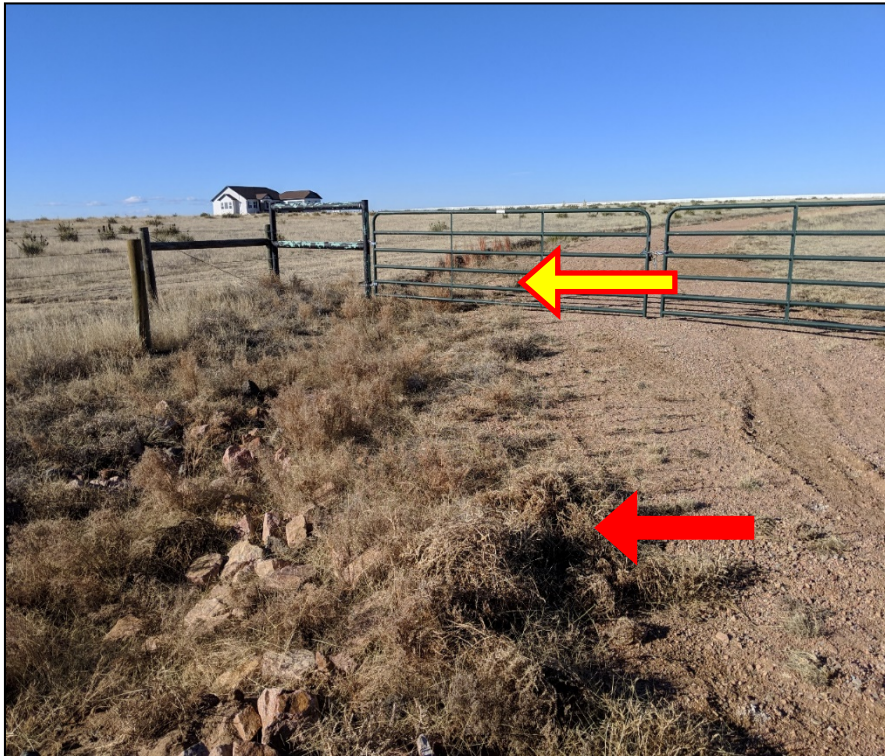
**COGCC Photo 3.** Weed debris remains in the drainage channel (red arrow). Further up the channel (yellow arrow) no BMP's are in place to slow water flow. Additional BMP's are required up slope e.g. check damns. The vegetation in the channel is predominately weeds, therefore not stabilizing the drainage channel.

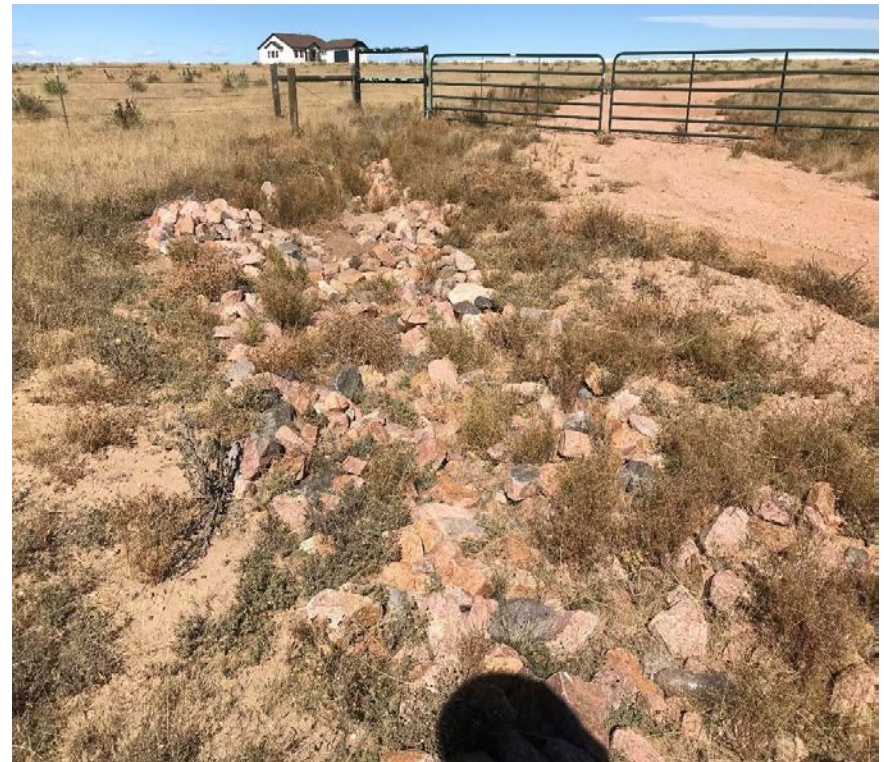
**10-3-18 - LTE/Hilcorp Photograph 2:** Corresponds to COGCC inspection photo 5. Erosion has been repaired and vegetation is filling in to stabilize.

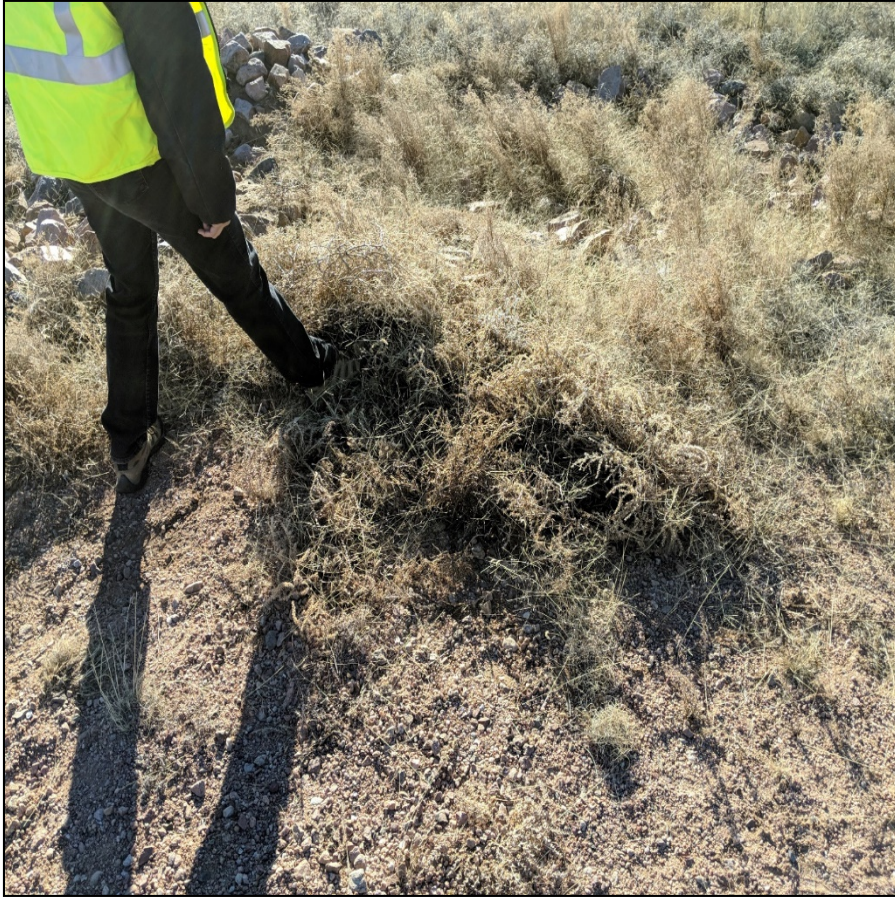
**Photo 4.** Piles of weed debris was noticed along the side of the road and in the drainage ditches. The debris piles need to be removed.

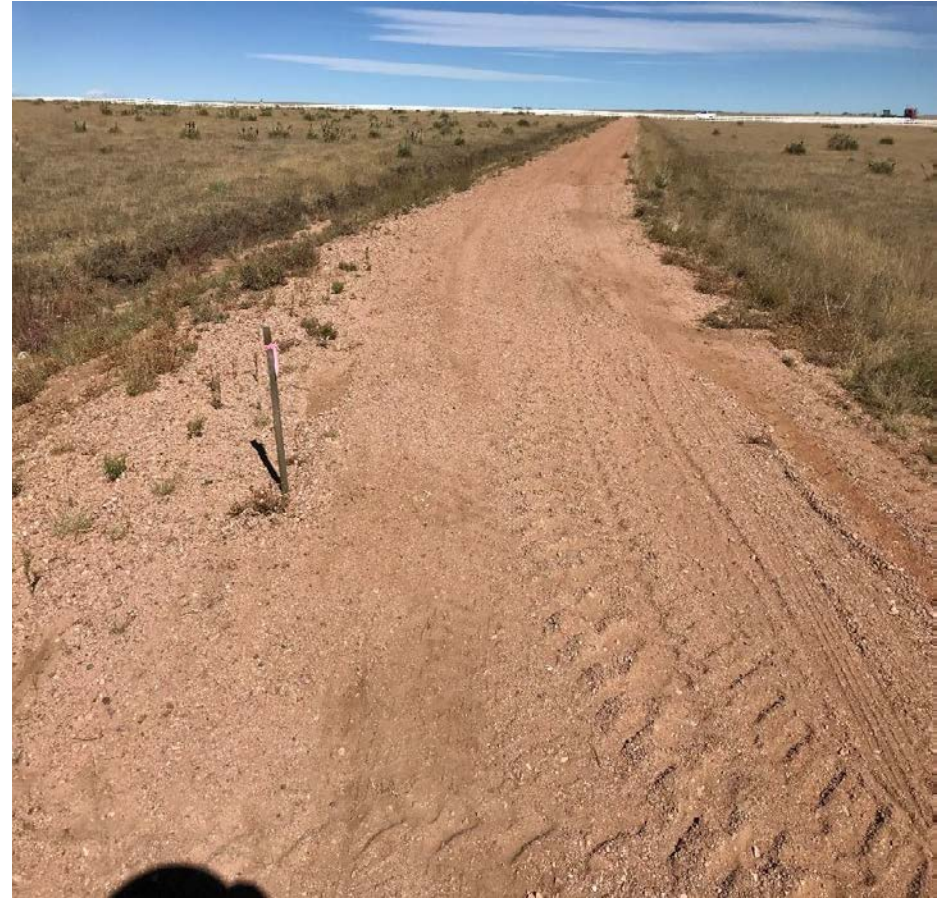
**10/3/18 - LTE/ Hilcorp Photograph 4:** Corresponds to COGCC inspection photo 8. Weeds have been removed and road has been stabilized.

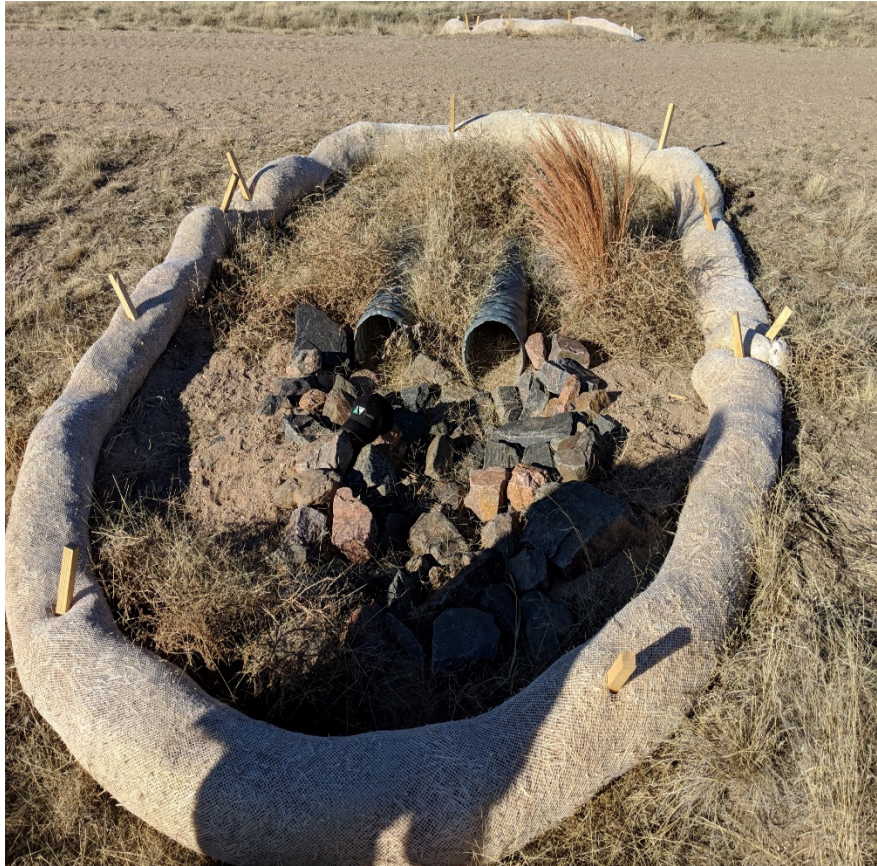
**COGCC Photo 5.** The outlet culvert. Rock rip/rap is improperly installed as it is piled too high in front of the culvert which appear to be restricting water flow. The wattles are temporary BMP's and are not a long term solution.

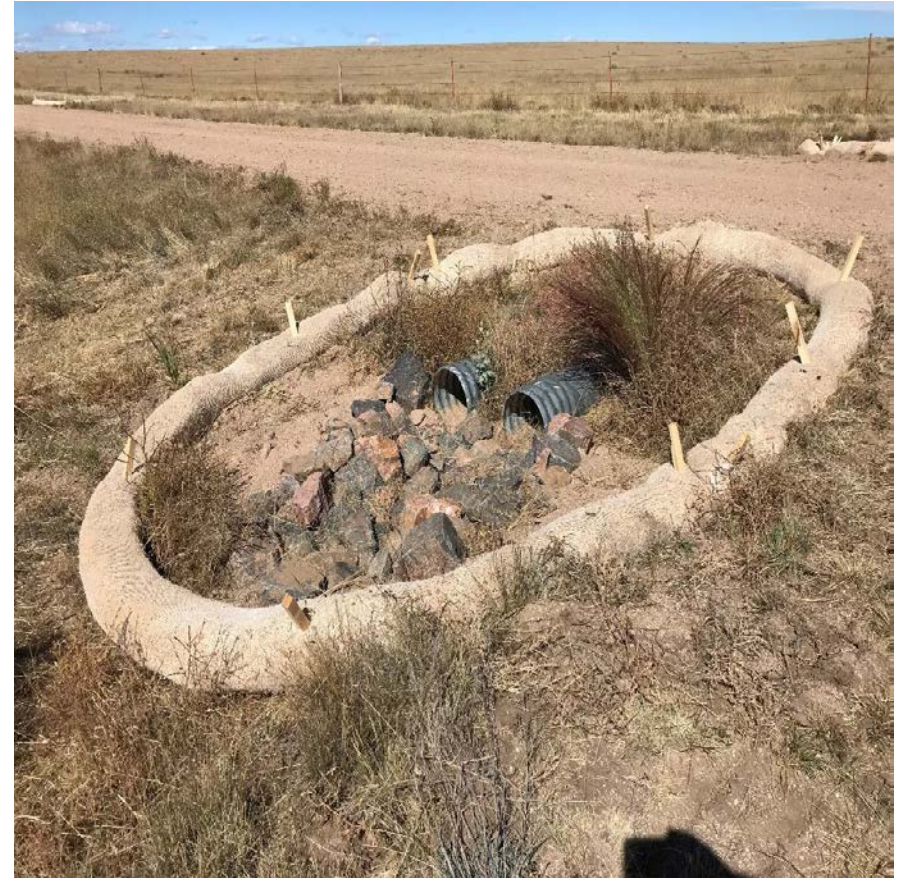
**10/3/18 - LTE/ Hilcorp Photograph 7:** Corresponds to COGCC inspection photo 12. Sediment has been removed. Inlet and outlet protection have been added.

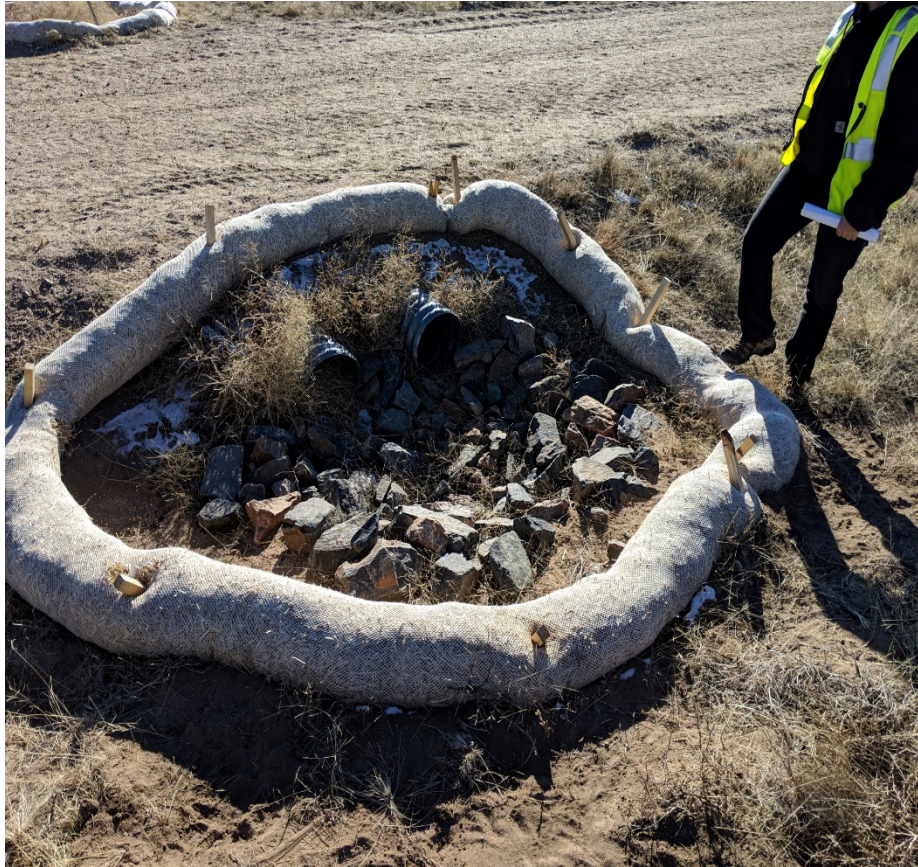
**COGCC Photo 6.** The inlet culvert. Rock rip/rap is improperly installed as it is piled too high in front of the culvert which appear to be restricting water flow. The wattles are temporary BMP's and are not a long term solution. A long term solution could be sediment traps and rock check dams.

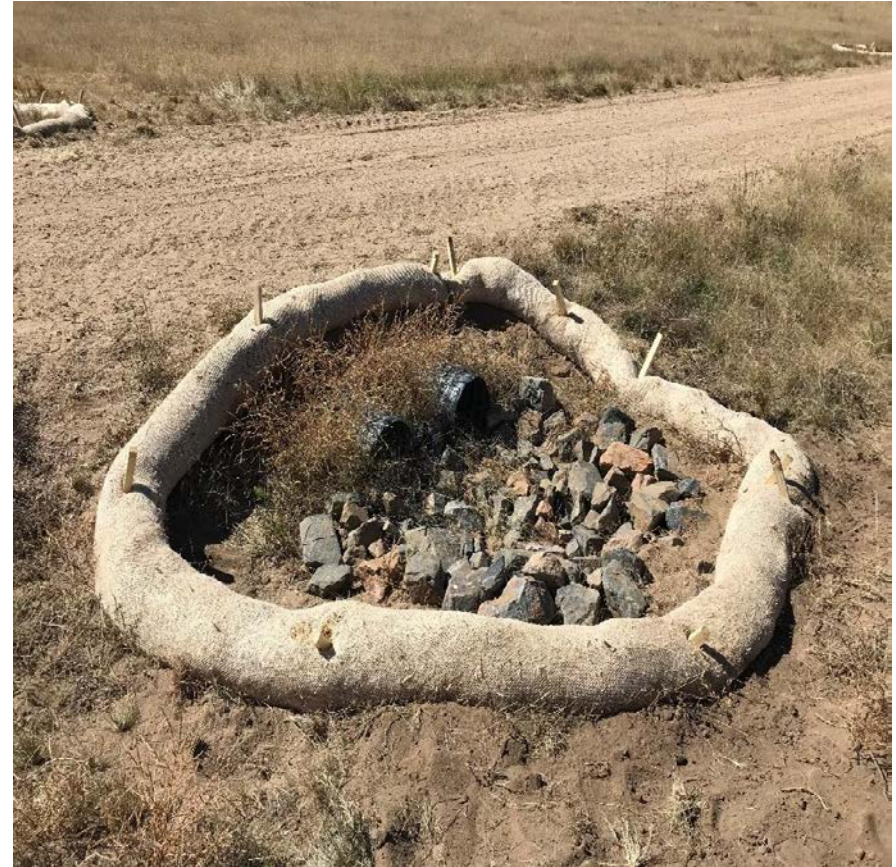
**10/3/18 - LTE/Hilcorp Photograph 8:** Sediment has been removed. Inlet and outlet protection have been added to all 3 culvert locations.

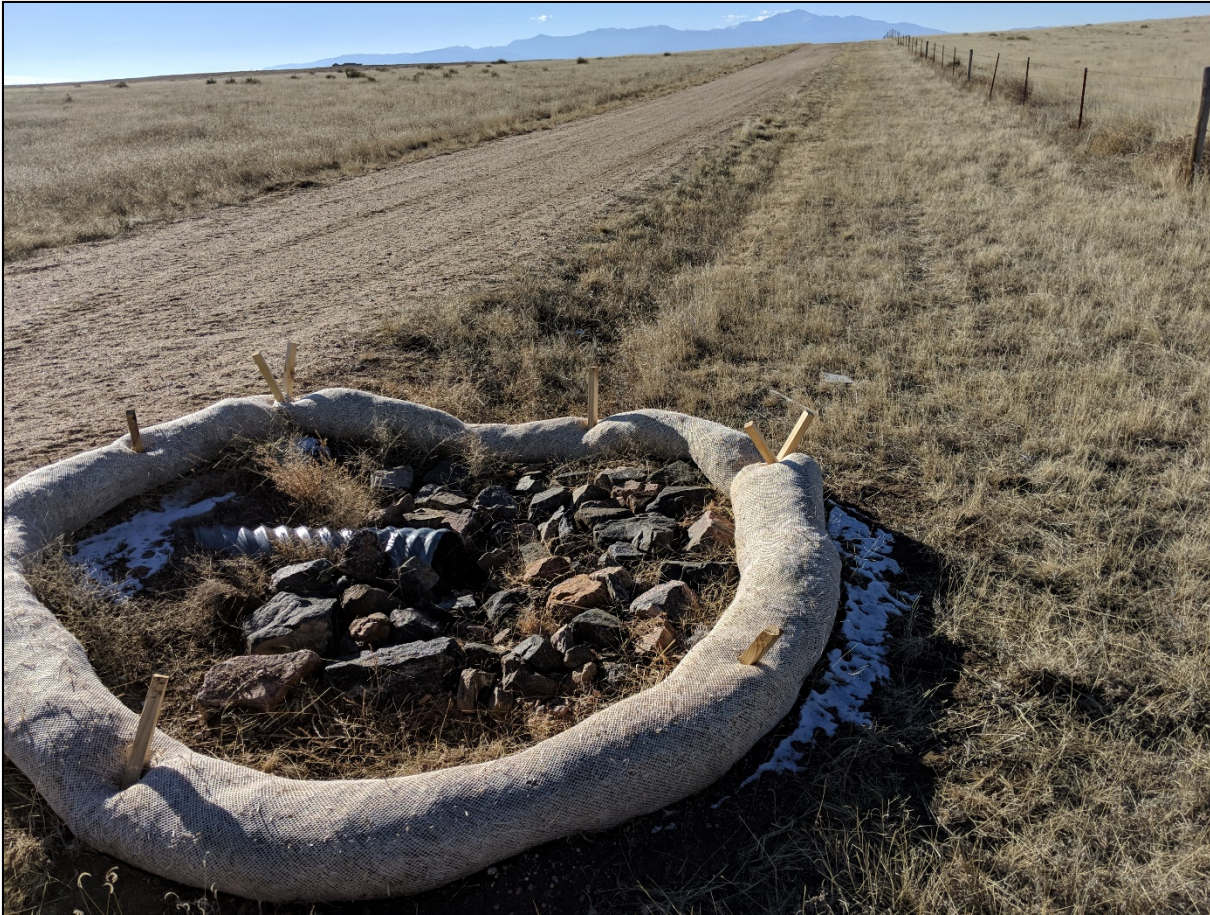
**Photo 7.** The inlet culvert. Water flows from the east and the west to the culverts. Rock rip/rap is improperly installed as it is piled too high in front of the culvert which appear to be restricting water flow. The wattles are temporary BMP's and are not a long term solution. A long term solution could be sediment traps and rock check dams.

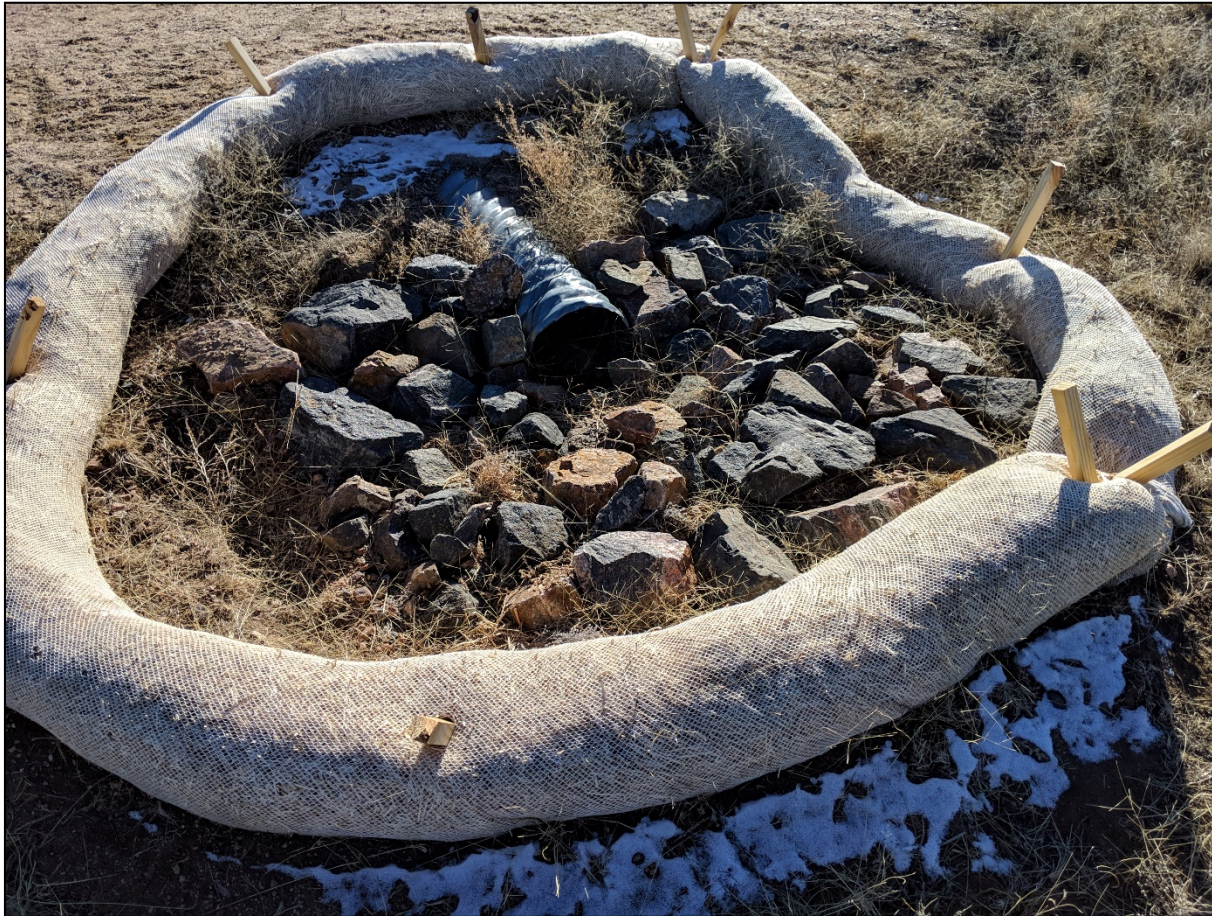
**Photo 8.** The inlet culvert. Rock rip/rap is improperly installed as it is piled too high in front of the culvert which appear to be restricting water flow. The wattles are temporary BMP's and are not a long term solution. All culverts need to have long term sediment controls.

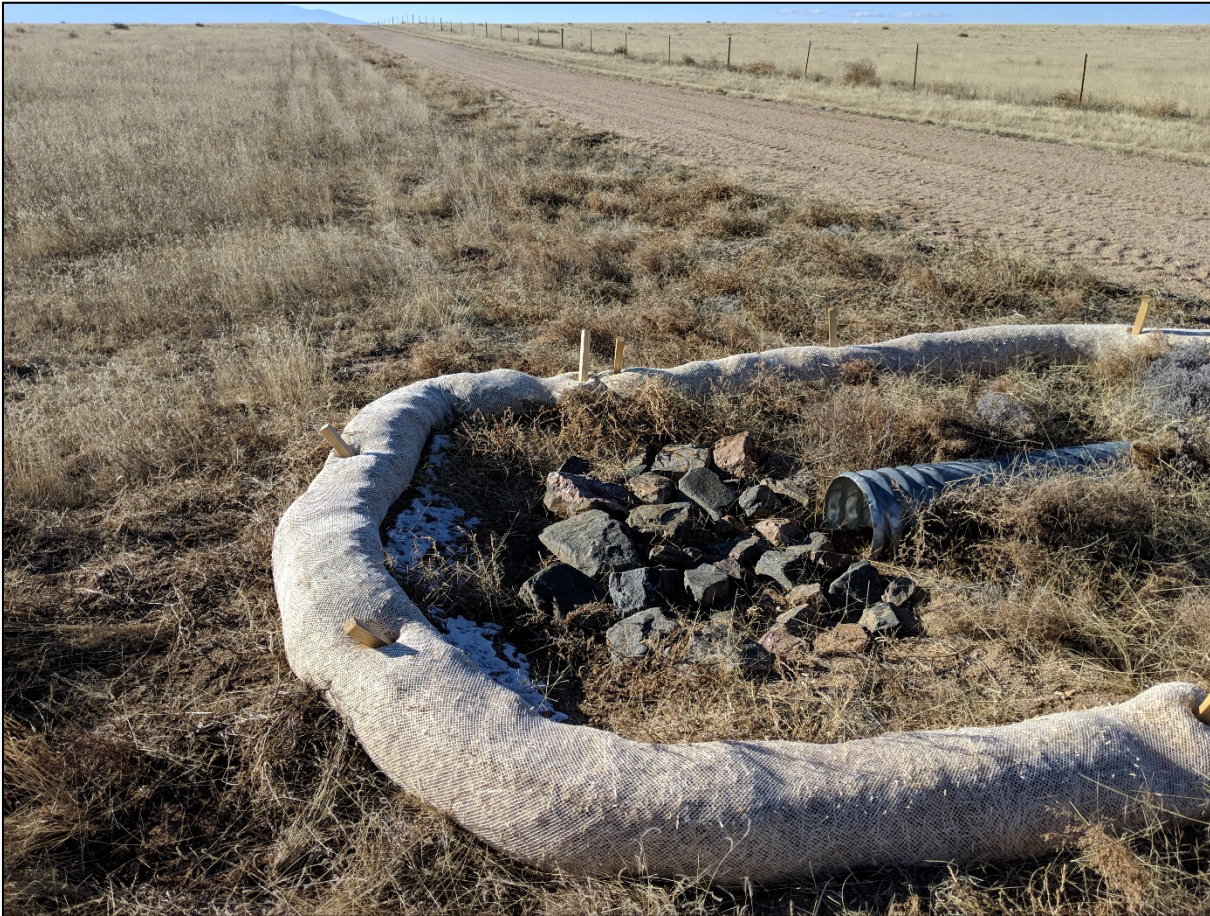
**Photo 9.** The outlet culvert. Rock rip/rap is improperly installed as it is piled too high in front of the culvert which appear to be restricting water flow. The wattles are temporary BMP's and are not a long term solution. All culverts need to have long term sediment controls.

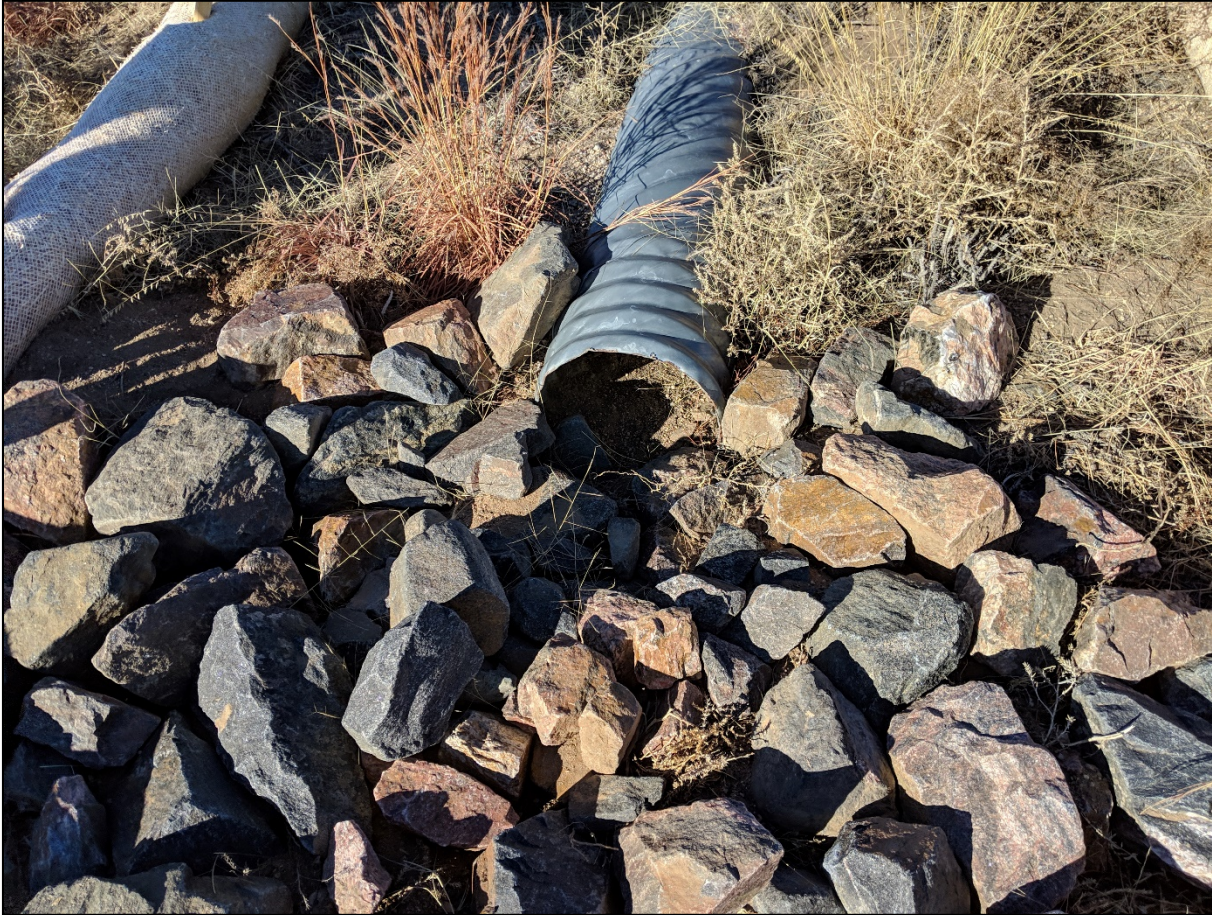
**Photo 10.** Sediment remains in the culvert. Rock rip/rap is improperly installed as it is piled too high in front of the culvert which appears to be restricting water flow.

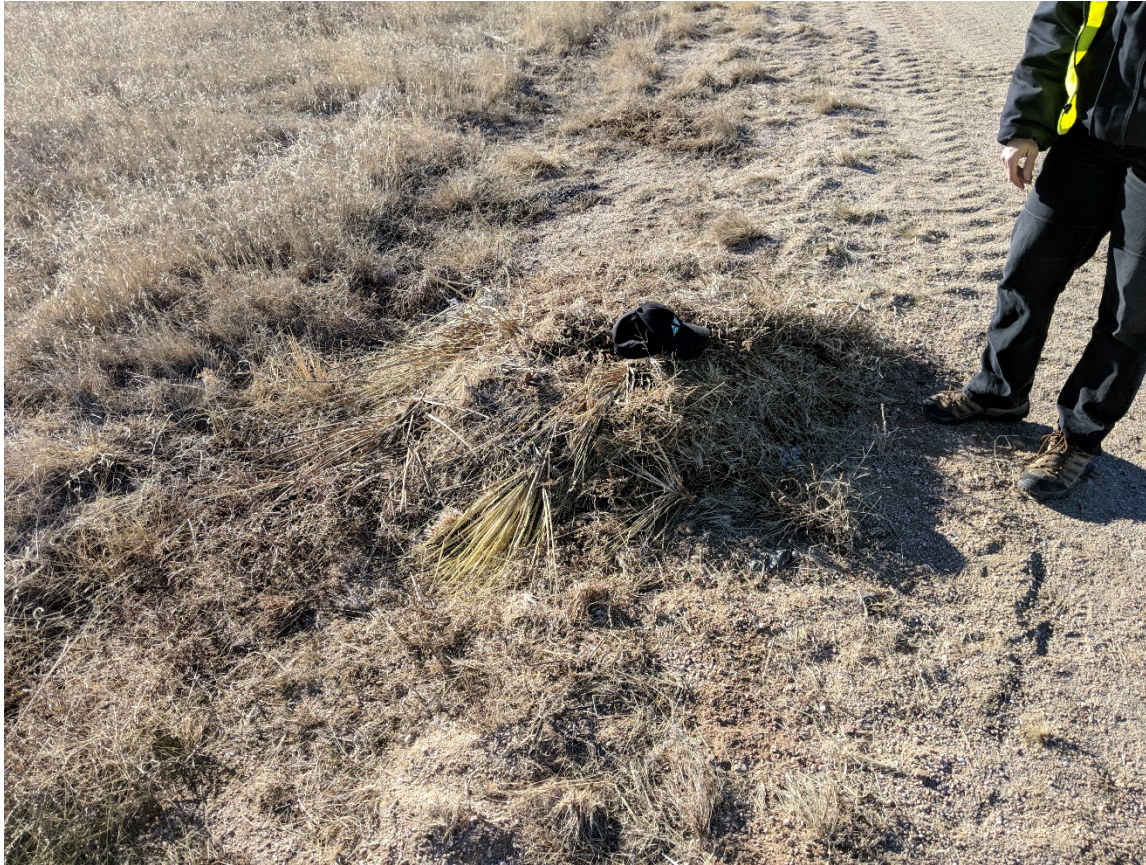
**Photo 11.** Piles of debris were found along the access road. It appears seeding operations dragged debris into piles. The debris piles need to be removed.

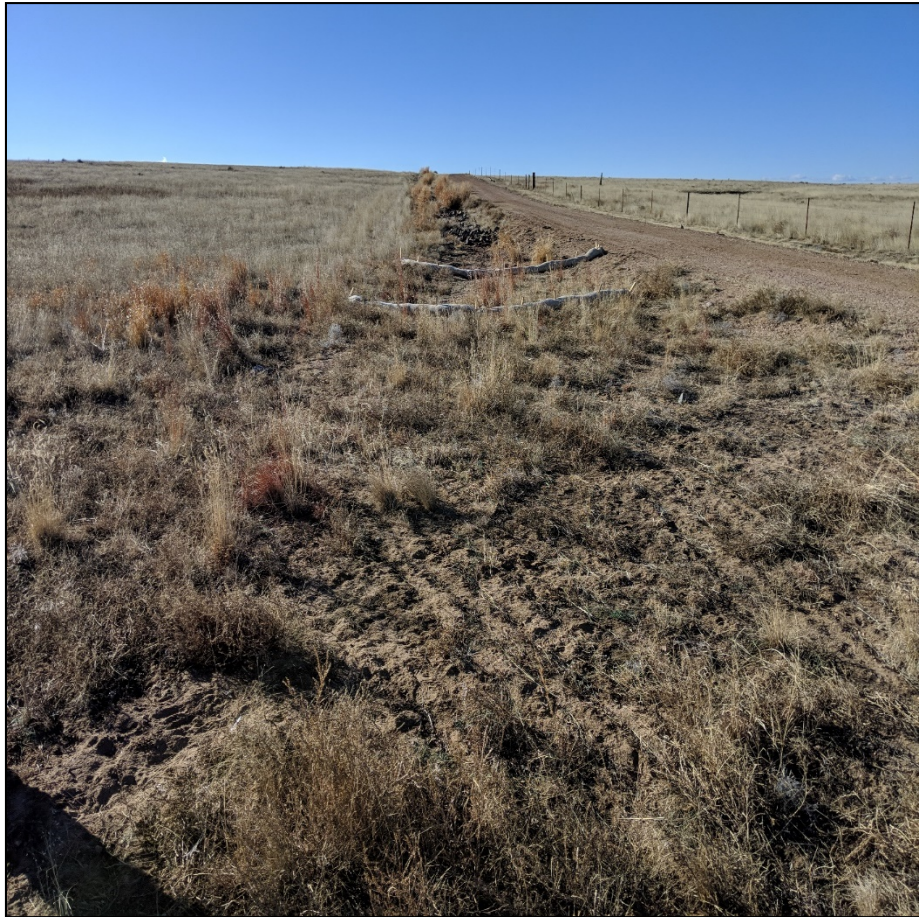
**COGCC Photo 12.** The disturbance along the side of the road appears to have been interseeded, however it is unclear that the process was successful..

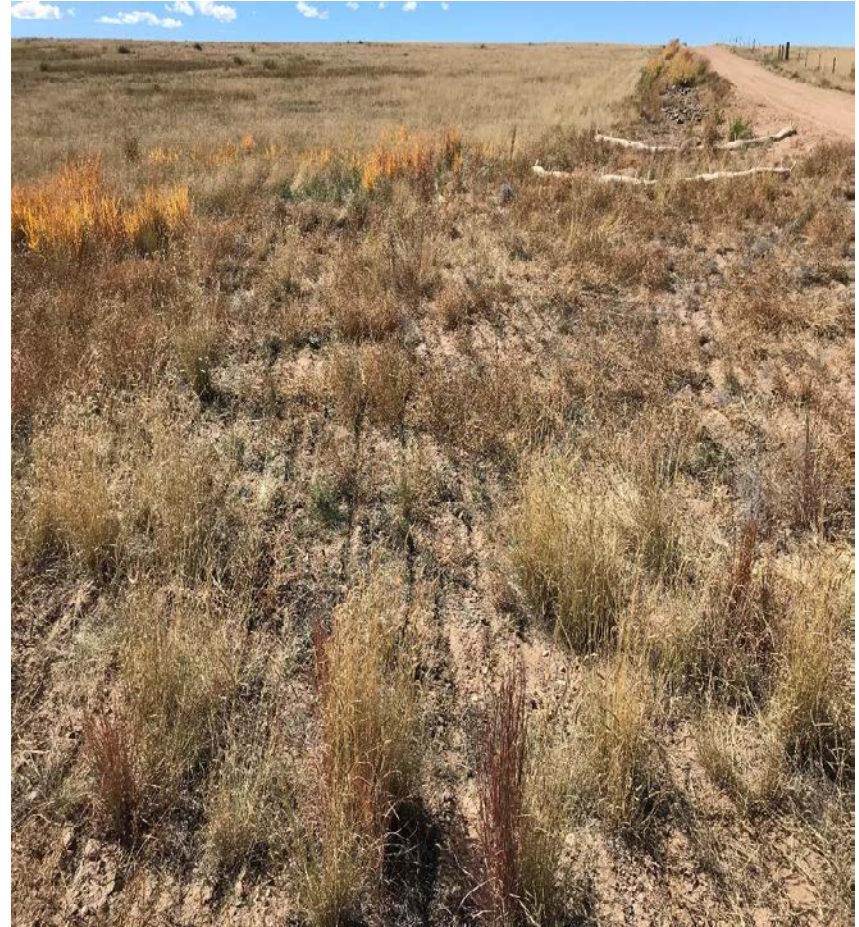
**10/3/18 - LTE/Hilcorp Photograph 9:** Corresponds to COGCC inspection photo 14. Area has been interseeded.

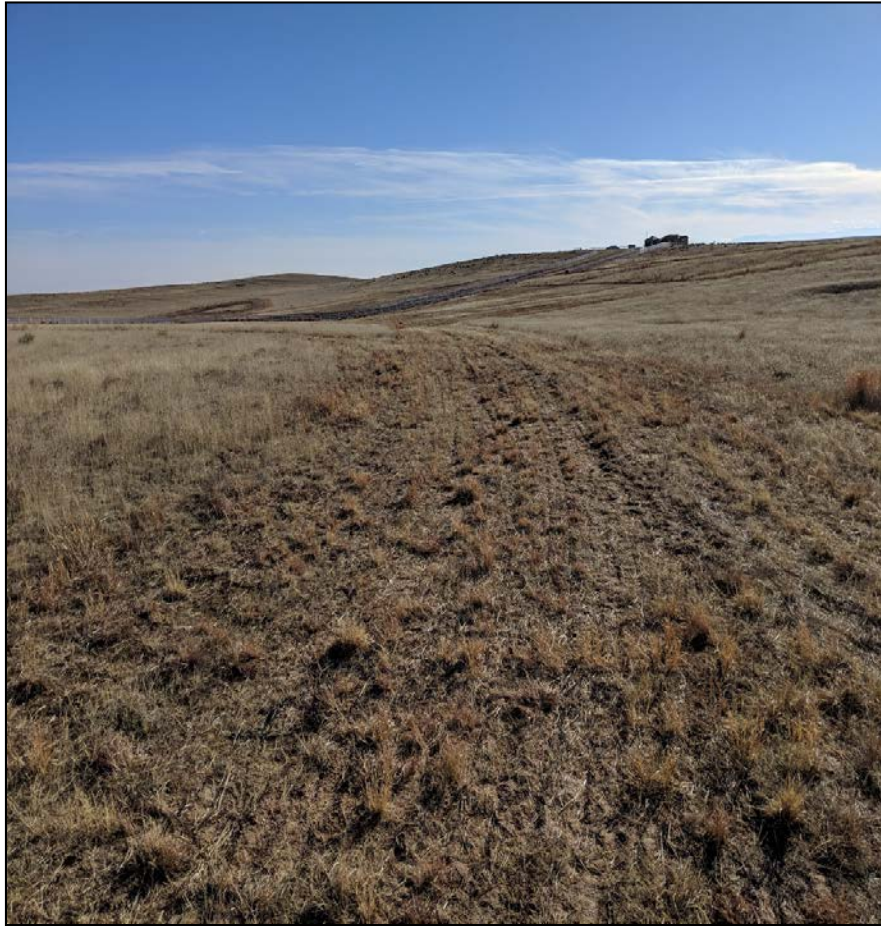
**COGCC Photo 13.** Facing south toward the location. Vegetation has not established in this area. The area appears to have been interseeded, however it is unclear that the process was successful..

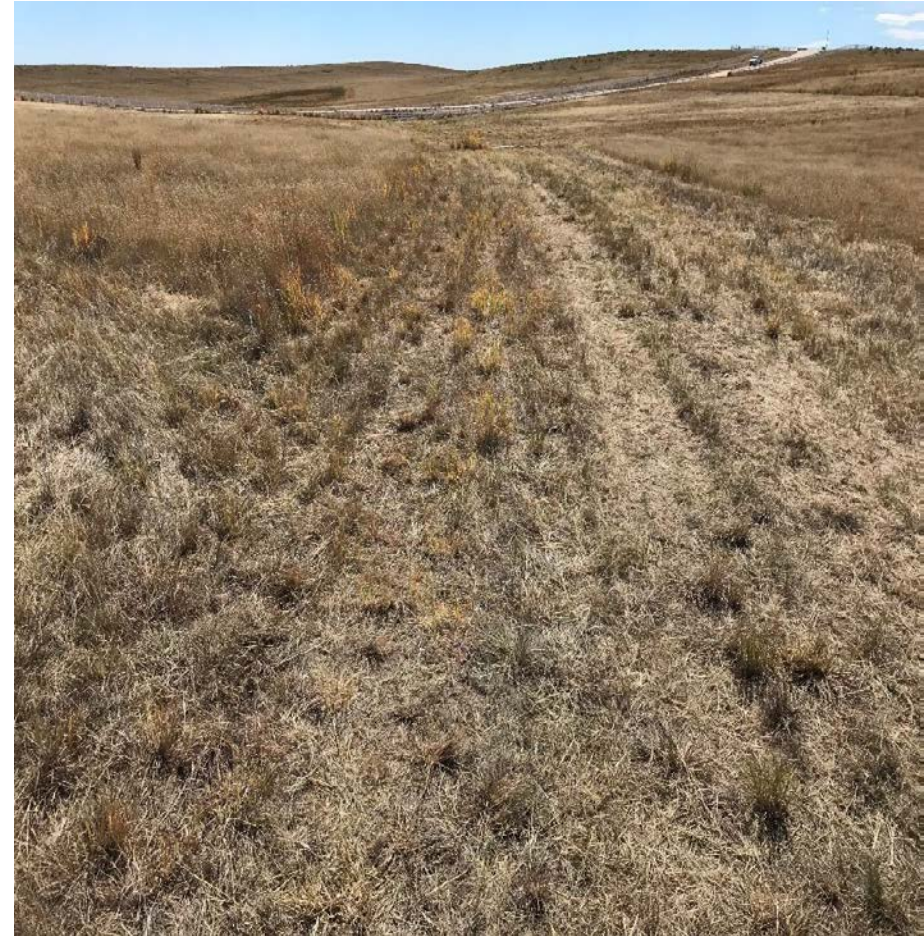
**10/3/18 - LTE/Hilcorp Photograph 11:** View of reclaimed portion of former access road facing south towards former well pad area. Area has been mowed and interseeded.

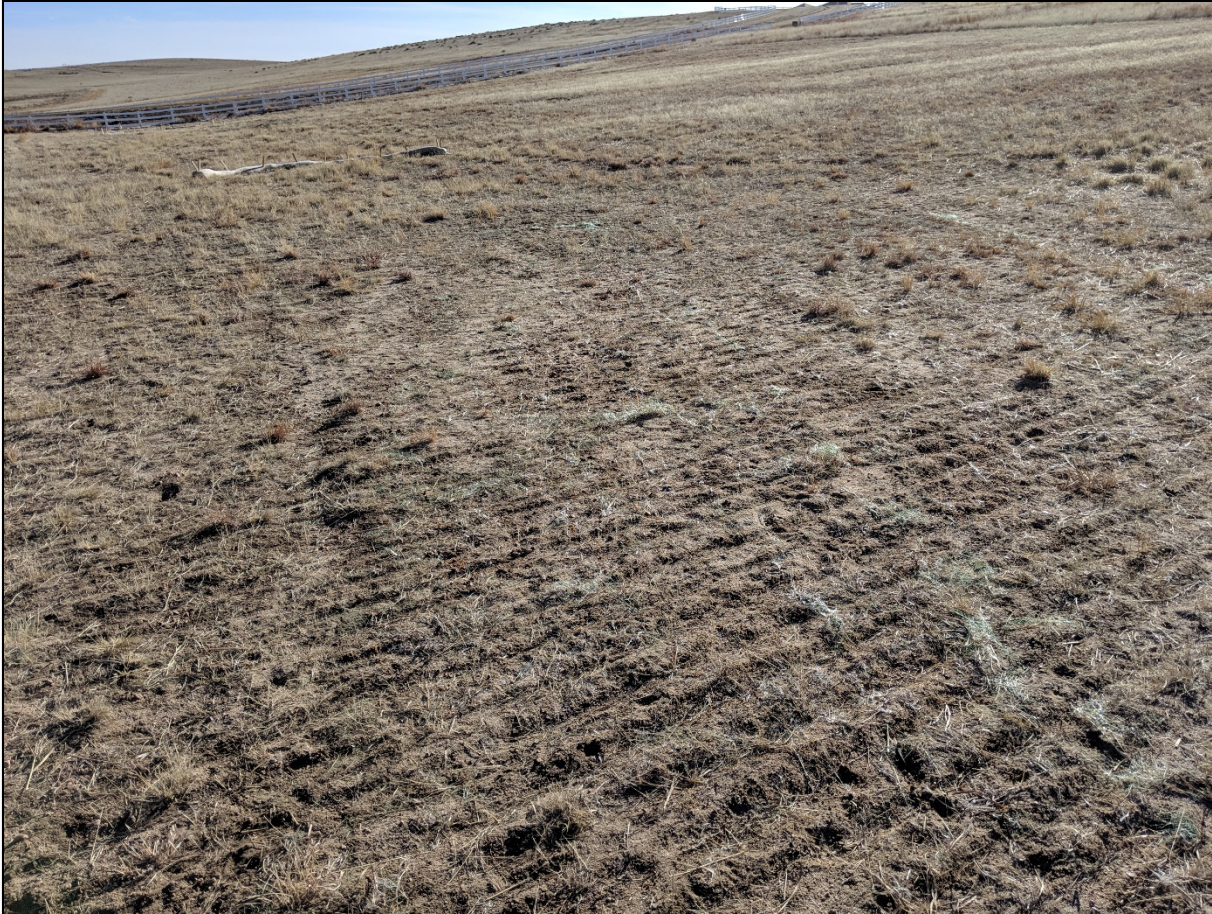
**Photo 14.** Facing south at the location. Vegetation has not established in this area. The area appears to have been interseeded, however it is unclear that the process was successful..

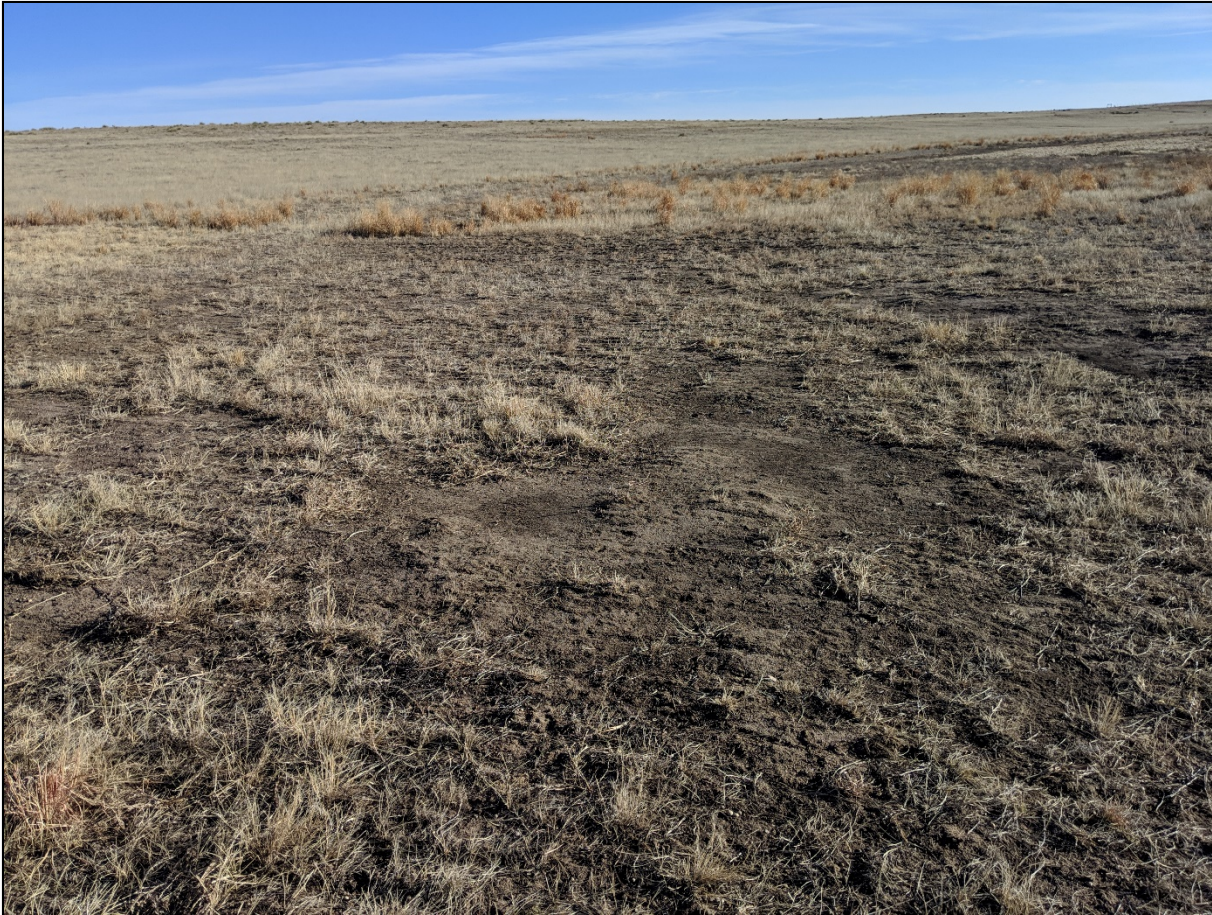
**Photo 15.** South side of the location. This area appears to have been interseeded, however it is unclear that the process was successful.
