Inspection Photos
Location Name: UPRR 23 Pan AM D#2
Location ID: 319939

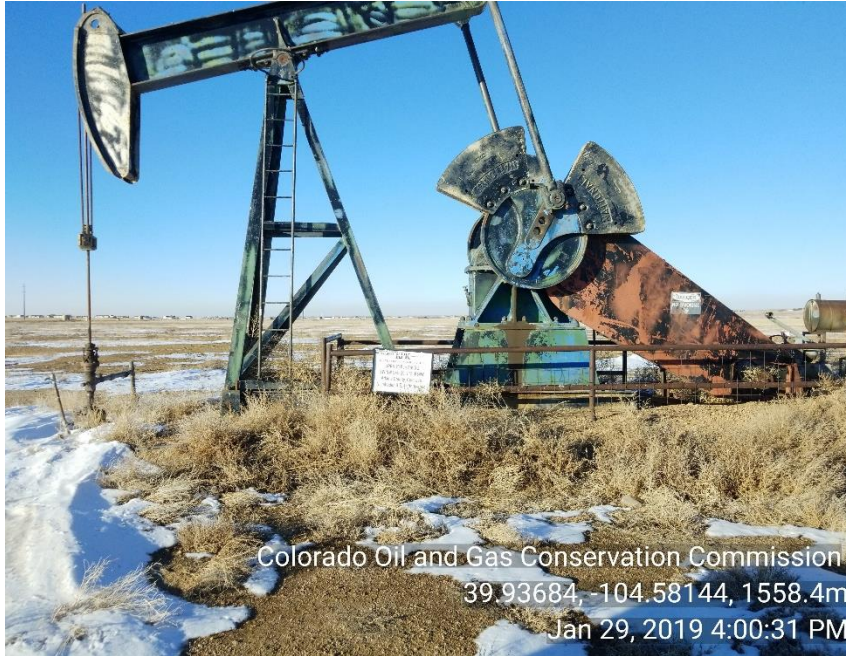
Photo 1 WH/PU dead weeds

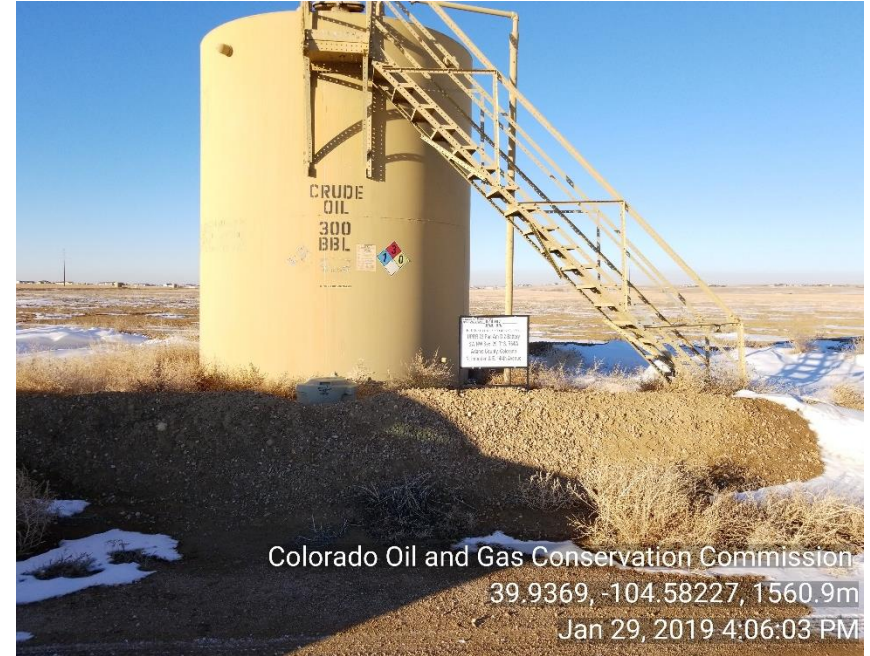
Photo 2 TNK BTRY dead weeds

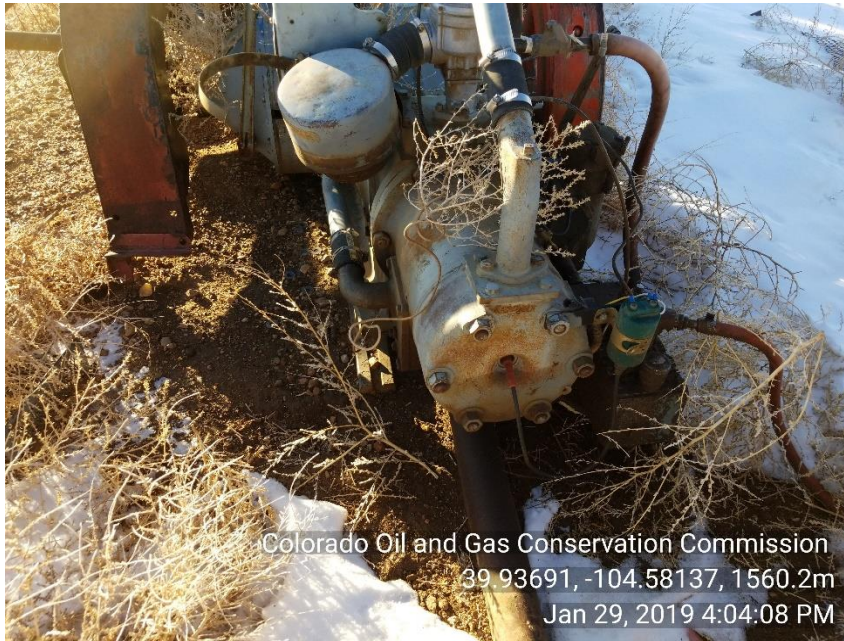
Photo 3 stained soil around PU motor

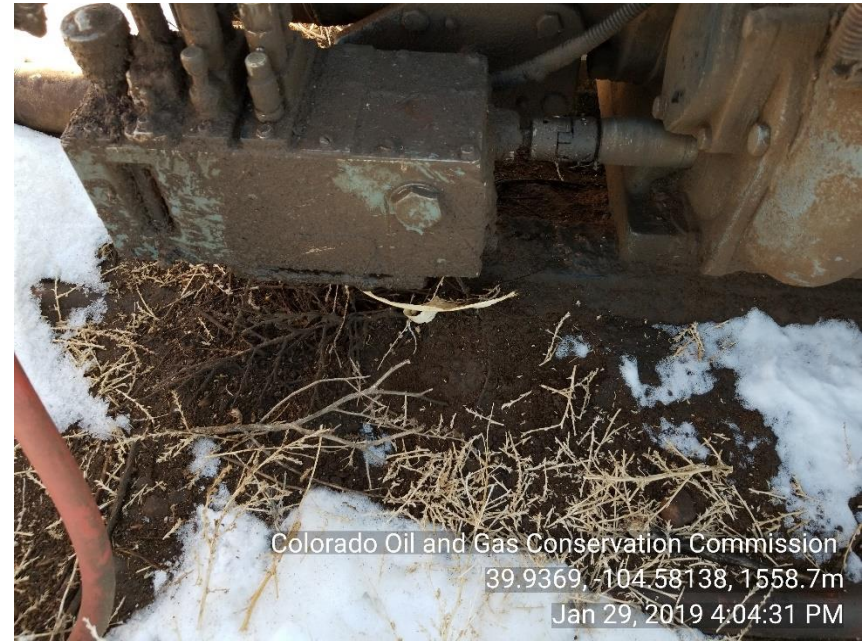
Photo 4 Stained soil around PU motor

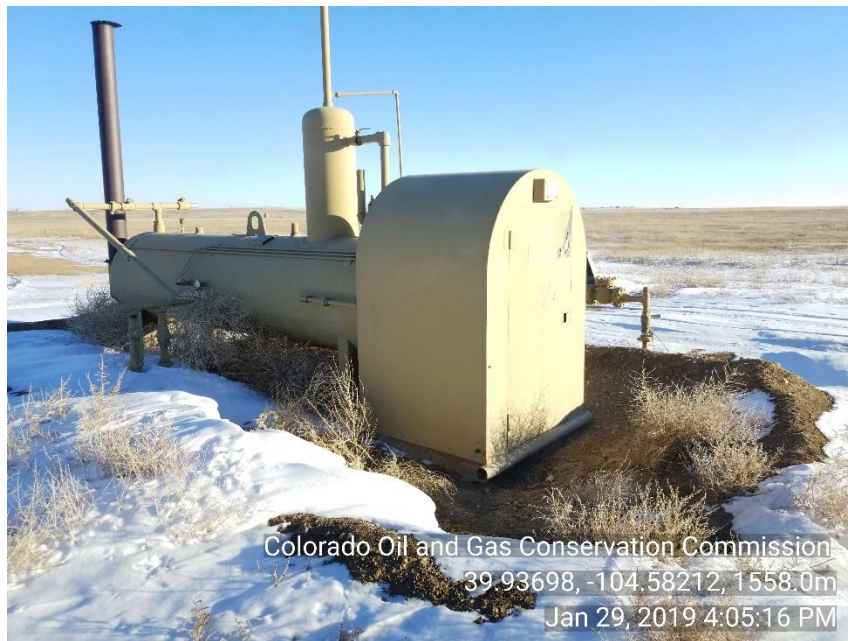
Photo 5 Dead weeds around Separator
