Inspection Photos
Location Name: Champlin 117 AMOCO C #6
Location ID: 319839

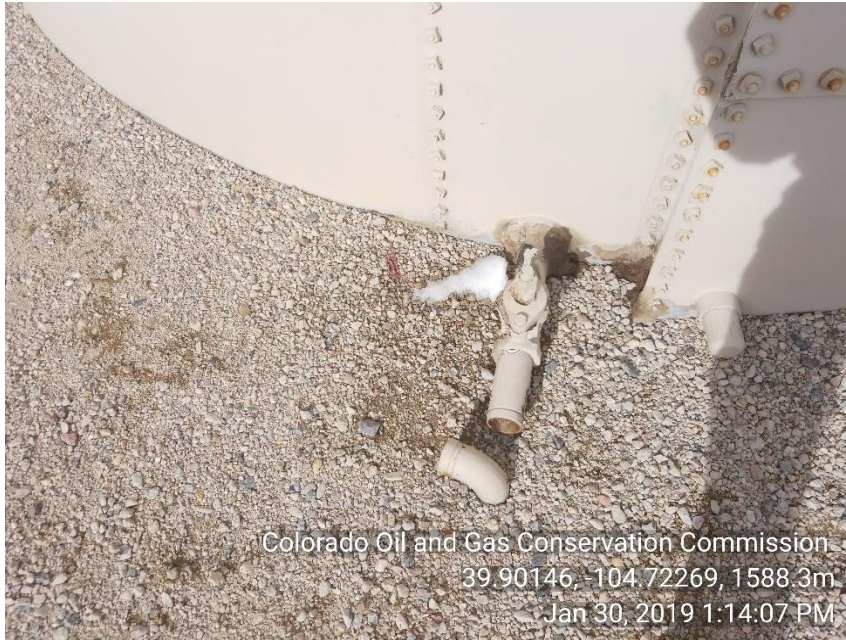
Photo 3 load line to west crude oil tank not capped or plugged.
