Inspection Photo (s)
GMR 21-8D
API # 05-045-09285
Inspection # 689303118

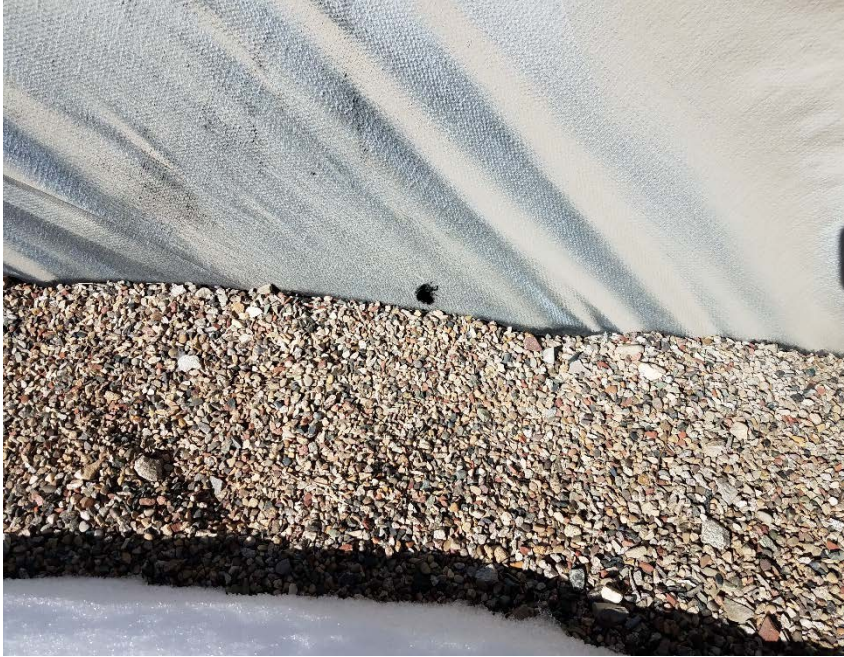
Location Photo #3, Hole in secondary containment liner.

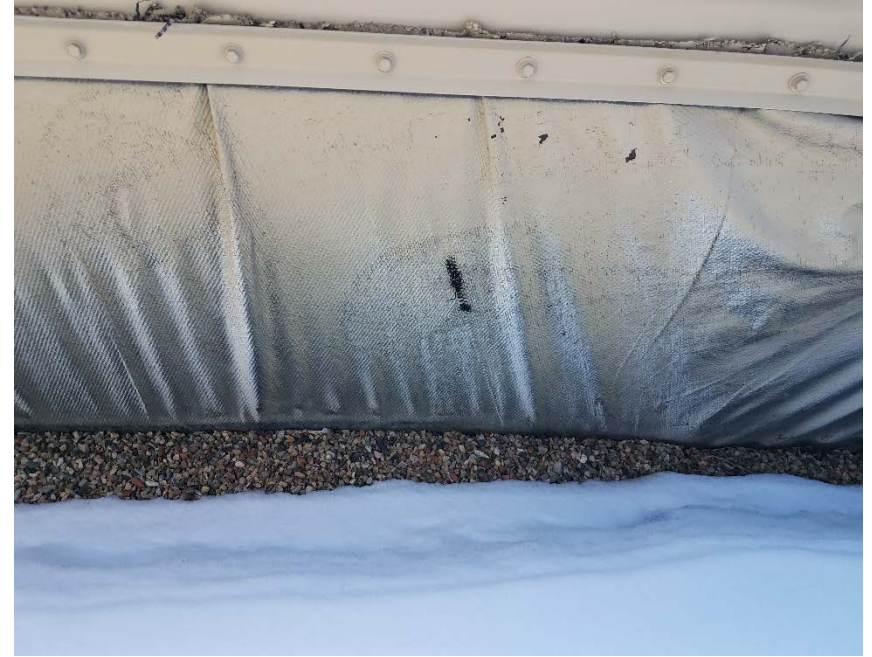
Location Photo #4, Hole in secondary containment liner.

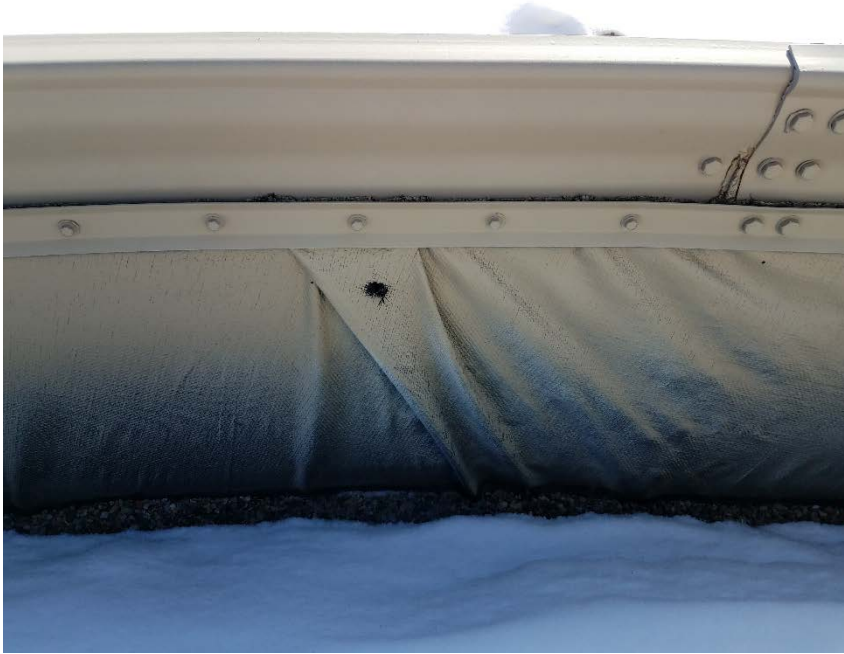
**Location Photo #5, Hole in secondary
containment liner.**
